**Banganarti: Archaeological
Excavation on the Site in 2007**

Polish Archaeology in the Mediterranean 19, 327-341

ARCHAEOLOGICAL EXCAVATION OF THE SITE IN 2007

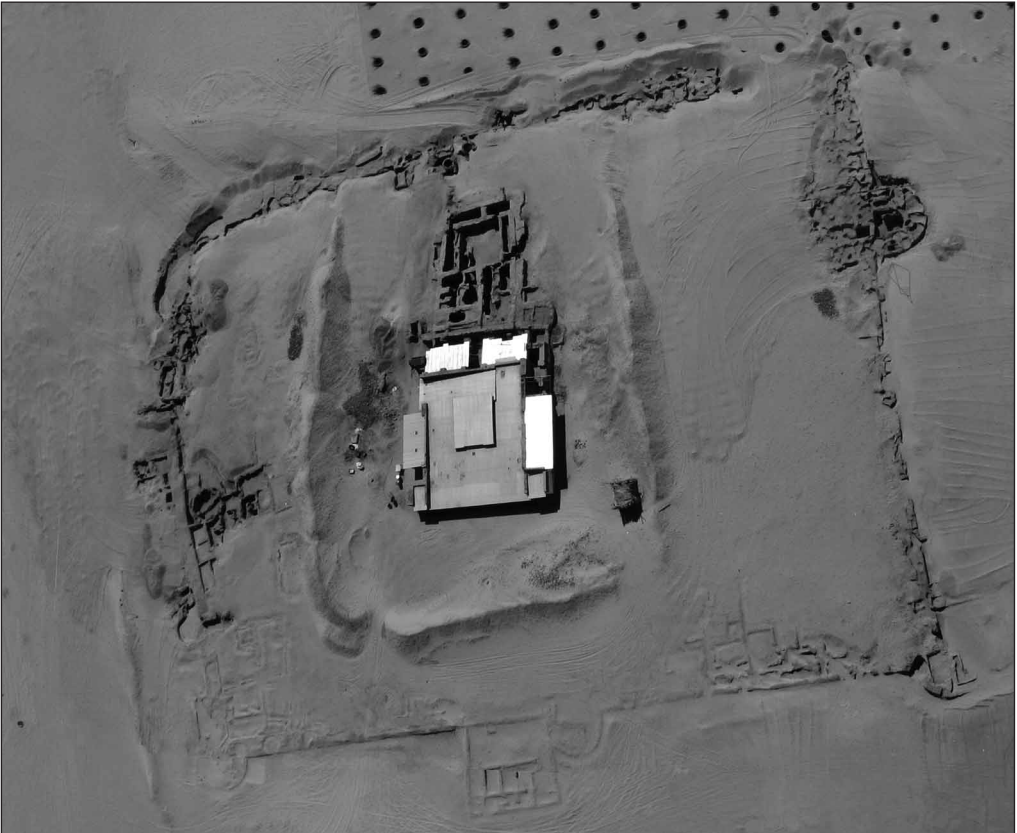
Fig. 2. Aerial (kite) photo of the site after the end of excavations in 2007 (north is as in Fig. 1)
(Photo B. Żurawski)

built alongside the enclosure wall [Fig. 2].

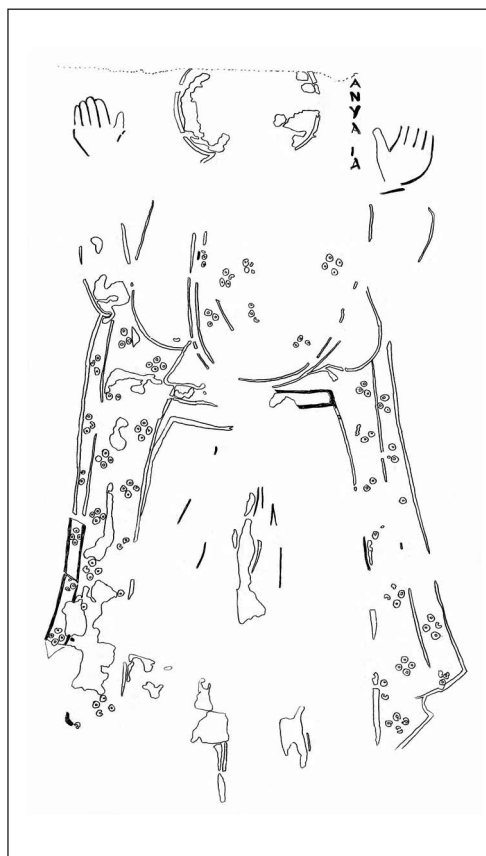
Fig. 7. Orant, wall painting on the west wall in test pit 4b (Drawing L. Piekacz)

The other part of the enlarged trench, test pit 4b, was excavated on the other side of the blocked southern entrance to the Lower Church. Poorly preserved traces of a wall painting were uncovered on the eastern face of the west wall next to the doorway [Fig. 7].

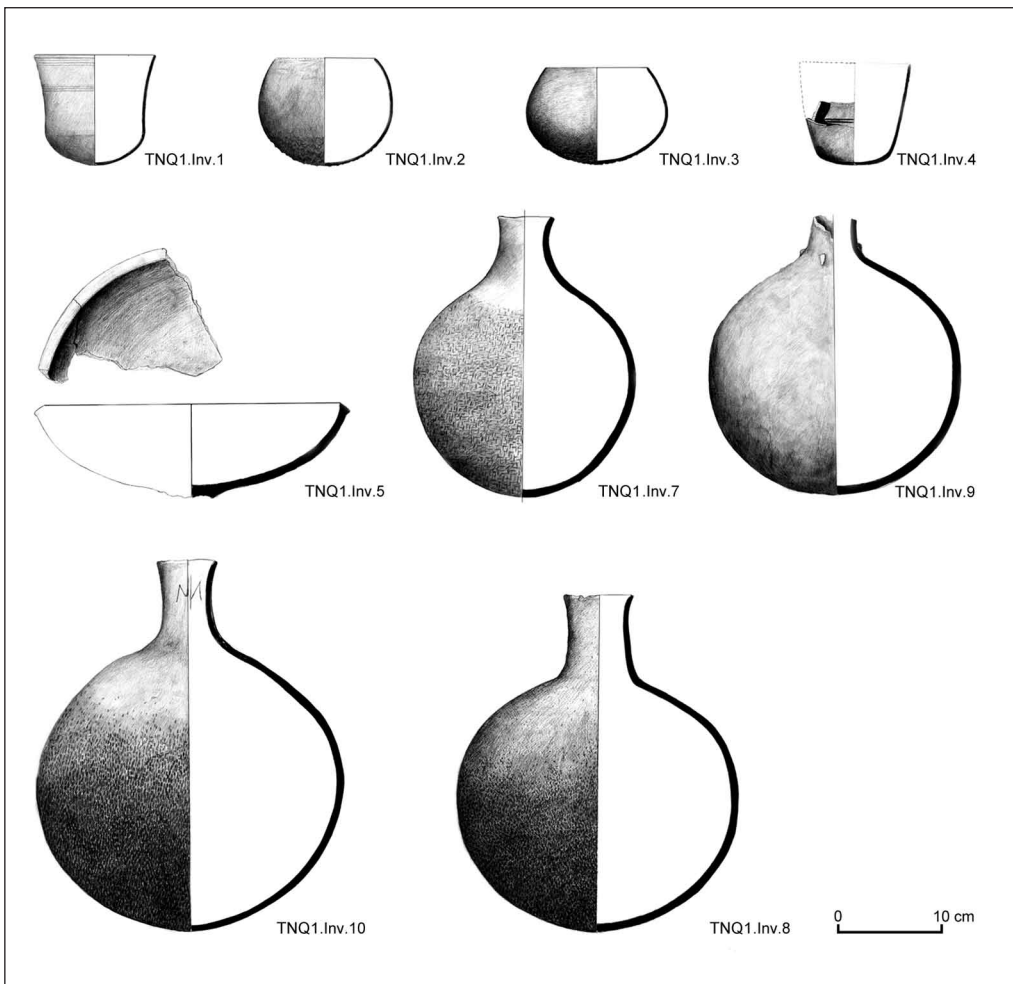
Fig. 8. Clay vessels from the burial chamber of tumulus TNQ1
(Drawing, A. Płaskowska)

An accidental discovery of the pottery furnishings from a post-Meroitic tumulus tomb in the village of Tanqasi, including eight complete bowls — four *qullal*, a cup and two bowls [*Fig. 8*] — necessitated salvage explorations (supervised by A. Płaskowska). There were no traces of a superstructure. The shaft and the burial chamber, which was 1.70 by 0.60 m, the two separated by a row of large stones, were excavated 0.80 m into a hard silty ground. A shallow cavity at the southern end contained the skeleton of a woman aged
