Alexandria: Excavations and Preservation Work on Kom El-Dikka : Preliminary Report 2009

EXCAVATIONS AND PRESERVATION WORK ON KOM EL-DIKKA, PRELIMINARY REPORT 2009/2010

Polish Centre of Mediterranean Archaeology, University of Warsaw

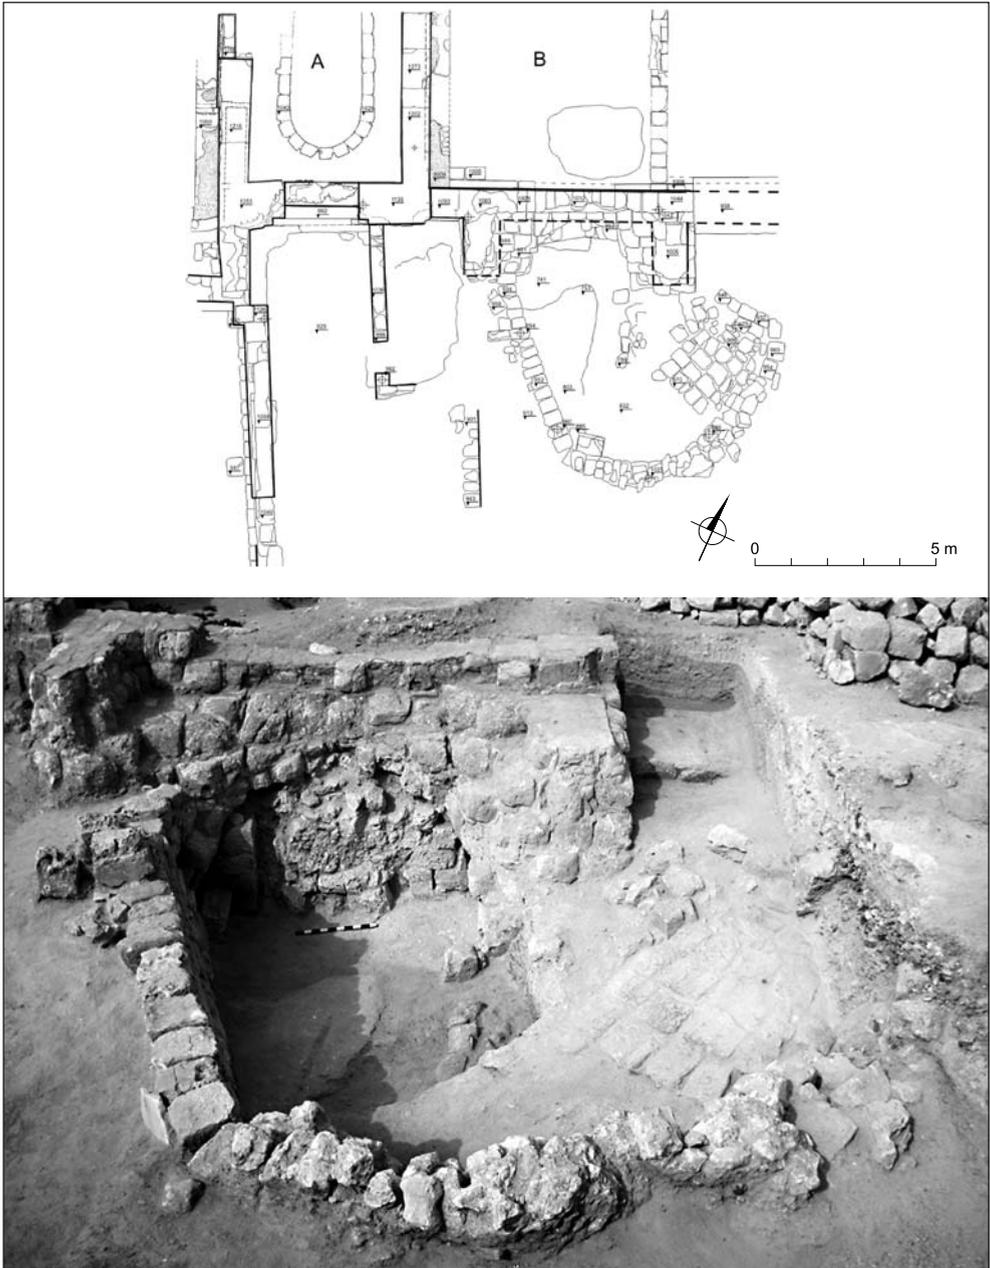
Fig. 3. Western entrance to the basement of the bath: localization plan (top) and view looking north including the ramp (Drawing K. Kamiński, J. Dobrowolski, updated 2010 G. Karpińska; photo E. Kulicka)

The western entrance occupied almost the whole width (approx. 3.05 m) of the underground chamber located directly below auditorium B [Fig. 3]. Previous exploration in this area had shown that the floor level of auditorium B is now substantially lower due to caving in of the original vaulting underneath. The collapse

Preliminary analysis of the structure indicated that the vaulting was constructed together with the huge southern perimeter wall of the bathhouse and should thus be considered part of the original design. The entrance was found to be flanked by two massive, now heavily weathered, buttresses. Both buttresses, some 1.60 m wide, were built in a technique similar to that employed in the construction of buttresses discovered further to the east (area F). A floor level was cleared some 1.70 m below the preserved keystone (the vault is now substantially disintegrated). Made of battered ashes and tamped soil reinforced with lime mortar, the floor attained extraordinary hardness. The most unusual feature, however, was uncovered in front of the entrance. It was a wide, sloping ramp, turning slightly to the left (i.e., to the east) and leading up to the south portico of the bath. While the section next to the entryway had only a tamped-soil floor, the midsection was reinforced with large limestone pavers, and in the top section (on near-ground level) several stone-made steps were cleared [Fig. 3, top]. The chronological and stratigraphical context of the ramp is yet to be resolved. While it appears that the entrance itself was part of the bath's original design, it is obvious that the sloping ramp is of a substantially later date. Even taking into consideration the apparent subsiding of the vault, the cleared floor is definitely too high (approximately 1.70 m below the preserved keystone) to be original. Secondly, its side walls, made of reused large blocks, were placed against a thick stratum of accumulated ashes. Two small lateral pillars, reducing the original width of the

entrance, rest on the tamped floor and were therefore a later addition. The general direction of the ramp implies the presence of an additional door in the perimeter wall, next to auditorium B. To conclude, the ramp must have been formed following the transformation of nearby halls A and C into auditoria (late 5th–early 6th century AD); its construction cancelled out the original access to the bath basement. On the other hand, it is quite obvious that the original floor level of the basement could be found underneath.

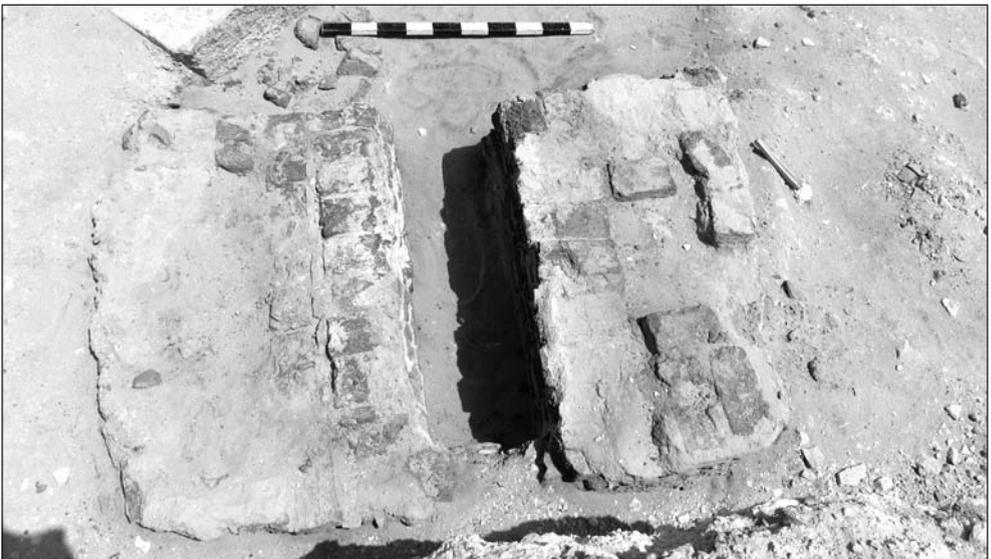
Fig. 4. Oven in area Q
(Photo G. Majcherek)

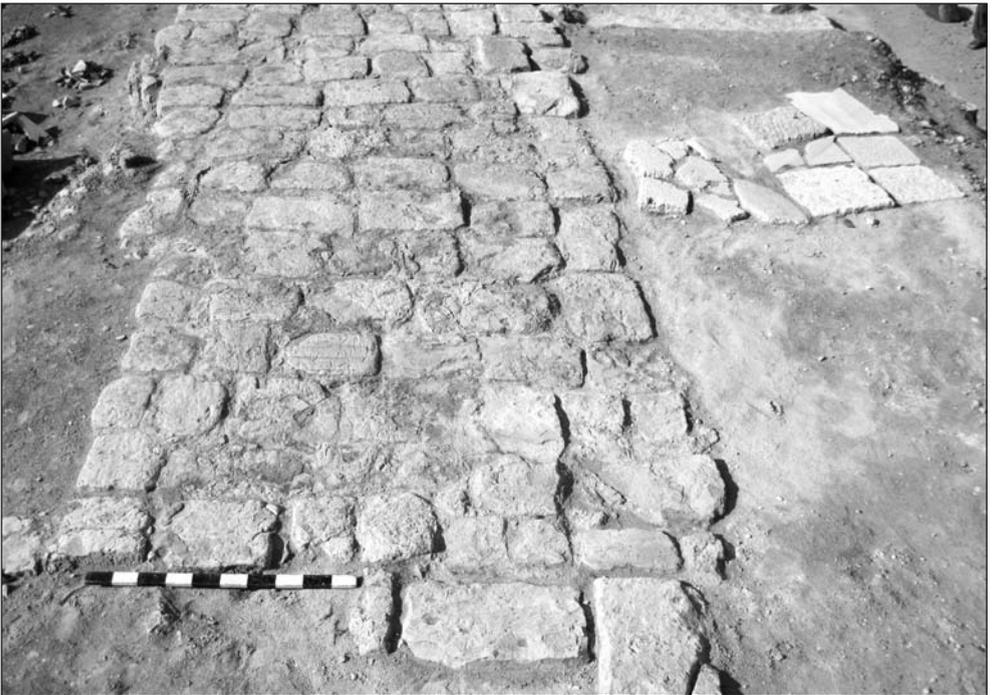
Fig. 5. Late pavement in area Q
(Photo E. Kulicka)

corresponding with that of the southern bath portico, although no original paving was preserved there. A higher level, however, produced a series of metallated floors, usually reinforced with lime, crushed bricks and pottery. It apparently lost its original function. A large brick-masonry kitchen oven occupied the middle of the area [Fig. 4]; similar ovens were previously cleared in the vicinity (Rodziewicz 1984: 278–279, Figs 295–296). It seems that towards Late Antiquity the entire area gained a new, service function, catering to bathers' needs. Still later the whole area was backfilled, substantially raised and repaved with reused pavers [Fig. 5]. However, the purpose of this refurbishment remains unclear. The chronology of this latest phase

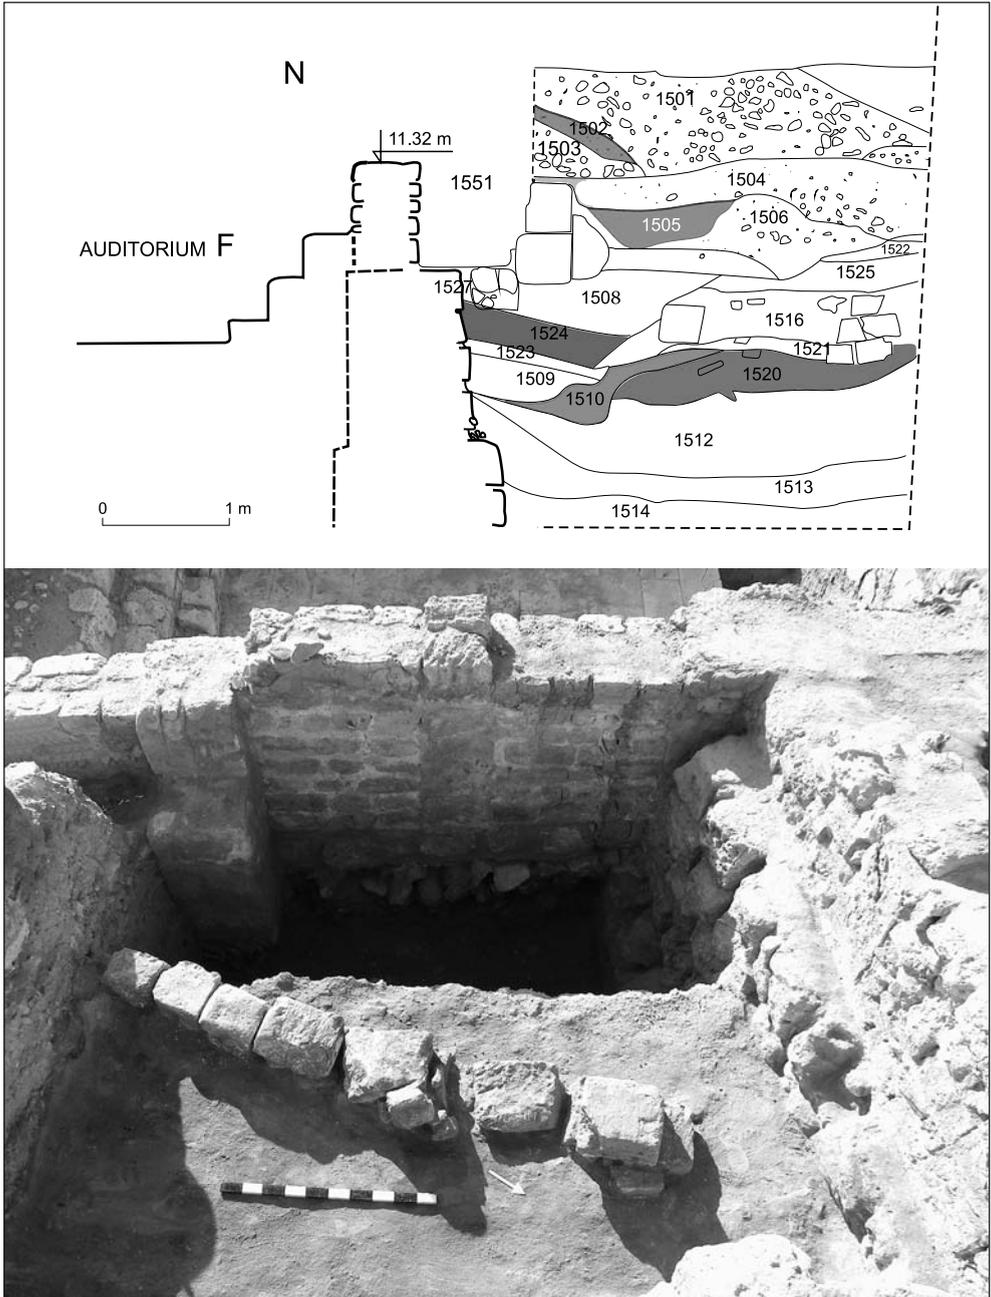
Fig. 6. Trench H-east. Section, east trench wall (top); view of east wall of auditorium H from the west (Drawing K. Lach, A. Smilgin; photo Ł. Wójnarowicz)

The other trench, H-east, dug in the corner formed by auditoria F and H, produced similar stratigraphical and chronological results. The east wall of auditorium H (structured in the pillar technique) was built in a deep trench, cutting through the thick deposits of urban refuse and ashes [*Fig. 6*, bottom]. Finds from layers predating the cut pointed to a rather surprisingly late date (6th century AD) for the construction of the wall [*Fig. 6*, top]. This may seem to collide with earlier findings concerning other auditoria and calls for a substantial chronological reappraisal. However, the footing of the wall foundation was placed level with the floor in auditorium H and as such could not have been part of the original design, but rather a later rebuilding or adaptation. The south wall of auditorium F, structured in the typical pillar technique, was also built on top of a huge, earlier construction. Although found in a very deep trench, its surface appeared to be heavily weathered — clear evidence of prolonged exposure. This heavily buttressed wall, made of large ashlar, shares the technique, mortar type, size of ashlar and other features with other structures of apparently earlier date preserved in the vicinity, such as the walls dividing auditoria F and G, and auditoria A and B, as well as the huge perimeter wall at the southern limit of the bath complex

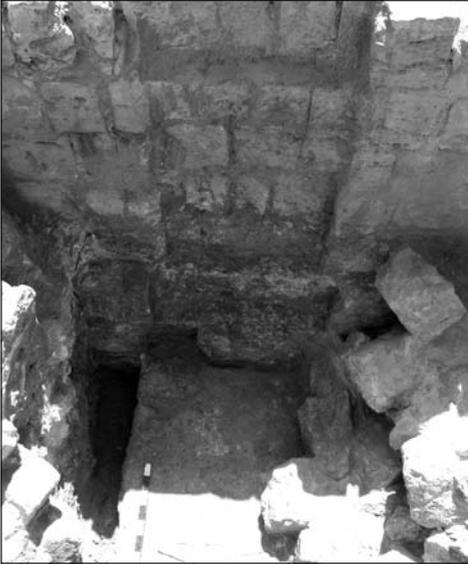
Fig. 9. Abutment of the east–west wall and the portico back wall (Photo A. Smilgin)

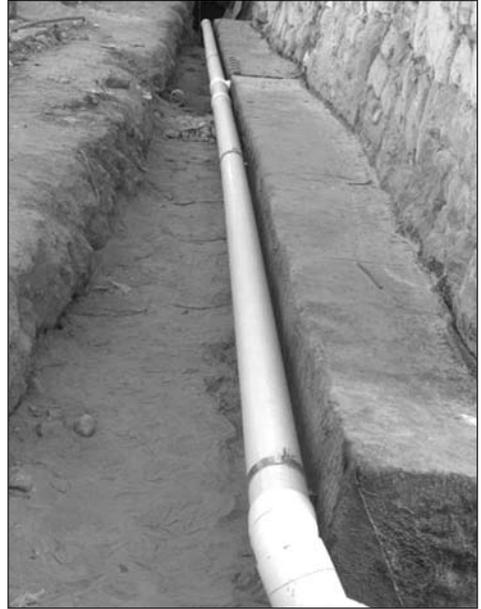
Fig. 10. Consolidated foundations and rainwater drainage of the east wall of the mosaic shelter (Photo J. Brochocki)

The foundations of the east wall of the shelter, which made use of a Late Roman wall, were cleared down to the footing

along the entire length of the wall (approximately 16 m). The deteriorated wall structure was repaired, missing or deteriorated blocks being replaced with new ones and the whole foundation consolidated with new mortar. The top and side surfaces of the foundations were rendered and waterproofed with pitch coating [Fig. 10]. Additional waterproof coating of double-folded polyethylene insulation sheets was applied for more effective anti-damp protection. To prevent further water penetration, the wall coping was consolidated and reshaped with a slight fall towards the outside.

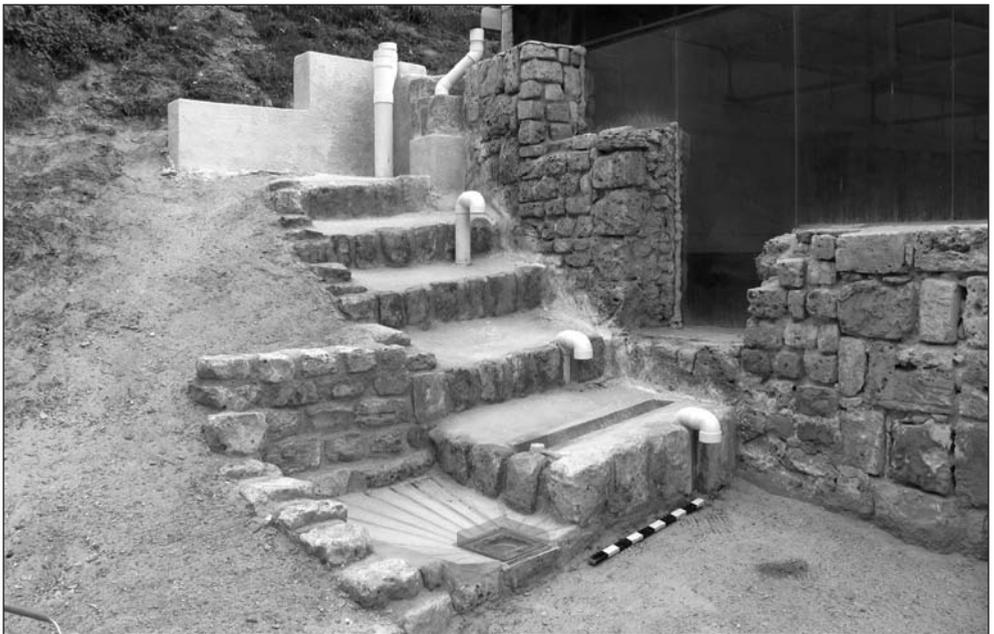
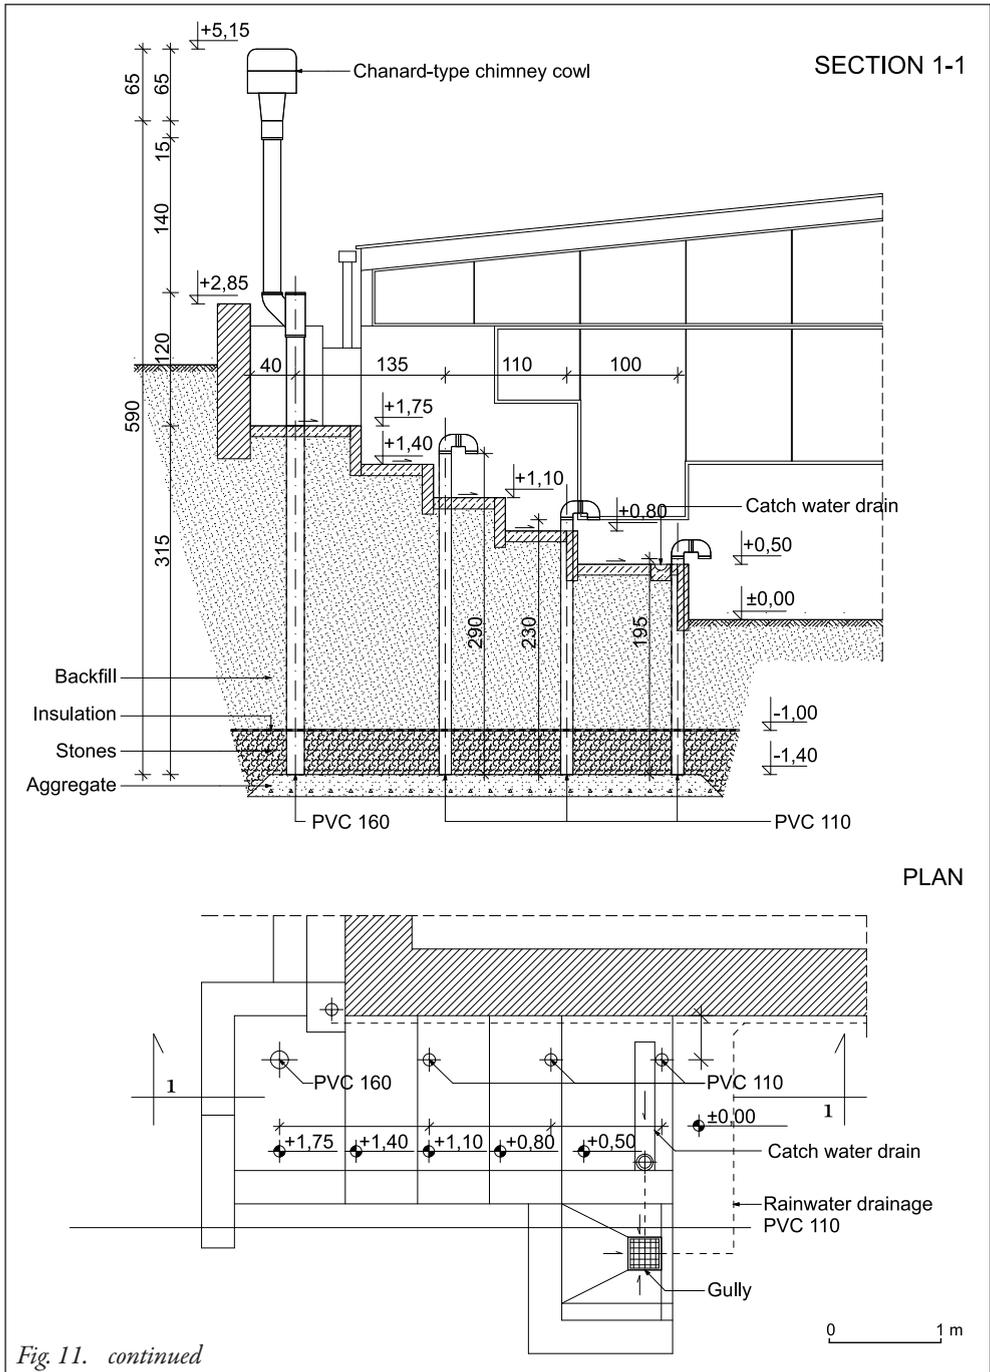
Fig. 11. Redesigned drainage system, plan and section (opposite page) and view of the southeastern corner of the shelter with the new drainage in place (top)
(Drawing Z. Nawrot, M. Polak; photo G. Majcherek)

The faulty rainwater disposal system was redesigned to collect rainwater from both roof slopes and to drain it off to a nearby ancient well [Fig. 11]. The gutters were either remodeled or new ones, shaped of squared sheet iron, introduced along the eaves of the roof. New downspouts (PVC Ø 100 mm) were installed at the eastern ends of both gutters. The downpipes discharged into the main drain (PVC Ø 100 mm) buried along the east wall, emptying into an ancient well located north of the shelter. The installation took into account Alexandrian climate, being designed to cope with frequent copious winter downpours.

An additional drying installation was introduced in the southeastern corner of the shelter, which is the part of the structure that is the most liable to water seepage and hence most endangered [see Fig. 11]. As in other locations along the eastern elevation, the foundations were first consolidated and pitched. Then, the trench was filled with aggregate and gravel. Ventilation shafts of PVC pipes of varying length, corresponding to the rise of the ground, were installed vertically at 1.00–1.30 m intervals. The largest shaft (PVC Ø 150 mm, 5.15 m long) was positioned in the corner and was topped with a turbovent-rotary chimney cowl (Chanard-type). Considerable differences of atmospheric pressure have made the installation extremely effective in removing damp from the lowermost part of the foundations.

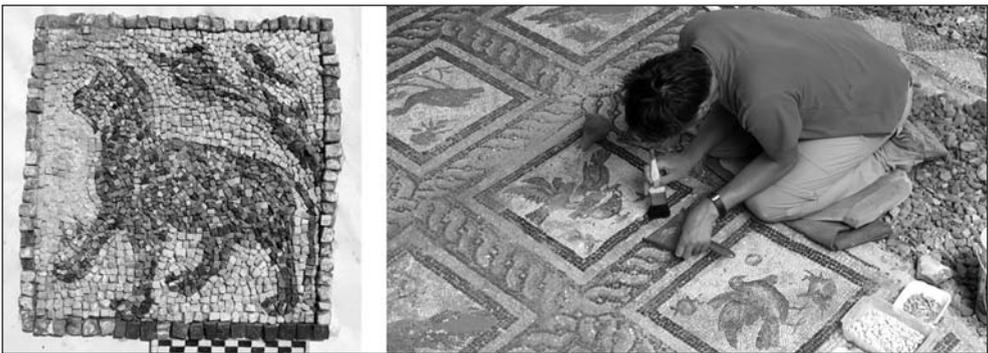
Fig. 12. Conservation of mosaics: detached emblema during conservation (left) and work on the mosaic floor (Photos G. Majcherek)

The mosaics were likewise consolidated. Conservation *in situ* carried out in the late 1990s in accordance with the premises of the Villa of the Birds Conservation Project had not anticipated certain problems. The draining system installed at the time proved insufficient to secure a stable environment; seasonal and daily variations of temperature and humidity caused salt precipitation and rapid deterioration of the multi-colored tesserae (both marble and glass ones) and lime mortar bedding. Two of the most endangered mosaics were treated this season. The central emblema (21 cm by 22 cm) of mosaic α -6 (“Panther mosaic”) was detached and consolidated [Fig. 12, left]; some disintegrated glass and faience tesserae were removed and replaced with new ones. Losses were likewise completed with ancient cubes retrieved during excavations. A new layer of limestone mortar with ground marble filler and acrylic resin PLEXTOL B 500 was applied on the backing. The emblema was

then relaid on an aluminium honeycomb panel (2.5 cm thick), the support fixed with ARALDITE and reinstated. Mosaic α -5 (“Mosaic with Birds”) was treated likewise [Fig. 12, right]. The surface was thoroughly cleaned and salt efflorescence removed mechanically. Some loose tesserae were fixed, decayed lime mortar and voids under the tesserae treated by injecting new mortar and the edges of the mosaic repaired. Mosaic α -3 (combining *opus tessellatum* and *opus sectile* techniques) was also secured. Its surface was cleaned and damaged sections of edges fixed. Conservation of the mosaics will be continued next season.

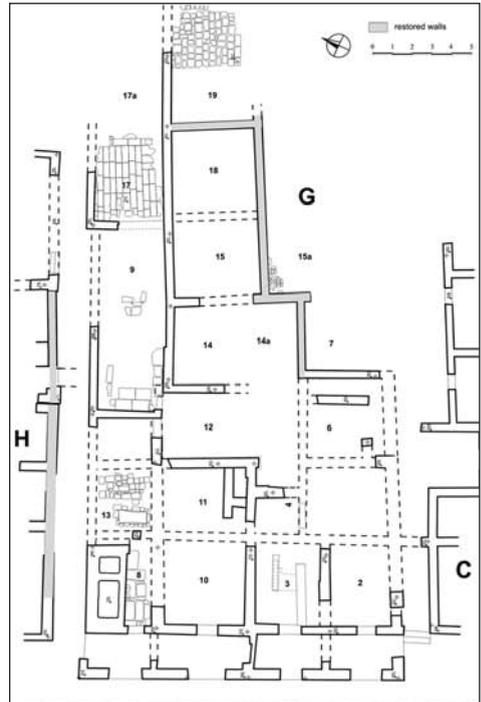
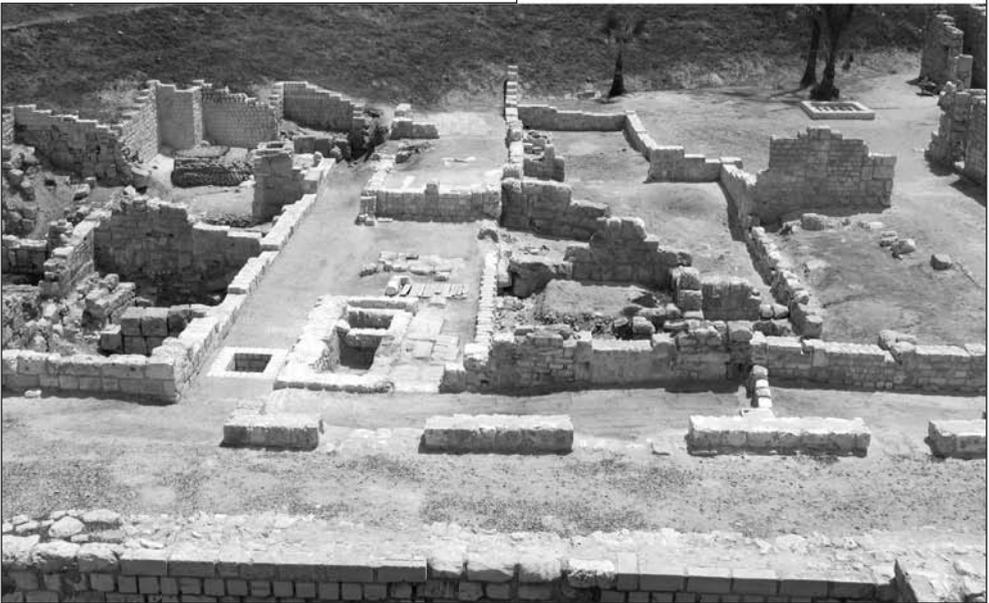
Fig. 13. Houses G and H, following wall restoration in 2010, looking east; top, plan of the area, restored walls marked in gray (Drawing K. Karpińska; photo G. Majcherek)

The south and east walls of room G18 were restored (altogether a stretch of 9.5 m) and the south walls of rooms G15 and G14a were also rebuilt. The restoration stopped one course above ground level as the excavation did not record the location of doors [Fig. 13, far back]. Most of the original walls (as evidenced by the extant sections) were structured in the pillar technique with a large block made of pillars set at regular intervals and the space between them filled with smaller assorted stones. In building H conservation was limited to the consolidation and partial restoration of the southern elevation [Fig. 13, top]. A large section of the wall (approximately 14 m long, 0.45–0.50 m thick) enclosing the southern wing of house H was restored to a height of approximately 1.10–1.30 m. Here the wall was structured in regular masonry with large ashlar set in isodomic courses. The restored wall courses were separated from the original masonry with a layer of bitumen tar paper, acting as both

A narrow east–west lane (perpendicular to street R4) dividing houses G and H was re-arranged to prepare the area for public display [see *Fig. 13*]. The operation included backfilling of some post-excavation trenches and surface leveling. A city sewer of Late Roman date running along the lane was also subjected to limited conservation. Several sections along the southern elevation of house H were consolidated and a manhole giving access to the sewer was partly restored. The manhole coping was rebuilt and made flush with the street level to secure safe traffic for visitors.

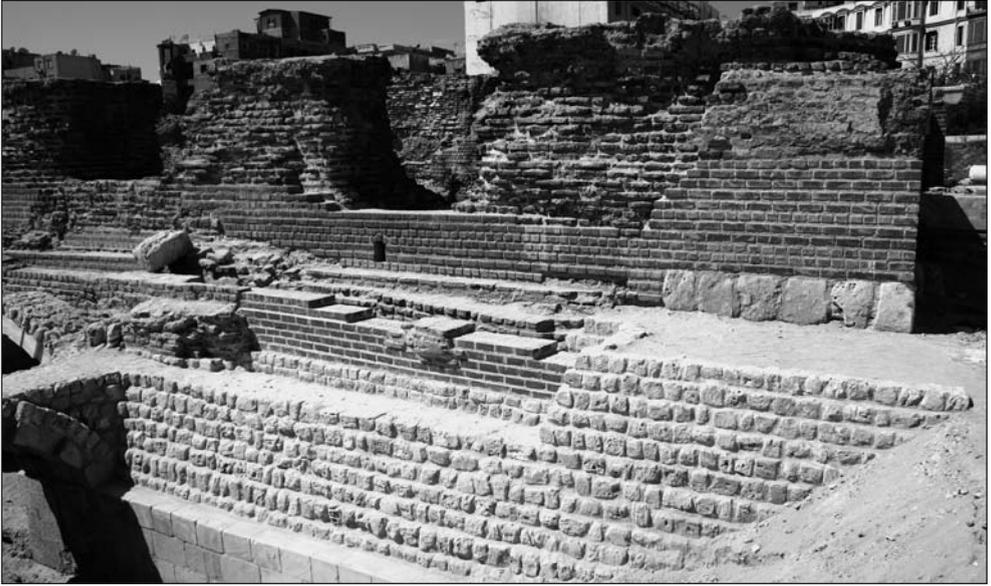
*Fig. 14. Restored channel in the southeastern corner of the bath
(Photo A. Pisarzewski)*

In the bath area, a modern stairway down into the cellar continued to be constructed; three steps were done out of the planned seven. A fragment of a channel running along the southern elevation of the bath was restored instead [Fig. 14]. The channel was originally designed to drain waste water from tubs and basins located there. Built of red bricks, it was lined with waterproof mortar and covered with unusually large limestone blocks. The channel was sunk in a pavement of assorted fragmentary slabs of marble and nummulitic limestone. Conservation procedures involved not only consolidation and partial restoration, but also re-integration of some loose wall fragments found *sub situ*.

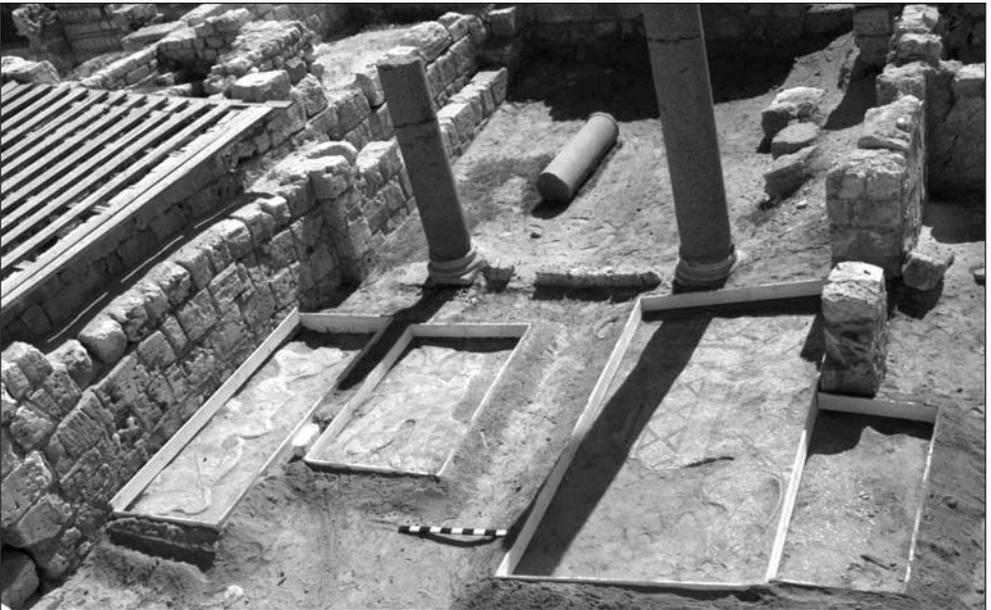
*Fig. 15. Mosaics protected in area F (House FB)
(Photo R. Mabler)*

Current maintenance preservation included, as usual, multiple locations and issues, ranging from basic procedures applied to wall fabric (tapping and grouting) to more elaborate ones, like stone replacement and shaping the wall coping. Measures were also taken to protect a fragmentary black-and-white mosaic with a geometric design discovered in house FB (Majcherek 1999), which was threatened by continuous heavy rains and vegetation. To preserve the integrity of the mosaic and to shield it from rainwater, the mosaic was protected with a specially built wooden casing [Fig. 15] and covered with a thick (0.15–0.20 m) protective layer of clean sand.
