Church of Mar Elias Btina in Beirut (Lebanon) and its Wall Paintings : Conservation Project Report

Polish Archaeology in the Mediterranean 23/1, 403-414

2014

CHURCH OF MAR ELIAS BTINA IN BEIRUT (LEBANON) AND ITS WALL PAINTINGS. CONSERVATION PROJECT REPORT

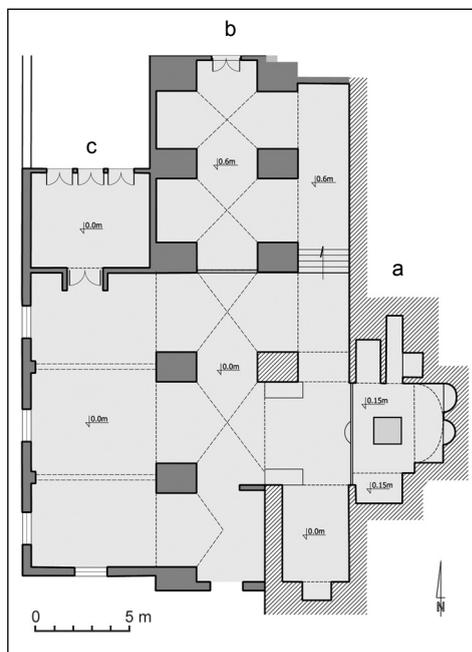
The church edifice was incorporated into a building that was raised in the final quarter of the 19th century to house a monastery. The main body of this edifice is square in plan, three floors high (including the ground floor) and has a large central courtyard [Fig. 2]. An external staircase on the north wall of the building leads to the first floor, which features two-level galleries opening onto the central court, the semicircular arcades supported on slender columns. The church occupies the west wing of the building up to the level of the first floor. The interior consists of three stylistically different parts that are also chronologically distinct, resulting in a fairly complex and heterogeneous layout [Fig. 1].

The earliest, eastern end of the church features a small, square presbytery [Fig. 1:a]. The walls and barrel vaulting were hewn from solid rock. The upper

Fig. 1. *The Mar Elias Btina College in Beirut* (Plan S. Lenarczyk, M. Puskarski)

part of the east wall terminates in a broad, hemispherical conch, below which are two small niches. Two small rooms of irregular shape adjoin the north wall, with a slightly wider room abutting the south wall. A cuboid altar of stone stands in the middle of the presbytery. A wooden iconostasis separates the presbytery from the remainder of the church. The principal section of the interior [Fig. 1:b] was constructed along with the monastery complex in the 19th century. Its broad expanse is divided by a row

of pillars supporting a groined vault. At the north end this part of the interior is around 2 m higher, forming a kind of choir loft accessed by a few steps. The east and southeast walls (like the adjoining presbytery) were excavated in solid rock, the remaining walls are masonry. The most recent addition to the church is the west end [Fig. 1:c], built in the 20th century. This part of the church interior was enlarged by introducing a flat ceiling over it and preceding it by a small vestibule through which the church is entered.

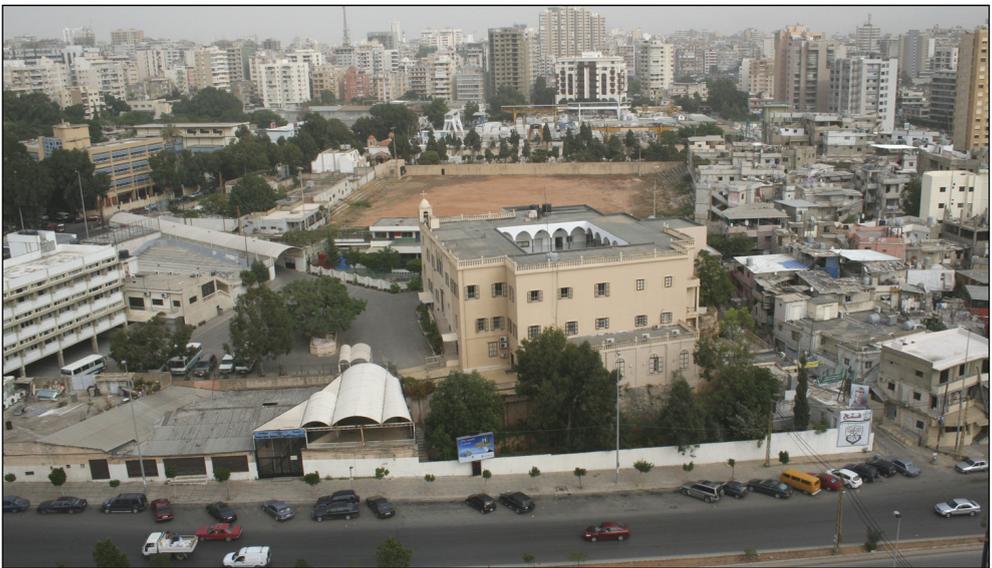
Fig. 2. *The Mar Elias Btina College in Beirut nowadays*
(Photo M. Żelechowski-Stoń)

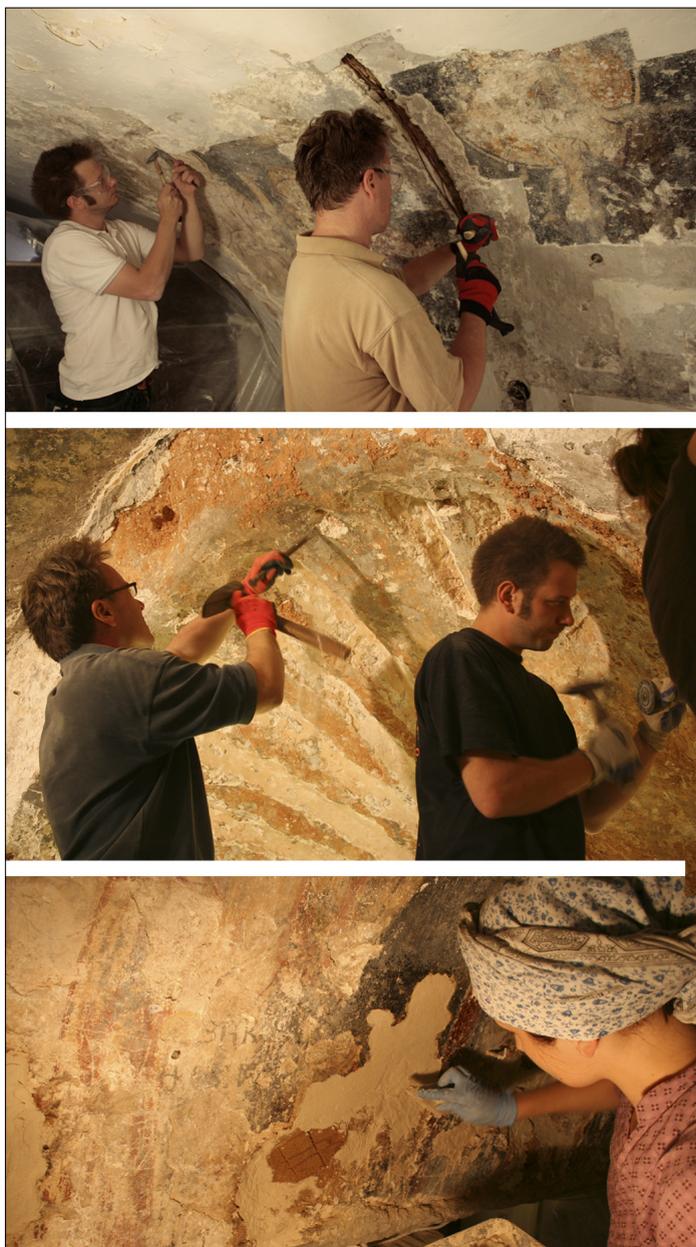
The wall paintings were uncovered in stages, removing carefully with knives, hammers and scalpels the overlying plaster layers [Figs 3–5]. In 2010, the extant murals covering the upper section of the concave wall surfaces of the presbytery

Fig. 3. Uncovering the wall paintings in the presbytery of the Mar Elias Btina church: top, removing plaster coats from paintings on the north wall; center, removing non-original plaster from the conch (discernible shape of the carved shell decoration); bottom, new mortar filling gaps in the murals on the south wall (Photos M. Rogowska)

- consolidation of delaminated plaster,
- structural reinforcement by impregnation of plaster with synthetic resin,
- securing of damaged plaster edges with fresh mortar,
- surface cleaning of murals to remove layers of secondary calcite, salts, black soot and dirt,
- impregnation of weakened paint layer where necessary,
- filling of losses in the carved stonework of the conch with fresh mortar,
- filling of plaster losses in the wall paintings and vaulting with fresh mortar,
- chromatic integration of the fresh mortar used on the surface of both the conch and vault.

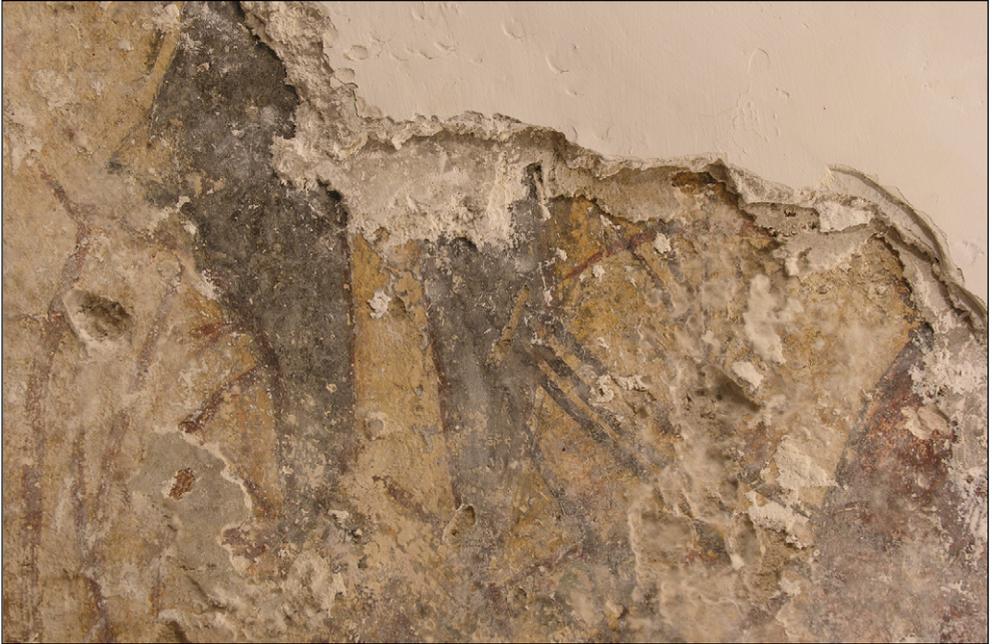
The unexpected falling of a piece of white wall plaster from the north wall of the church presbytery in 2007 uncovered a fragment of damaged wall painting. Conservators from the Academy of Fine Arts in Warsaw, then working on another project in Beirut, were called in to test the plaster coats in the oldest part of the church for other wall paintings and, once the presence of murals was established, the decision was taken to remove all secondary coats of plaster and to undertake essential conservation measures. This work was carried out over two summer campaigns held in 2010 and 2011.

*Fig. 4. Fragment of wall painting uncovered by chance in 2007
(Photo K. Chmielewski)*

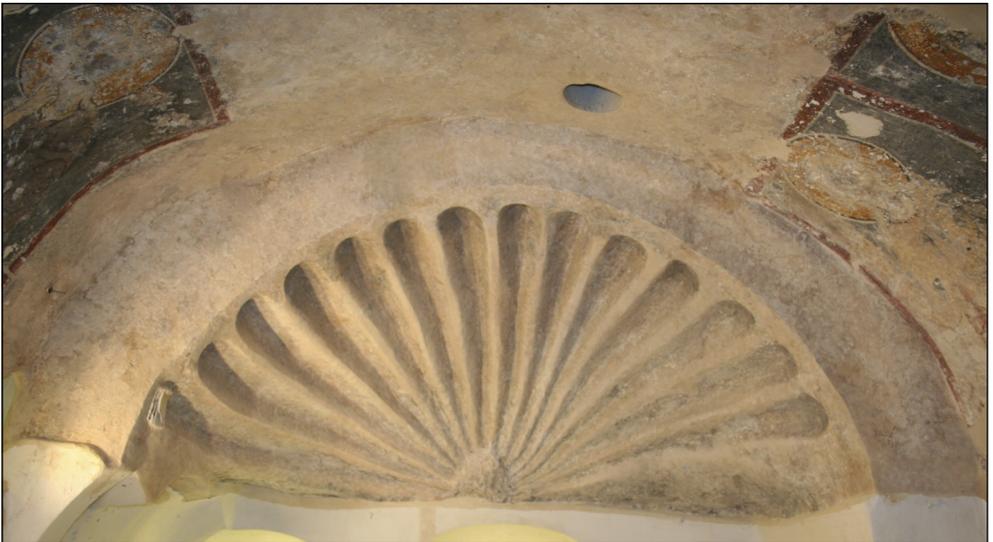
*Fig. 5. Conch with carved shell decoration after treatment
(Photo M. Rogowska)*

a monumental shell carved in solid rock. Its sculpted form gradually became discernible as successive layers of secondary plaster, in some areas as many as ten, representing successive episodes of reno-

vation, were removed. Some of these layers were additionally painted a homogeneous grey or dark blue, others were white or clay-colored. The end effect was a complete obscuring of the details of the shell.

The carved shell discovered in the conch of the presbytery probably dates from Late Antiquity, attesting to a larger architectural structure, such as a tomb (for an almost identical conch from the Roman period, see Deir Mar Touma in Saydnaya in Syria, Castellana, Di Bennardo, Fernández 2007: 133 and 139, Figs 98 and 110). In the medieval period, it was incorporated into the interior of a church or chapel built on the site.

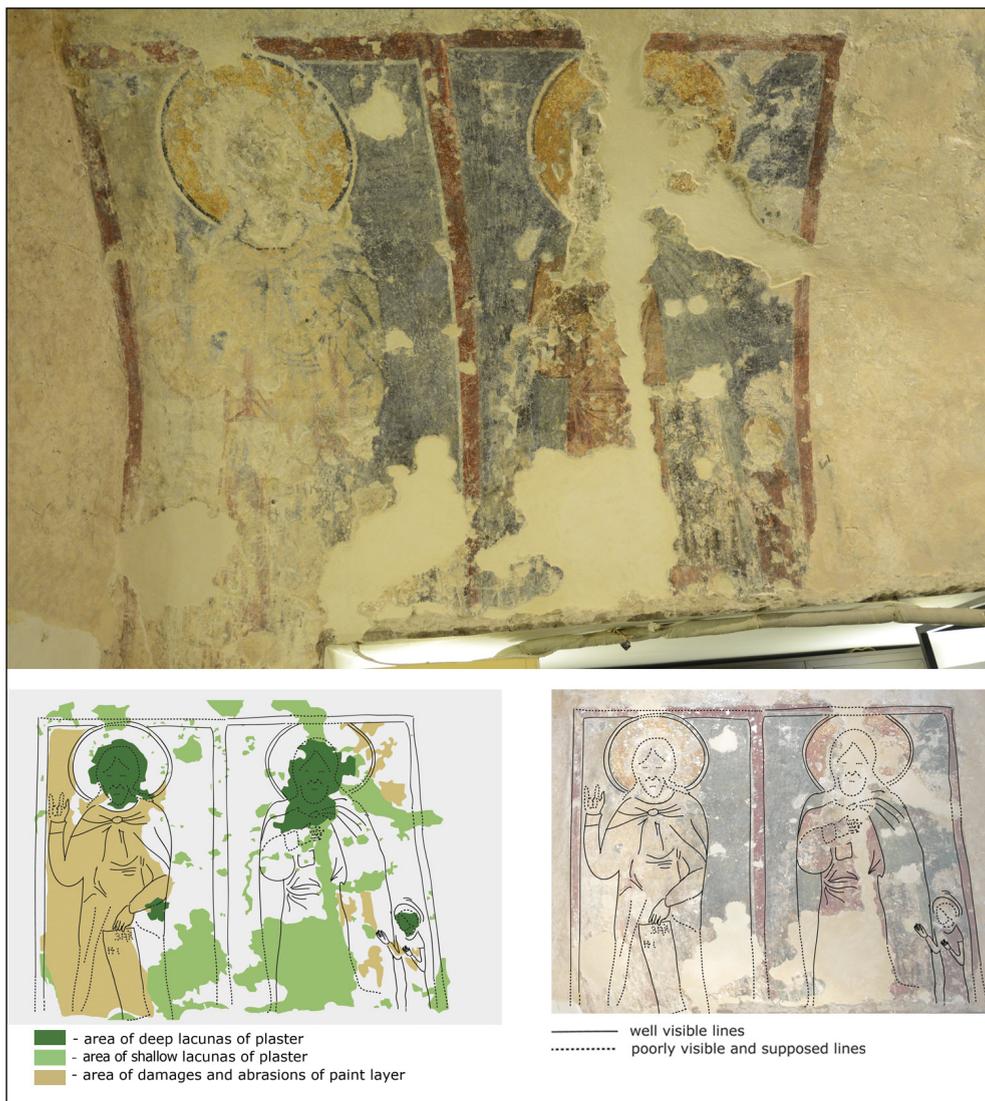
The south wall of the presbytery bore two compositions depicting two figures of unidentified saints standing against a grey-blue background. The painting was damaged, surviving only partly in the underlying drawing. The figure on the

left holds the right arm aloft, bent at the elbow, in a gesture of benediction. The left arm hangs loosely, the hand clutching an unfurled scroll, on which several damaged and poorly legible Greek letters can be seen. The saint wears an undergarment and a mantle around his shoulders, which is fastened on the chest [Fig. 7].

The saint on the right is similarly attired in a red robe with a green mantle around his shoulders. His right arm is bent at the elbow with the hand poorly discernible; in his left hand he holds a damaged scroll. To the saint's lower left is a small, standing figure (donor?) clad in a red robe, the arms raised in prayer. The faces have been lost,

Fig. 7. Composition of two standing saints on the south wall: top, painting after treatment; bottom left, map of lacunas; bottom right, clarifying drawing (Photos M. Rogowska, drawings M. Żelechowski-Stoń)
