Polish Archaeology in the Mediterranean 13, 23-29

KOM EL-DIKKA

PRESERVATION WORK, 2000/2001

Wojciech Kołataj

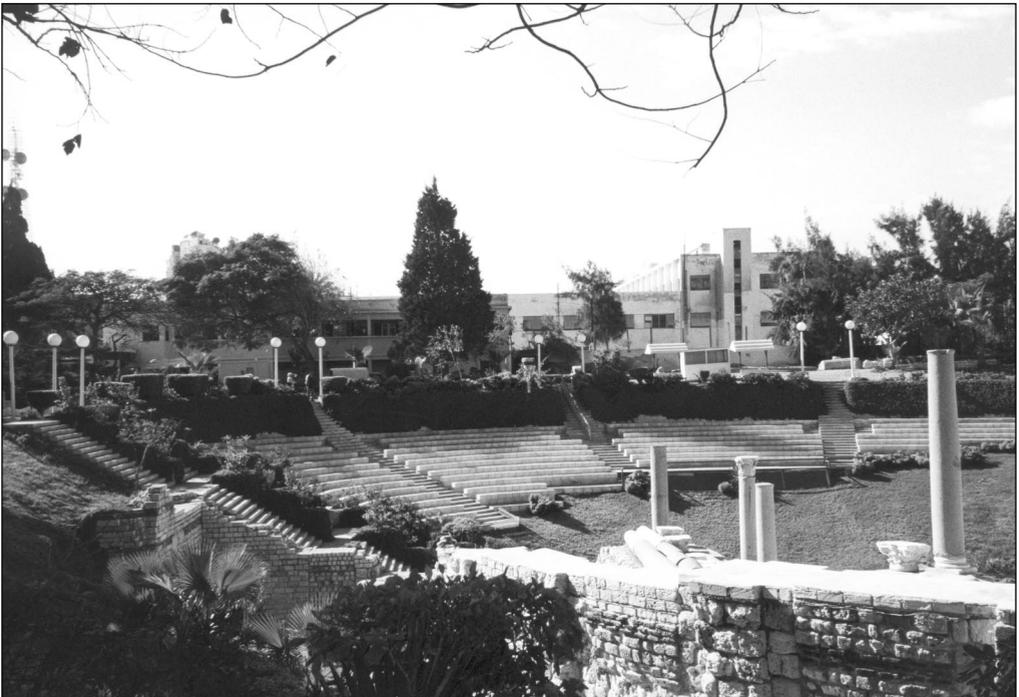
Fig. 1. New auditorium erected west of the ruins of the ancient theatre (back wall visible in the foreground) (Photo W. Kołataj)

The abrupt decision of the Egyptian authorities, in August 2000, to build a new auditorium on the slope opposite the ancient theatre on the Kom el-Dikka site came as a total surprise. Within three weeks, during the summer break in archaeological work, a big part of the stone-built auditorium was erected (*Fig. 1*), as well as a showy staircase which extends the Roman street in front of the theatre to the south. Thus, an architectural conception that I had proposed several years ago has finally been given shape (see previous reports in PAM).

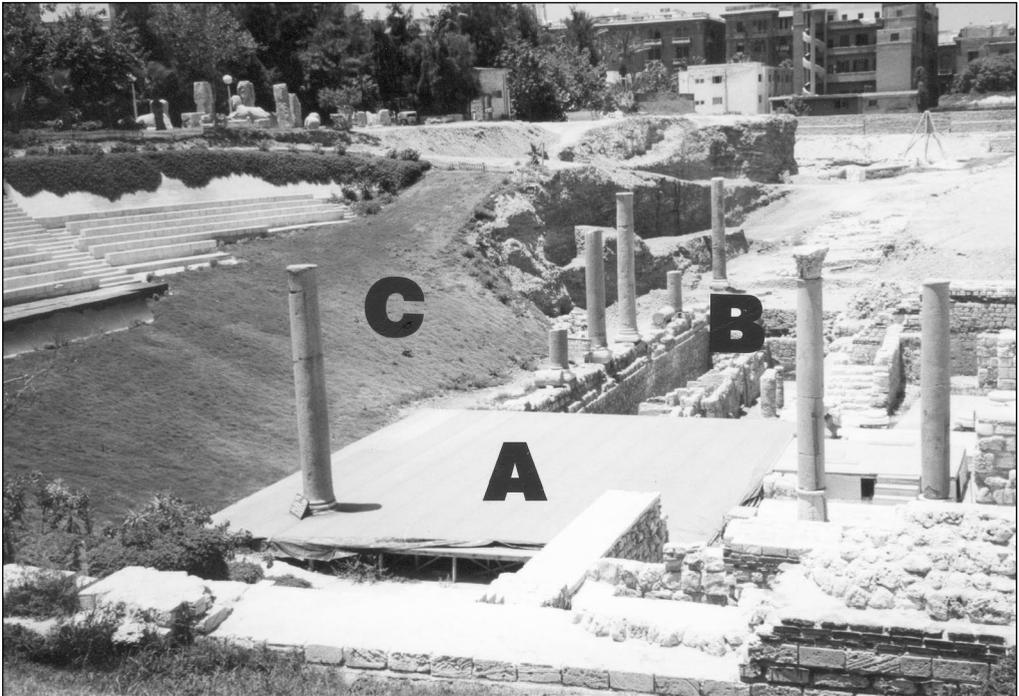
Fig. 2. Area west of the ancient theatre: A, B, C problem areas requiring a solution in the future (Photo W. Kołtataj)

- How to construct the new wooden stage-platform so that it does not inter-

fere with the tourist flow (*Fig. 2: A*)?

- How to connect the newly excavated area and the future mosaic-floors display in this area with the modern structure (*Fig. 2: B*)?
- How to extend, if at all, the new auditorium to the north (*Fig. 2: C*)?
- How to drain away rainfall water?
- Why the material used in the new structure is not of appropriate quality?

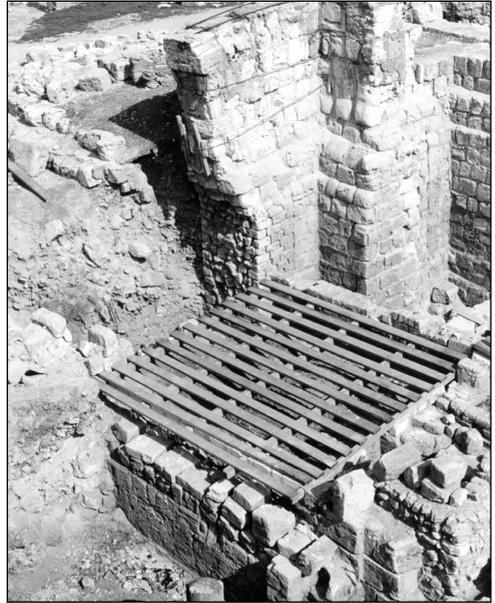
Fig. 3. Roman baths. Western section of the southern outer wall before anastylosis (Photo W. Kořataj)

In the bath, the southern outer wall of the complex in the western section was completed. Major parts of this wall were reconstructed using original blocks found during excavations (*Figs. 3, 4*). Nearby, one of the underground vaulted chambers (probably the eastern entrance to the underground service area) was protected and partially reconstructed. The work will be finished next season once the existing part of the outer wall has been cleaned and examined archaeologically. The cellar, fitted

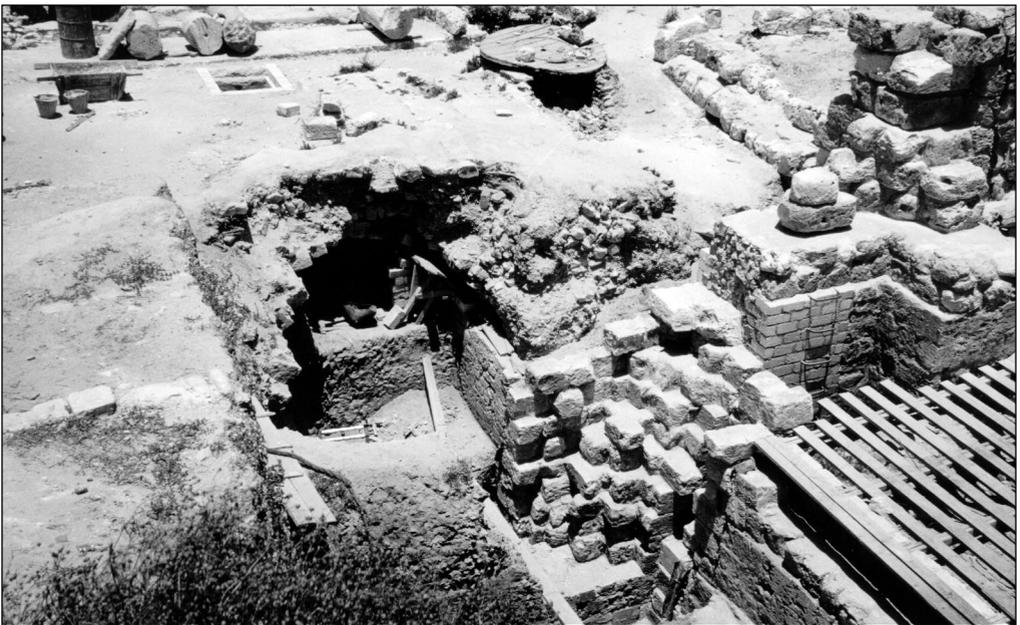
Fig. 4. Roman baths. Western section of the southern outer wall after anastylosis (Photo W. Kořataj)

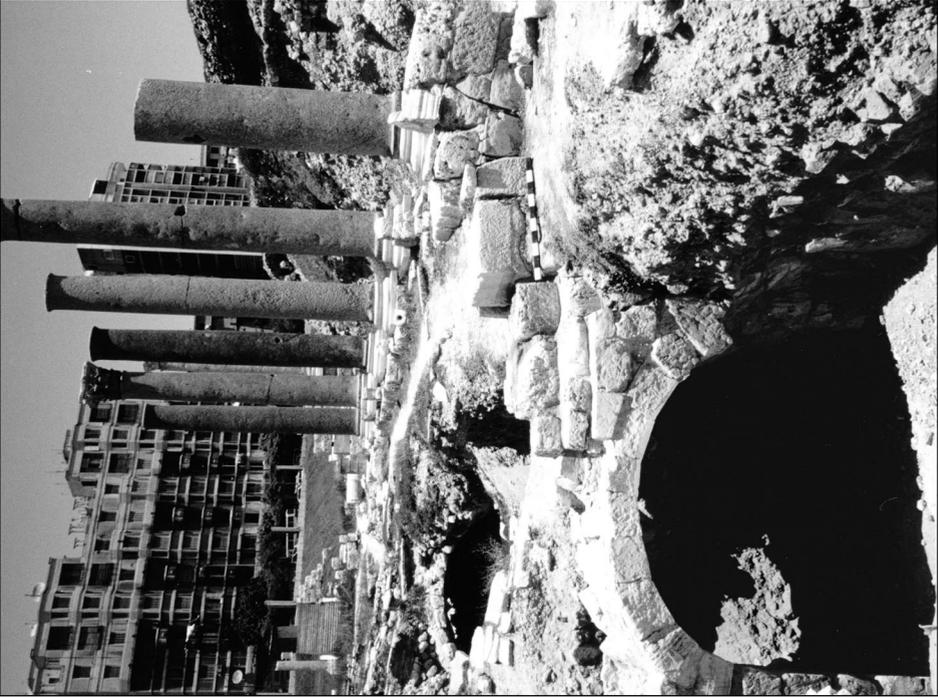
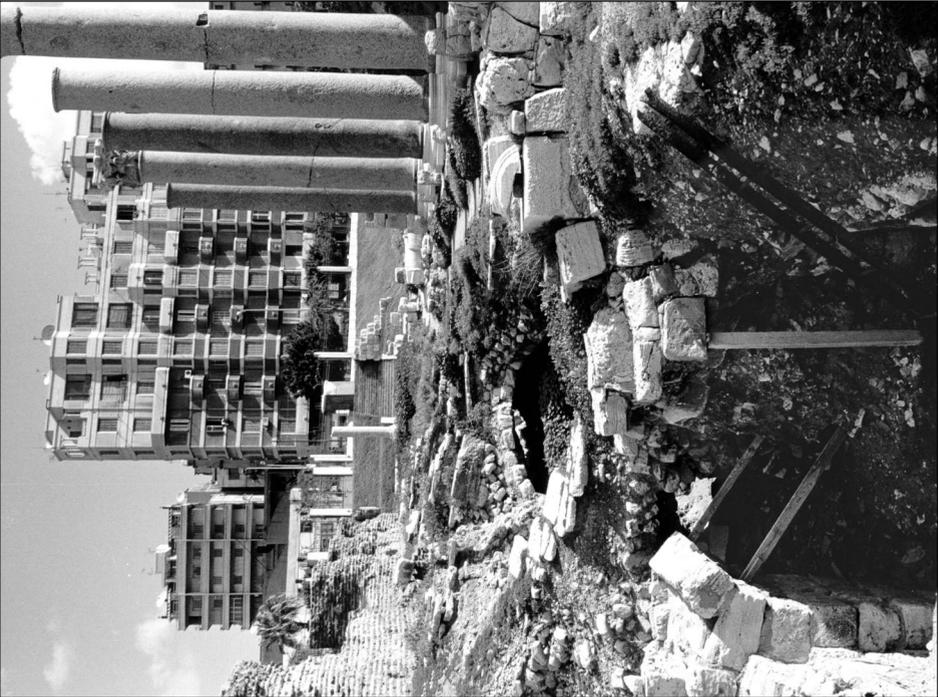
Fig. 5. Roman Baths. Gateway arch of the southern section of the underground service area corridor before (left) and after reconstruction
(Photo W. Kotqataf)

In the southern section of the corridor of the underground service area, in its western part, a gateway arch was protected and partially rebuilt (*Fig. 5*).

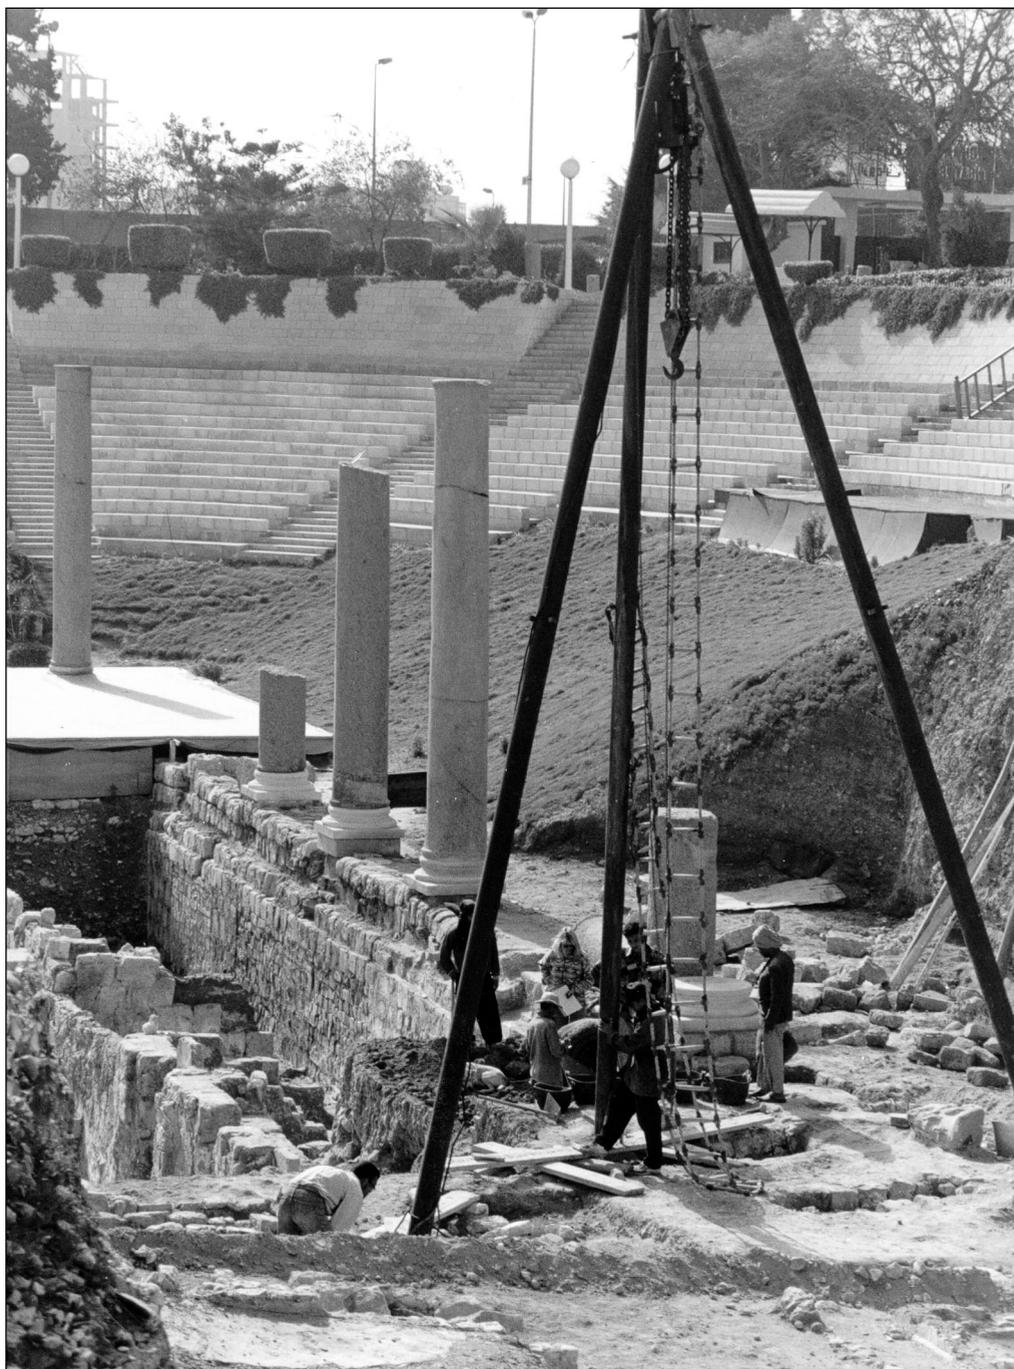
*Fig. 6. Theater Portico. Raising another two columns discovered during excavations of the portico
(Photo W. Kořtáj)*

In the theatre portico, the planned anastylosis of the two newly uncovered columns took place (*Fig. 6*) and preparations were made to raise three other columns in the coming season (two of them in the northern wing of the portico). In the Villa of the Birds shelter, a new rainwater gutter at the southeastern corner was installed in order to better protect that part of the structure against rising damp.
