Polish Archaeology in the Mediterranean 14, 237-252

THE SOUTHERN DONGOLA REACH SURVEY PROJECT, 2002

Bogdan Żurawski

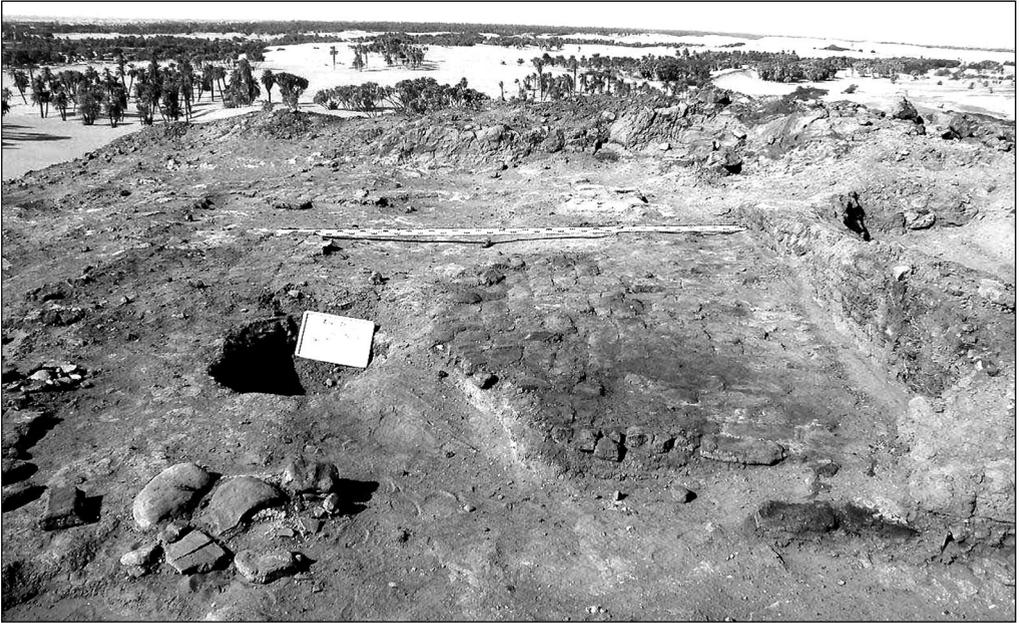
*Fig. 1. Site of the Abkur (Istabel) fortress church
(Photo B. Żurawski)*

chronology of the fortress (most of the work was done near the outer walls where the foundation courses of the walls were revealed). Finally, the presumed site of the fortress church (identified in aerial photographs) was cleared of sand and construction debris. The church was found to be destroyed to the level of the brick pavement (*Fig. 1*).

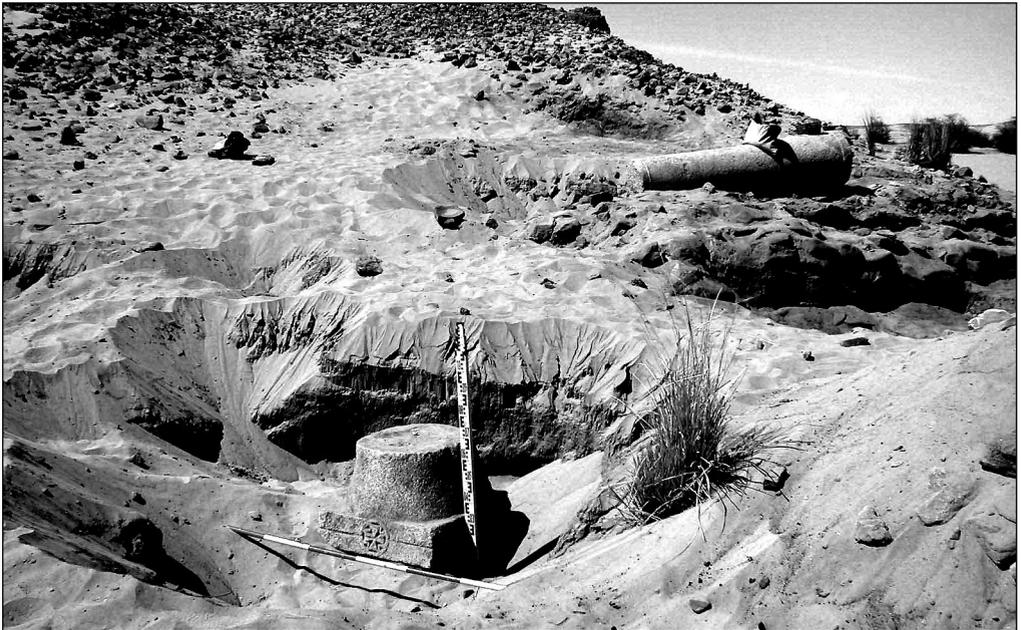
*Fig. 2. Granite capital from the church in Diffar with the fallen column in the background
(Photo B. Żurawski)*

northeastern part of the fortress around a fallen granite column. A capital (the diameter fitting the upper diameter of the fallen column) was found buried in sand in a test trench dug to reach the foundation courses of the girdle wall (*Fig. 2*). (This was plausibly the capital seen and sketched by John G. Wilkinson in 1848). Testing in the uppermost part of the kom evidenced the building sequence in the central part of the fortress (the upper castle).

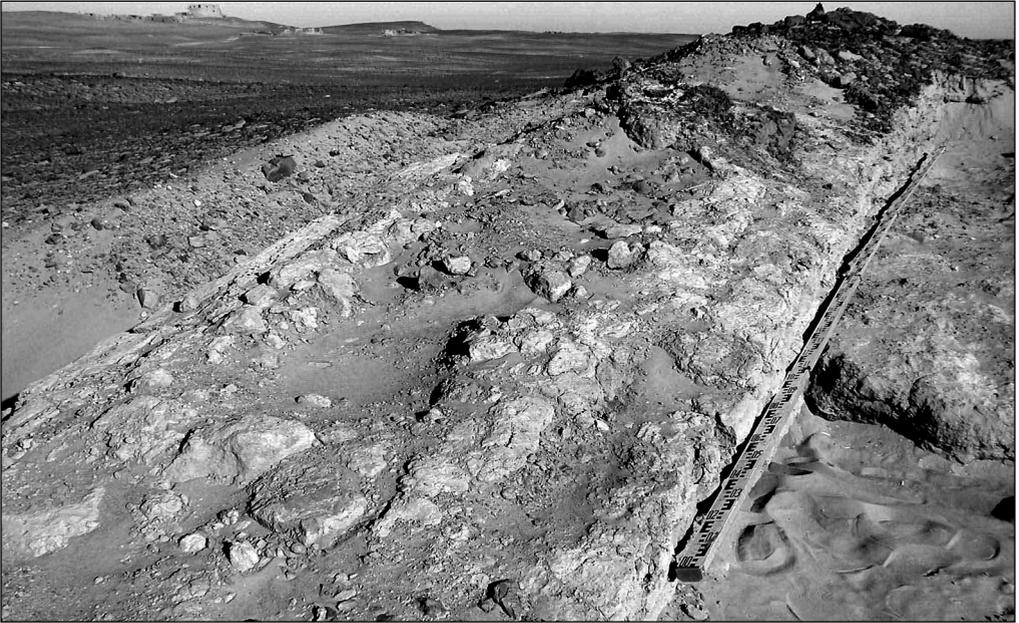
*Fig. 3. The outer girdle wall at Old Dongola (the Mosque is visible to the far left)
(Photo B. Żurawski)*

Work at Abkur and Ed Diffar was followed by high-intensity surveying and testing on the outskirts of the so-called Abandoned Village of Old Dongola, but still within the outer fortifications of Old Dongola (*Fig. 3*).⁵⁾

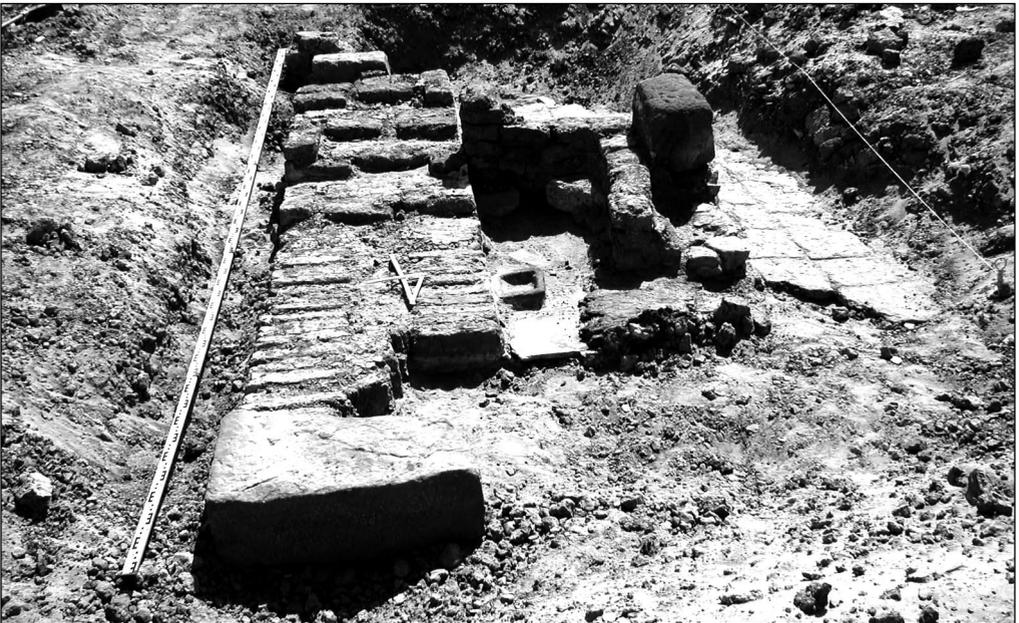
Fig. 4. Lowest courses of the walls and foundations of the northeastern corner of the church within the "Great Enclosure" of Dongola (Photo B. Żurawski)

wall (the so-called Great Enclosure of Old Dongola) a hitherto unknown church was identified. The trench uncovered the northern pastophorium with foundations of the outer wall, a stone altar and red brick pavement (*Fig. 4*). Another trench was dug near the outer wall of the enclosure, providing a section through the fortifications and some structures associated with them.

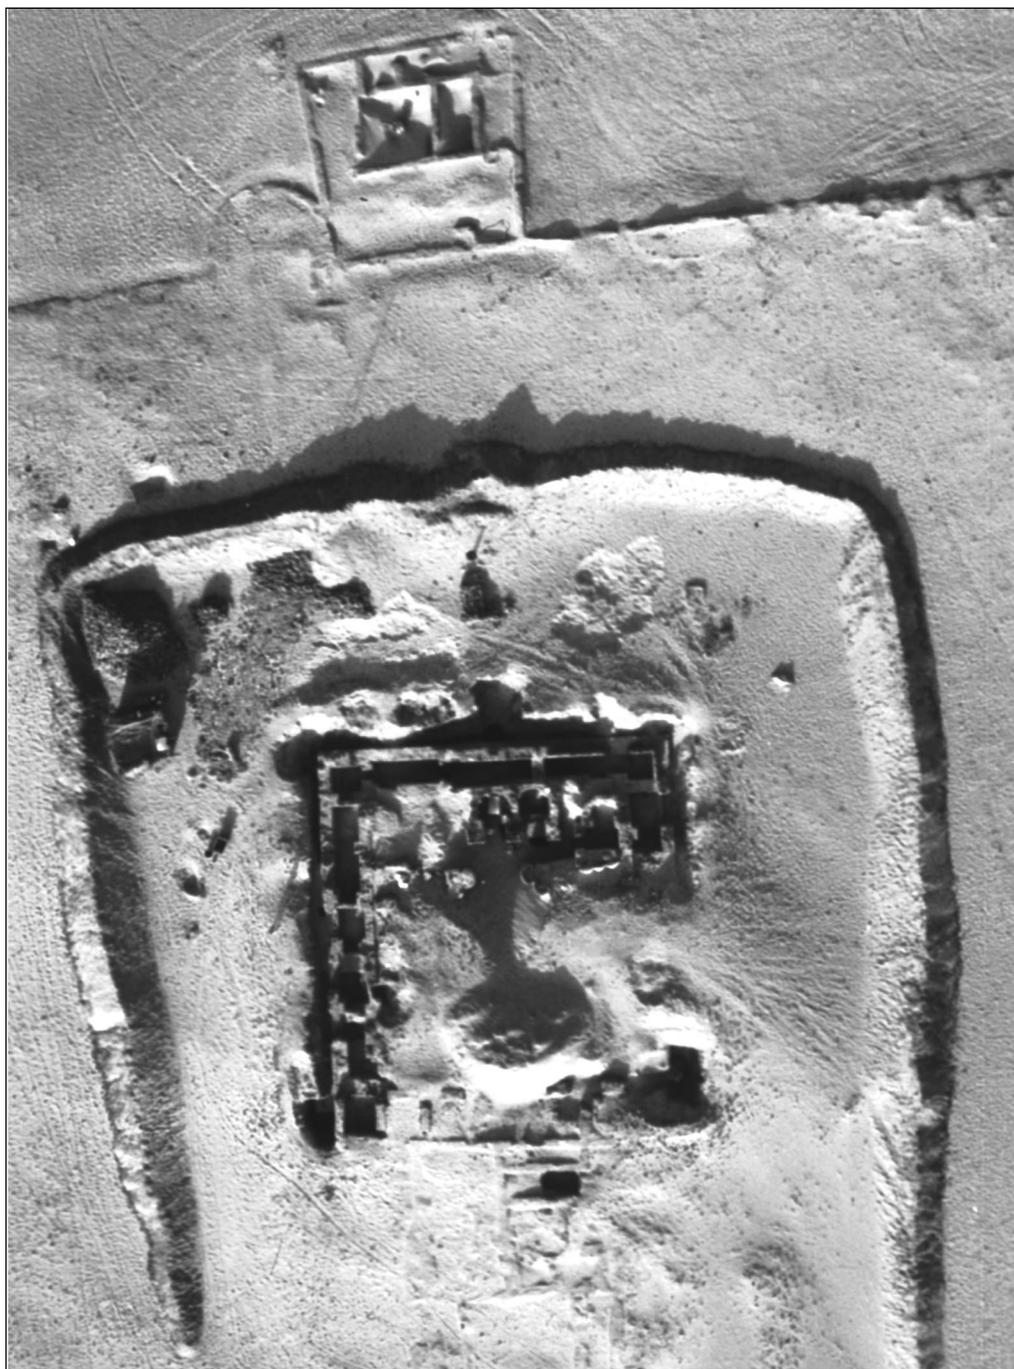
*Fig. 5. Vertical low-altitude (kite) aerial photograph of the Banganarti site in 2002
(Photo B. Żurawski)*

Testing at Banganarti (Kom Es Sinada) in 2001 had revealed a fortified enclosure around a central building, convincingly identified as a church (*Fig. 5*).⁶⁾ The complex was provisionally dated on the evidence of the pottery to the 8th-13th century, with the *floruit* falling in the 9th through 11th centuries (most of the ceramics are dated to this period). At the close of this period, the church was embellished with the first and still surviving layer of murals. Sometime in the late 10th or in the 11th century, the collapse of the north wall of the church necessitated

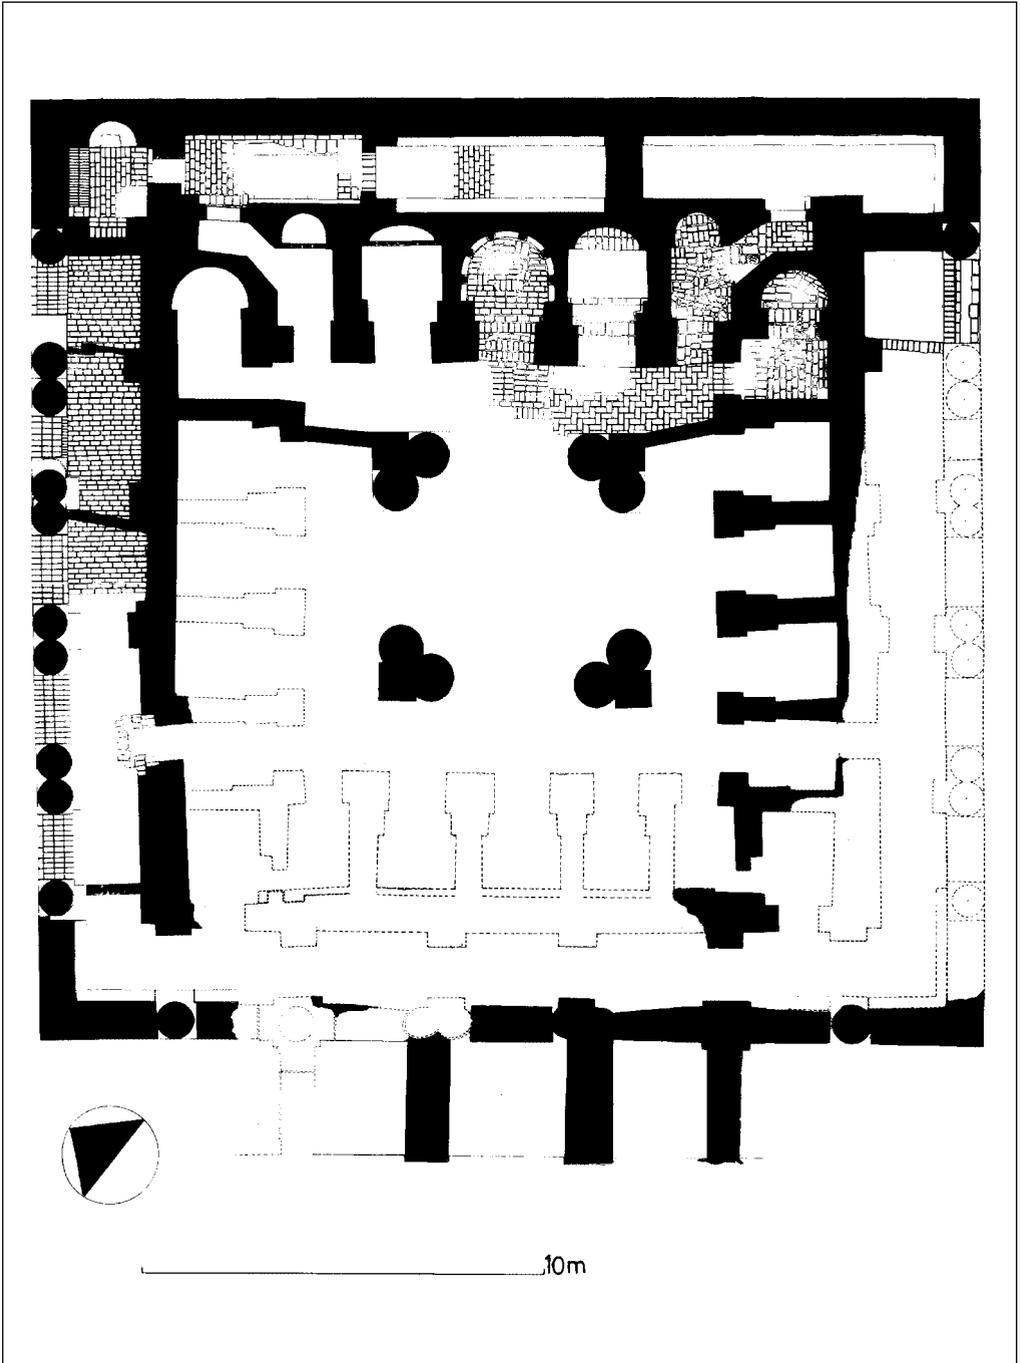
Fig. 6. The reconstructed plan of the Banganarti church (excavated parts are marked in black) (Drawing SDRS Expedition)

Fieldwork in 2002 revealed that the Banganarti church was in fact a square structure, rising around the central four supports. The original stone foundations of the church from phase one were reinforced at vulnerable points (near the corners) with mastabas made of stone and red brick. These precautions were taken apparently to counter a tendency for the alluvial ground to subside. The risk was indeed considerable, resulting at least once in serious damage when the north wall of the church collapsed, presumably in the late 10th century. The rebuilding that followed involved erecting thicker mud brick walls that fitted the original plan. Another catastrophe came in the next century, this time resulting in a complete dismantling of the church down to the foundations. Only the piers supporting the central dome were left in place (and they are the only elements in the church where three layers of plaster have been found).

The reconstructed church followed the same general plan but with some modifications. The porticoed outer section was rebuilt in reinforced form with some of the columns being doubled and pilasters being erected to buttress the original double columns. A new layer of murals embellished this restored building, designated as the Phase II church.

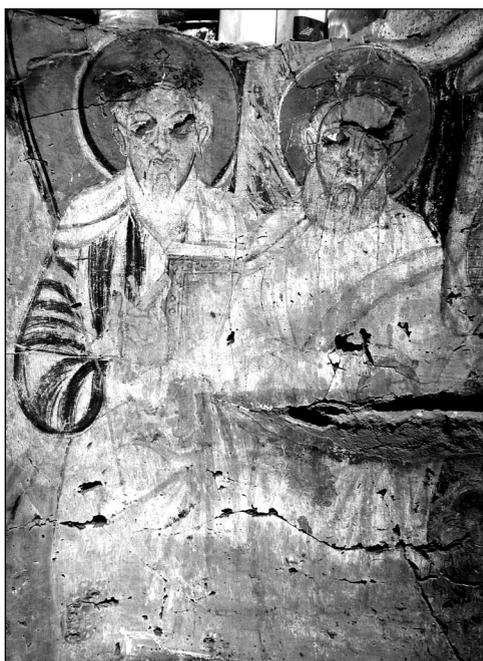
*Fig. 7. Two apostles flanking the king's portrait on the left (Chapel 3)
(Photo B. Żurawski)*

The superb iconographical program of the royal chapels provides much information on the political theology of Makurian kingship. For instance, portraying Nubian rulers between the apostles (*Fig. 7*), in position usually occupied by the image of Christ was, from the 12th century onwards, a reflection of the evolution taking place in Byzantine political theology with its stress on *christoumimesis*. It strengthened the authority of the Makurian dynasty by emphasizing the divine aspect of kingship.

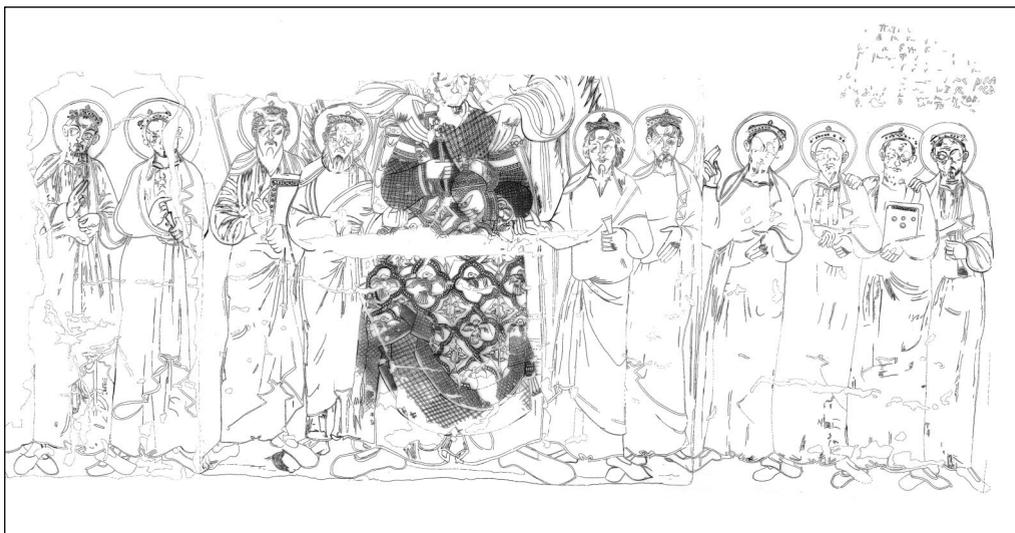
Fig. 8. Ink copy of the wall decoration in Chapel 3 (Drawing SDRS Expedition)

The iconographical program of the decoration in the apsed eastern chapels turned out to be the same in all cases. A ruler was depicted standing, clad in full-blown regalia with royal purse, robes of honor, etc., wearing a crown and holding another one in the left hand, while grasping a peculiar type of scepter in the other hand. The scenes included figures of the apostles pictured on both sides of the ruler and an Archangel standing in back. At least in one mural (in Chapel 3, *Fig. 8*)

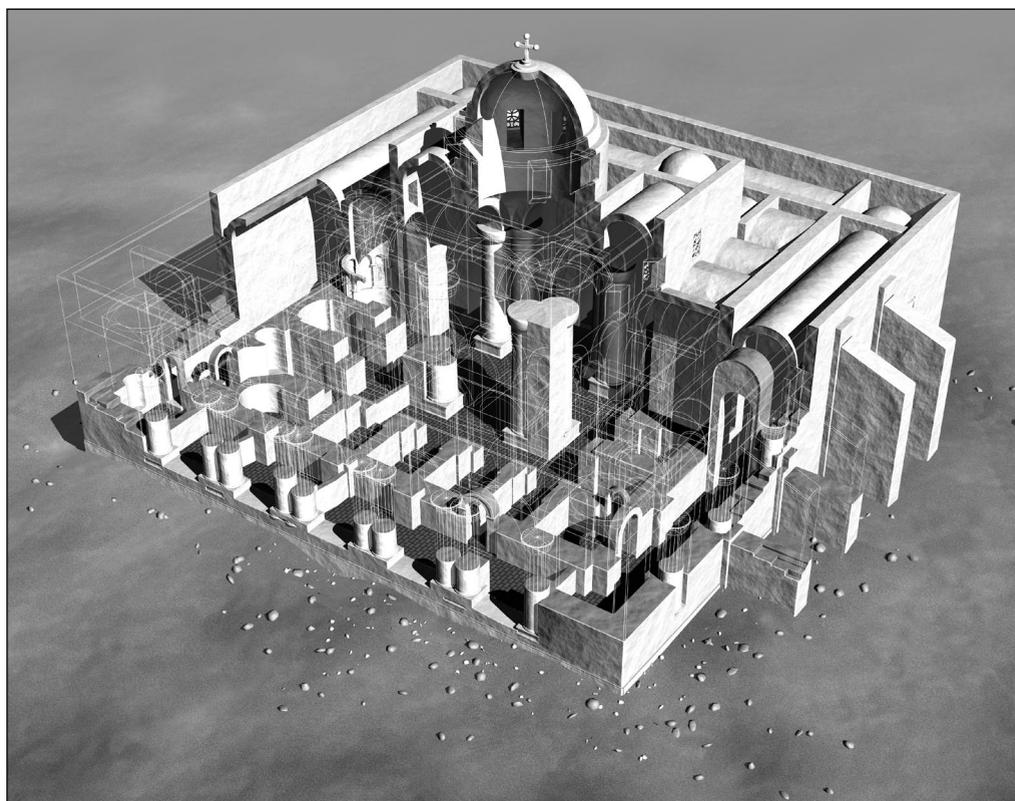
*Fig. 9. A 3D reconstruction of the Banganarti church
(Rendering B. Żurawski)*

The general layout of the church can now be reconstructed following the clearing work and testing conducted over the course of the last two seasons. The basic unit is a square space. Indeed, the entire interior between the four central dome supports and

the outer walls was arranged as a set of 18 chapel-like spaces (*Fig. 9*).

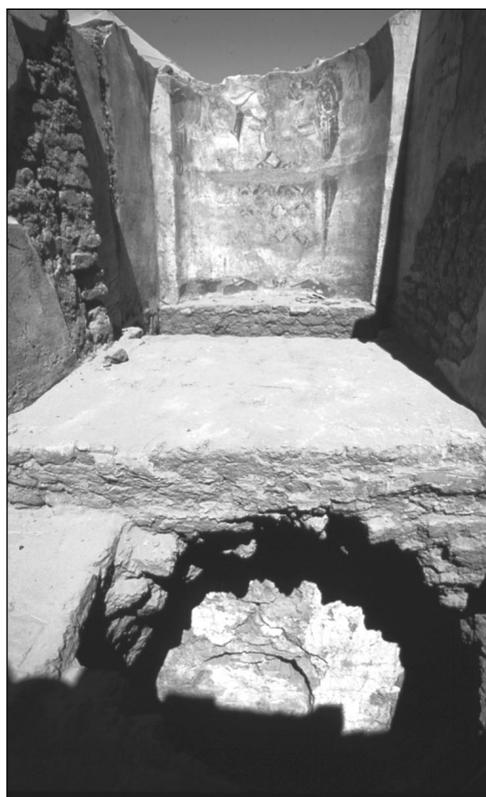
Fig. 11. Trial pit in front of the threshold to Chapel 3 (Photo B. Żurawski)

In February 2002, a test pit was started in front of Chapel 3, where the brick pattern of the floor appeared disturbed and some of the bricks had been removed. A wall was exposed going down, its foundation courses

lying 4 m below the church pavement. Curiously enough, the wall was set in clear sand, a most unusual thing on a Nile island formed of alluvium (alluvial stratigraphy has been shown to reach a depth of more than 8 m). At a depth of 1.15 m below the church pavement, the voussoir bricks of an arched entrance were noted (*Fig. 11*), apparently left behind by robbers who promptly abandoned the idea of breaking through this way (they had probably removed and disturbed the pavement above).

Two layers of plaster were identified on the wall, the first of lime and the second of lime mixed with mud. Murals and inscriptions were recorded on both layers. Significantly enough, the entrance (or niche ?) had been blocked before the first layer of plaster was introduced.

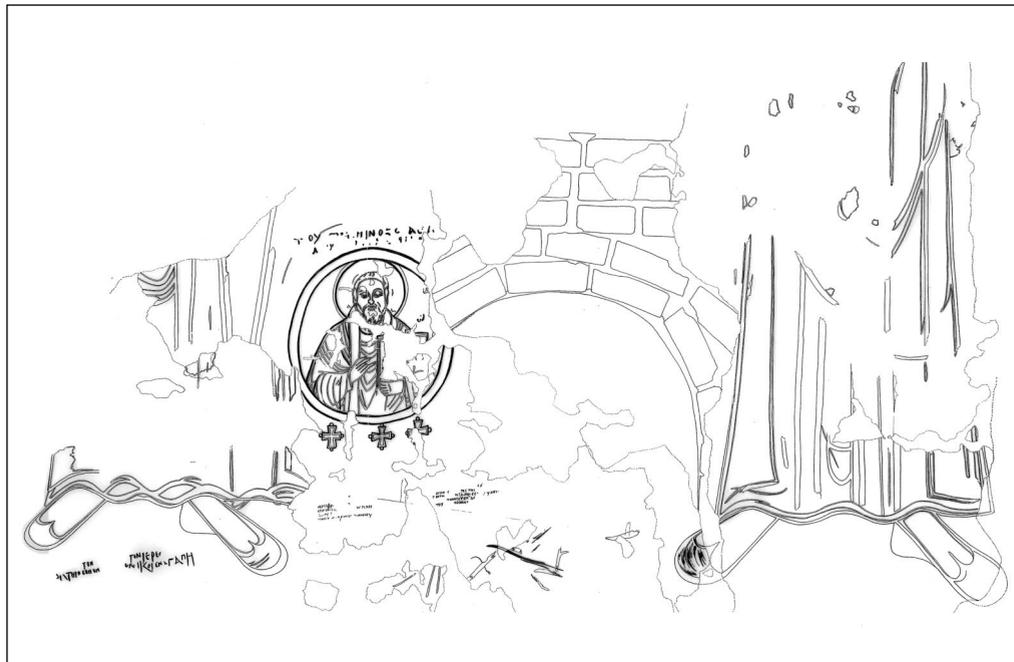
Fig. 12. Ink copy of the painted decoration on the wall beneath Chapel 3 (Drawing SDRS Expedition)

The figures of saints painted on this very first layer of plaster (*Fig. 12*) were rendered in less rigid stance than their Faras counterparts, wearing, however, the same slender black-colored boots that are a distinctive feature of early Christian painting in Nubia. They are accompanied by the very earliest Greek inscriptions known from Makuria. One inscription requests love (*agapē*) for an individual who is addressed as *hierēus*. On the second layer of plaster a tondo with Christ(?) or a saint (the *omophorion*-like scarf is problematic, as is also the *alpha* and *omega* around the tondo) was painted, along with a series of new inscriptions, tentatively dated to the 7th-9th century.

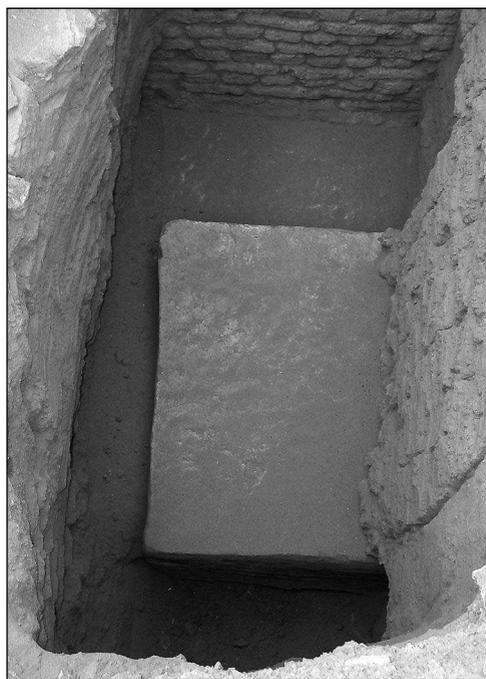
Fig. 13. Early Christian grave under Chapel 6 (in the northeastern part of the church) (Photo B. Żurawski)

The theory that the eastern chapels had been raised above tombs to venerate individuals buried beneath was validated when a trial trench dug in the corridor behind Chapels 5 and 6 revealed two standardized Nubian-type mastaba graves on the same level as the flooring in the space under Chapel 3 (Fig. 13). The grave under Chapel 6 had a huge solid mastaba covered with a hard creamy lime-plaster coating. A similar layer of broken Aswan Pink amphorae was found corresponding in level to that in the space below Chapel 3. The grave found behind the eastern wall of Chapel 5 was built prior to its northern neighbor. Its plastered superstructure was still protruding above the surface when the first-phase church was erected, so it had to be pulled down flush with the church pavement.

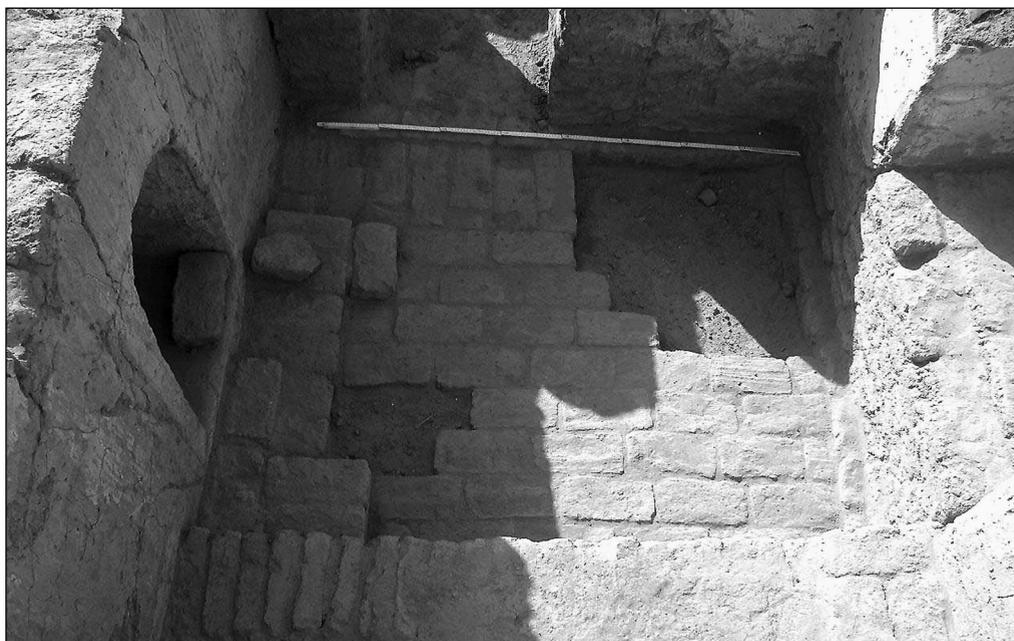
*Fig. 14. The so-called prothesis in the Banganarti church
(Photo B. Żurawski)*

Excavations in the easternmost areas of the church yielded abundant ceramic finds. An intact chalice and paten found in the northeastern corner (labeled *prothesis* for the sake of convenience, Fig. 14) were accompanied by plenty of fragmented liturgical paraphernalia. The intact jar found in the southern pastophorium was accompanied by numerous oil lamps scattered abundantly throughout the eastern part of the church (most of them belong to the latest period of liturgical use in the church).

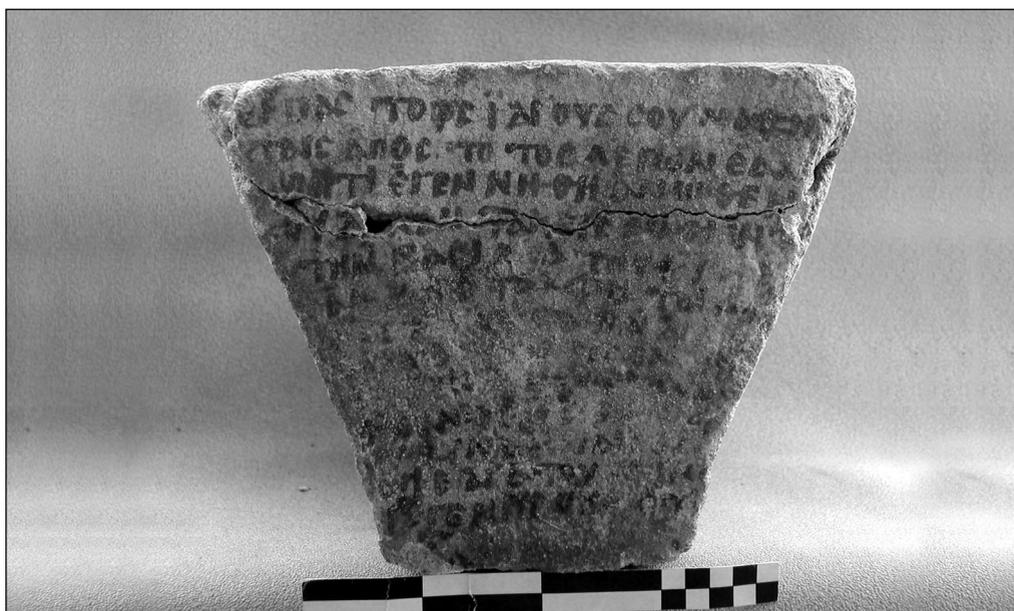
*Fig. 15. Altar top found in the so-called prothesis
(Photo B. Żurawski)*

An altar mensa or rather top of a brick altar was found incorporated into the late pavement in the so called *prothesis* (Fig. 15). It should be dated to the 11th century or later on paleographic grounds.⁹⁾
