## Old Dongola: Kom A (Acropolis), 2003

Polish Archaeology in the Mediterranean 15, 193-215

# OLD DONGOLA

## KOM A (ACROPOLIS), 2003

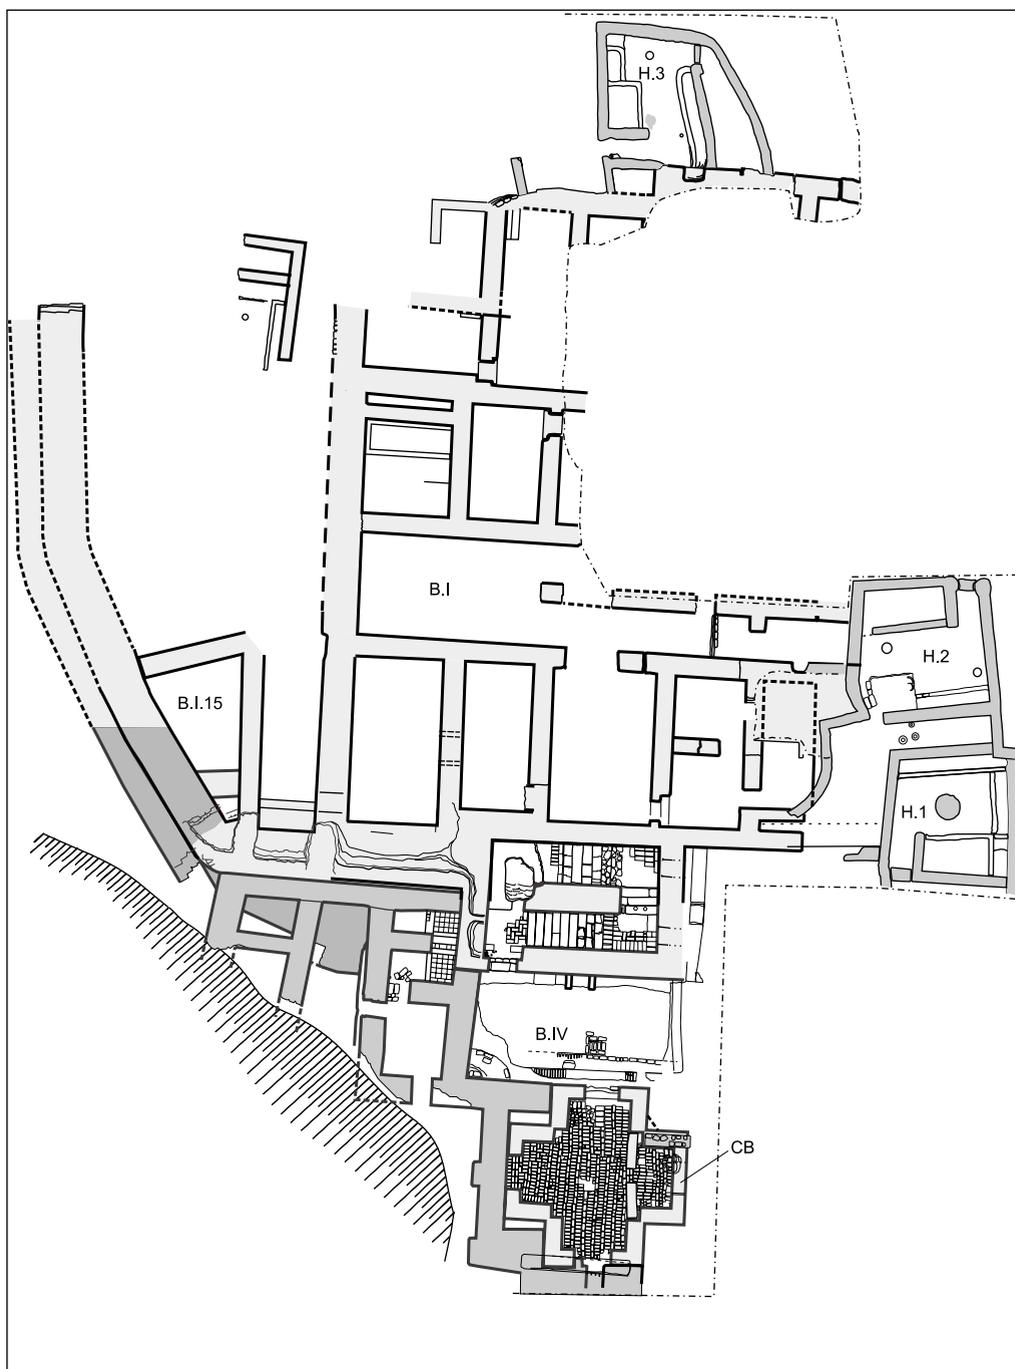
Fig. 1. Citadel. Site SWN, plan after the 2033 field season  
(Drawing W. Godlewski, M. Puszkarski, D. Zielińska)

A relative chronology of the architecture in the southwestern part of the ancient town (SWN) was established in the course of the fieldwork. The sequence starts at the turn of the 5th century and can be traced through the 17th century as follows:

1. Building IV and the riverside fortifications
2. Palace (B.I) and Cruciform Building (B.III.1)
3. Building II
4. Cruciform Church (B.III.2)
5. Dwellings (H.1-H.4)

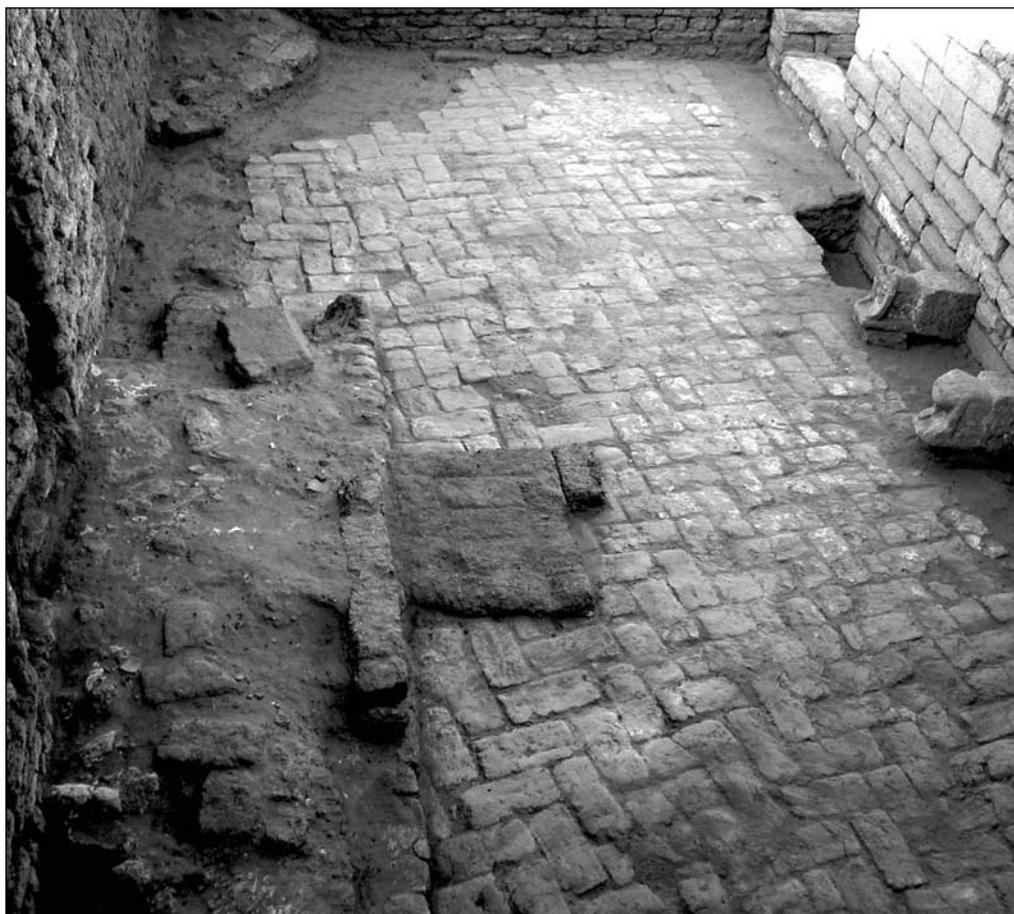
*Fig. 2. Citadel. Site SWN, Building IV, surviving brick pavement (Photo W. Godlewski)*

The remains of the southwestern corner of this structure, dismantled down to the floors, were found between the Palace (B.I) and Cruciform Building (B.III.1). Both the later structures were founded on bedrock, disturbing in the process the pavement and south wall of Building IV (*Fig. 2*). A section of the pavement of this earlier

The south wall of B.IV had rested on bedrock. It was erected of baked red brick, fairly soft and measuring at least +31.0 x 17.0 x 7.5 cm. One course of headers set on edge, which had been used as a foundation, was discovered to run for a distance of

more than 4.50 m. The southern face of this wall, which had an overall thickness of c. 70 cm, was damaged presumably during the building of B.III. The paving of B.IV consisted of baked bricks, 32.5 x 15.5 x 7.5 cm, set headers on edge on a regular bedding that looked as if it were a woven mat. The floor was cleared over a distance of over 7 m, the wall obviously taking its course to the east, under an artificial embankment; at the western end it was destroyed by the riverside defenses of the

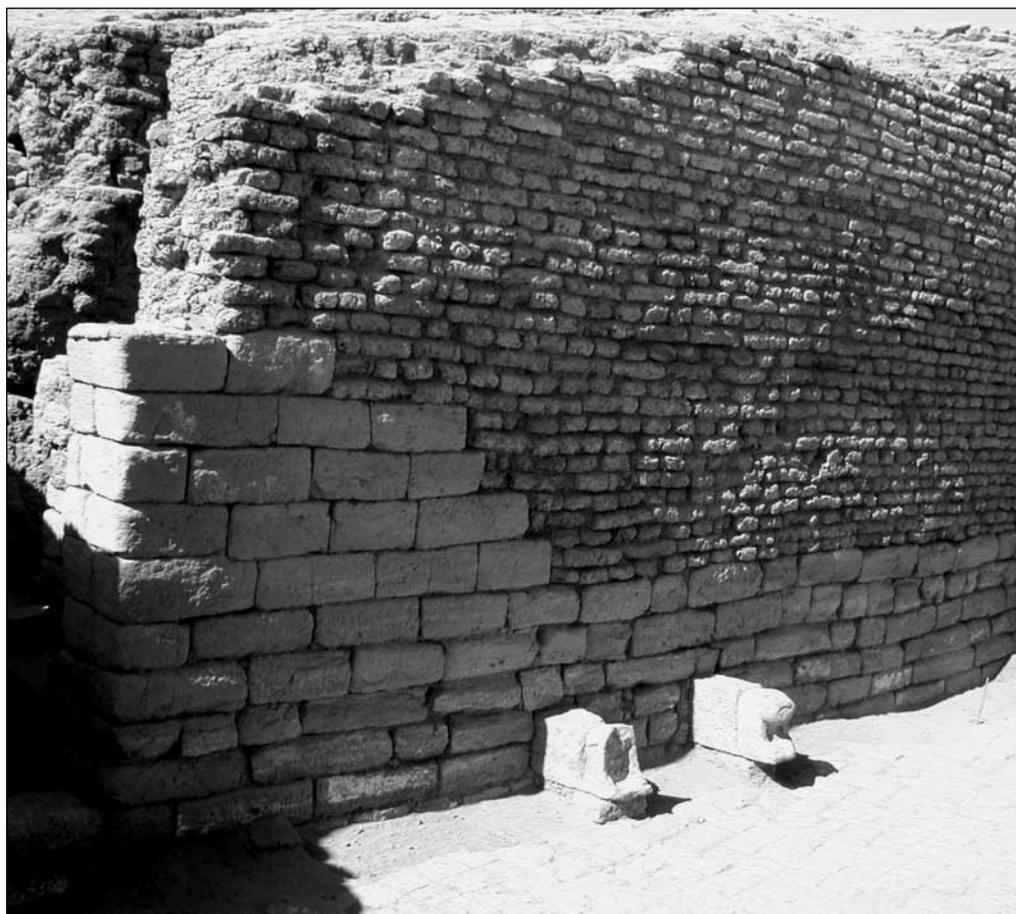
Fig. 3. Site SWN, Building B.I, south wall (staircase façade)  
(Photo W. Godlewski)

facilitating communication between the floors. The southern staircase facade has now been cleared in its entirety (section 8.75 m long) down to the foundations. The bottom parts of the walls were constructed of gray sandstone (*Fig. 3*). The stone wall is 1.15 m high overall, except for the section by the southern entrance in the southwestern corner, where it is even with the door jambs supporting a stone arch of voussoirs above the doorway.<sup>5)</sup> To the east of the entrance two stone blocks decorated with lion protomas projected from the stone base of the wall. The top back part of these stone blocks was squared and presumably served to support a horizontal

stone ledge. The structure appears to have been some kind of bench. The upper sections of the south facade were erected of baked brick on the outside and mud brick on the inside, forming a uniform construction. Windows lighting up the staircase were pierced only through the east wall.

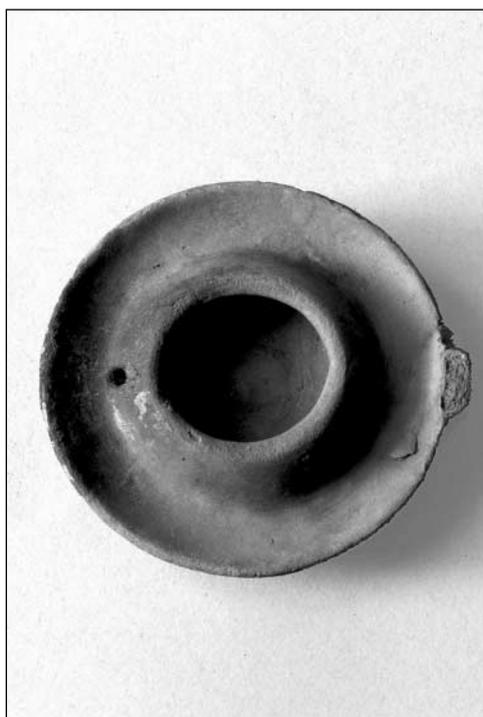
*Fig. 5. Lamp (Add.03.088), Red Ware (Photo A. Obluski)*

as imports from Egypt (e.g. toilet vases) includes red- and white-ware products (Figs. 4,5) – mainly small hemispherical bowls, plates and basins. A small percentage of the vessels features painted decoration in the form of concentric bands on the floors of small bowls or straight and wavy lines on the ledge rims of large plates. Amphorae imported from Egypt constitute an important group. More examples of storage vessels from Aswan, Middle Egypt (LR.7) and the Mareotis were identified.<sup>6</sup> Previously unnoted Palestinian amphorae were represented by the upper part of a vessel with vertical rim and bag-shaped body with ribbing and painted white decoration on the body (Peacock-Williams class 46).<sup>7</sup>

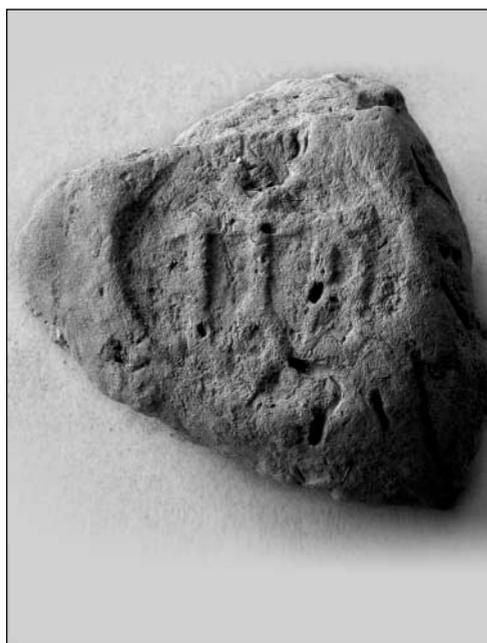
Fig. 6. Mud stopper with round stamp (Add.03.120) (Photo A. Obtuski)

The deposit also contained numerous amphorae mud sealings with inscribed round and elongated stamps (Fig. 6) – over 50 examples altogether, providing good evidence for the actual number of amphorae, presumably only of the LR.7 type, supplied to the residents of the building.

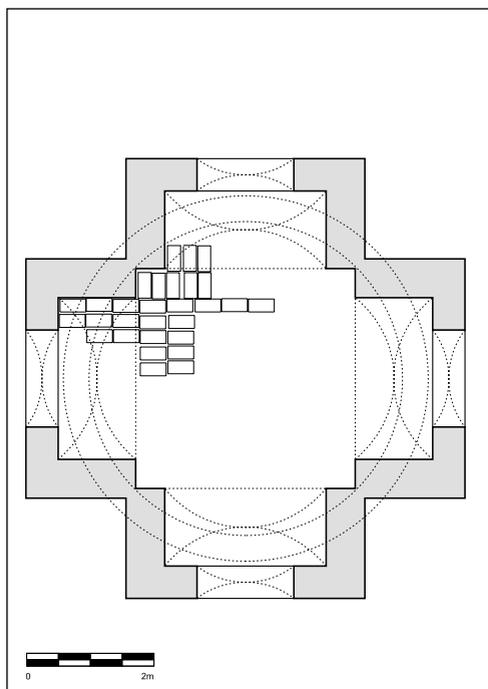
Fig. 7. *Cruciform Building (B.III.1), plan (north is at the top)*  
(Drawing W. Godlewski, D. Zielińska)

The outer dimensions of the building were 6.80 x 6.80 m (*Fig. 7*). Inside, the square central space measured 3.30 x 3.30 m. The four arcades opening of this center-square were each 1.20 m deep and 3.35 m wide. The entrances in the end walls of each of the four arms also had an

The original paving, obscured by a later cement floor, was cleared in the western and northern arms of the structure and partly in the center (cf. *Fig. 7*). It consisted of bricks (33.0 x 16.0 and 36.0 x 17.0 cm, thickness as yet unknown) laid flat in a regular arrangement. From what can be said after fieldwork in 2003, the bricks in the northern arm were arranged longitudinally, that is, parallel to the lateral walls. The southern arm presumably mirrored this arrangement. In the center and in the western arm, the bricks ran parallel to the side walls in this arm, that is, following an E-W orientation. This was presumably

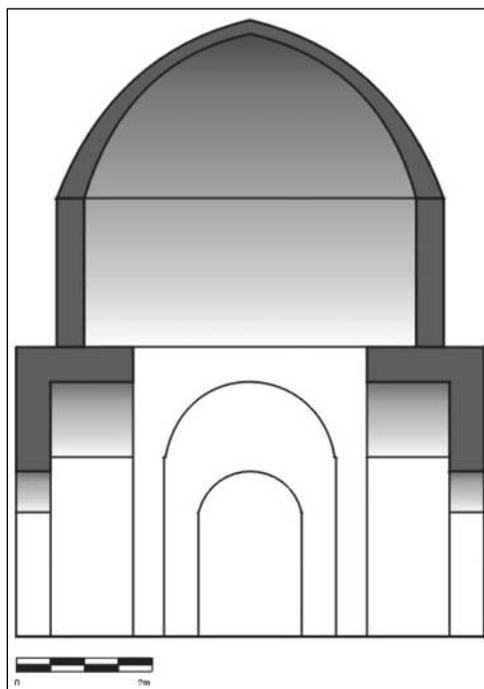
Fig. 8. *Reconstruction of the Cruciform Building (B.III.1)*  
(Rendering D. Zielińska)

the vaults and the stone pendentive described above, a reconstruction of the building has been attempted (*Fig. 8*). This small cruciform structure obviously had projecting vaulted arms and a central dome supported on a drum. The assumed total height of the structure was c. 9.20 m.

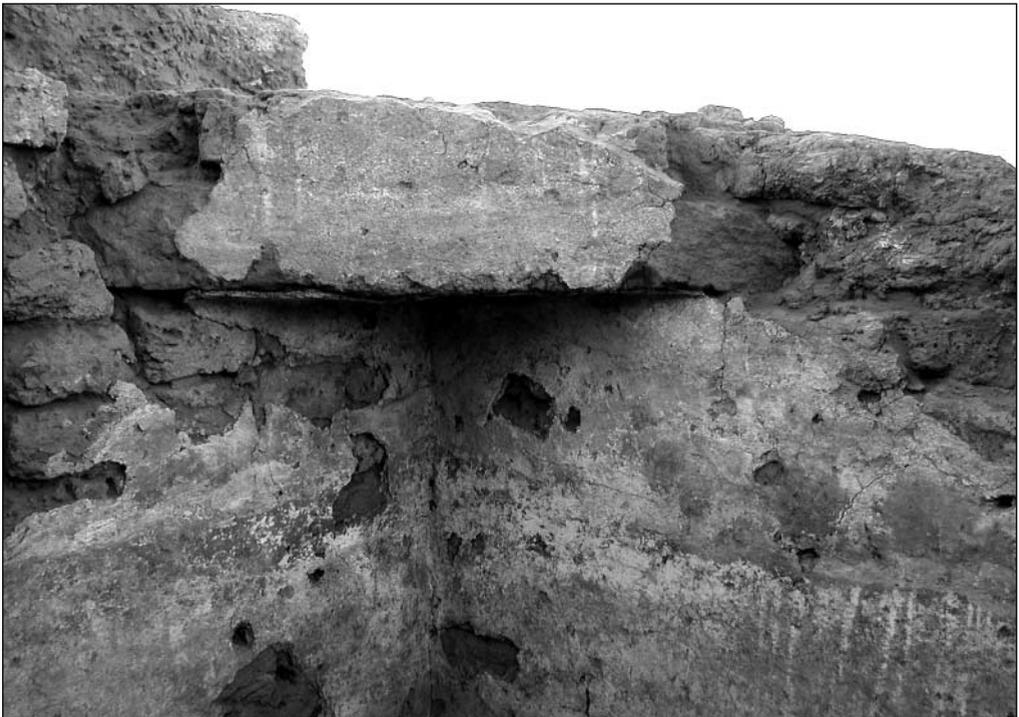
*Fig. 9. Cruciform Building (B.III.1). Pendentive of the dome in the outer northeastern corner of the structure (Photo W. Godleuski)*

In the outer northeastern corner, where the northern and eastern arms meet, a block of sandstone was preserved, 14 cm thick and c. 30 cm wide, squared and laid along the diagonal of the two joining walls, 3.34 m above the foundation level. It was structurally one with both walls and plastered on the outside like the entire structure. It must have been a kind of external pendentive under the circular drum of the dome (*Fig. 9*).

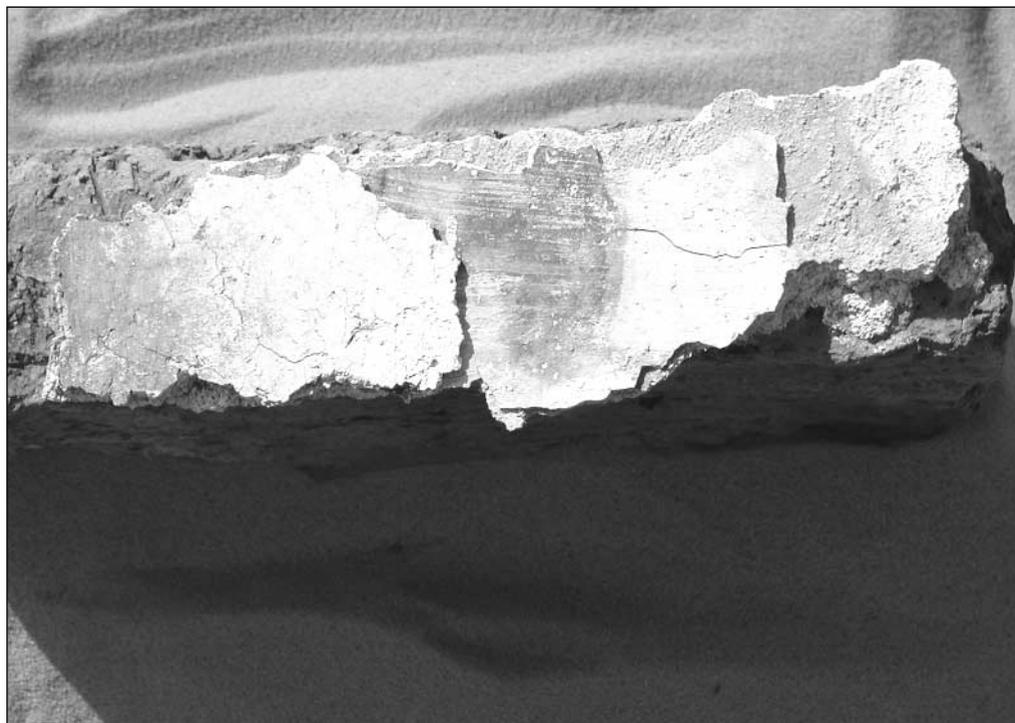
*Fig. 10. Three layers of limestone plaster with painted decoration, from the interior of the Cruciform Building (B.III.1) (Photo W. Godlewski)*

On the inside walls, three successive coats of lime plaster were noted, corresponding to successive renovations of the interior (*Fig. 10*). Evidence of renovations has been preserved in the bottom parts of the walls, just above the original pavement and below the level of the late floor. It is not clear whether successive coats of plaster covered the entire interior or only the bottom parts of walls that were most exposed to damages in an open interior. The second coat of plaster was especially fine and very smooth. The entire interior was decorated with wall paintings, executed obviously by master painters in the tempera technique. On the vault of the eastern arm of the building, the first coat of plaster preserved a representation of Nubian warriors standing in a heavenly meadow.<sup>9)</sup> The bottom parts of the walls presumably had decoration imitating marble revetment and stuccowork emphasizing the tectonics of the interior.

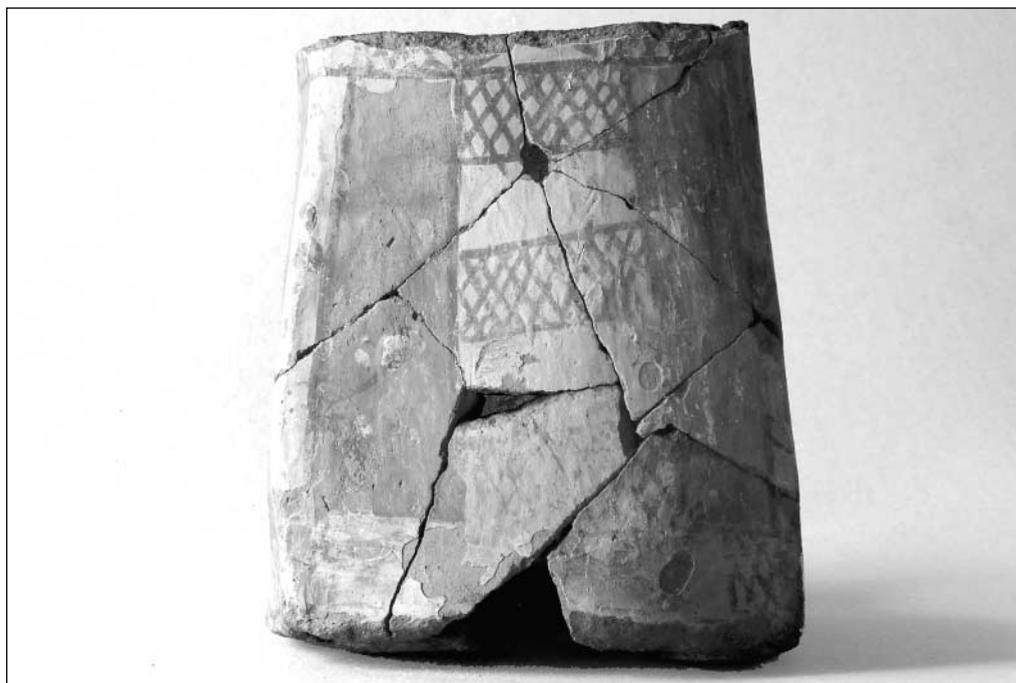
*Fig. 13. Painted clay box from the late house H.3 (Add.03.412)  
(Photo A. Obtuski)*

room of this house (H.3.1) was cleared down to the mud floor; the other room, which was much smaller, presumably served storage purposes. The walls of the main dwelling quarters were whitewashed repeatedly. The furnishings included a bench by the east wall and a large rectangular platform by the west wall, most likely a bed; two similar platforms stood in the northwestern corners of the room. A series of storage jars and cooking pots was uncovered in room H.3.1, as well as two terracotta boxes, finely painted on the outside (*Fig. 13*), intended for personal belongings or for household bric-a-brac.
