Marea Excavations 2004

Polish Archaeology in the Mediterranean 16, 43-54

MAREA

EXCAVATIONS 2004

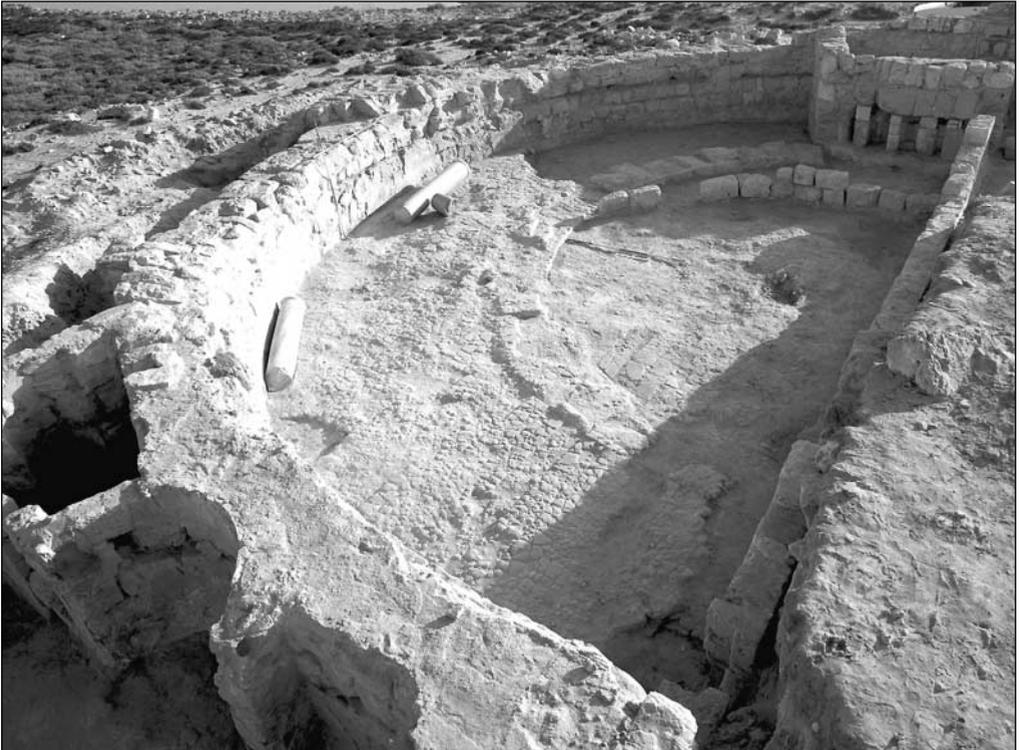
Fig. 2. North wing of the transept with stylobate under the columns, view from the west. Note the circle of stones protecting a late fireplace (Photo J. Kucy)

Work commenced last year in the north wing of the basilica transept was now continued with more limestone blocks from the collapsed walls being cleared from further sections of the building [Figs. 1,2]. The stylobate, which was revealed in the north transept, was made of blocks of nummulithic limestone averaging 1.00 by 0.75 m. Of the marble columns that had stood on the stylobate, three shafts of 0.35 m diameter were found on the floor of the transept in this area.

One complete shaft was 2.21 m long; the other two were fragmentary. Furthermore, Grossmann's presumed intercolumnar space of c. 2.40 m has now been confirmed.⁴ Consequently, the number of columns in the transept should be reconstructed as twelve. Four of these columns were later incorporated into the wall of the northern pastophorium (prothesis?) during a rebuilding of the church, as indicated by the negative impressions in lime mortar of three of these columns, recorded during

last year's work. The fifth column (third counting from the intersection of the transversal colonnade with that of the nave) must have been removed presumably because the wall of the pastophorium and the north wall of the basilica were joined to a narrow (0.30 m thick) stone wall. The width of the ambulatory between the colonnade and the transept wall was 2.80 m. The evidence points to the intentional removing of three column shafts to a place by the outer wall; this was done by people who occupied the building once it had been abandoned as a church. They erected in this part of the transept a circle of blocks taken from the collapsed walls and meant to protect a fire, traces of which are still evident today.

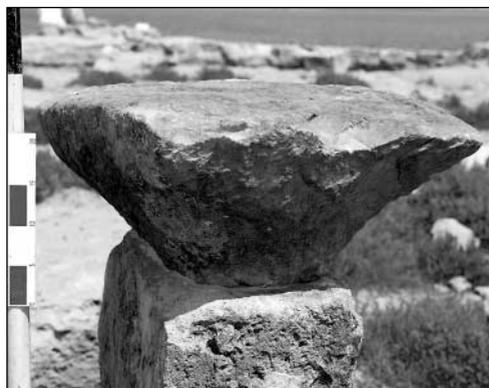
Fig. 3. *Capital stripped of carved decoration, found in the northern wing of the transept (Photo J.M. Kucy)*

An interesting find of a capital was made in a corner between the wall of the northern aisle and the wing of the transept. The top surface of the capital measured 0.47 by 0.45 m, the bottom diameter 0.26 m [Fig. 3]. It was not ornamented. Perhaps the decoration was never executed or else the decoration was hammered away at one point in order for the element to be painted.⁵

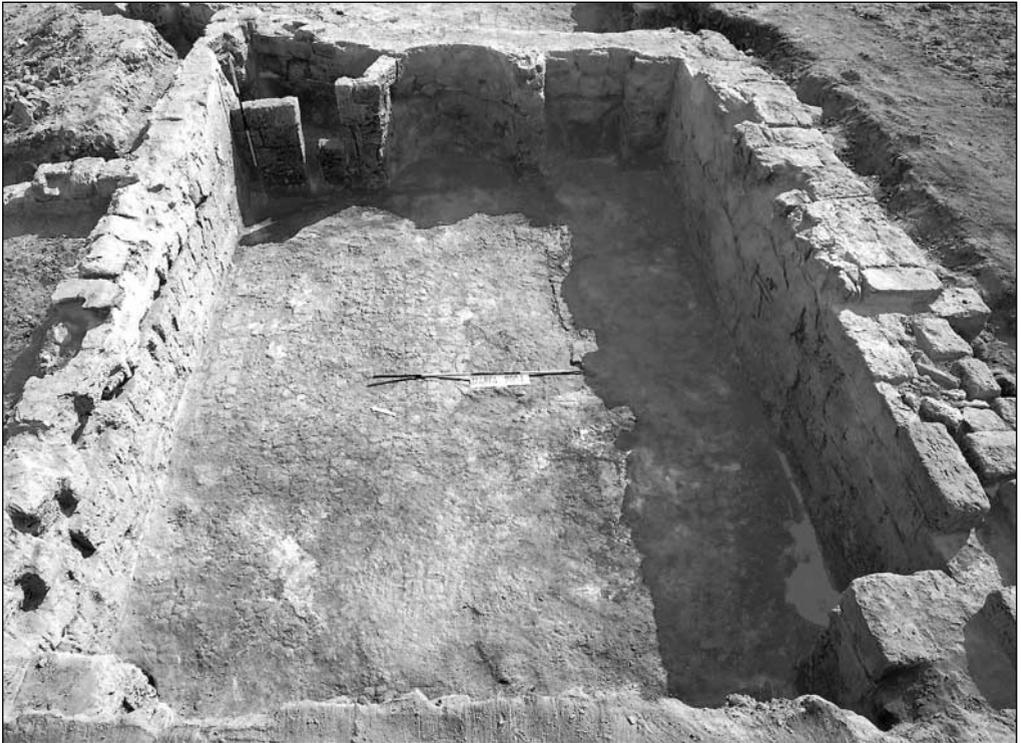
Fig. 4. Chapel adjoining northern aisle. View from the west (Photo J.M. Kucy)

The room adjoining the basilica on the north proved 6 m wide [cf. *Fig. 1*; *Fig. 4*]. A third of it was cleared in the course of this campaign. Meriting attention is the difference in the thickness of the walls between the apse, the outer wall of the basilica and the side room: 1.20 m, 0.80 m and 0.50 m respectively.

Much would suggest that this room was used as a chapel. Two niches were cut into the western part of the transept wall: one semicircular (0.80 m deep and 1.80 m wide), the other rectangular (0.40 m deep, 1.20 m wide). The space between them and the north wall of the chapel was occupied by

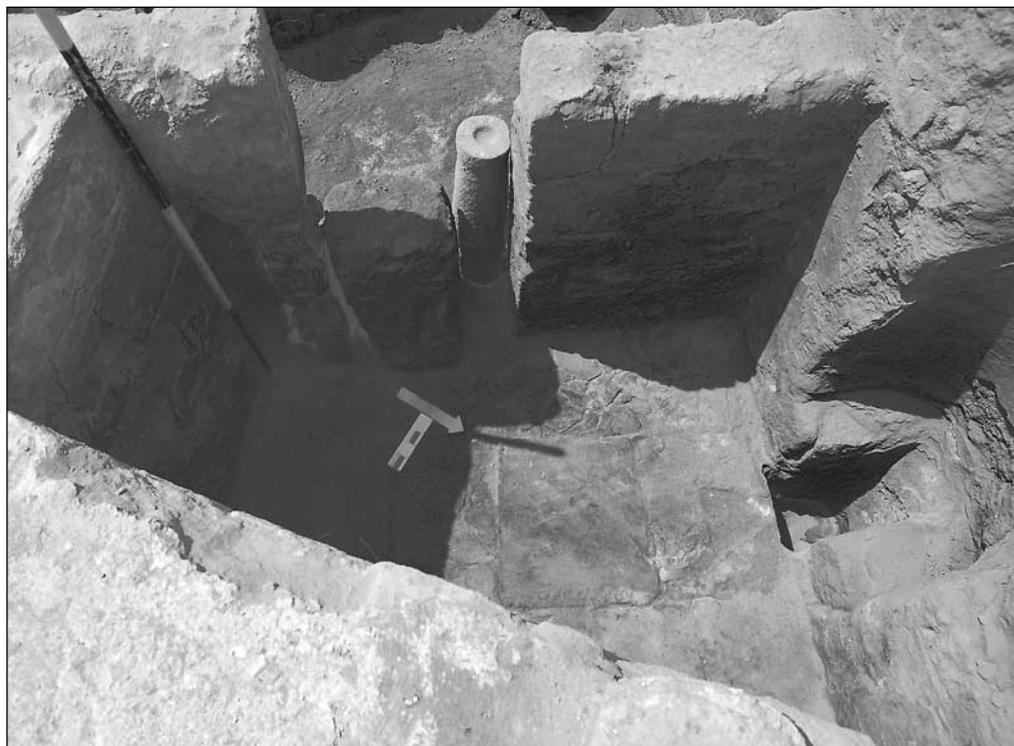
Fig. 5. Blocked passage between alleged chapel and small next-door room. Note opening of a channel in the wall of the room on the right (Photo J.M. Kucy)

a small chamber paved with limestone slabs, entered from a narrow passage leading from the west. This passage was later blocked with a piece of destroyed wall and a granite column (diameter at the base 0.22 m; height 0.85 m) incorporating a base and shaft which narrowed toward the top [*Fig. 5*]. Its shape and the depression for a bowl in the top of the shaft indicate that it had served as the foot of a washbasin. Nearby, by the north wall of the chamber, a small channel was discovered, presumably intended as a means for discharging water from a washbasin that had once stood there and which served liturgical purposes in the chapel.

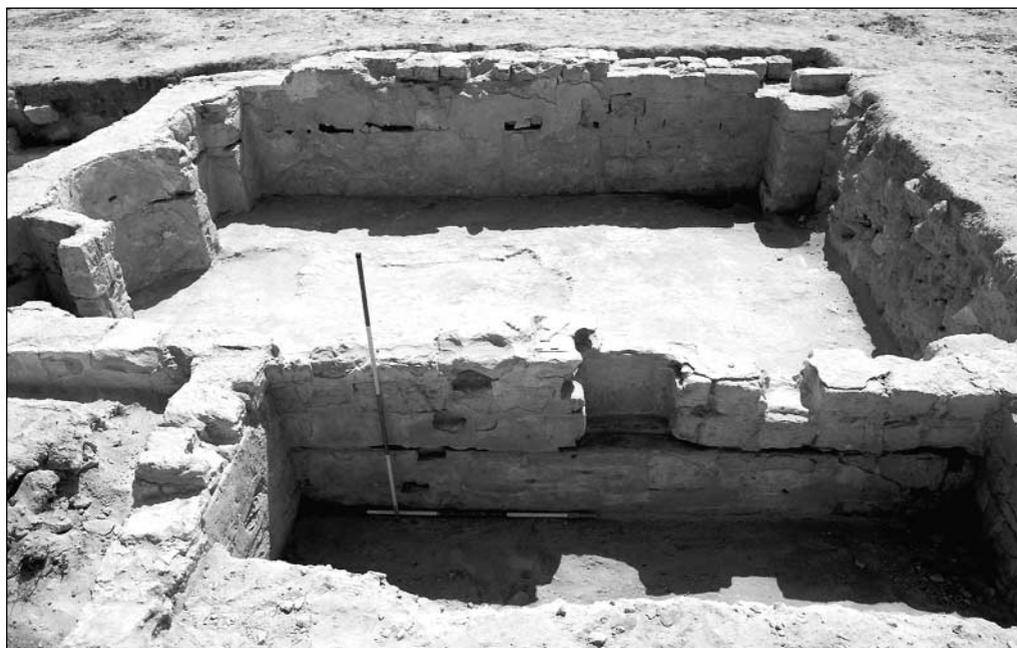
Fig. 6. Evidence of a staircase leading to the gallery in the northern aisle. View from the north (Photo J.M. Kucy)

and the other a little further away [cf. *Fig. 1*]. They are suggestive of yet another chamber being located behind the wall here. Ledges for steps, possibly leading to the emporas in the aisle, were noted in the wall between the two walls [*Fig. 6*]. The fill behind the wall yielded a sherd from a Coptic plate featuring a wavy edge and painted scene from the Dionysiac repertoire [*Fig. 7*].

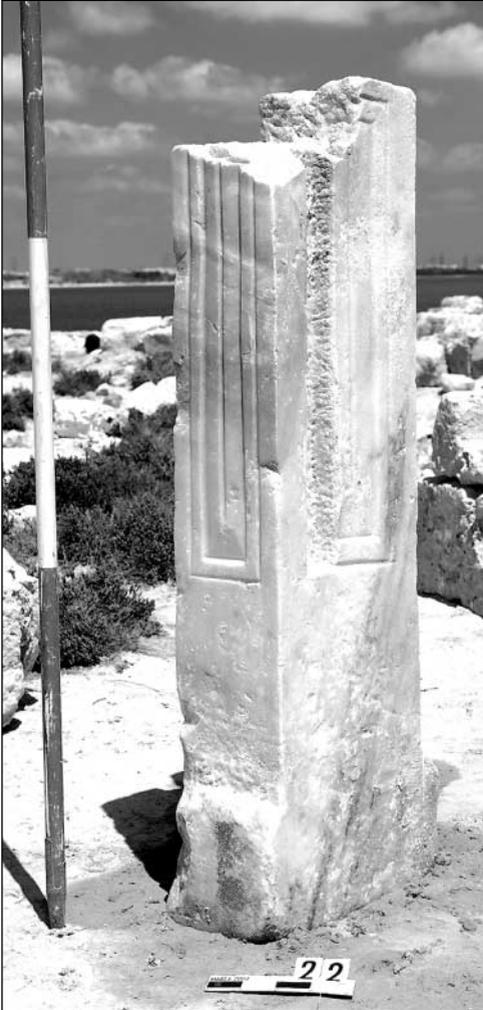
Fig. 8. *Chancel post from the altar, recovered from underlying rubble*
(Photo J.M. Kucy)

The bottom of the kiln was explored further down in order to remove another chancel post standing inside it. This element (H. 1.30 m; W. 0.21 m) differs in size from the pillar found last year; it also bears evidence of reuse [Fig. 8]. Originally, it may have flanked the entrance to the bema, but was later moved to the corner of the balustrade, as indicated by modified profiling with secondarily cut grooves for mounting screens. It adds to the list of finds testifying to alterations introduced in the interior decoration of the church.

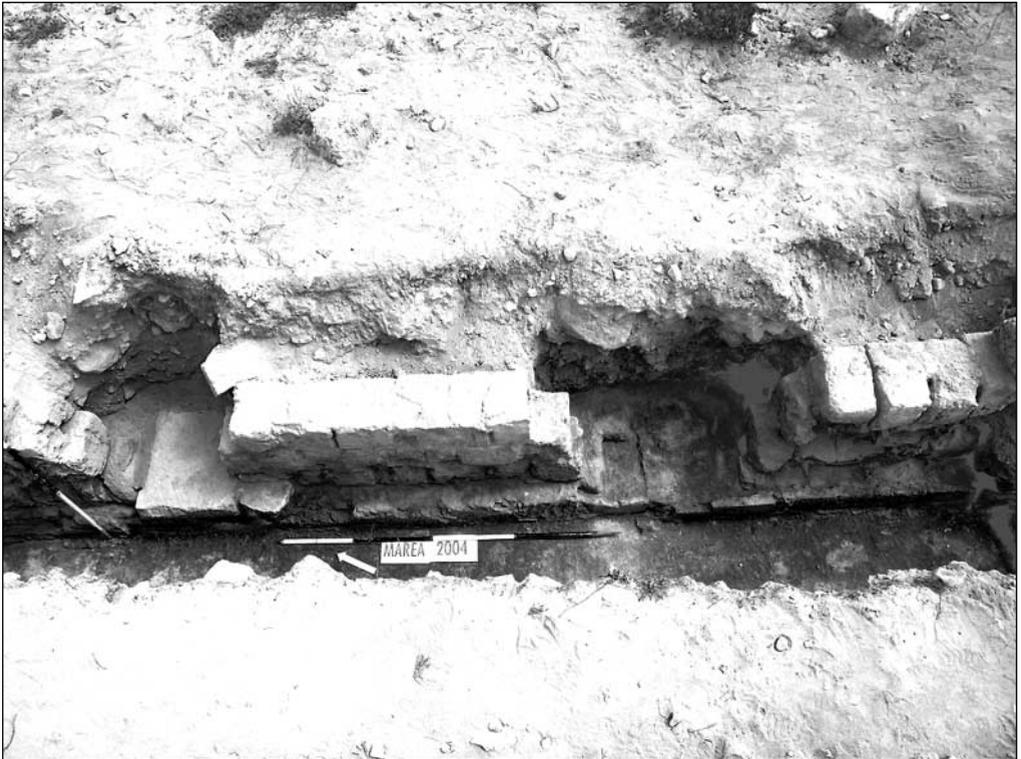
Fig. 9. Main entrance in the west wall of the basilica. View from the west (Photo J.M. Kucy)

Another objective of this year's investigations was to locate the main entrance to the basilica, believed to be in the west wall of the building. Excavations in this part of the church revealed at a depth of about 1.20 m below the preserved top of the walls, an entrance 6.40 m wide, clearly divided by two pillars (evidence of one of these pillars was preserved on the threshold). Later the space between the two pillars was blocked, thus forming two doorways of a width of c. 1.10 m each [Fig. 9]. Under the threshold, used as a support under a slab, was a small, undamaged marble Corinthian capital. The pavement

was laid 0.60 m below the threshold. Leading to the entrance from both north and south were three steps. Above the steps on the north side traces of burned ground were found – evidence of a Bedouin fire. The layer of burning yielded over 50 marble tiles coming from the decoration of the basilica, mostly square, hexagonal and triangular pieces. The fill further yielded two fragments of plaster giving an idea of what the ceiling could have been like: one with impressed bunches of reeds on the reverse and the other from a corner with impressed images in the negative of the construction supporting the roof.

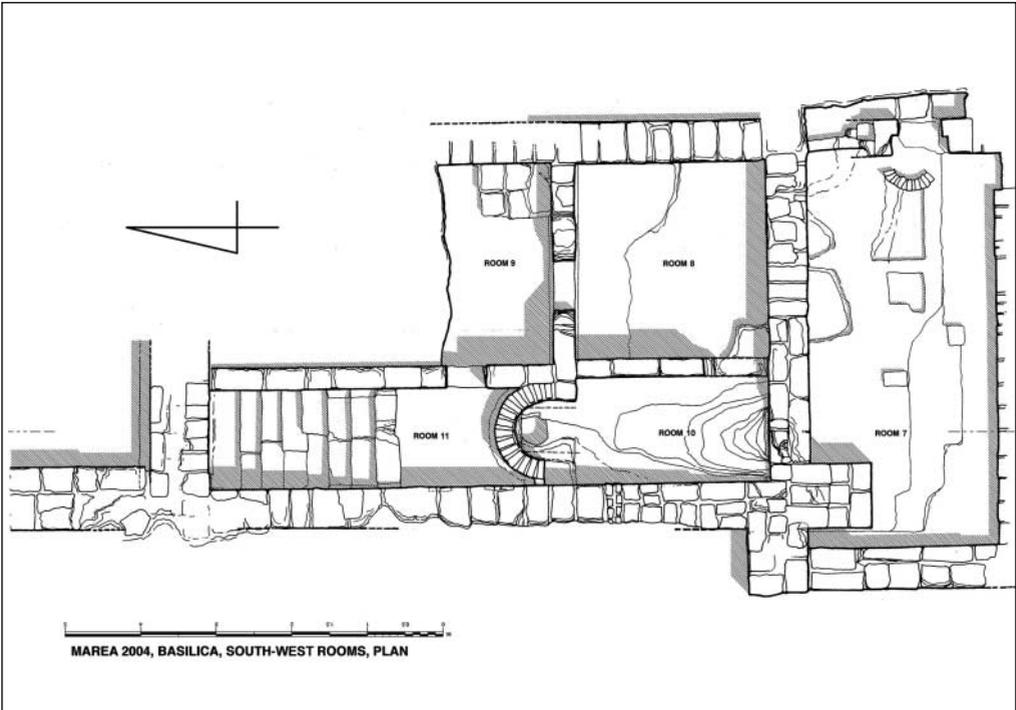
Fig. 10. Rooms beyond the southwestern corner of the basilica
(Drawing B. Wrońska-Kucy)

Explorations this year also covered the area beyond the southwestern corner of the basilica. A series of rooms adjoining the south wall of the church was cleared. On the south, they were closed off with an interlocking wall [Fig. 10].

Directly behind the aisle of the church there was a set of six steps leading to an upper level (room 11). Under the steps on the south side, at a depth of 1.50-1.60 m, a rubbish dump was discovered. It has not been fully explored yet, but already it has yielded a huge quantity of *opus sectile* tiles [Fig. 11], of differently colored marbles, as well as tiles ready to use for floor inlays. Other finds from the dump included discarded fragments of bone inlays used in

interesting finds of the season. The chamber is 2.70 by 2.50 m and had two floors: a paved floor of limestone blocks c. 1 m below the preserved top of the walls and another floor, this time of lime mortar, underneath it. On the partly preserved upper pavement, more than a hundred bronze coins were found,⁷ as well as more than 30 handles of lamps from a *polycandelon*.⁸ This last pavement may have been stabi-

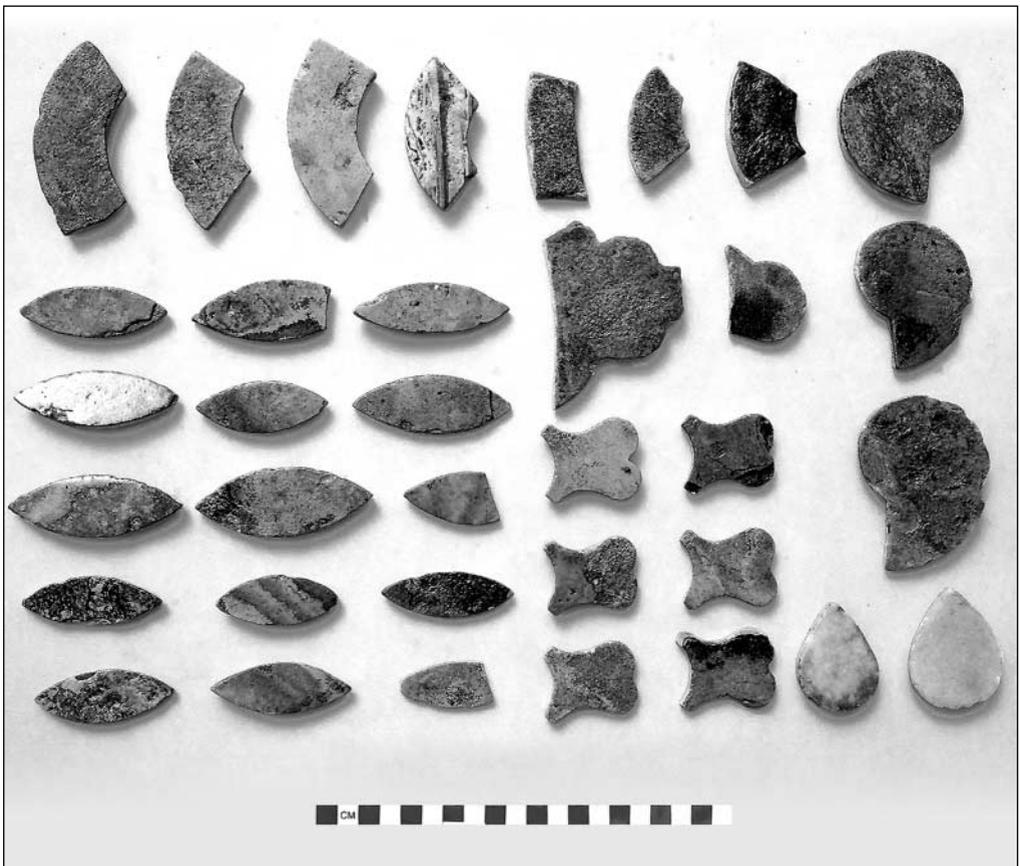
Fig. 11. Collection of marble *opus sectile* tiles from the basilica area
(Photo J.M. Kucy)
