## Some Remarks on the Stratigraphy and Architectural Vestiges in Sector 1 at Tell Farama (Pelusium) : Season 2005

Polish Archaeology in the Mediterranean 17, 136-141

# SOME REMARKS ON THE STRATIGRAPHY AND ARCHITECTURAL VESTIGES IN SECTOR 1 AT TELL FARAMA (PELUSIUM) SEASON 2005

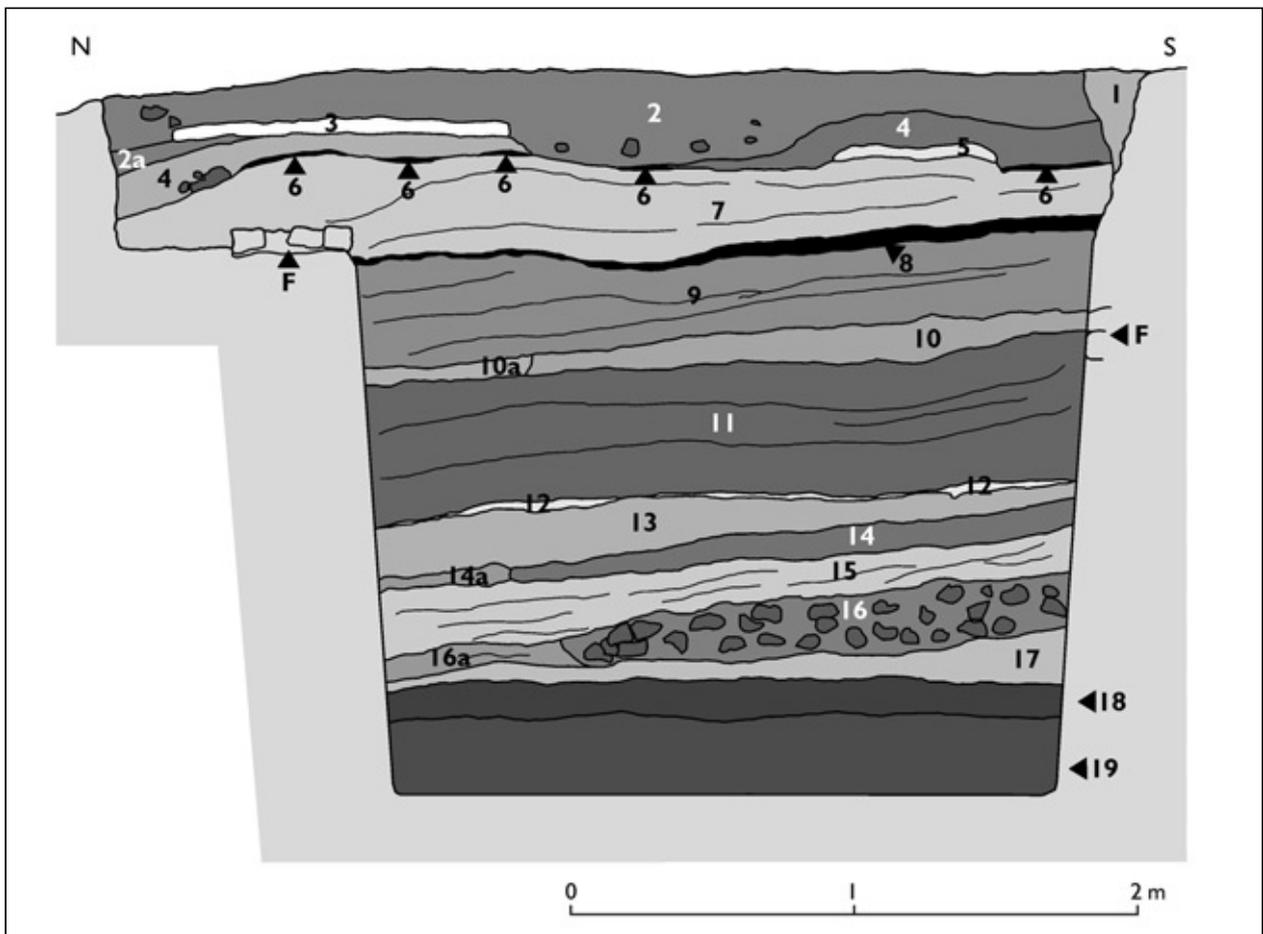
Fig. 1. East trench wall section in the northeastern test pit in Sector 1: 1 - ghost wall; 2, 2a - soil with sherds and building debris; 3 - floor; 4 - brown soil; 5, 6, 8 - concentrations of ashes; 7, 9, 11, 13 - soil with animal bones, sherds, building debris; 10 - animal bones and sherds on a layer of lime (10a); 12, 14a - large animal bones; 14 - potsherds and crushed burnt brick; 15, 16a, 17 - soil with sherds (varying amounts), burnt brick, bones; 16 - burnt brick and bones; 18 - soil with few sherds; 19 - sterile soil; F - bedding for a wall foundation (Drawing S. Mašlak)

Test pits were dug in three corners of the main trench in order to shed light on the local stratigraphy.<sup>3</sup> The northeastern pit measured approximately 1.50 by 2.50 m and descended 2.60 m, counting from the present ground surface. A fragmentary floor (no. 3 in the section drawing in *Fig. 1*) was found directly under the topsoil with fragments extending further to the northwest. The sequence under this floor consisted of mostly soil layers containing rubbish and sherds, animal bones, crushed baked brick, lime, ashes, etc. The bottom two (nos 18 and 19) were practically sterile (few sherds) and were deposited more or

Distinctive layers included no. 10, which corresponded perhaps to the upper part of the foundation of a lost wall, and certainly formed the walking level of a courtyard or at least a deposit accumulated on such a level. Layer no. 16 consisted mostly of tightly packed chunks of baked-brick rubble, originating from the dismantling of a nearby wall, or else transported to the dump from a more distant place. This refuse function was only

into consideration the huge quantities of bones (cf. *Fig. 1*) and evident traces of butchering observed on them, we must be dealing with meat processing on a large scale, carried out somewhere probably in the nearest vicinity. While bones were found only in deep-down layers,<sup>14</sup> coins, which were found in abundance, were recorded both in the rubbish deposits and in connection with architectural remains. Their presence in such numbers can be explained by the nearness of the harbor and the Pelusiac branch of the Nile some meters to the north. Unfortunately, most of them were corroded beyond identification. The few that have been read date the rubbish dump and the architectural vestiges to the 4th century AD. The exact date for the abandonment of the building(s) and consequently the beginning of baked-brick robbing in this area remains vague for the moment.

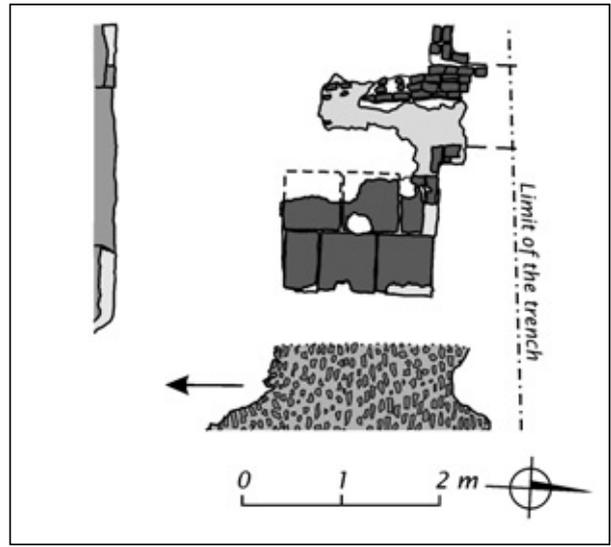
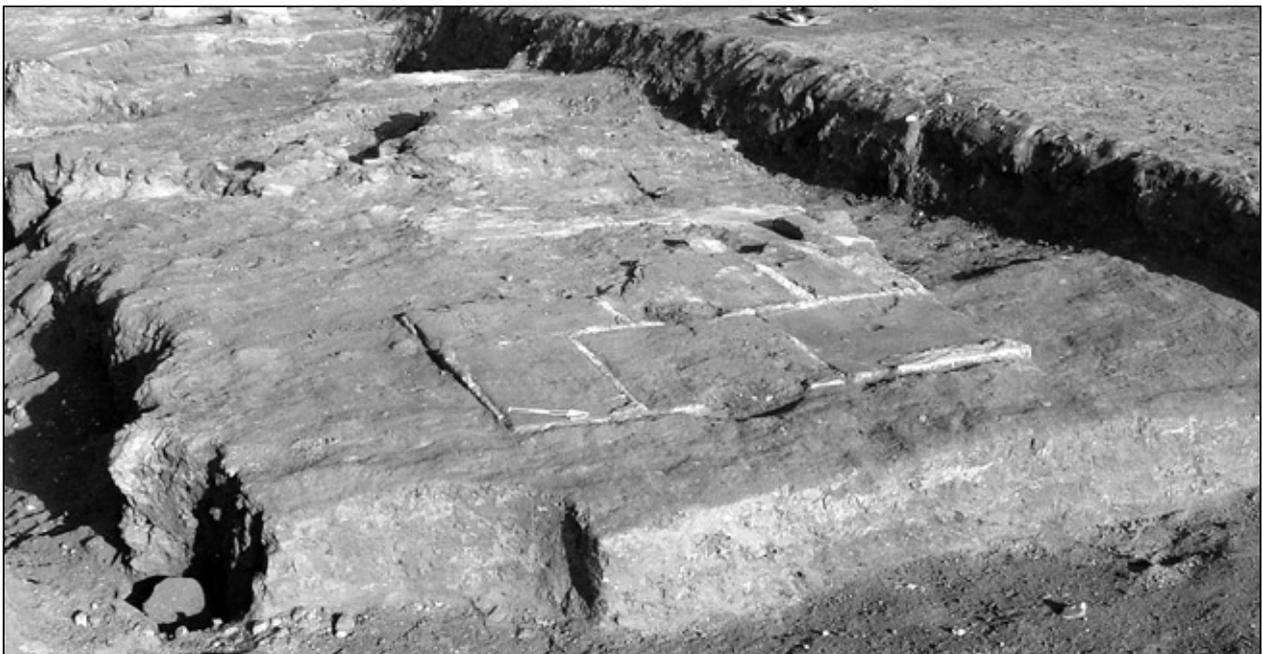
*Fig. 2. Floor of baked-brick tiles in Sector 1: Plan (fragment from plan in Fig. 5 on p. 130 above) and view (bottom) from the east (Photo K. Jakubiak)*

A floor of baked-brick tiles came to light slightly to the north of the mud-brick one [*Fig. 2*]. It measured approximately 1.50 by 1.20 m, including the missing southwestern corner. Four tiles were square in shape (58 x 58 cm), two

others rectangular (respectively 35 x 58 cm and 23 x 58 cm), and all 5 cm thick. Lime mortar was used for bonding, mixed with powdered black charcoal making it grey in color. Another floor made only of the same

ashy-lime mortar (3 cm thick) was found directly to the west. This mortar covered some courses of broken baked bricks, set longitudinally on edge and intentionally inclined eastward to level the ground under the proper floor.<sup>9</sup>

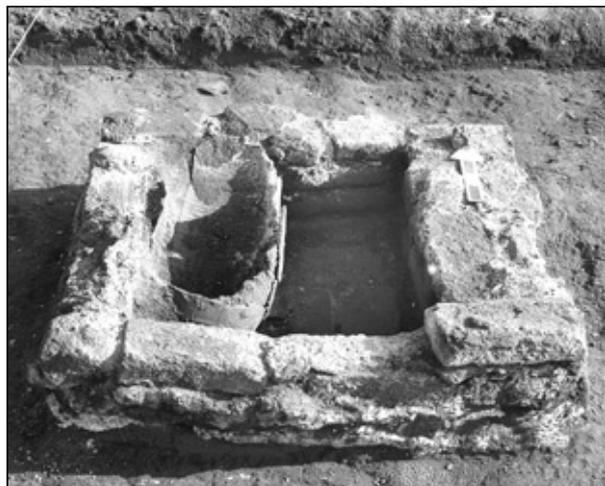
*Fig. 3. Container of baked brick with amphora preserved inside it (Photo K. Jakubiak)*

One of the most interesting features was a virtually square (0.75 by 0.80 m) container, constructed of baked bricks (22-23 x 11-11.5 x 5-5.5 cm and 21-22 x 10.5-

11 x 5-5.5 cm) bonded in lime mortar, but of extremely poor quality [Fig. 3]. Since an amphora was found in it, the container could be interpreted as a liquid jug stand, probably with internal compartments.<sup>11</sup> Many hearths or ovens were identified in the trench.<sup>12</sup> The first group includes pots containing black ashes, found sunk into the ground and surrounded with bricks. The hearth discovered in the northwestern corner of the trench was different. It was a ring (approx. 1.40 m in external diameter) made of mostly broken baked bricks bonded in clay mortar (the only full-sized brick: 23 x 11 x 4.5 cm). Together with the black ashes deposited inside, there was also a fragment of large storage vessel (amphora) placed against one of the walls.<sup>13</sup> It cannot be excluded that the structure was the bottom of a simple bread oven.
