## Banganarti 2004

Polish Archaeology in the Mediterranean 17, 301-321

# BANGANARTI

## 2004/2005

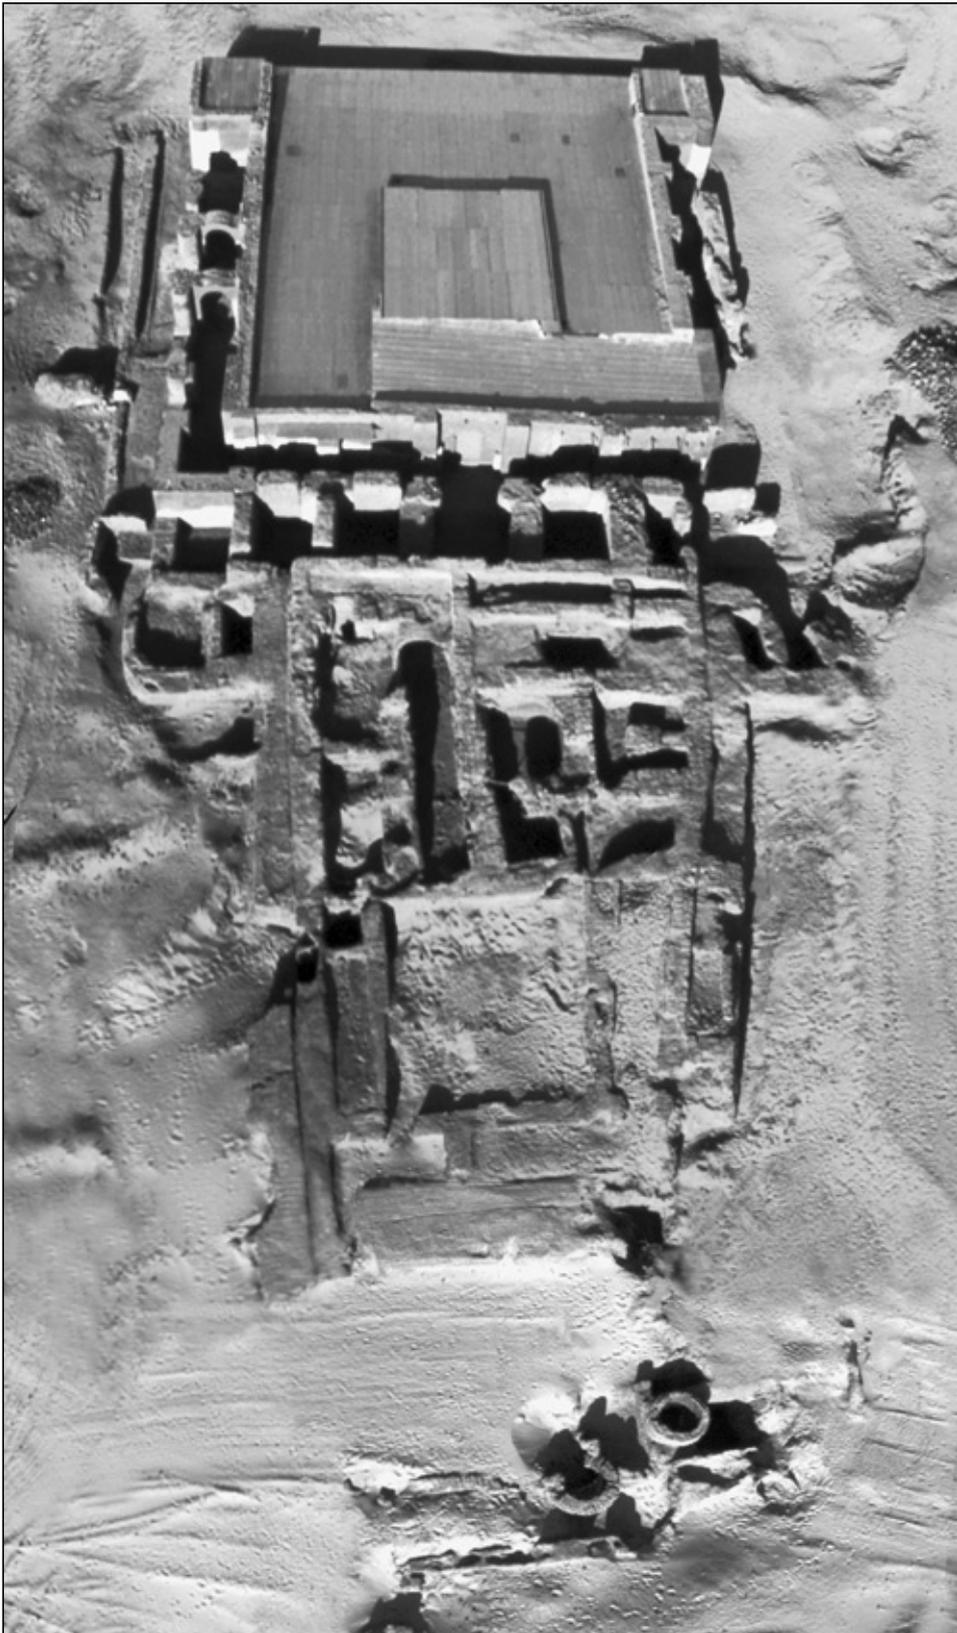
*Fig. 1. Aerial view of the Banganarti church complex including the Western Building and kilns (at bottom of picture). View from the southwest. Note the shelter roof installed over the Upper Church interior at top (Photo B. Żurawski)*

at least 1500 aerial photographs have been taken of the kom and its surroundings [Fig. 14]. In 2005, low-altitude photographs were taken of the kiln site, the girdle walls and, from a higher perspective, the Upper Church [cf. Fig. 1].

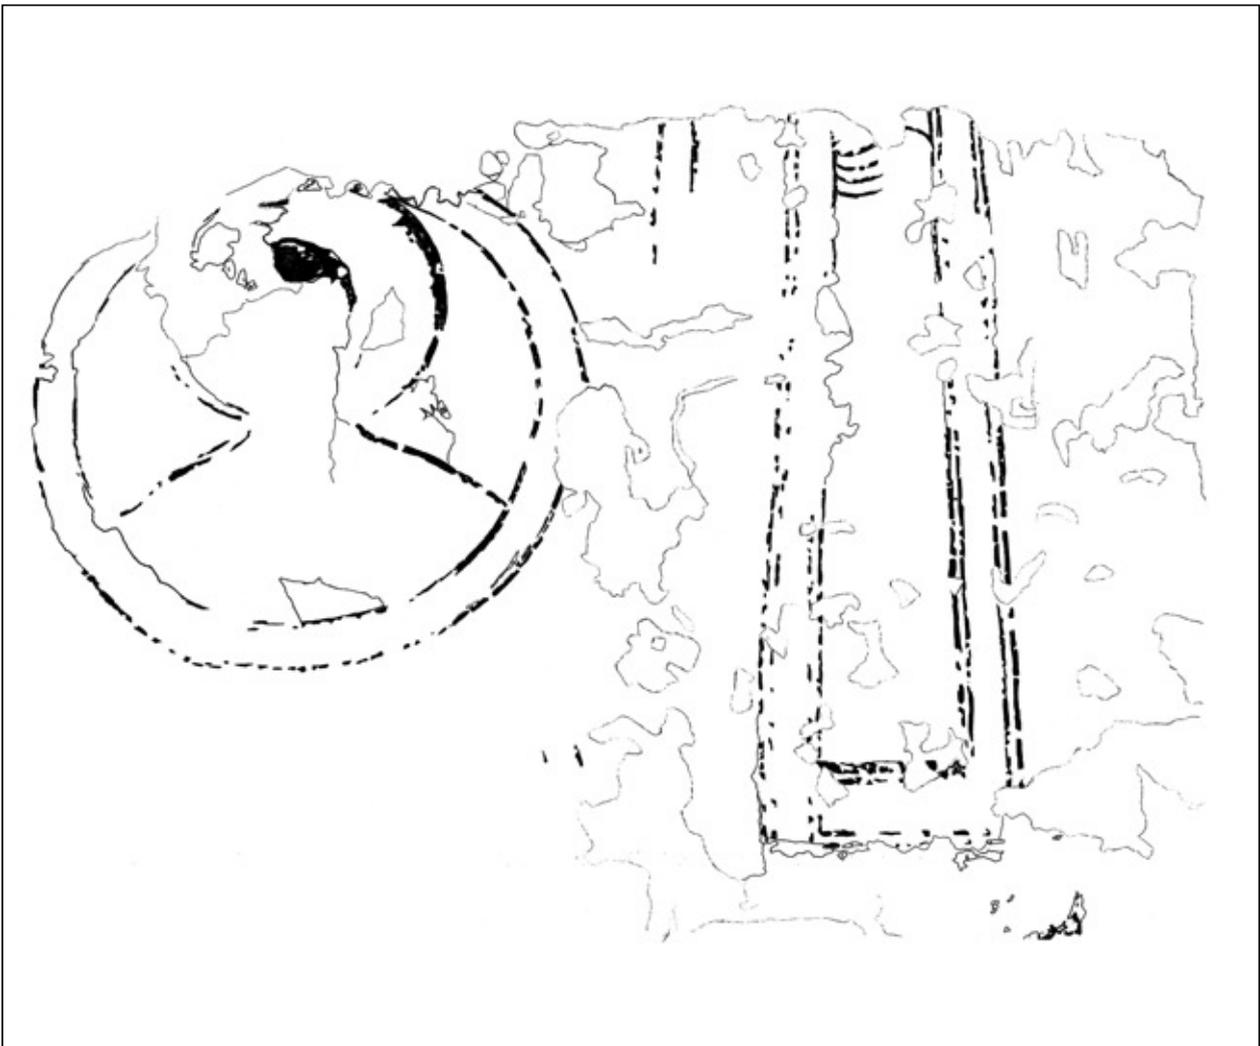
Fig. 9. Ink copy of a mural on the west wall of the northern exedra of the Lower Church (Trench S.5) (Drawing A. Błaszczuk)

of the Lower Church northern exedra [Fig. 9]. The foundation course of the Upper Church revealed in the northern trench wall was extremely well-preserved. A faintly preserved composition of a standing figure was preserved on the wall to the left and next to it a bust in tondo.

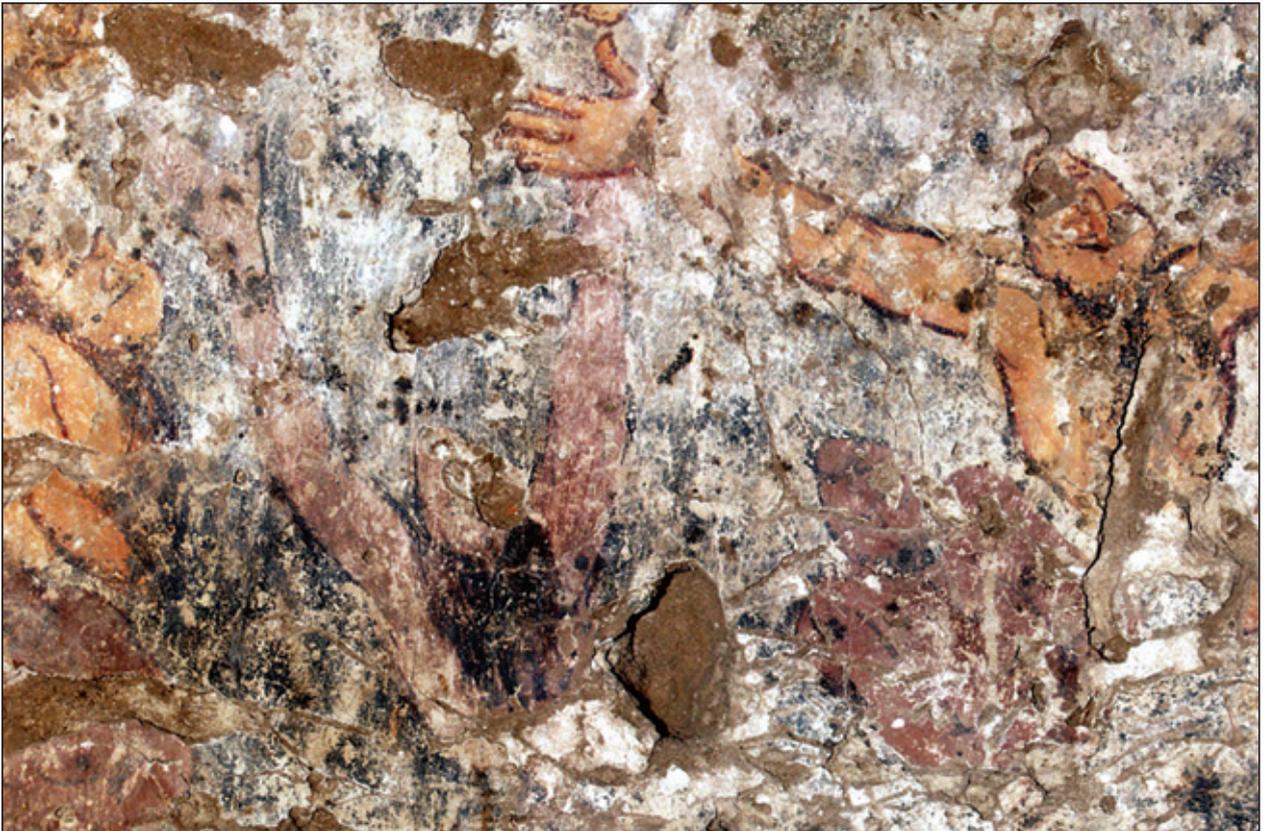
Fig. 12. *The dead as seen on the wall before conservation* (Photo B. Żurawski)

The figures of the dead are treated separately, each one painted in an individual and most original posture [*Fig. 13*]. The scene is vigorous and dynamic, the figures are writhing in pain. It is a far cry from the static Byzantine 'diagrams' of the Underworld where fully clad Justs statically and solemnly await redemption.<sup>8</sup>

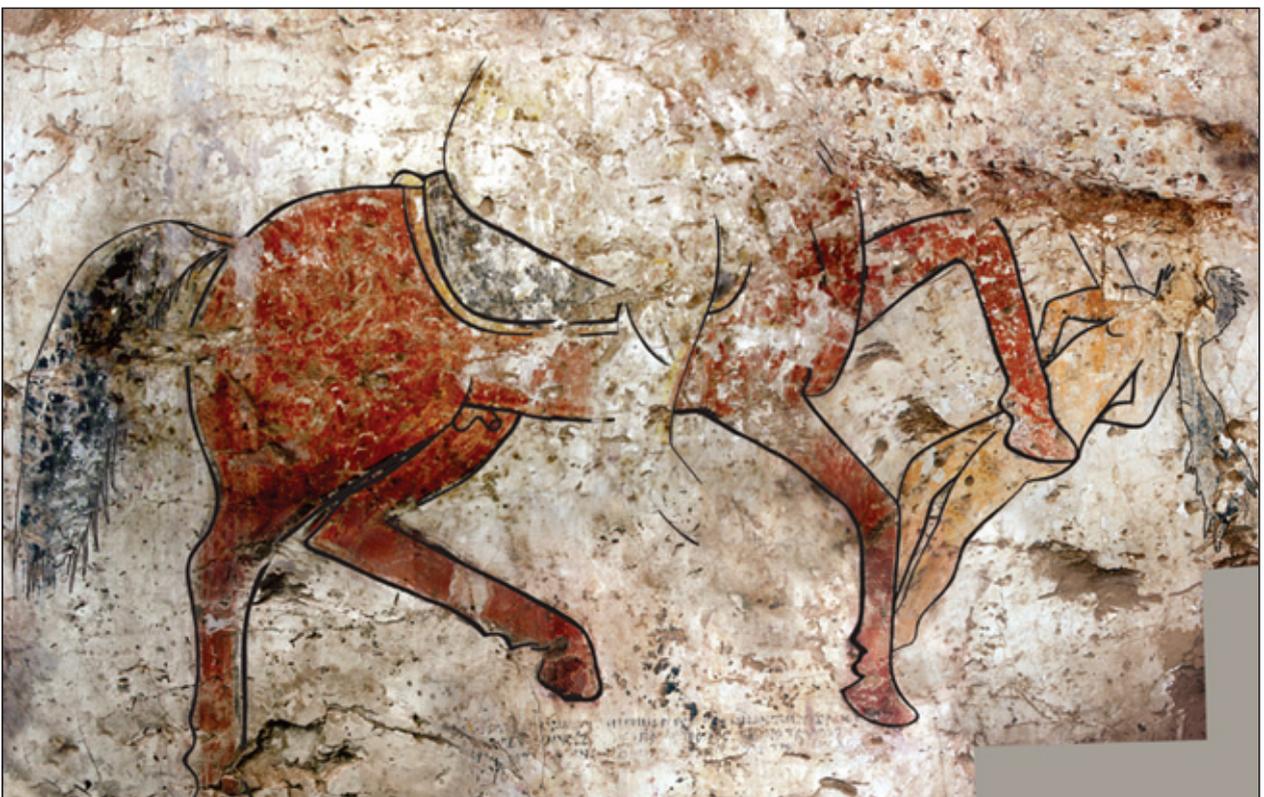
Fig. 13. *Equestrian saint trampling female demon (black outlines enhanced)* (Photo W. Chmiel)

The scene to the left is unframed. It represents the well-known motif of an equestrian saint, mounted on a reddish-brown stallion and trampling a demon in the form of a naked woman [*Fig. 13*]. The demon's hands are probably tied behind

her back. Her dark long hair is tied close to the head and hangs loosely. This part of the picture is not clear, but the saint's spear appears to be stabbing her through the neck.

A particularly well founded suggestion as to the identity of the saint in question was proposed by Adam Łajtar who suggested St. George on the basis of the hardly legible inscription below the horse's belly.

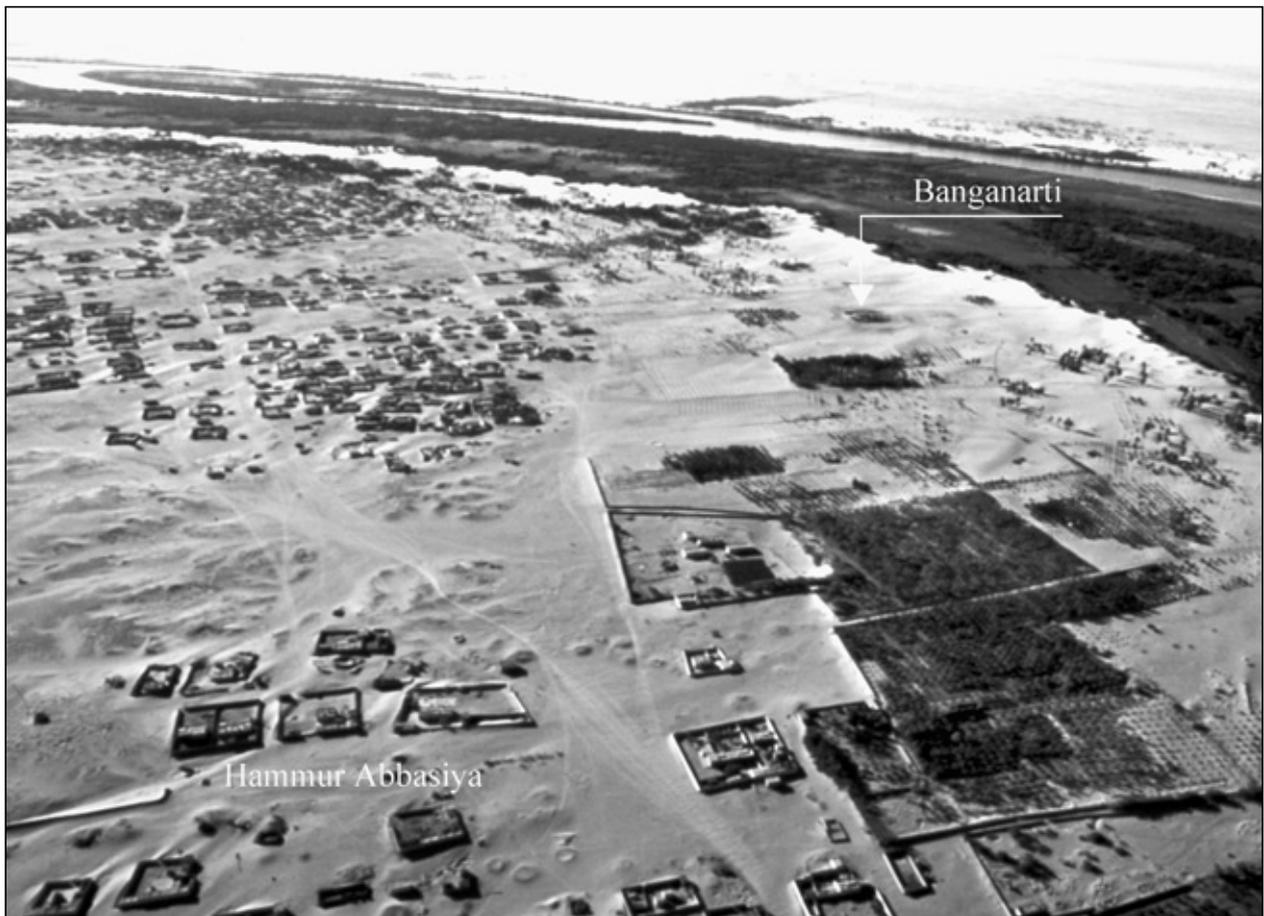
*Fig. 14. Aerial view of the post-Meroitic tumulus cemetery of Hammur Abbasiya in the foreground and the site of Banganarti in the upper right (Photo B. Żurawski)*
