**Marea: Sixth Season of Excavations**

Polish Archaeology in the Mediterranean 17, 55-66

# MAREA

## SIXTH SEASON OF EXCAVATIONS

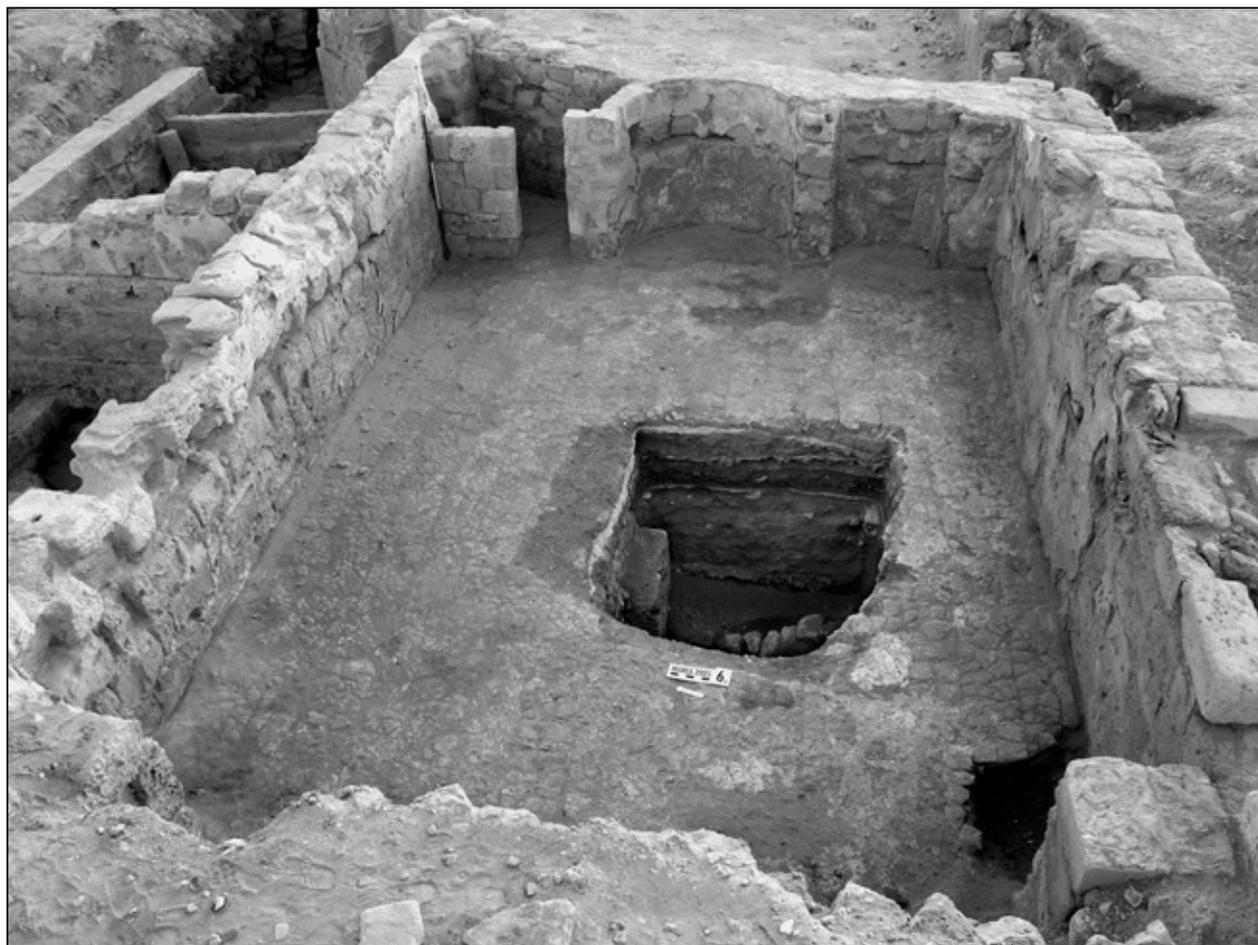
*Fig. 1. Pit C cut into the floor of the chapel  
(Photo D. Dziedzic)*

square pit (2.20 x 2.40 m) had been cut into the floor of the chapel; it was dug to a depth of 2.00 m [Fig. 1]. A wall of stone blocks, oriented N-S, undoubtedly a relic of an earlier structure, passed down the middle. A pile of human bones, contemporary with this wall, was uncovered in the western pit wall; the bones turned out to be a virtually complete skeleton belonging to a tall man (lacking only the finger bones),<sup>2</sup> obviously secondarily interred above a crushed amphora of the 2nd-3rd century.<sup>3</sup> The other

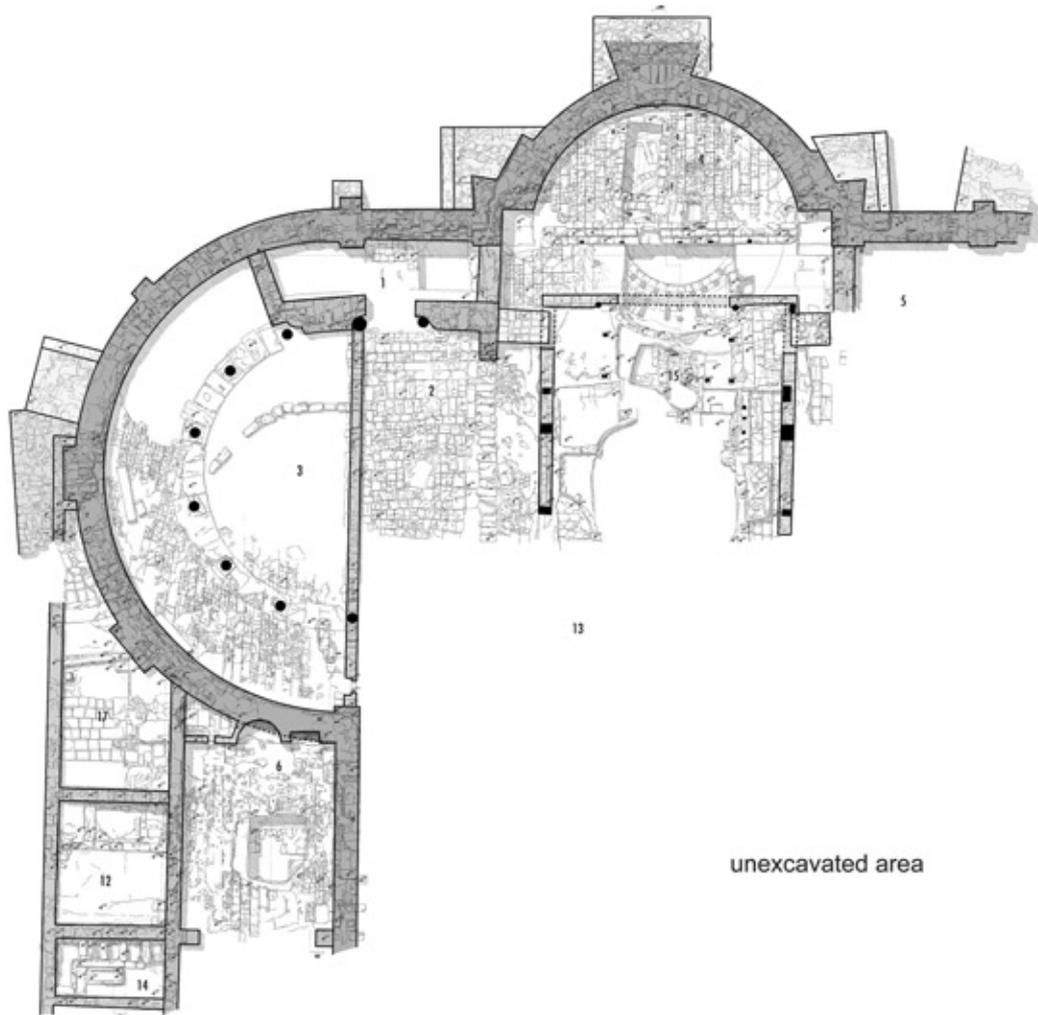
Fig. 2. Plan of the basilica in Marea after the 2005 season  
(Drawing D. Tarara)

Sections of the nave (7.00 m) and northern aisle (3.80 m) were cleared excavating westward. A baptistery [Fig. 2: no. 15] was found 1.80 m from the wall of the pottery kiln uncovered in 2003. This structure, originally part of the mud-brick building, reached down to the level of the grate of the kiln. Despite considerable

First from the west was a rectangular latrine (4.00 x 2.20 m) [cf. *Fig. 2*, no. 14]. Three toilet seats were aligned along the eastern wall [*Fig. 8*], preserving *in situ* only the blocks supporting the seating, the latter being found in the debris. Two of the

In the next room, measuring 4.00 x 4.50 m [cf. Fig. 2, no. 12], two occupation levels were uncovered: one contemporary with the floor of the chapel, preserved only in the form of an offset by the eastern wall, and a second, earlier one, c. 0.50 m below, with a floor of stone slabs [Fig. 10]. On this lower level, by the northern wall, there were found the remains of a primitive, small oven with traces of burning. Above it, fragments of two floors were preserved: one of clay and the other of lime mortar. It seems that these relics date from before the room was built, except for the southeastern corner, in which a small cellar (?) was found. Judging from notches in the wall used to install individual steps, stairs had once led from this spot to a floor above the chapel. This room yielded most of the 314 coins discovered this year, in similarity to the case of the "shops" behind the southern wall of the basilica [cf. Fig. 2 nos 9,10,11]

Another room [cf. *Fig. 2*, no. 17], measuring 4.00 x 4.80 m, was, like the ones discussed above, created as a result of closing a space behind the chapel wall. From the east, it was delimited by a diagonal wall of limestone slabs, which reached the western buttress reinforcing the transept wall [*Fig. 11*, bottom left]. There is much to suggest that the unit served industrial purposes. By the northern wall there are two sturdy counters for preparing food, made of stone blocks and

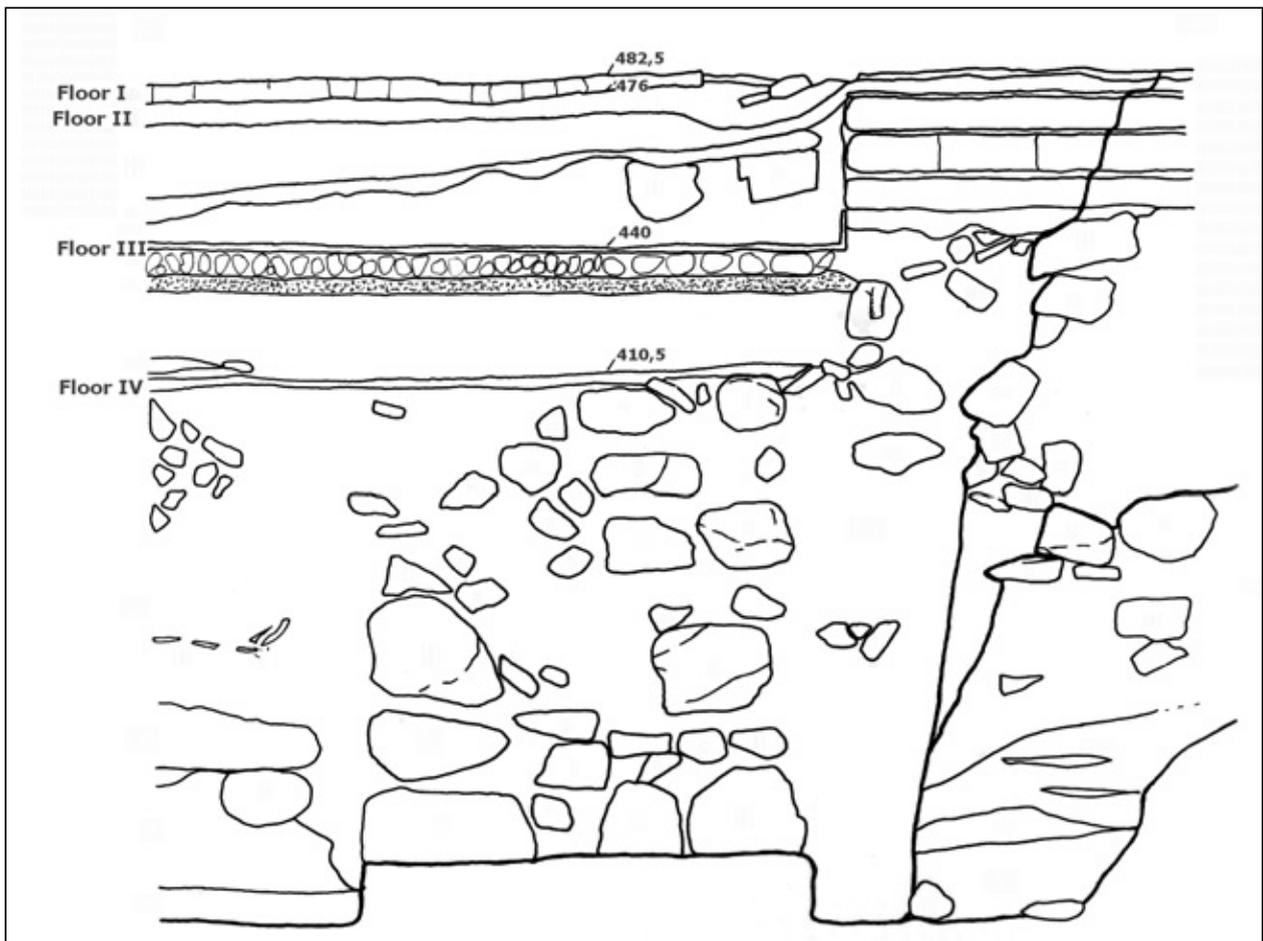
Fig. 3. Section through strata underlying the basilica (south trench wall in pit C). Scale 1:10. Note successive floors: I and II (lime mortar); III (lime mortar on a substructure of pebbles poured with mortar mixed with ashes, on top of a layer of sand with crushed shells and a leveling layer of soil mixed with potsberds, plaster, rock); and IV (lime mortar on top of a similar leveling layer) (Drawing D. Dziedzic)

three pit walls revealed clear stratigraphical evidence of four successive lime-mortar floors [Fig. 3]. The earliest floor (IV) was laid after the last occupation level, which included the above-mentioned wall, had ceased to function. Over it, on a leveling layer nearly 0.40 m thick, another floor (III) was laid. It was carefully constructed, on a substructure made of two layers: pebbles set in mortar mixed with ash, and sand with crushed shells. Above it, there was a wall of mud-brick preserving patches of thick plaster. Only floors II and I belonged to the basilica. Level measurements indicated that

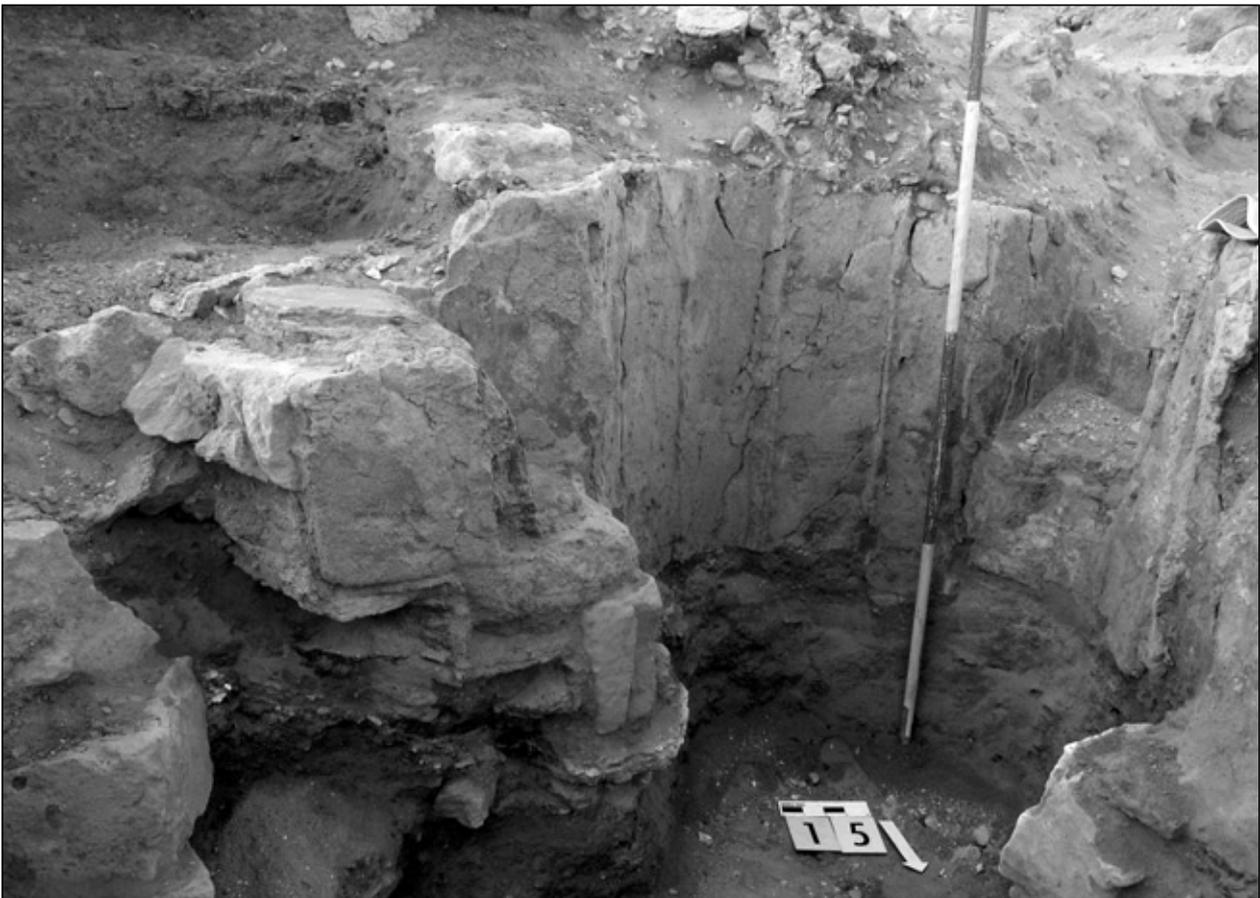
Fig. 4. *Baptistery. View from the north*  
(Photo J. Babraj)

deterioration, its shape is clearly discernible [Fig. 4]. It belongs to the round *piscina* type (1.08 m in diameter and 1.00 m in depth), with descending flights of steps situated facing each other on the eastern and western sides, two steps on each side.<sup>4</sup> The wall of the basin, preserved only on the south side, and the steps, were made of lime mortar and covered with red, waterproof plaster (*opus signinum*). Vertical imprints are proof of marble revetment on facing the walls. The location of the baptistery below the floor and under or in the vicinity of the altar points to a dating earlier than the

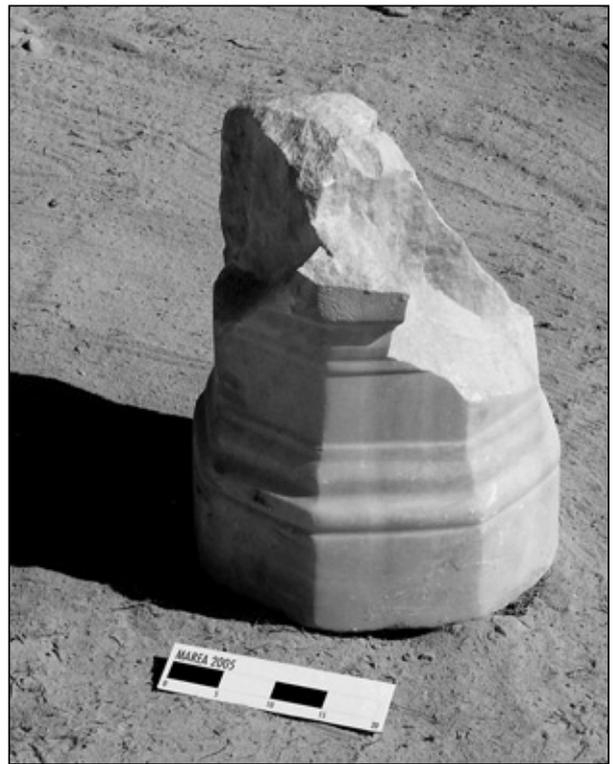
Fig. 5. Polygonal column base from the nave of the basilica (Photo H. Szymańska)

The work in the nave supplied data on the successive building stages of the basilica. Moving westward, the debris of stone blocks, which had fallen from the side walls of the basilica and remained in the fill, ended c. 2.50 m from the wall of the kiln. Found here was a small number of fragments of marble column shafts, 0.24, 0.30 and 0.35 m in diameter, as well as, appearing here for the first time, polygonal column bases [Fig. 5], which are typically Byzantine<sup>5</sup> and which were

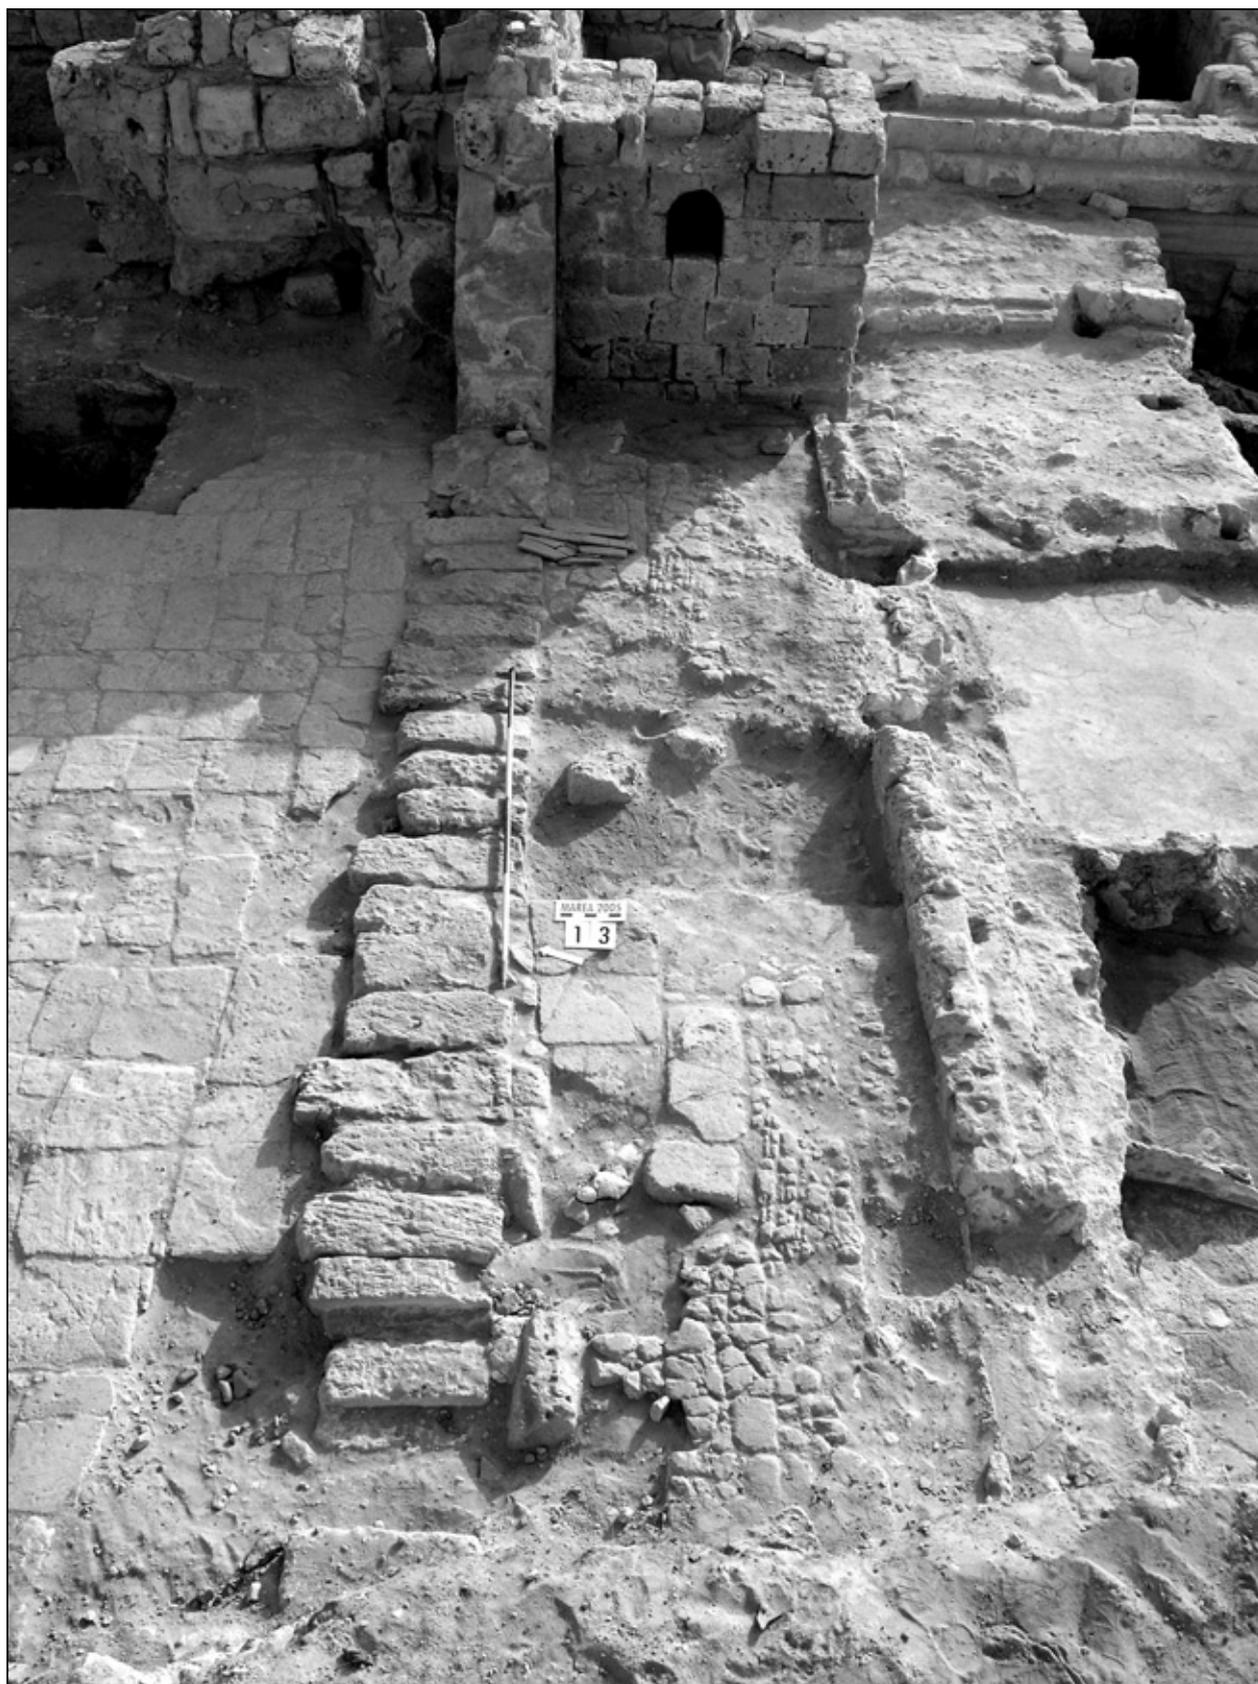
*Fig. 6. Stylobate under a colonnade separating the nave from the northern aisle of the basilica  
(Photo J. Babraj)*

In the northern aisle, yet another part of a floor with tile imprints was uncovered, as well as a stylobate under columns separating it from the nave [*Fig. 6*].

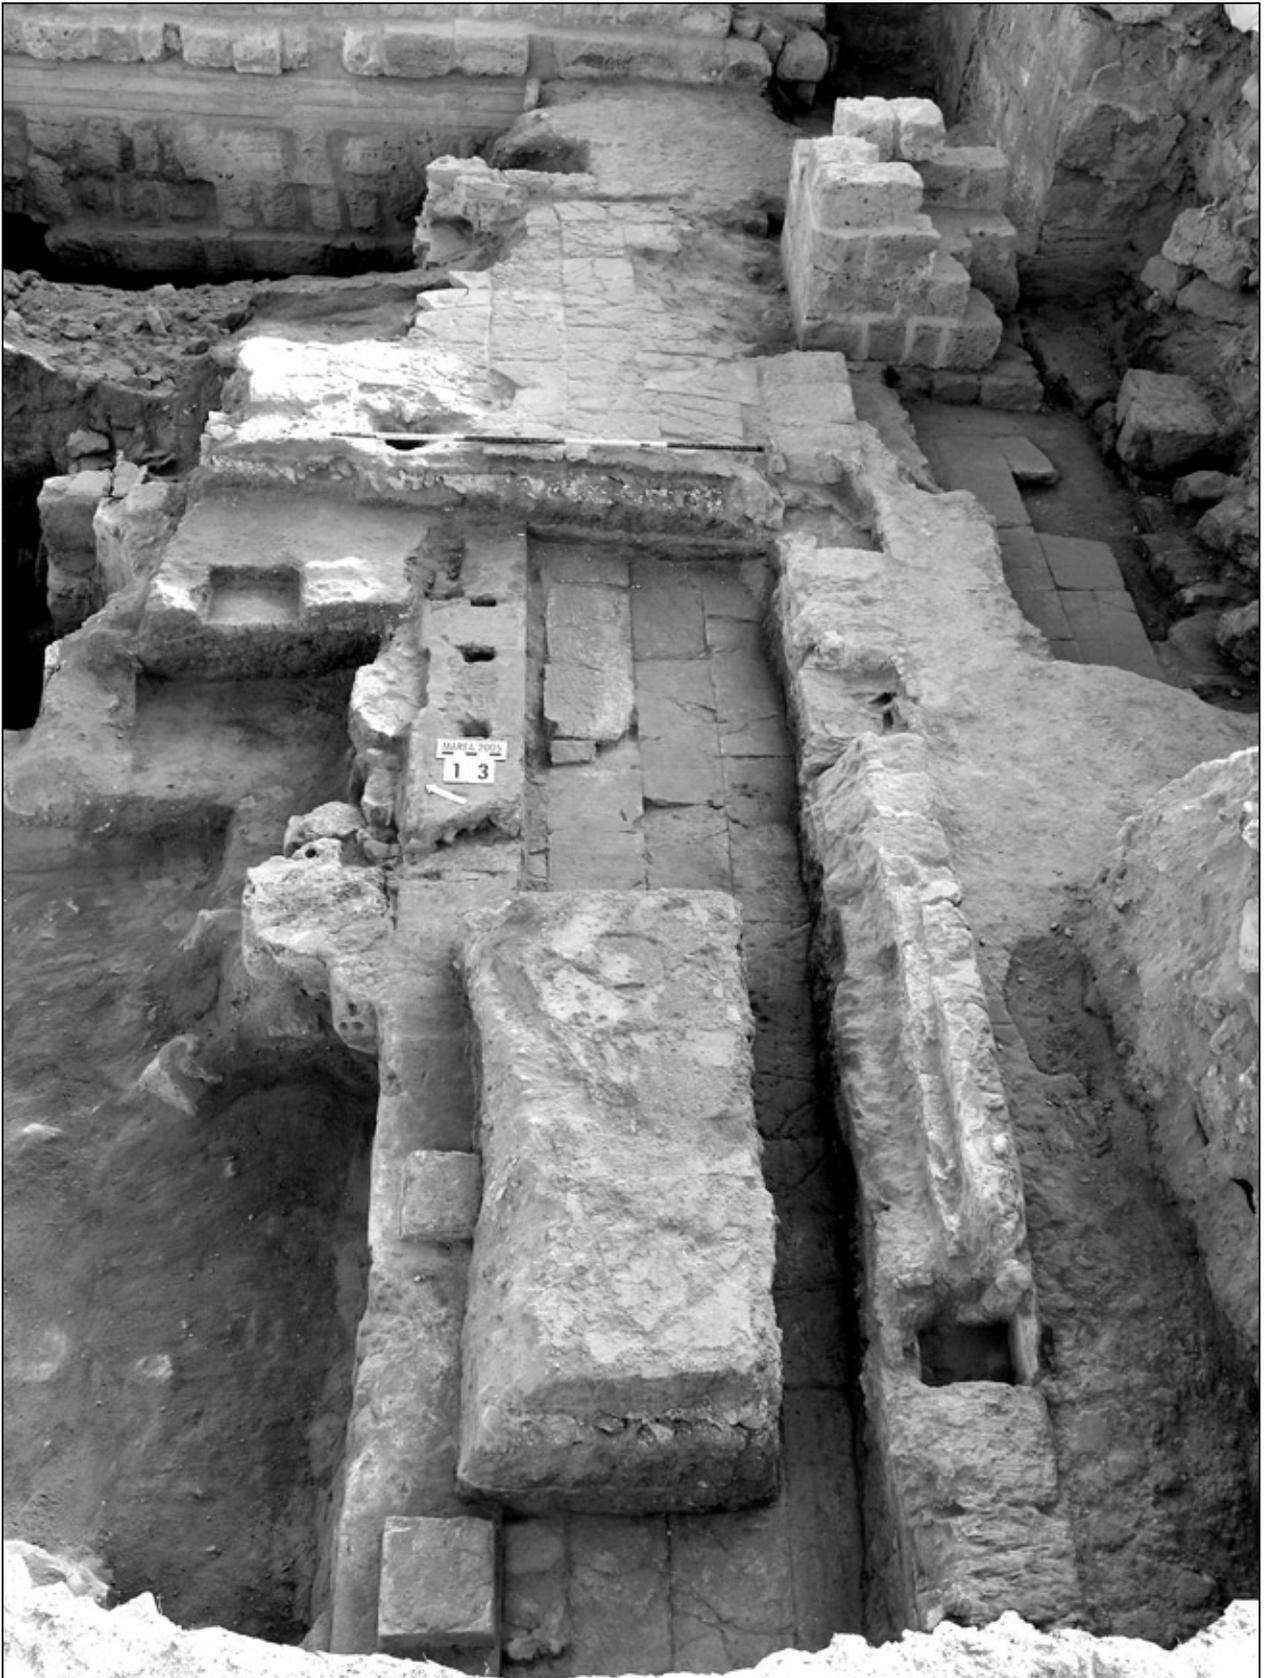
*Fig. 7. Southwestern part of the nave showing remains of two floor levels. View from the west (Photo J. Babraj)*

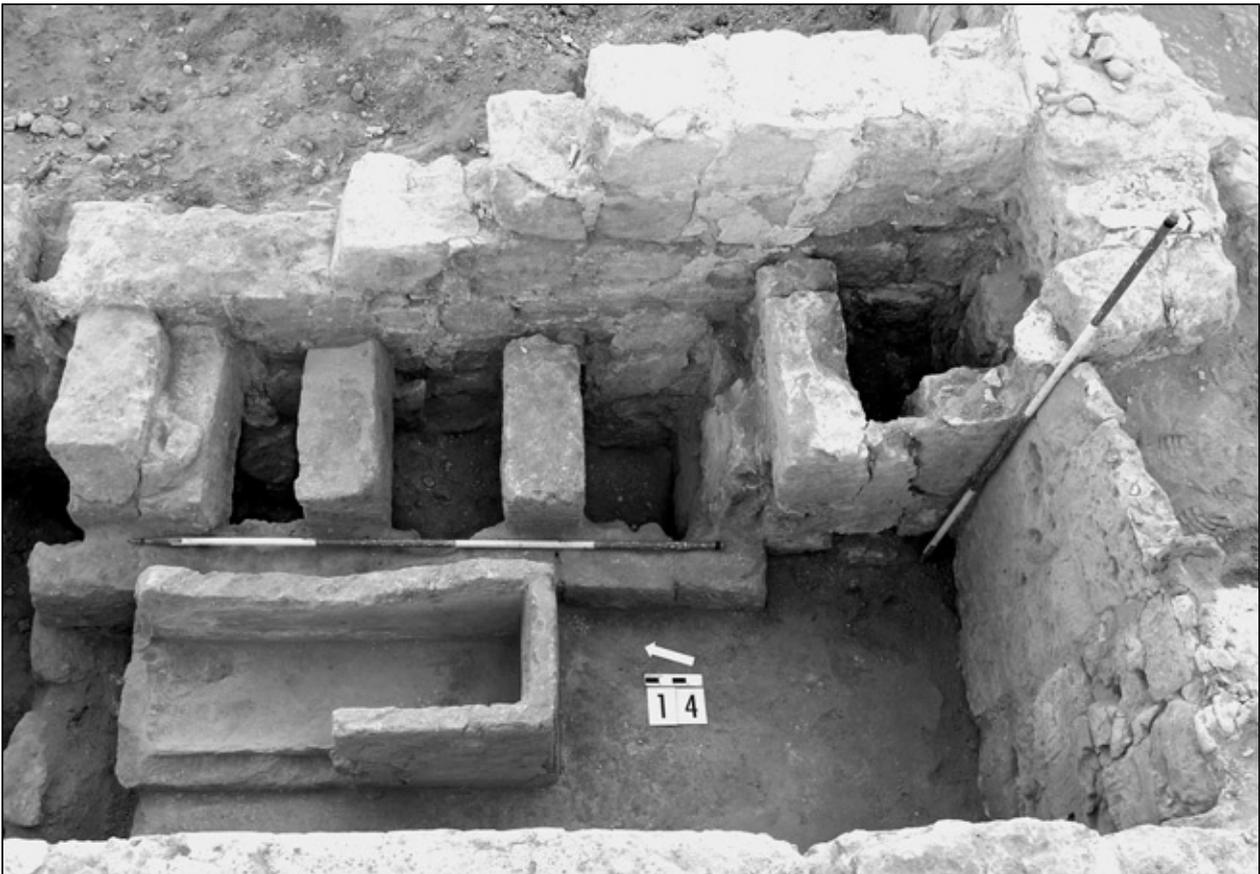
*Fig. 8. Latrine uncovered behind the northern wall of the chapel (Photo D. Dziedzic)*

seats measured 0.75 by 0.46 m and 0.40 by 0.20 m. In the southeastern corner, there was a fourth toilet, which was converted into a water tank (?) at a later time. Alongside the toilets there is a stone foot rest, and in front of it a deep and well preserved basin made of stone slabs, measuring 1.40 x 0.80 m, presumably for washing hands and rinsing sponges. Both the inner and the outer walls of the basin were coated with waterproof plaster that bears traces of water stains. A thick layer of *opus signinum* is also visible in the north-eastern corner of the latrine. Originally, the latrine was accessible from the church, specifically from a room situated behind the western entrance to the chapel (to be excavated next year). The second entrance was in the western wall of the latrine. Both doorways were later blocked. The exploration of the latrine, which will also be continued in the upcoming season, yielded many finds, including fragments of a painted Coptic plate with motifs of birds and fish [Fig. 9], two terracotta figurines

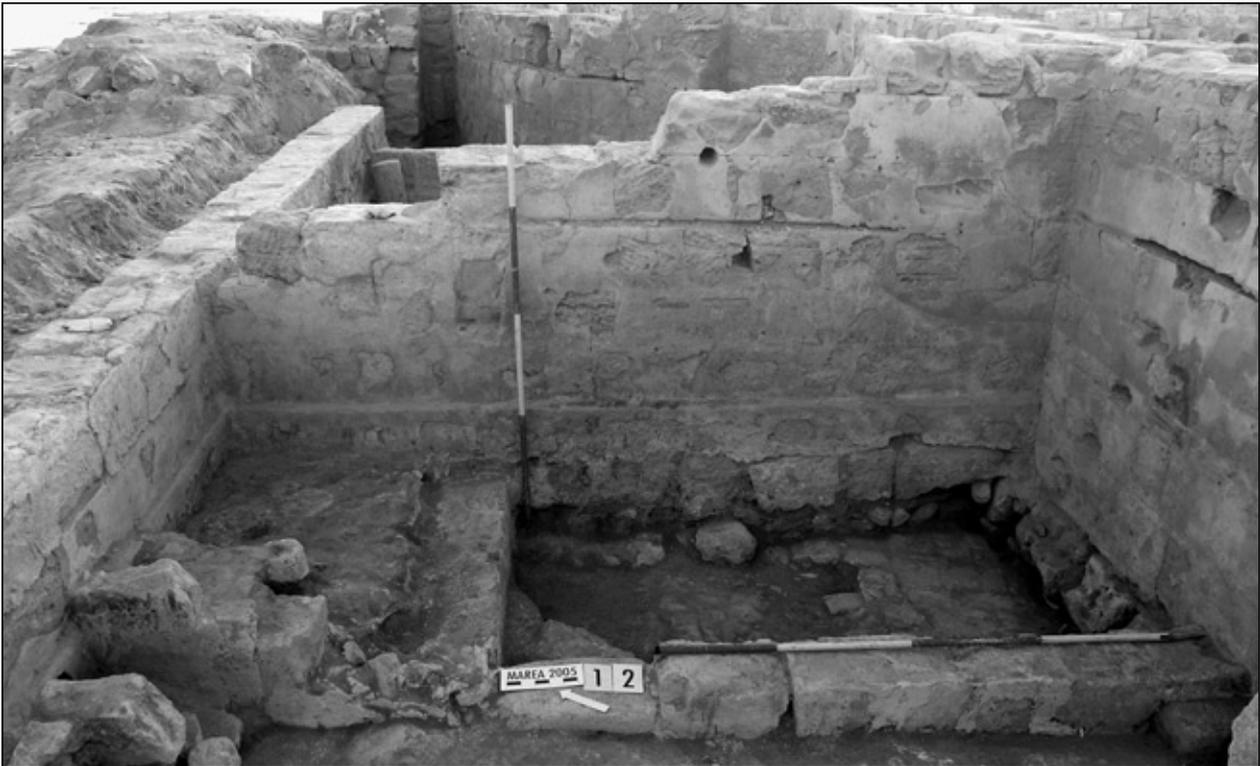
*Fig. 10. Room 12 behind the northern wall of the chapel. View from the west  
(Photo J. Babraj)*

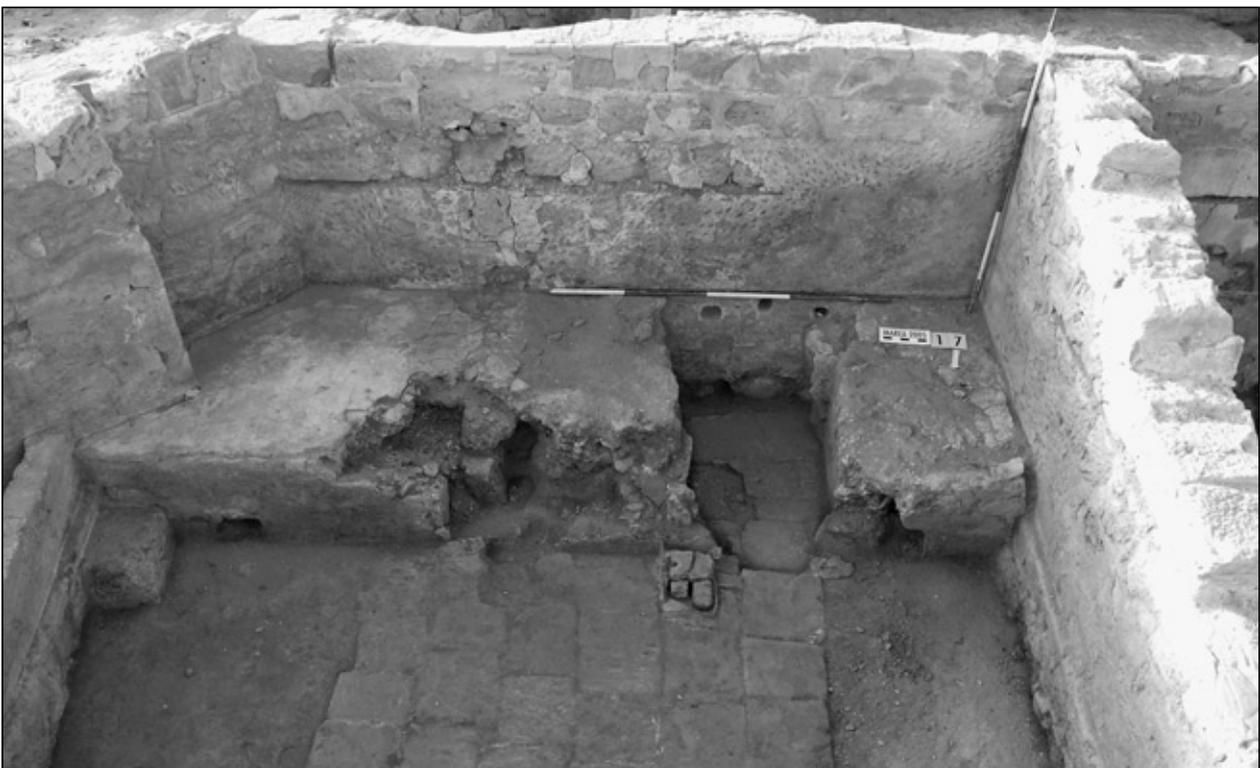
*Fig. 11. Room 17 behind the northern wall of the chapel. View from the north  
(Photo J. Babraj)*

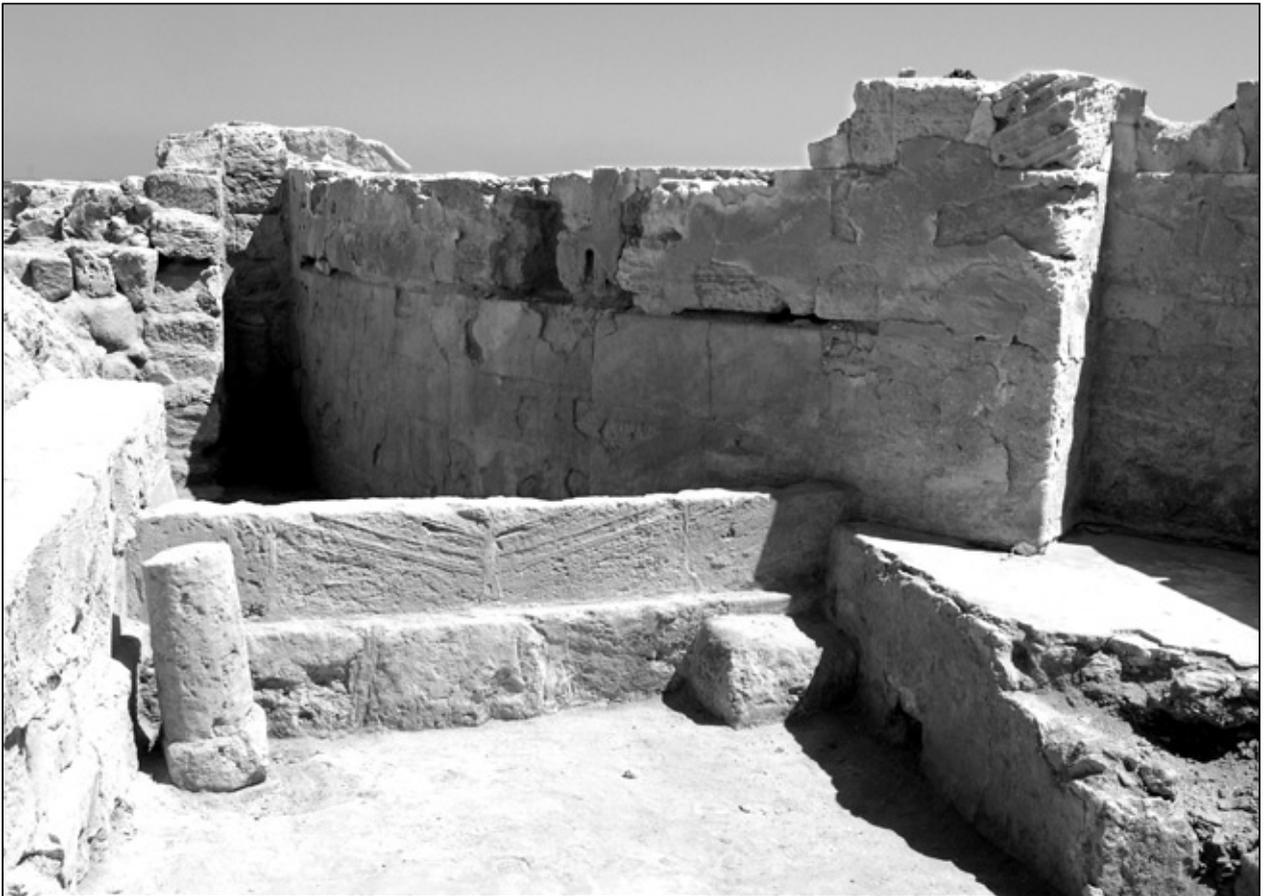
*Fig. 12. Washbasin stand in room 17. View from the west  
(Photo J. Babraj)*

covered with a thick layer of lime mortar sealed with *opus signinum*. Inside they were filled with tiny potsherds, the rounded edges of which suggest water erosion. In the wall between the counters, there are three round openings for wooden beams that probably supported another counter or table (?). In the northeastern corner, there stood a limestone washbasin stand [*Fig. 12*], confirming the utilitarian purpose of the room. The floor was covered with limestone slabs that reached up to the part of the northern buttress added in the second phase, for the building of which another washbasin stand was used.
