Old Dongola: Fieldwork Seasons 2005

Polish Archaeology in the Mediterranean 18, 325-348

OLD DONGOLA

SEASONS 2005/2006 AND 2006

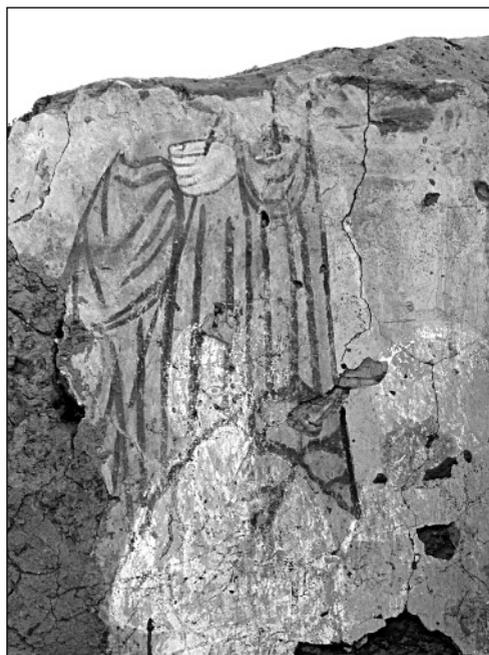
Fig. 16. Angel and two saints (monks ?) in Room CB.2 (Photo S. Jakobielski)

of white-robed figures with haloes and the face of one of the saints have been preserved [Fig. 16].

Another important conservation effort this season was to protect the murals newly discovered in the Central Building (H-CB), among others, a depiction of an angel on the north wall of Room CB.2 (cf. above, *Fig. 16* on page 340).

The first step was to clean the surface with glass fiber brushes. The painting surface was covered with 3% KLUCEL G in alcohol. To make the plaster stronger and in order to make the loosened part of the plaster re-adhere to the wall, injections were made of PRIMAL AC33 with VINA-VIL NPC (1:1) in water (1:6). The outer edges of the plaster were reinforced and the surface plaster losses filled with a lime putty (one part lime to four parts sand with PRIMAL E330 and VINA-VIL NPC added), used in conformity with the original lime coating of the wall.

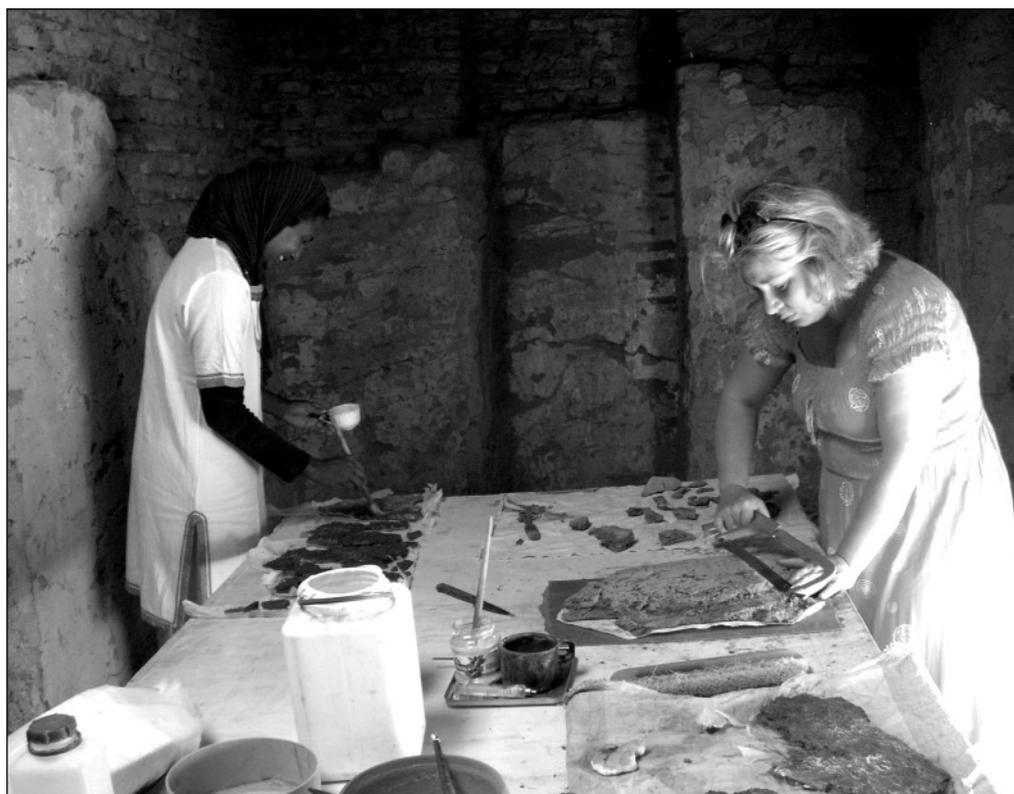
*Fig. 1. Work on the murals in a makeshift conservation atelier at the site
(Photo M. Martens-Czarnecka)*

One of the chief tasks of the conservation team working this season in the monastery on Kom H (for previous conservation reports, cf. Jakobielski 2001: 278; Jakobielski 2003: 228-229; Jakobielski 2005: 272) was to put together the mural depicting the *Massacre of the Innocents* from the tumbled southern part of the vault in Room 6 of the Southwestern Annex. The original vault had been constructed of mud brick, coated with mud plaster and white-washed with kaolin clay. The difficulty lay in the fragmentation of the remains, many being preserved on single bricks or as loose pieces of plaster, which had additionally been twice removed from their original position, further breaking any connections which may have remained after the first exploration of the vault. Closer observation of the material also indicated that part of the plaster had been distorted and the painting layer washed out by rain sometime in the distant past.

Considering the short season this year, the decision was taken to salvage all the bigger pieces, which were easier to identify and replace in position. Smaller loose fragments and parts of the background have been protected by placing them in sand in flat boxes and storing them for further work.

The painted surface of fragments of murals still adhering to loose bricks was cleaned mechanically and consolidated with a 2% solution of PARALOID B72 in toluene. Once the solvent had evaporated, the surface was protected with several layers of Japanese tissue paper attached with KLUCEL G (c. two big spoons of dry adhesive per half a liter of water). The painted layer was cut away from the bricks [*Fig. 1*]. It was then placed face down and the back side was reinforced by daubing it delicately (so as not to dissolve it) with a water dispersion of PRIMAL AC33 (1:10). Putties made of fine sand, clay from crushed mud brick with a few percent of polyvinyl acetate added were used to fill the losses. The Japanese tissue was then removed from the face by soaking and the elements were arranged on a 2 mm mesh screen, attached to it with the same plaster used for the putties.
