MAREA

REPORT ON THE EXCAVATIONS OF THE POLISH ARCHAEOLOGICAL MISSION IN 2006

Hanna Szymańska, Krzysztof Babraj

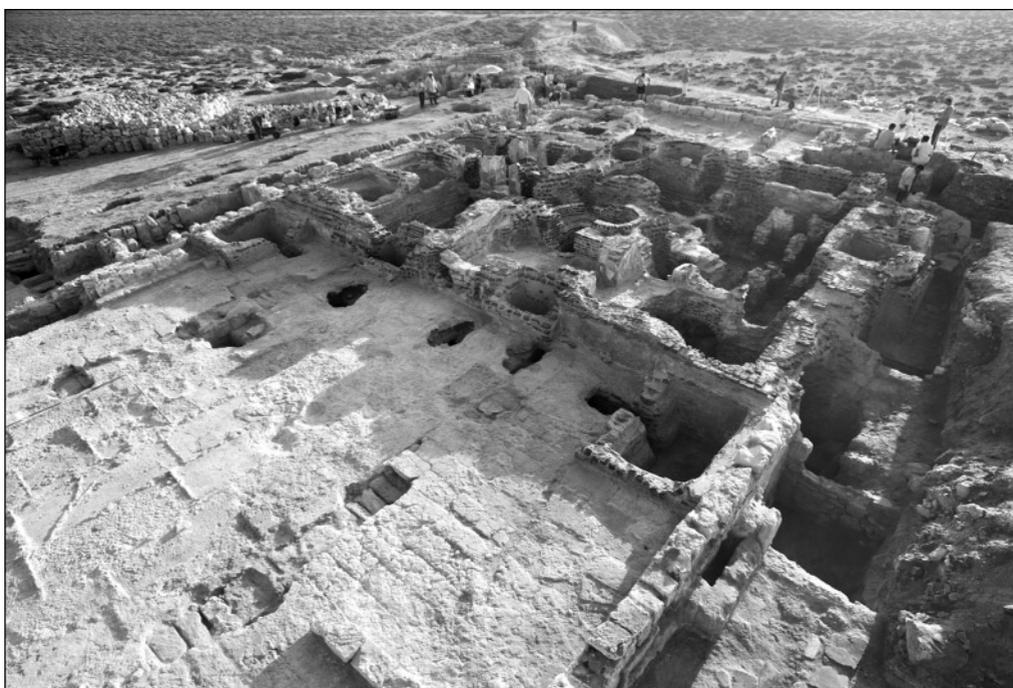
Fig. 1. Byzantine baths. Courtyard F6 with imprints of the marble pavement slabs preserved in the limestone bedding. View from the southwest (Photo P. Suszek)

The first task was to finish the excavation of the baths. The western courtyard (F6), which was excavated partly in 2001, had to be cleared completely. It turned out to measure 14.72 by 13.83 m and was paved with marble slabs, of which only imprints in the limestone bedding have survived [Figs 1, 2]. Apart from sections that were repaired, the slabs followed no size standards, ranging from 1.80 x 0.89 m to 0.80 x 0.80 m. Two marble slabs found in the rubble, a surprising 0.04 m thick, most likely originated from the courtyard. A small fragment of the marble revetment was preserved in the northwestern corner.

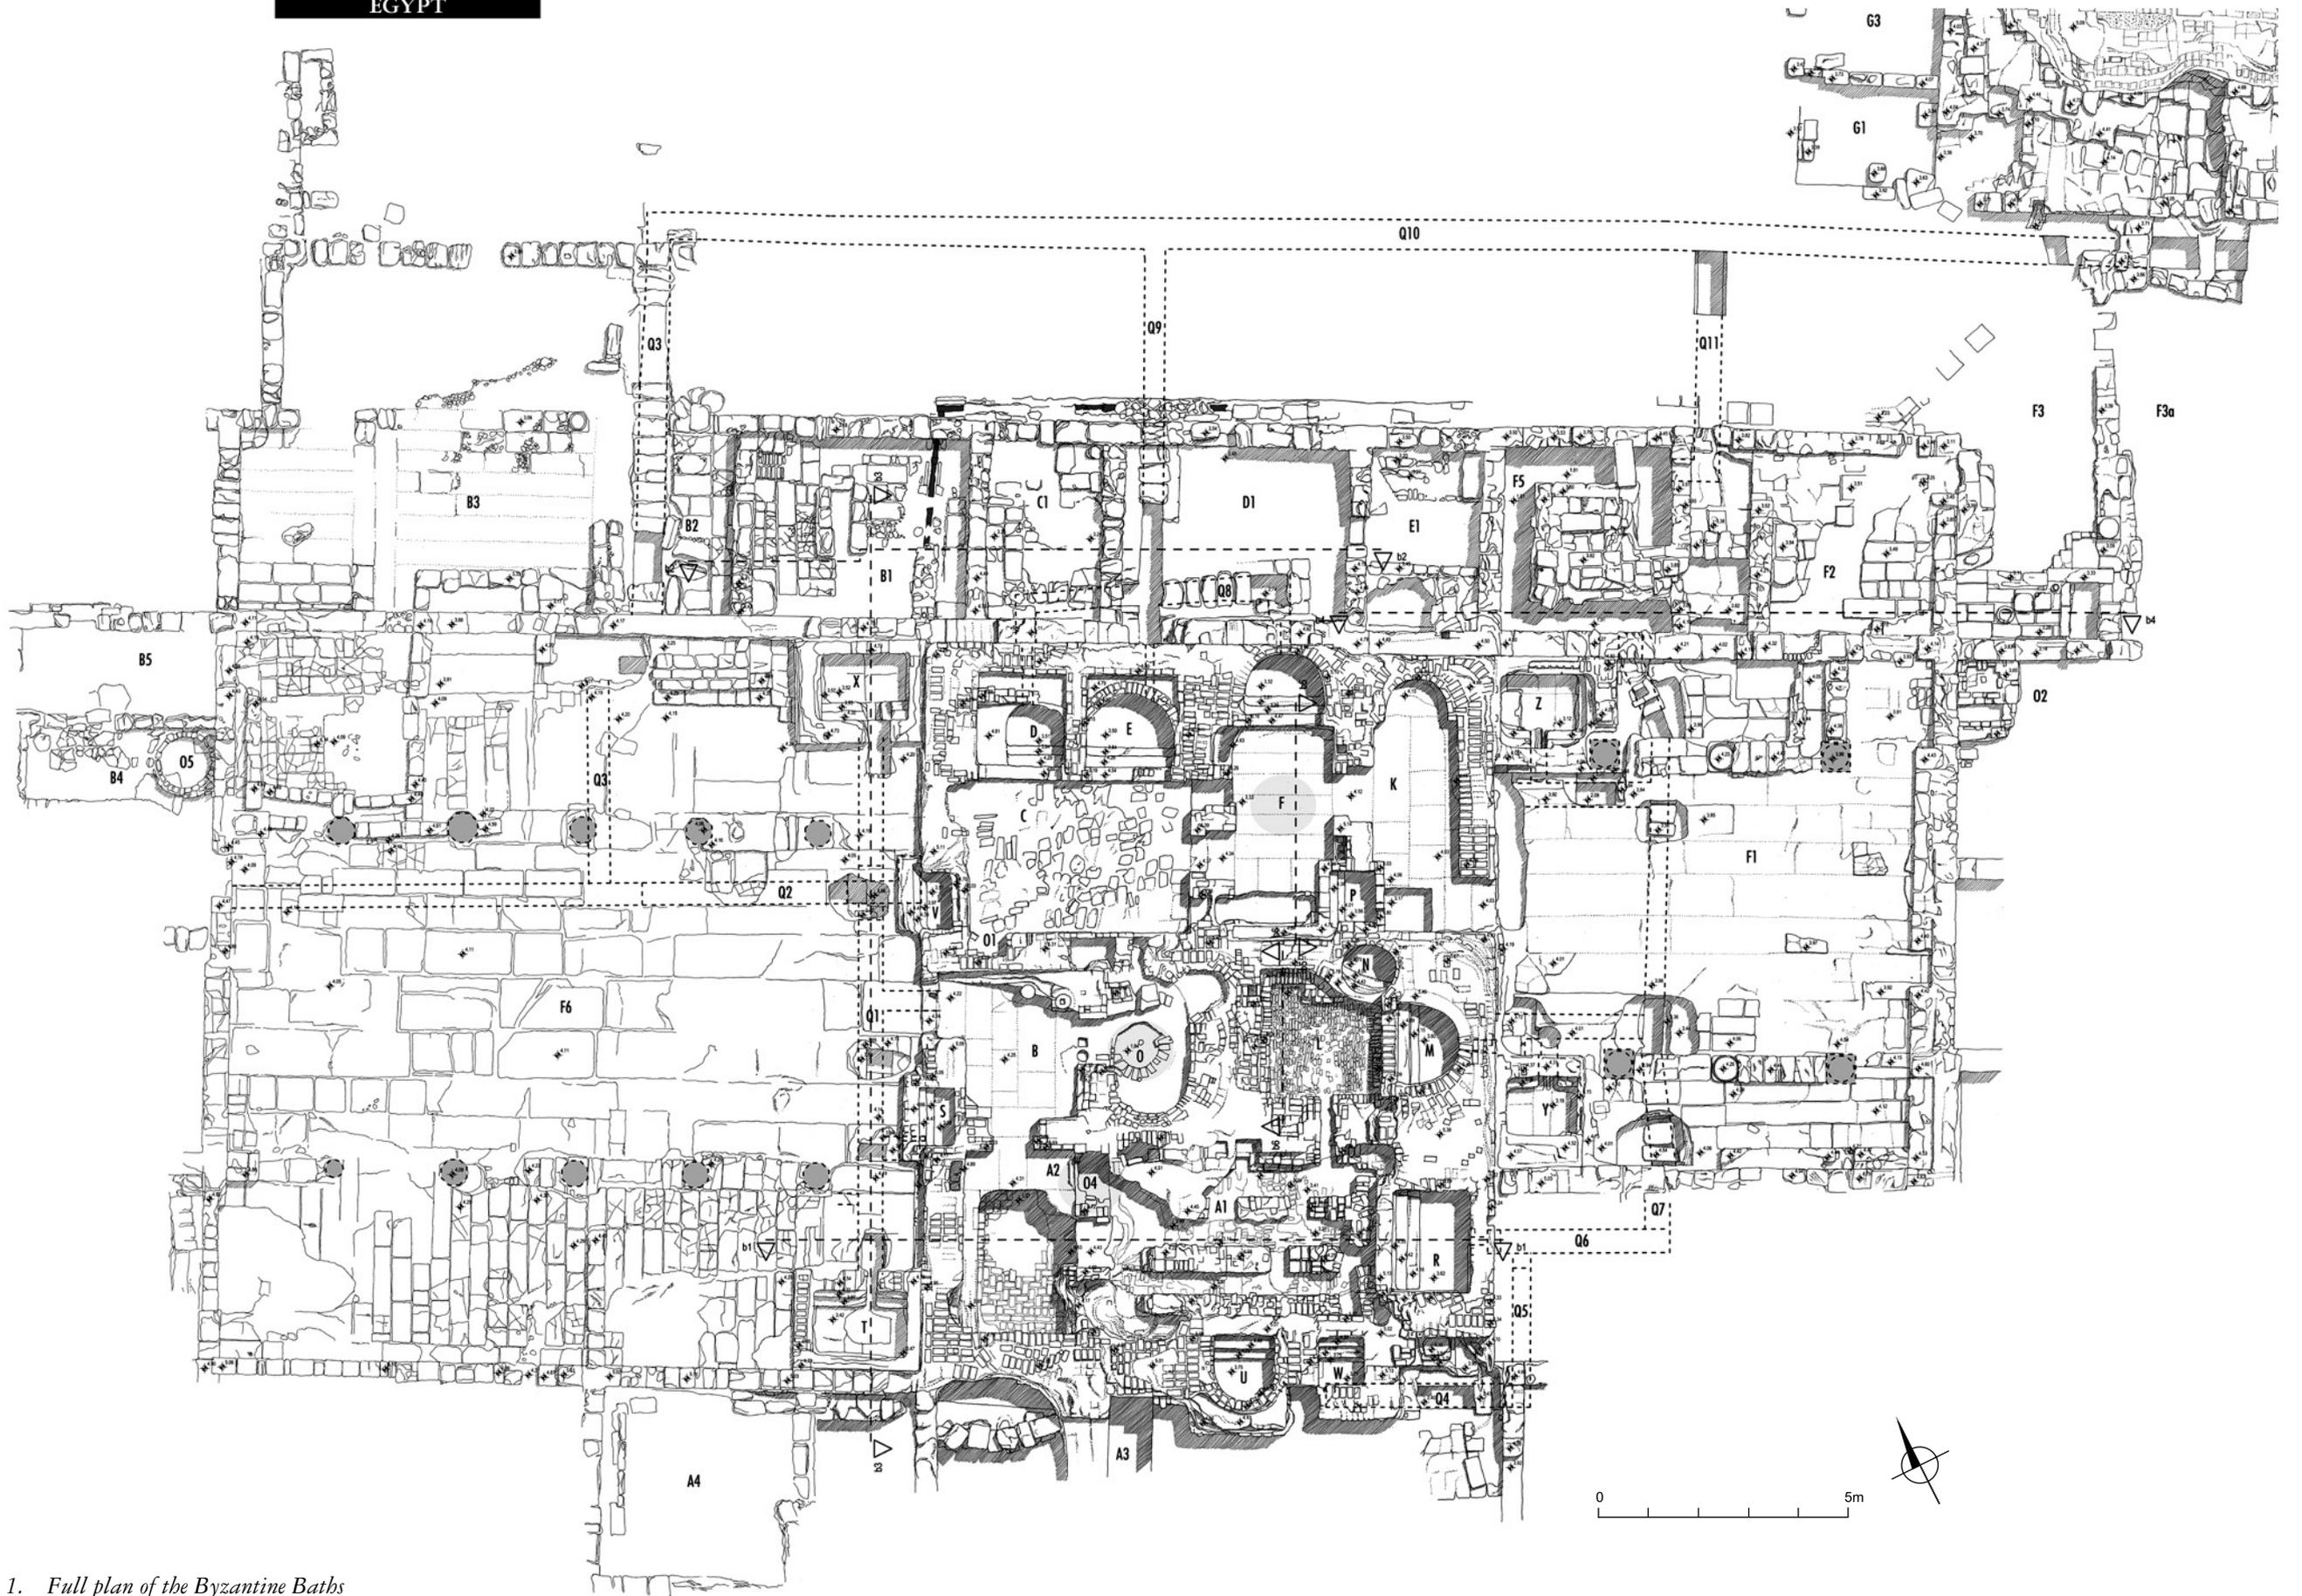
Fig. 1. Full plan of the Byzantine Baths
(Drawing D. Tarara)

Two pools, X and T, were built immediately adjoining the west wall; they are contemporary with the courtyard [cf. Fig. 2]. Other features are not, however, like a perpendicular N-S wall attached to the south wall and an enclosure formed by two walls set up on the pavement in the southwestern corner. These are later additions that find no justification during the operation of the baths. In both cases, a single course of blocks was preserved.

Four separate walls were built perpendicular to the north bath wall of stone blocks [cf. Fig. 2], forming four units of different size: starting from the east, E1 (2.26 x 3.48 m), D1 (3.48 x 4.48 m), C1 (3.61 x 2.18 m) and B1 (3.74 x 4.29 m). By parallel with other bath facilities, these units can be interpreted as shops providing bathers with the necessary bathing supplies, like fragrances etc. The present work (for previous exploration in 2001, see Szymańska, Babraj 2002: 56-57) extended the trench to the north, tracing the north wall of these rooms, which was located from 3.48 to 3.70 m away from the outer wall of the baths. All four shops were entered from the north and they were interconnected. Once the shops went out of use, these inner passages and the entries were all blocked [Fig. 8].

covered on top with slabs of stone (nine such slabs were preserved in place). From there, the waste water ran through channel Q9 to the north to reach the city sewage. Channel Q10, oriented E-W, already belonged to the public sewage system. It was also reached by channel Q3 which ran under courtyard F6 and after turning at an angle of 30° under room B3. Channel Q2 continued in a westerly direction under courtyard F6, until the west wall where it ended. Channel Q10 collected water also from a branch of the channel designated as Q11, exiting from the latrine [cf. *Fig. 2*].

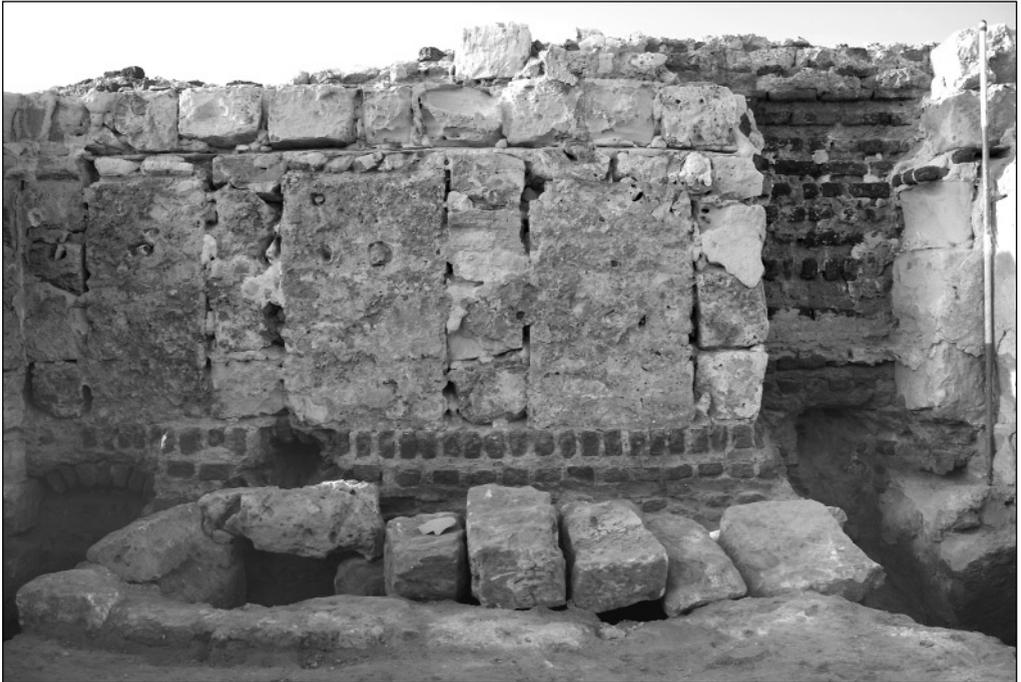
Fig. 3. *Byzantine baths. Technology of mortared rubble work employed in the north wall. View from the north (Photo P. Suszek)*

- 2 The north wall of the baths is constructed in typically Byzantine technology: pillars built of one or two courses of stone blocks in lime mortar and the space between them of mortared rubble. The surface of the wall was subsequently coated with a thick layer of mortar.

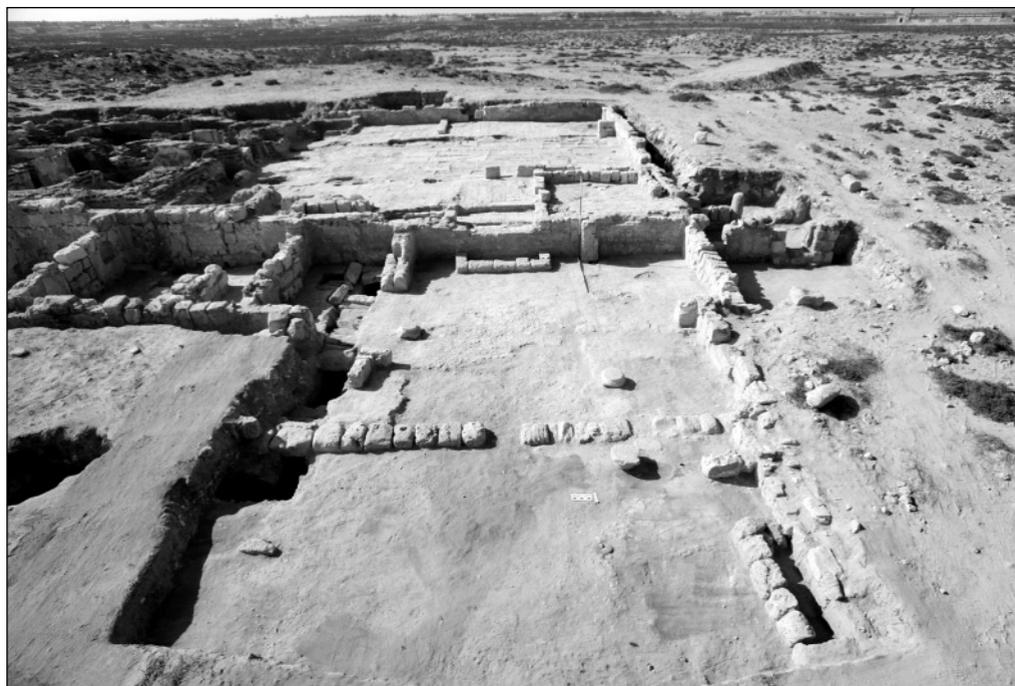
Fig. 4. Byzantine baths. The western entrance with a small space with two stylobates for columns in front of it. View from the north (Photo P. Suszek)

The first step of the stairs matched the western entrance in width [Fig. 4]. In front of it, a small open space was uncovered (B3), measuring 7.48 m by 6.71 m. The marble-slab pavement concealed two stylobates oriented E-W: one which is an extension of the wall lining the shops and the other 4.00 m to the north of it. An Attic marble column base was found *in situ* on the first of the two stylobates. An identical base lay in the rubble. This suggests the existence of a portico.

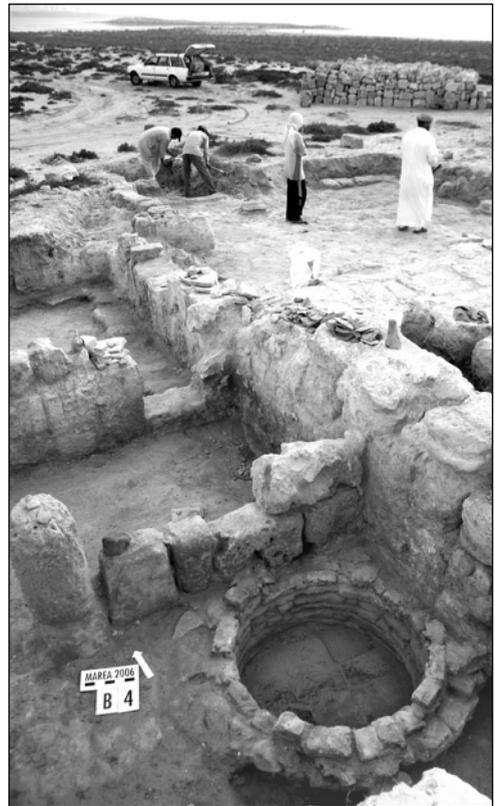
Fig. 5. Byzantine baths. Round bread oven of red brick beyond the west wall, view from the south (Photo P. Suszek)

The former protected a round bread oven (O5), 1.20 m in diameter, built of red brick (7 courses preserved, maximum height 0.50 m), surrounded by a row of stones, the filling hole in the southwestern side [Fig. 5]. The bottom was paved with limestone slabs.

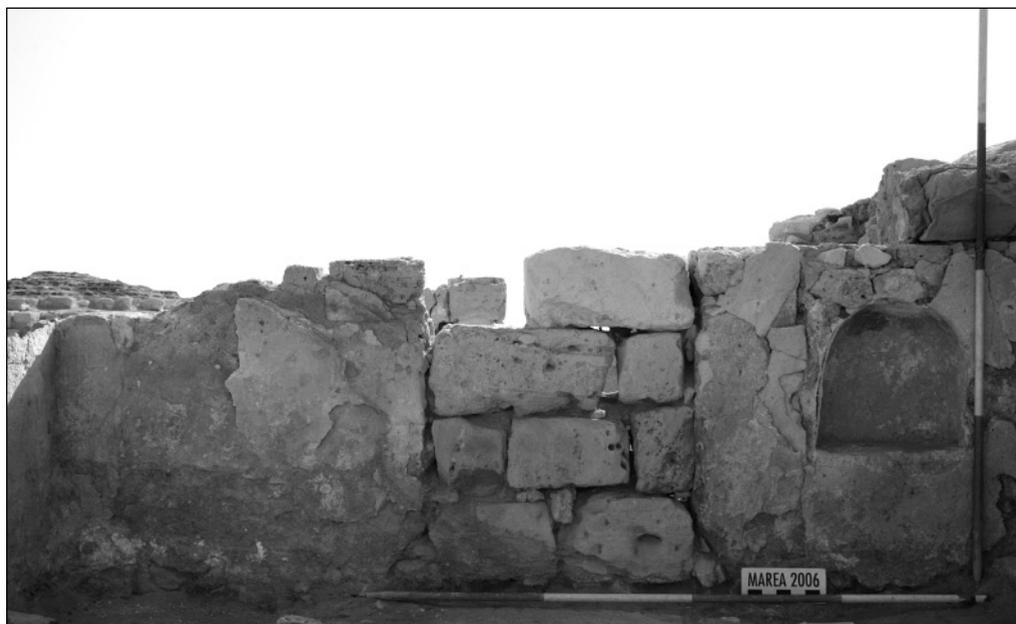
*Fig. 8. Blocked inner passage between shops B1 and C1. View from the west
(Photo P. Suszek)*

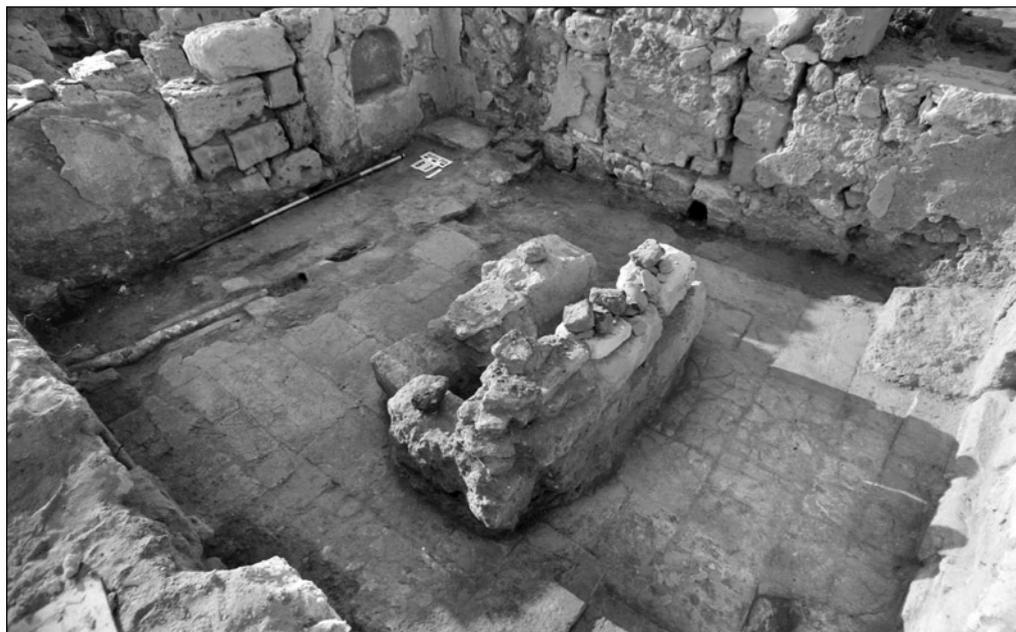
*Fig. 9. Shop B1 with stone structure in the centre. View from the northwest
(Photo P. Suszek)*

Almost all of the limestone flagstones of the pavement in shop B1 have been preserved in place. Running under them is a pipe supplying water from the saqiyah (see below). A stone structure measuring

1.80 x 0.50 m was found in the center of the shop. It was open from the south and its function remains in the sphere of conjecture [*Fig. 9*]. It most certainly belongs to a later phase in the operation of the shop, as it stands directly on the pavement.

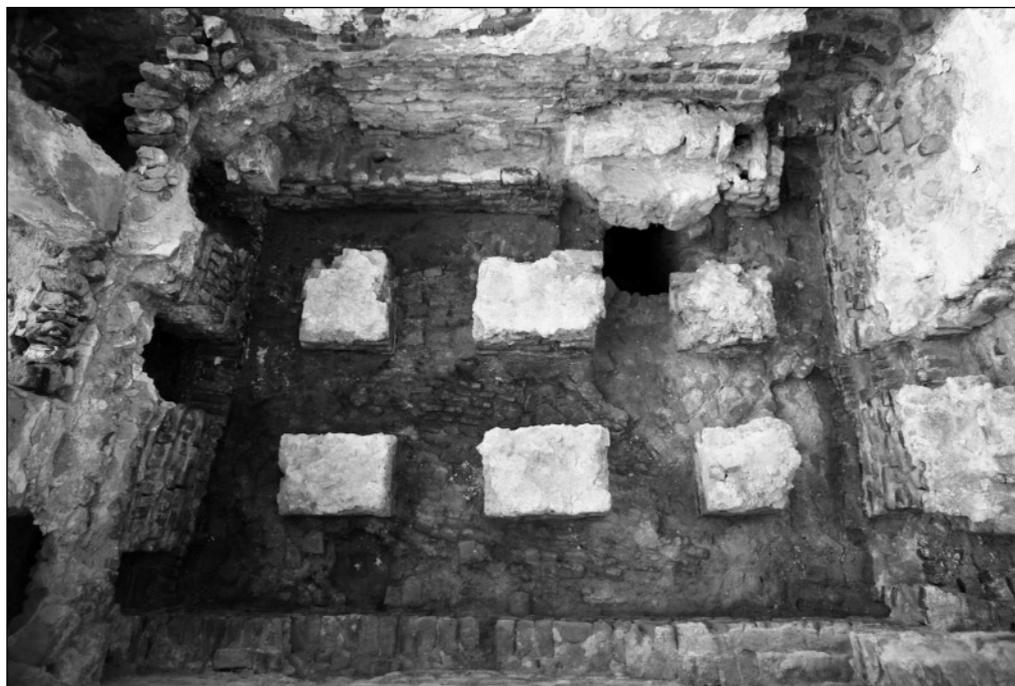
Fig. 10. Hypocaust C with installations comprising six brick pilae. View from the north (Photo P. Suszek)

furnace O1, running in the thickness of the south wall of the room and heating the two caldaria: C and F. The hypocaust measured 3.10 by 4.44 m [Fig. 10]. The stone floor all but destroyed the ancient *suspensura*, of which only a small section has survived in the southeastern corner; fragments of marble paving were recorded 1.80 m above the bottom of the hypocaust cellar. The inside installations are in fair condition, comprising six regularly spaced, square *pilae* of brick, c. 0.48-0.50 m high. The level of the original pavement indicates that the *pilae* were higher originally, even taking into account the presumed thickness of the *suspensura*. A wall screening the north wall from the heat was also found. Located behind this wall were pools E and D. A similar protective wall adjoined the south wall. Between the vent from furnace O1 and the west wall, traces of *tubulatio* were discovered. The next two installations of the type were placed symmetrically in the west wall. They each contained presumably three *tubuli*. Numerous fragments of obviously rectangular section were discovered both in the wall and in the nearby rubble. The *tubulatio*-heated walls also served to warm up the water in pool V located behind the west wall.

The east wall played the most important role in the circulation of hot gasses. Beneath it there were three arcades: in the middle, under the threshold to caldarium F, the flue bringing hot air into the latter room, flanked by smoke vents, one on either side. The walls between the smoke vents were constructed of bricks in alternating courses of headers and stretchers. The floor was made of irregularly laid bricks.

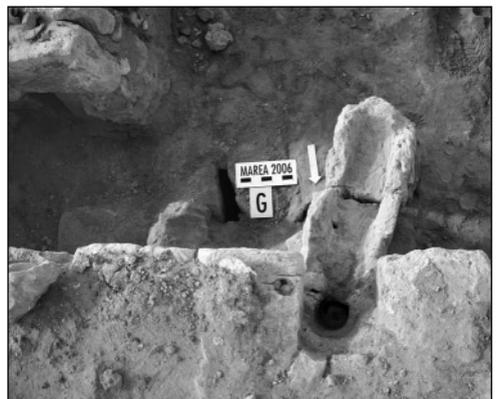
Fig. 11. Clay pipe under last block of *sāqiyah* pool and two sections of limestone casing (Photo P. Suszek)

of drawing water and transporting it to the baths had been presumed until now for lack of good archaeological data. The system was actually a simple hydraulic installation making use of the principle of connected vessels. Water was collected in the pool of the *sāqiyah*, from where it was pumped into clay pipes to run to the bath. Only one such supply pipe has been preserved, running to pool X by the west wall of the baths. The pipe, which can be observed under the last block of the *sāqiyah* pool, where also two parts of a limestone casing for the pipe are still standing in place [Fig. 11], ran under the floor of F3 for 5.20 m at an angle to the north wall of the baths, reaching the north wall (behind the shops) supported on stone slabs. It then ran behind the north wall for a distance of 18 m. Two segments of this part of the channels were recorded, set in stone casings of 0.30 m width. The pipe then turned at right angles (the turn has actually been preserved) into room B1, where it continued for a distance of 4.20 m until it reached the south wall; it then rose to a height of 1.50 m, being attached to

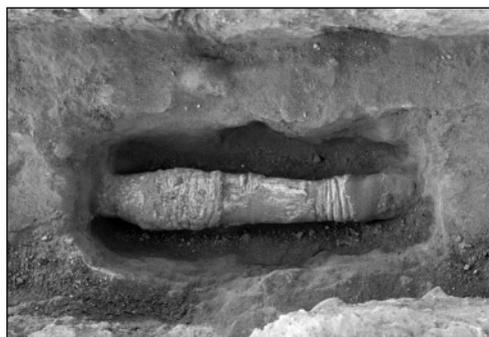
Fig. 13. Joining of two segments of pipe behind room D1. View from the north (Photo P. Suszek)

the wall by lime mortar (traces still evident on the wall face) and ended in pool X. In shop B1, two long sections of this pipe were preserved, concealed under the limestone flagging on the floor. One section was 1.00 m long and had a stone bedding; the other measured 0.40 m [Fig. 12]. The pipes at the joining take on a spindle-shaped form, hence the different sections (5.5-7 cm of diameter) and lengths of particular pieces. A connection of two segments can be observed clearly behind room C1 [Fig. 13]. Apart from pipes *in situ*, there were many loose fragments in the fill nearby; one was 0.36 m long, found in a completely unexpected place under the paving in the center of courtyard F6.

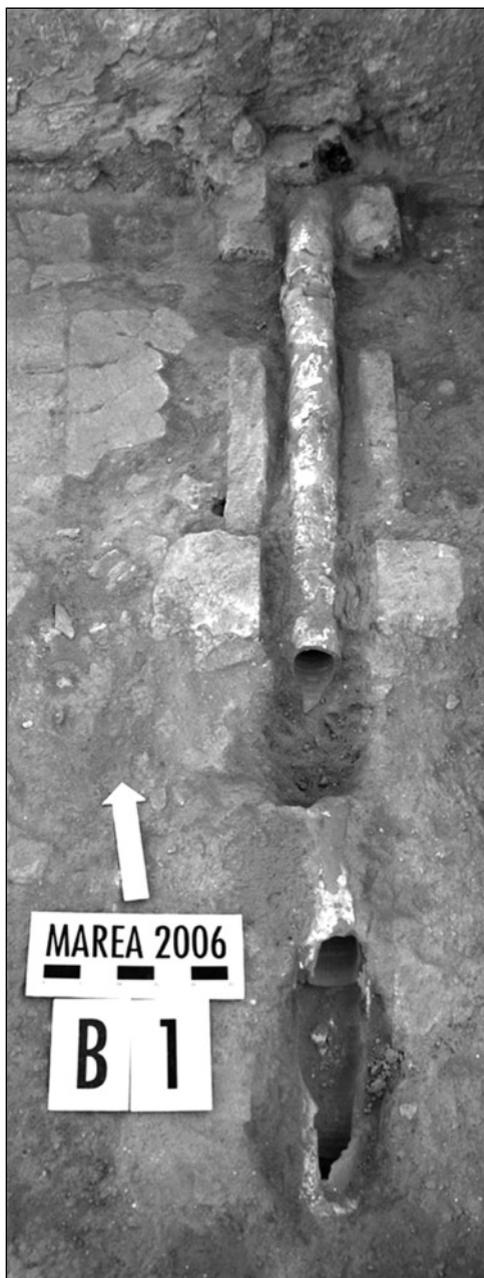
Fig. 12. Two long sections of pipe, preserved in shop B1. View from the south (Photo P. Suszek)

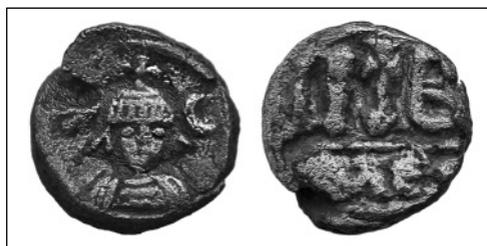
Fig. 14. Coin of Chosroes II (618-628)
(Photo P. Suszek)

This year's finds have confirmed the dating for the most intensive use of the baths in the 7th and early 8th century. The shops, and especially E1, yielded numerous coins of Chosroes II (618-621) [Fig. 14], while more than 10 of the legible Arab coins originated from the period around 689-750.³ The blind end of channel Q2, at the western edge of courtyard F6, contained numerous coins, including 25 *folles*, which
