Conservation and Restoration of Wall Painting in the Southern Chamber of Amun of the Hatshepsut Temple in Deir El-Bahari

Polish Archaeology in the Mediterranean 19, 285-295

2010

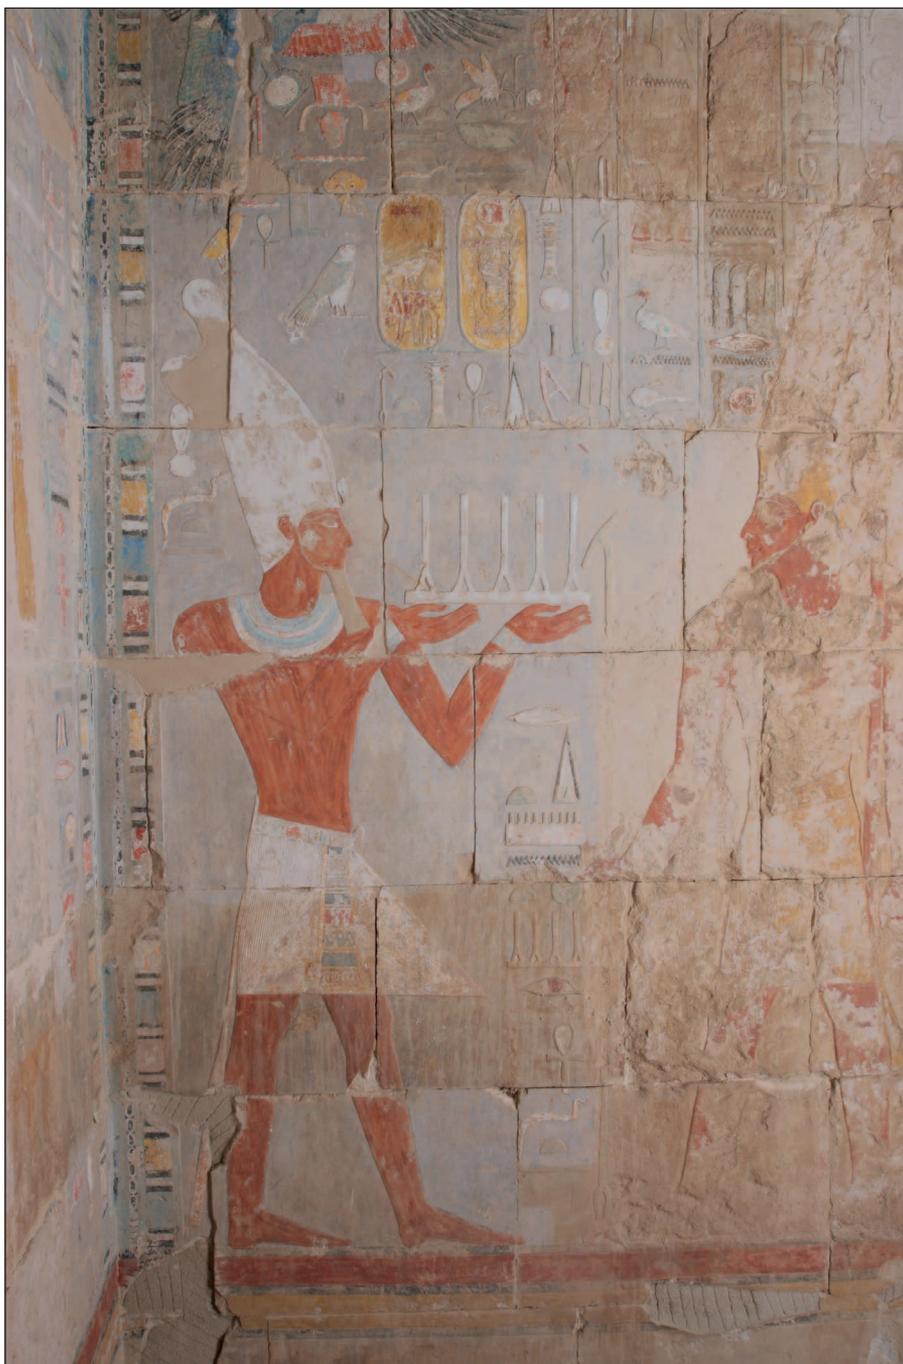
Fig. 1. South wall of the chamber with an image of Hatshepsut making offerings to Amun, during conservation and restoration (Photo M. Jawornicki)

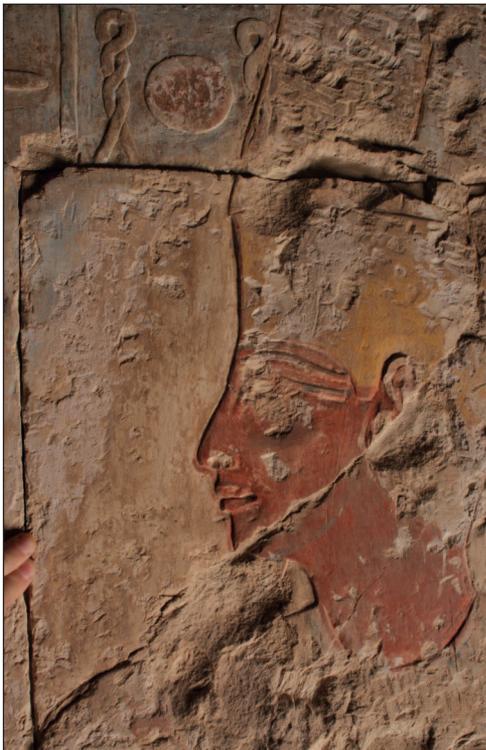
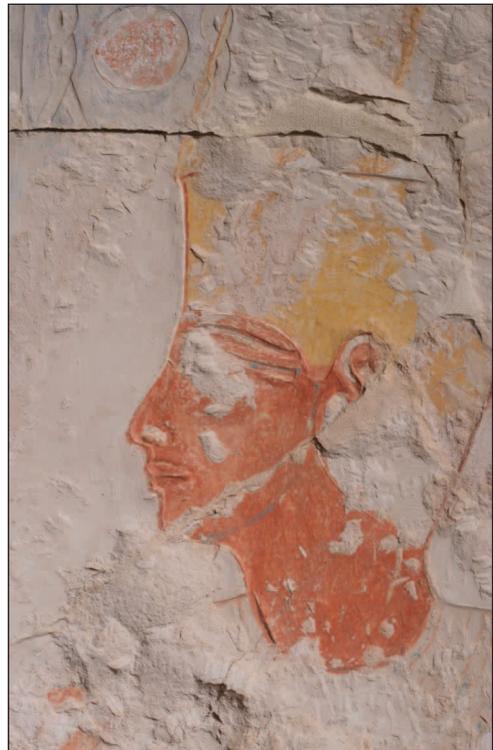
Fig. 2. Close-up of a representation of Amun, before (left) and after restoration (Photo M. Jawornicki)

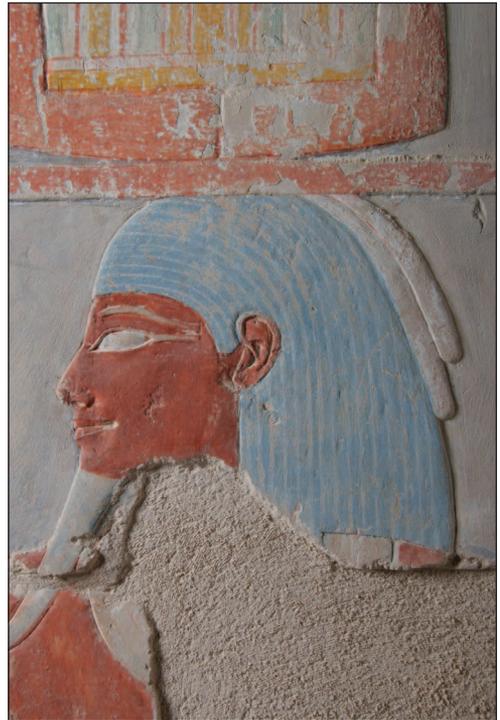
Fig. 3. Polychromy on the royal *ka*, after restoration (Photo M. Jawornicki)

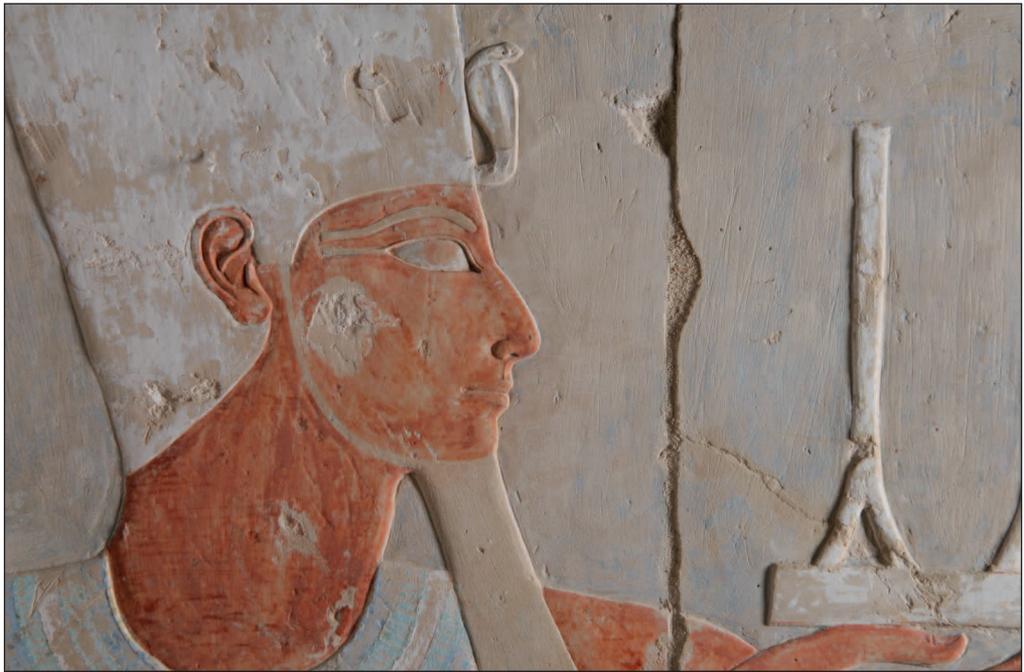
*Fig. 4. Figure of Hatshepsut, close-up after restoration
(Photo M. Jawornicki)*

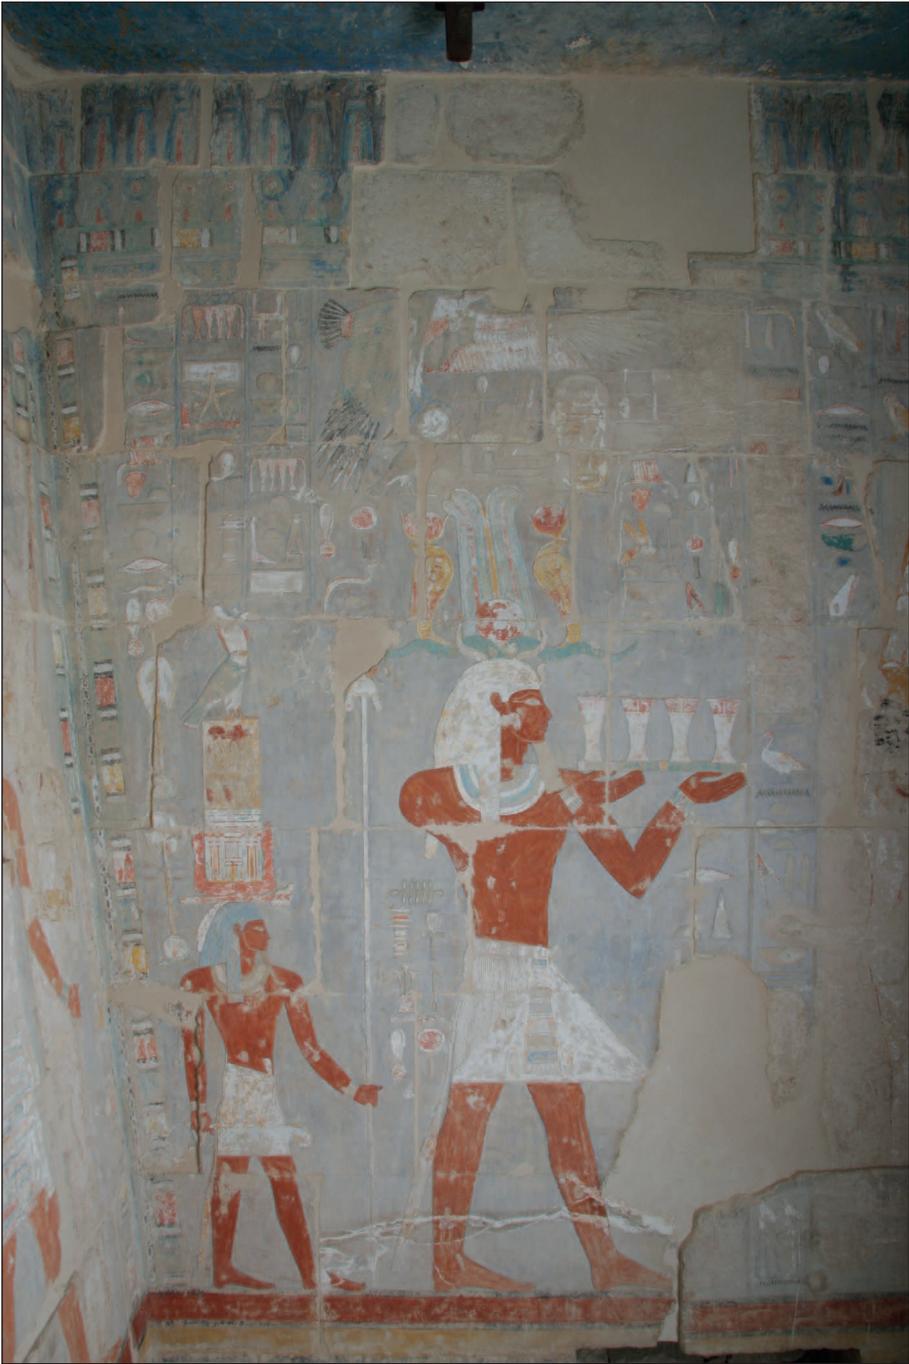
*Fig. 5. East wall of the chamber after restoration
(Photo M. Jawornicki)*
