Nea Paphos: Season 2007

Polish Archaeology in the Mediterranean 19, 503-514

SEASON 2007

Wiktor Andrzej Daszewski, Henryk Meyza with
Wojciech Machowski, Ewdoksia Papuci-Władyka,
Joanna K. Rądkowska, Olga Wasilewska

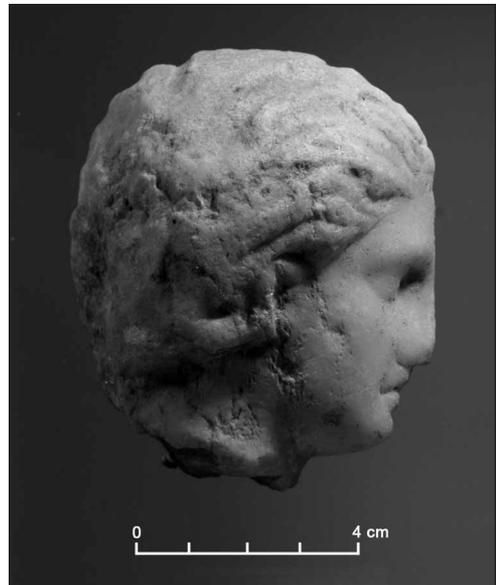
Fig. 1. Marble head with horn of Zeus Ammon (Photo W. Jerke)

Among the finds in this heavily disturbed area there is a small marble head possibly representing one of the young members of the Ptolemaic family. The head is shown wearing a diadem and the ram horn of Zeus Ammon on the left side of the head. It is well modeled and typically Hellenistic in style. The right side differs stylistically from the left and shows features of Cypriot sculpture with flat representation of eyes and generally cruder workmanship [Fig. 1].

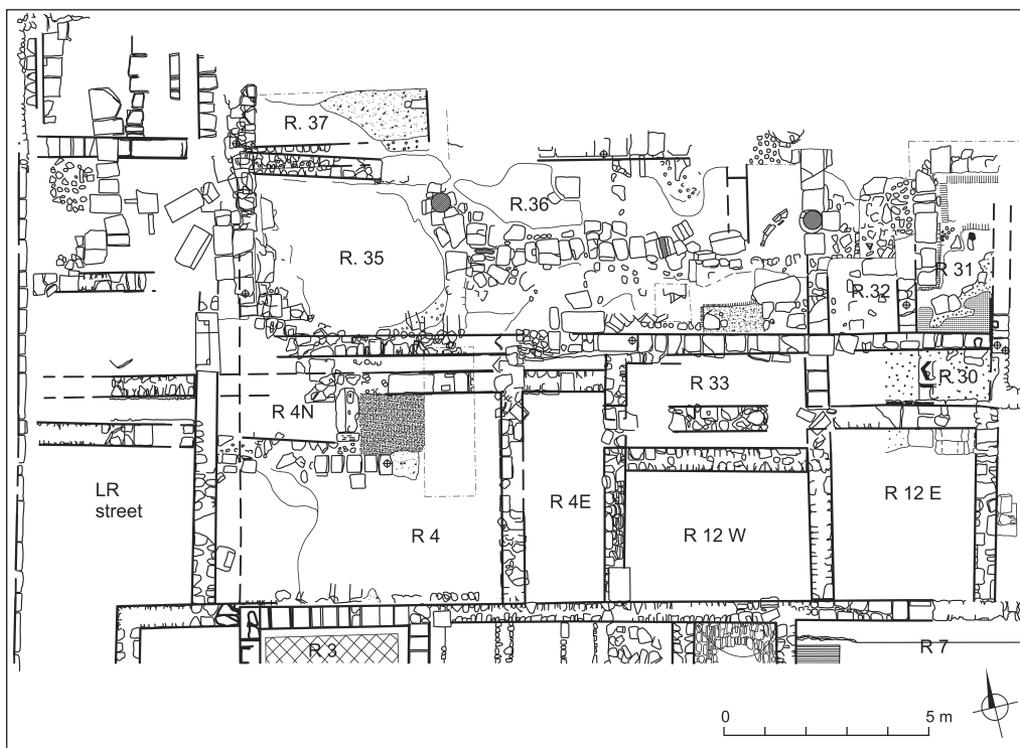
Fig. 2. Northwestern part of the House of Aion
(Plan S. Medeksza, A. Brzozowska)

above them yielded loose masonry blocks of large size. The northern parts of rooms in the east (32, 31) were deeply disturbed by a huge modern trench, but below it Early Roman structures were uncovered [Fig. 2].

To the east of room 35 a large courtyard was found, extending over 9 m E–W [36, cf. *Fig. 2*]. Its north wall is largely damaged and it is not clear how the remaining section, presently seen in the north side of the trench, related to the wall dividing rooms 37 and 35; the eastern end in turn has been damaged by various trenches. In the line of this wall, further east, remains of an oven were uncovered, cut by the north side of the trench. All in all, the width of the courtyard is uncertain (except for the part where the

A continuation of the east wall with more doors was found under the north wall of room 3 of HA [cf. *Fig. 2*]. At the northern end, the wall runs into an E–W wall with a corner 0.50 m to the west and turning north. The E–W wall is situated 1 m south of the north wall of room 4N. The eastern part of the earlier room was damaged by a pit. An earlier stone-paved floor appears to have been reused in Late Roman times north of these remains, under the southwestern corner of room 35. The pottery evidence indicates that this vestibule or small courtyard and two adjoining rooms to its west and east, preceding the Late Roman rooms 4, 4N and 35, were abandoned in the 1st/2nd century AD. The building, to which these rooms belonged, was clearly quite important, considering the quality of the stonework. They may have belonged to structures recognized also further east.

The other area where earlier structures were uncovered is the eastern part of courtyard 36 and the northern parts of rooms 32 and 31 [cf. *Fig. 2*]. The wall identified as the west wall of room 32 may have belonged to an earlier phase. In its

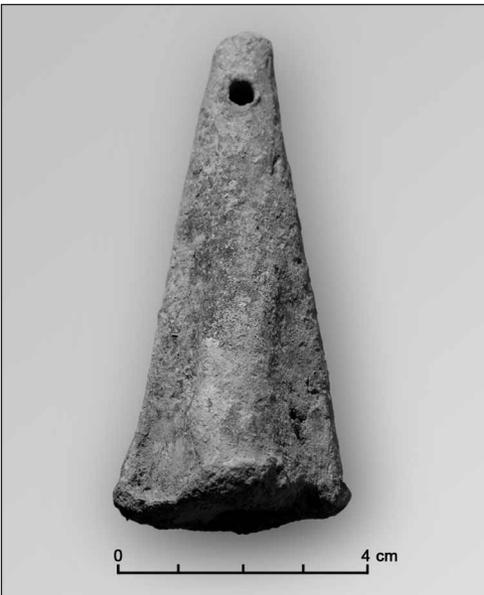
*Fig. 3. Prismatic lead weight
(Photo W. Jerke)*

One of the finds by this earlier wall is a terracotta bust of Eros [*Fig. 4*]. A prismatic lead weight was also found on a floor connected with the earlier walls [*Fig. 3*].

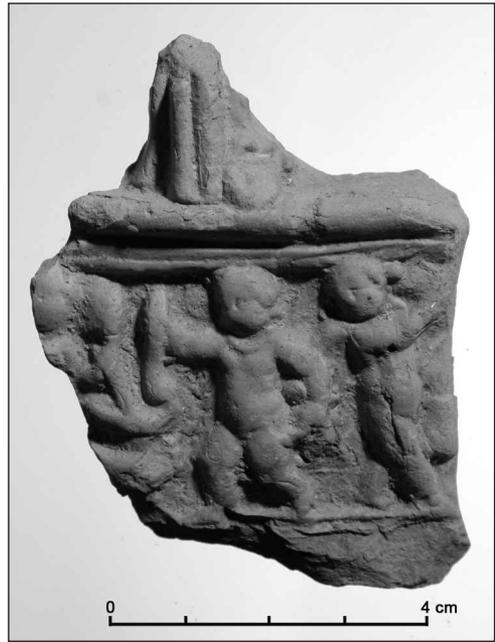
*Fig. 5. Terracotta base with relief decoration
(Photo W. Jerke)*

The fill below the mosaic floor in room 31 yielded a fragmentary terracotta base with a relief representing girls and boys dancing and playing castanets [Fig. 5].

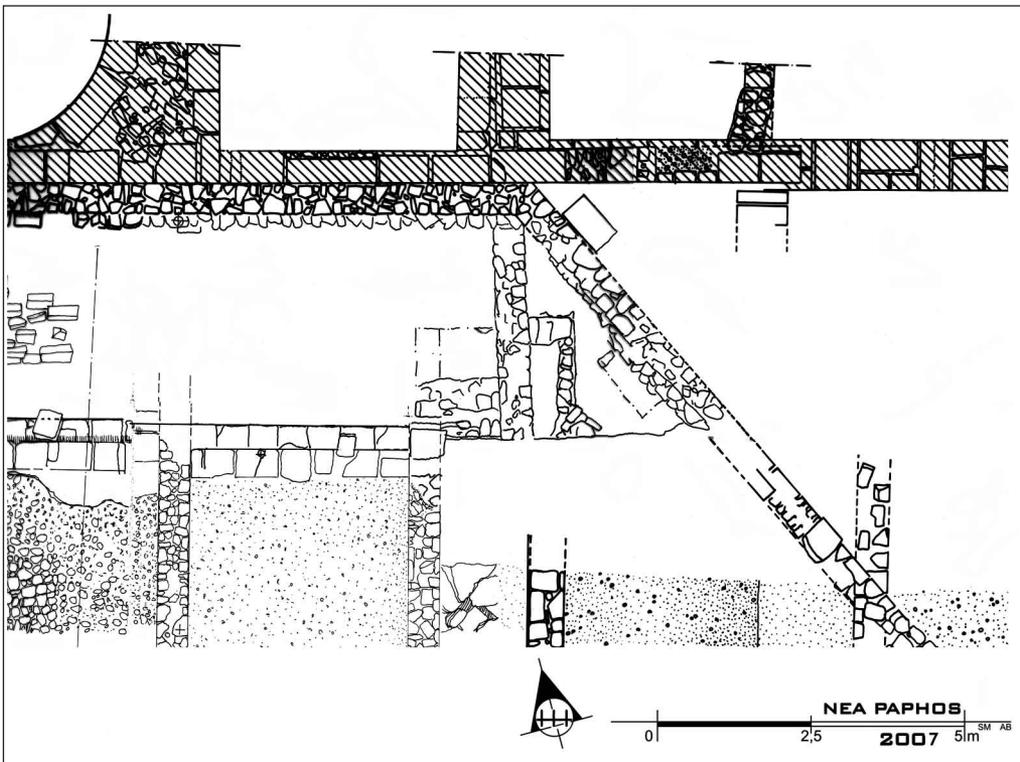
Fig. 6. Courtyard between the Villa of Theseus and the Early Roman House with Late Roman enclosure (Drawing S. Medeksza, A. Brzozowska)

Excavations of the so-called Early Roman House continued just south of rooms 44, 47 and 43 of the Villa of Theseus, in a trench measuring 4 m in width (N-S) [Fig. 6]. A late enclosure wall had been joined to the back of the south walls of VT rooms 44 and 48B, continuing the walls already known to

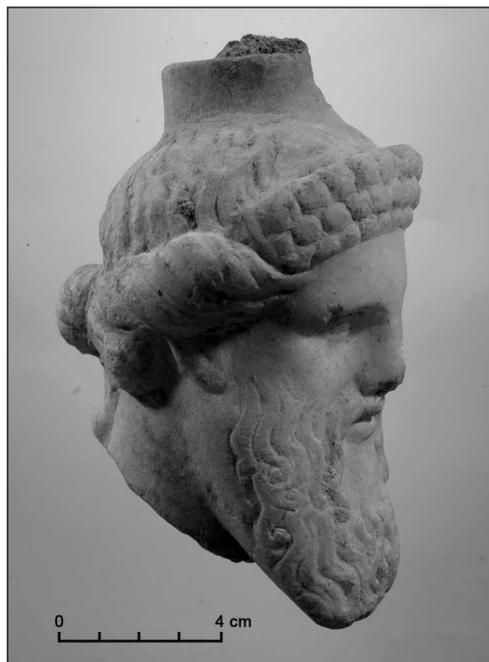
Fig. 7. Marble head of a herm
(Photo W. Jerke)

The rubble filling of these structures yielded a well-preserved marble head representing an old Dionysus [Fig. 7]. This herm sculpture is made in archaizing style with a cylindrical support on top of the head and traces of an iron clamp suggesting that the herm had been part of a bigger group.

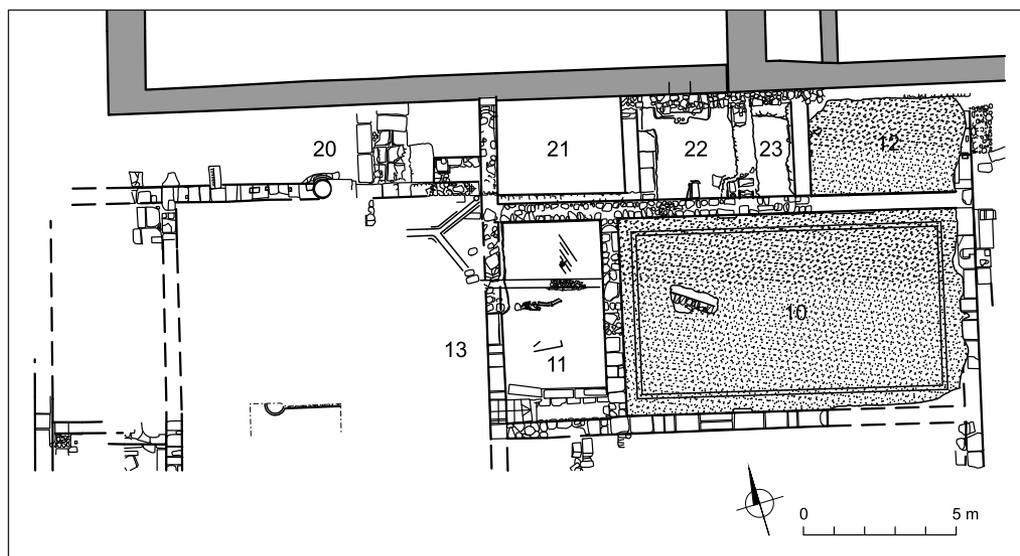
Fig. 8. *Plan of the northwestern part of the Hellenistic House*
(Drawing S. Medeksza, A. Brzozowska)

between, a series of rooms: 20–23 with floors at a level corresponding to the surface of courtyard 13 was excavated [Fig. 8]. The westernmost of the uncovered spaces, unit

20, initially formed the northern colonnaded portico of courtyard 13. Only the east and south walls are known, while the northern side of this room is covered by the south wall of VT and damaged by its foundation trench. The western side remains unexcavated.

Room 21 was situated east of portico 20 and north of room 11. The entire room was 3.80 m long (E–W) and its known width (N–S) is 2.50 m. It was excavated partly during earlier preparatory works for the shelter in 2003, in trial pit Λ3 (Daszewski *et alii* 2004: 289) and the pit was refilled. After removing this fill, a sequence of two floors at 1.00 m and 1.20 m respective depth below the surface was found. Large amounts of pottery were recovered from the fill above the upper floor. To the south, room 21 was separated from room 11 by two parallel and contacting walls. The wall situated to the north had two leveling courses built of regular masonry, at a level corresponding to the lower floor. This wall continued west on the line of the stylobate in portico 20. The southern wall continued east on the line of the wall dividing rooms 12, 23, and 22, and on the other side, rooms 10 and 11. In room 11 this wall was covered with painted plaster (Daszewski 1991: 73).

Room 22 was 3.00 m long (N–S) and 3.10 m wide (E–W), and was separated from room 21 by buttresses in its north and south walls. Only one level of floor was encountered here at a depth of 1.45 m. Two large rectangular blocks, 0.50 m high, were set upright against the south wall, most probably as table supports. Between them a deposit of kitchen vessels and amphorae was found with three cooking pots, jugs of various types, inturned-rim bowls and two early 1st century lamps. A blocked door entered up a step was situated in the north wall. Below it, another N–S wall belonging

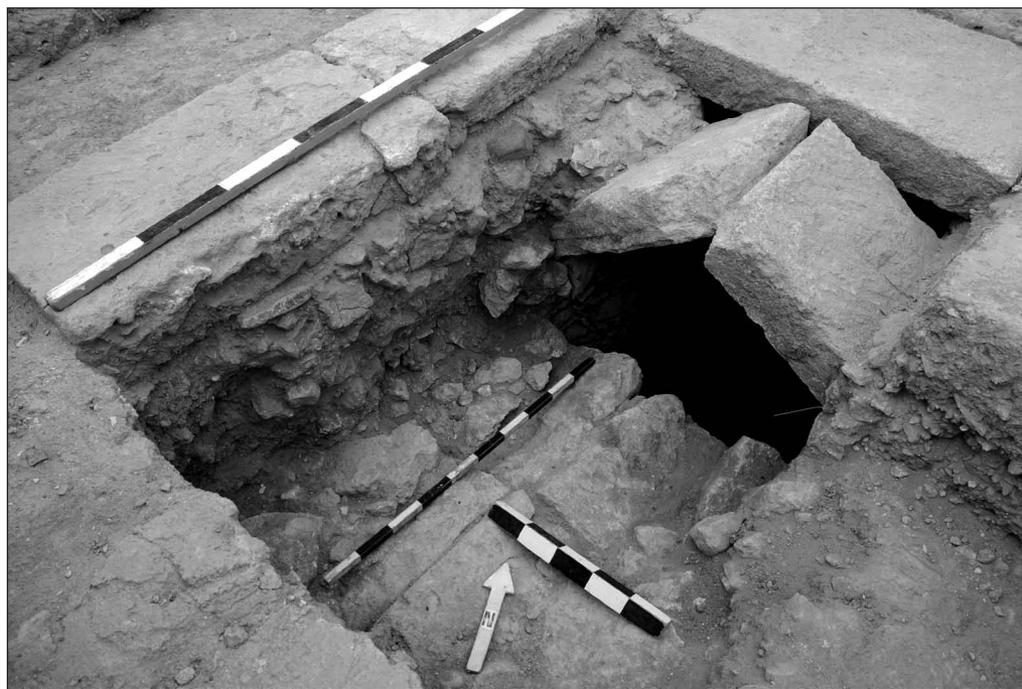
Fig. 9. *Gabled corridor leading to a cistern under the western courtyard of the Hellenistic House*
(Photo W. Machowski)

In the eastern part of the portico floor, a well-constructed line of blocks, situated 3 m to the west of the east wall, divided it into two parts. East of it, a sunken corridor running N–S was found under the floor. It was vaulted with a gabled roof below floor level. The corridor led to a huge cistern situated under the still unexcavated part of the western courtyard 13 [Fig. 9]. Its northern end is blocked by a wall, which is situated south of the south wall of the later VT western enclosure. It slopes to the south ending in a staircase of five steps leading down into the northern end of the cistern.

The staircase is also vaulted with a gabled slab roof. Partly filled with soil and rock fallen from the roof, the cistern could still be measured at 9.00 m N–S by 3.50 m E–W. The unfilled part is about 2.00 m high. In the center there is the vertical shaft of the wellhead, the opening still closed by a slab at approx. 2.50 m above the roof.

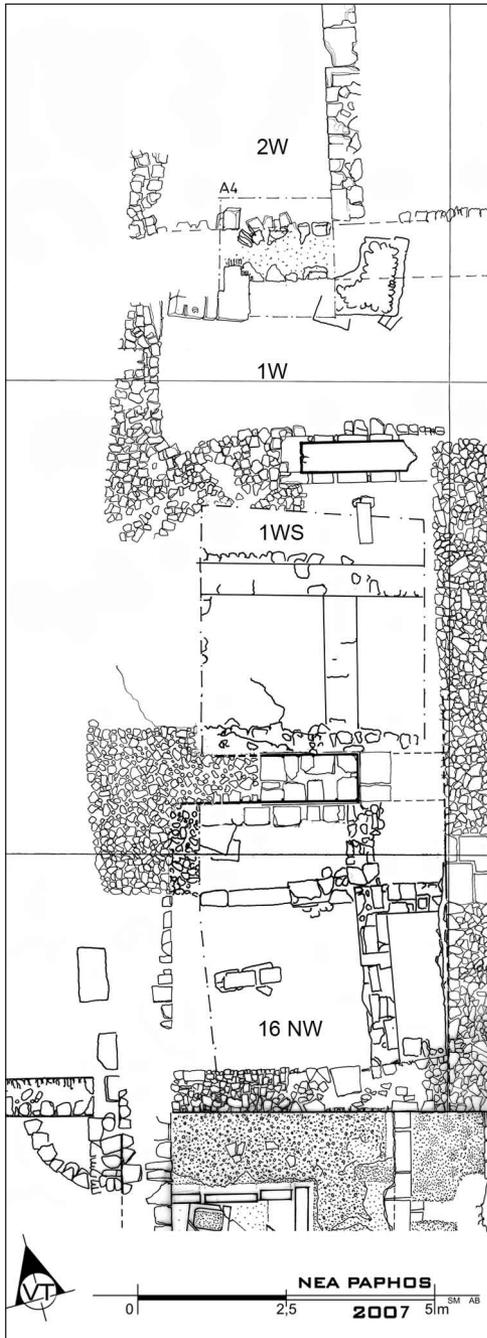
Fig. 10. Western part of the Northwest House under the Villa of Theseus (Plan S. Medeksza, A. Brzozowska)

Remains of an earlier building (Northwest House) were excavated under the floor of these rooms of the Villa of Theseus [Fig. 10]. The uncovered structures belong to buildings exposed already during earlier work in rooms 16 and 16N (Daszewski 1968: 43, 50–51, Pl. XIII: 5; 1989: 896; 1996: 99). It seems that they were related to the building with mosaic floor of the 2nd–3rd century found below the northwestern corner of the Villa. There is a difference of levels, the mosaic of NWH lying approximately 0.30 m below the floors

of the Villa of Theseus and the remains of the last floors further to the west another 0.40 m below that. The excavated walls were reconstructed at least once, doors being blocked at this time and new doorways pierced. Walls of the later phase were constructed on top of the earlier ones using them as foundations. The alignment was not precise with walls following only approximately the same direction. Three main sets of such roughly aligned walls were uncovered. One set continues N–S through rooms 16NW, 1WS and possibly 2W; the other runs E–W through rooms 16NW and 16N, and the third in 1WS is in line with the southern wall of the room with mosaic. In the small compartments placed west of the main N–S wall, a large deposit of broken, but mostly complete transport amphorae, cooking vessels, jugs and a large tableware jar [Fig. 11] were found. The pottery can be dated to the end of the 1st and the beginning of the 2nd century AD. This group of finds suggests a household function for these rooms.

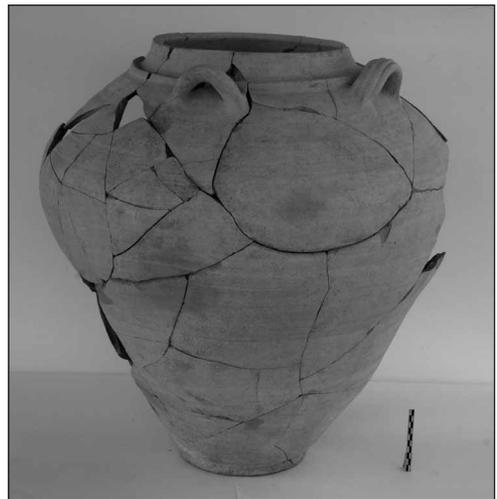
Fig. 11. Large tableware jar from the Northwest House (Photo W. Jerke)
