**Banganarti and Selib : Two Field  
Seasons in 2008**

Polish Archaeology in the Mediterranean 20, 251-266

# BANGANARTI AND SELIB TWO FIELD SEASONS IN 2008

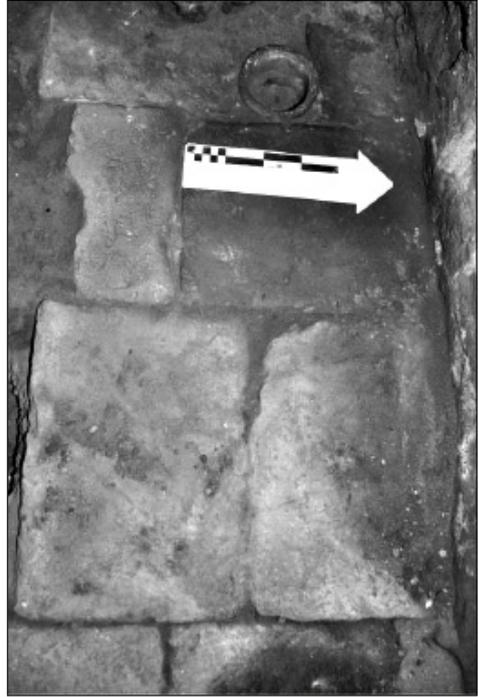
Fig. 1. Draining pipe in the ceramic pavement of the *prothesis* against the north wall, below a lamp niche (Photo B. Żurawski)

Of these, LC 3b proved of the biggest importance. The *prothesis* appears to be the only part of the Lower Church where the original ceramic tile paving has survived [Fig. 1] with ceramic pipes set vertically in the ceramic flooring (found in 2007), cutting down to sterile sand layers. The theory proposing their drainage function was confirmed by yet another pipe found against the north wall of the narthex. The

water would have been used plausibly for cleaning liturgical vessels and was disposed off directly to the layer of absorbent sand through the ceramic pipes.

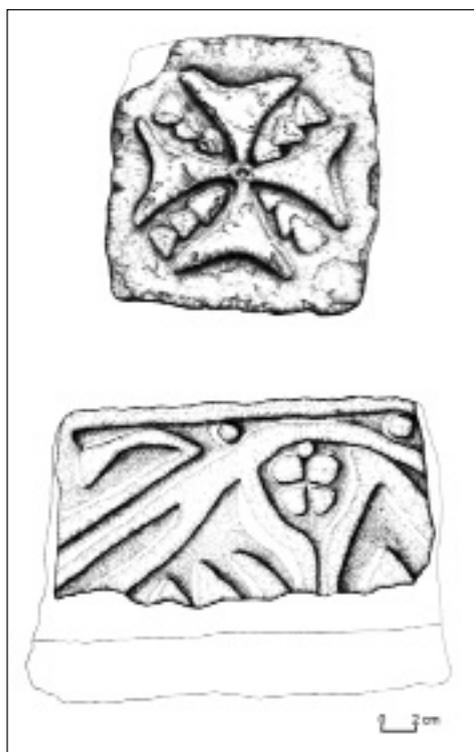
Fig. 6. Decorated architectural elements from the Lower Church found in the fill, the bottom one recut from a jamb into a lintel (Drawing A. Błaszczyk)

The trenches produced some architectural debris from the Lower Church, including plastered stone elements with polychrome painting in some cases [Fig. 6]. A corner fragment of a sandstone lintel featured a *polychronion* (wish of many years) for King Abraham I of Dongola painted on the render [Fig. 7]. The Abraham mentioned in it was apparently the adopted son of King Zacharias, who was involved in a well known dispute with Bishop Kyriakos (Monneret de Villard 1938: 96–97). Abraham's ephemeral reign fell before the year 768, when King Kyriakos was reported on the throne in Dongola by the *History of the Patriarchs of Alexandria*. The find proves that the Lower Church II, reconstructed in

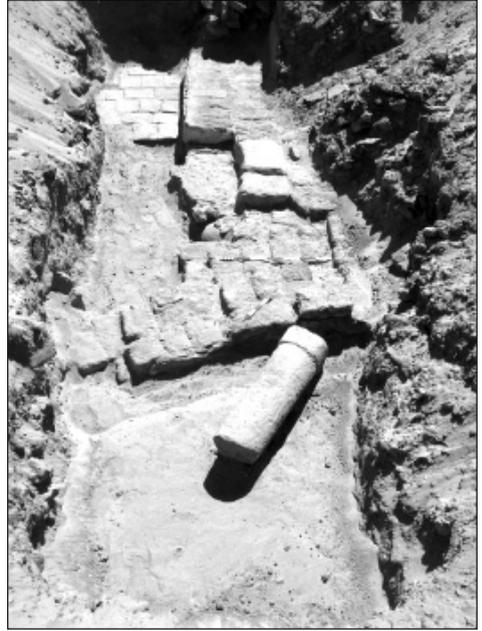
Fig. 9. Features excavated in the test trench at Selib (Photo B. Żurawski)

Testing on the central kom, supervised by Jarosław Świącicki in February 2008, verified the results of the magnetic survey which had revealed substantive architecture. A trench 4 m by 1 m uncovered a pavement associated with a wall lying to the south of

an apse, part of which was cleared [*Fig. 9*]. The complex appears to be situated on a level about 2 m above the surrounding surface and there is every reason to believe that it stands on top of some earlier structure.

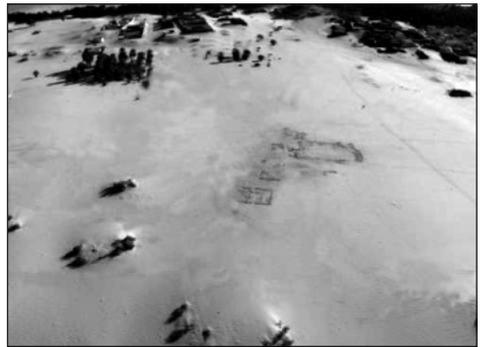
Fig. 10. Aerial kite view of the Meroitic site at Selib (Photo B. Żurawski)

this extensive settlement [Fig. 10]. The core is formed by a huge rectangular structure composed of a set of small rooms arranged around a central yard. It was built entirely of mud brick and provided with an entrance

in the northern (shorter) wall. Sherding gave a date in the 1st–2nd century AD (see Appendix 3 on the pottery).

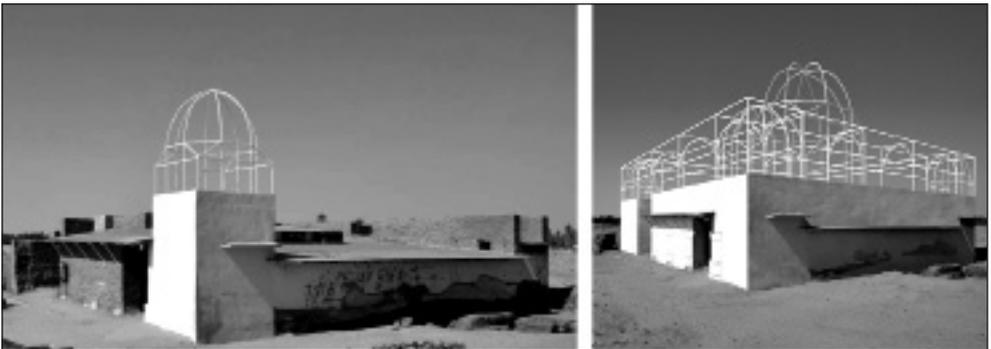
*Fig. 11. Computer generated model of the corner dome in the context of the standing shelter (left) and the final stage planned for 2012 (Photo B. Żurawski, model W. Chmiel)*

Project was carried out in the 2008 season. The objective was to raise a 1:1 scale model of the southeastern corner dome made of steel pipes by a local welder (supervised by Michał Mirecki [*Fig. 11*]). Part of the exterior of the building of the Raphaelion was plastered with good quality lime, as was also the church interior. Dividers were reconstructed together with the original pilasters in the western part. The project will be continued in future seasons.
