## Conservation Work in the Hatshepsut Temple in Deir El-Bahari (2009)

Polish Archaeology in the Mediterranean 21, 251-254

# CONSERVATION WORK IN THE HATSHEPSUT TEMPLE IN DEIR EL-BAHARI (2009)

Rajmund W. Gazda

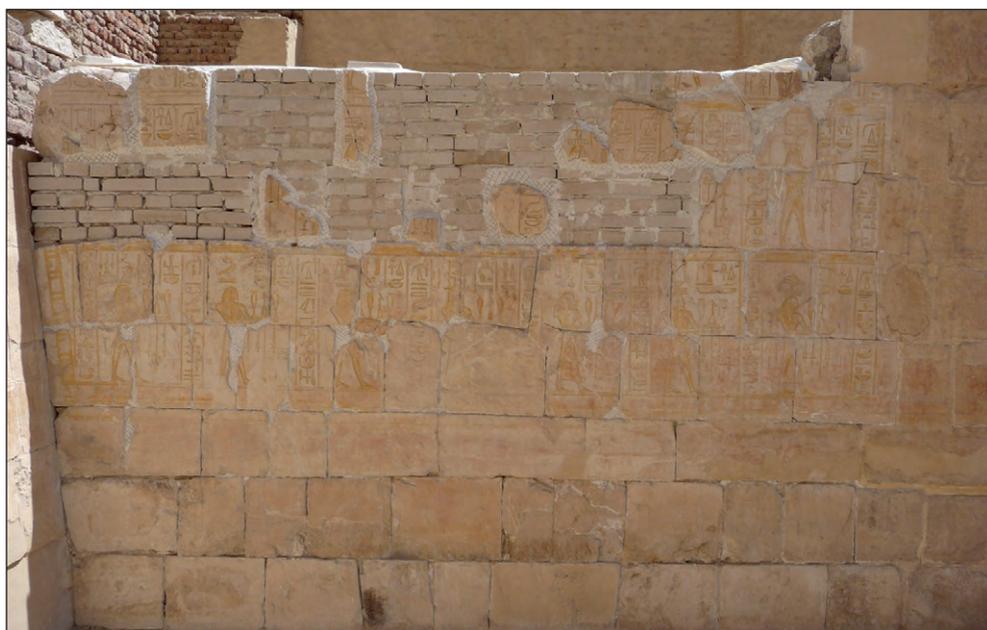
Fig. 1. Southern part of the east courtyard wall in the Royal Mortuary Cult Complex, view after anastylosis (All photos by the author)

In the next stage two courses of the southern part of the east courtyard wall were reconstructed, the blocks being replaced in their original position based on a reconstruction project prepared by Olga Białostocka (epigraphical and iconographical analysis) and Teresa Kaczor (architectural inventory). The anastylosis was carried out by a team comprising Olga Białostocka, Rajmund W. Gazda, Krystyna Wadzyńska, Teresa Kaczor and the Project's rais, Ragab Yassin. The work is planned for three successive seasons,

hence no aesthetizing work was carried out. The structural bedding was left in full view [Fig. 1].

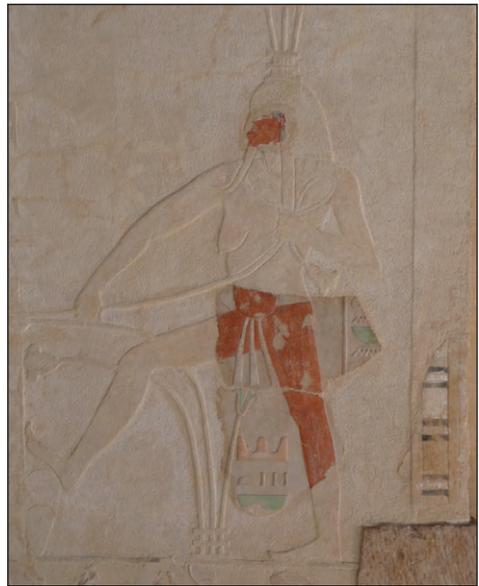
Fig. 2. *Sema-tawy* scene from the Bark Hall, after reconstruction with a new fragment

The previously reconstructed so-called *Sema-tawy* scene was supplemented with a fragment of a block carved with a representation of the head of the eastern (right) figure of a fertility deity. The Fragment was cleaned and protected with FUNCOSIL 300, then mounted back in the original position with a renovation mortar. The

bottom surface of the fragment corresponds with the course of wall blocks (conservation by Rajmund W. Gazda) [Fig. 2].

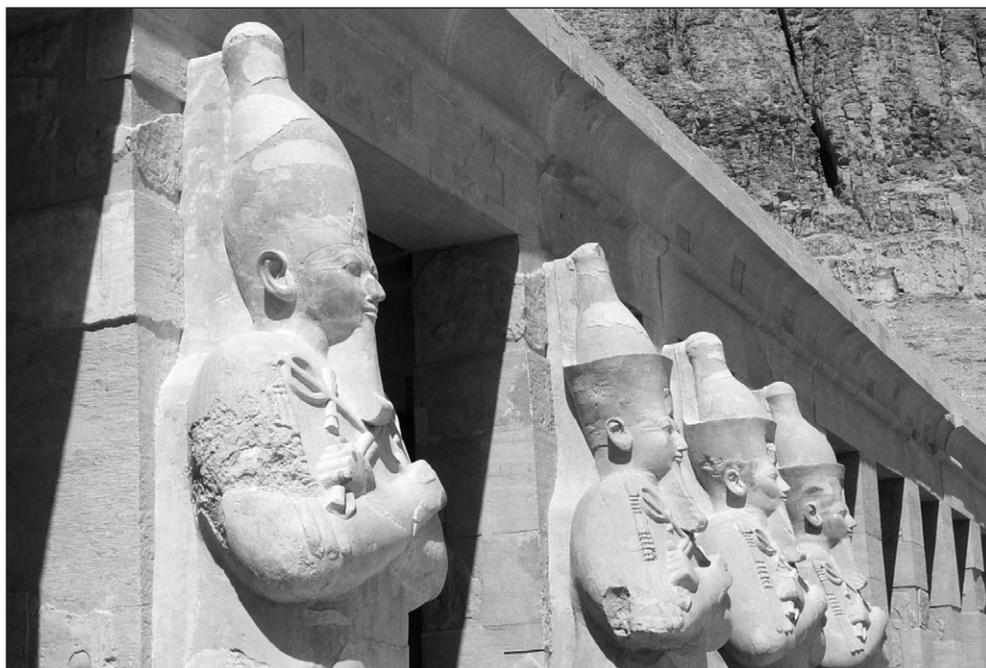
*Fig. 3. Reconstructed Osirides in the Coronation Portico*

The reconstruction and conservation program of the Osiriac statues from the Coronation Portico was continued (carried out by conservator-sculptor Wojciech Myjak). The work covered the faces and crowns of Osirides nos IV, XII and XIII [Fig. 3].
