**Alexandria Kom El-Dikka:  
Excavations and Preservation Work :  
Preliminary Report 2008**

# ALEXANDRIA KOM EL-DIKKA

## EXCAVATIONS AND PRESERVATION WORK

### PRELIMINARY REPORT 2008/2009

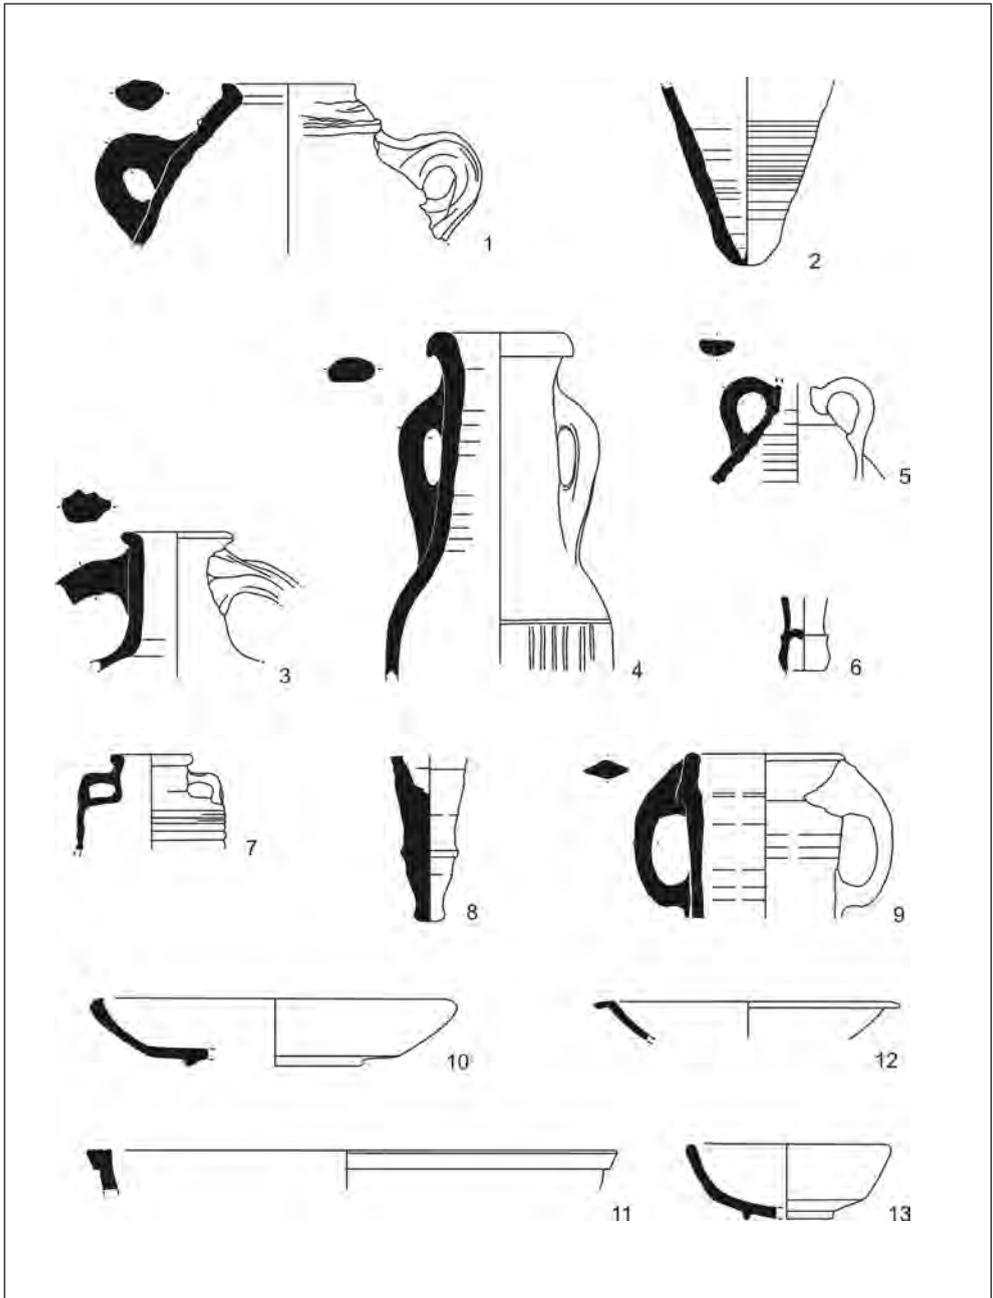
Fig. 1. Selection of pottery from the urban dump  
(Drawing E. Czyżewska, Ł. Wojnarowicz)

The pottery assemblage from the dump layers covered a period from the early 4th to the 7th century AD and revealed a typical range of wares [Fig. 1]. Quantification

of the material revealed a majority of amphorae and other coarse wares, domestic wares being recorded sporadically. The ratio clearly indicates a non-domestic provenience for the deposits. The largest group in terms of numbers of vessels was formed by common Mediterranean amphorae. Gazan amphorae predominated as usual, represented by at least three forms illustrating morphological development of the type [Fig. 1:1–2]. Different forms of LRA 1 were likewise abundant [Fig. 1:3]. Earlier (4th–5th century AD) deposits

included mostly Tunisian amphorae: *Africana Piccolo* and *Grande*, as well as earlier forms of the *spatheion* [Fig. 1:4]. Surprisingly enough, the frequency of micaceous LRA 3 amphorae was also relatively high [Fig. 1:5–6]. It is noteworthy that the bulk of them represented forms indicative of the 4th–early 5th century (with open tubular foot). In contrast, later 5th–6th century forms (with closed foot) were apparently imported to Alexandria on a much smaller scale. Of particular interest was a fairly large group of small, heavily ribbed *Agora M239* type vessels (white-washed red fabric), recorded in Alexandria for the first time in such number [Fig. 1:7]. Nile silt amphorae were represented by two basic forms: LRA 7 and Egloff 172 [Fig. 1:8–9]. Recorded fine wares included several examples of Cypriot Red Slip [Fig. 1:10–11], African Red Slip [Fig. 1:12] and their Egyptian counterparts, both A (Aswan) and B (Nile silt ware) groups spanning the entire period [Fig. 1:13].

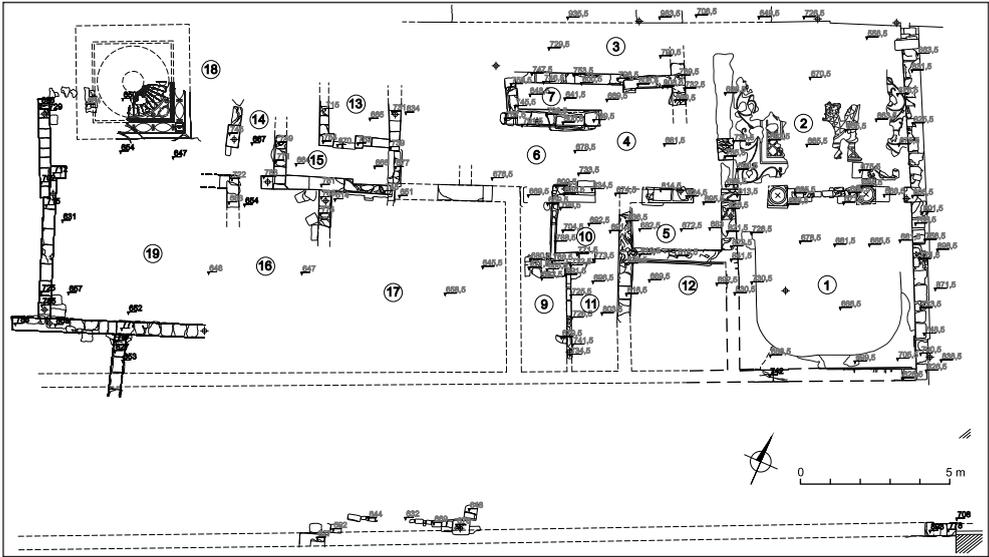
Fig. 2. Plan of house FB after the 2009 season  
(Drawing A. Brzozowska, G. Karpińska, M. Soltys)

Further exploration of Early Roman domestic architecture in area F was the main task of the season. The western section of house FB was cleared. A heavy concentration of architectural tumble, including blocks retaining faint colored plastering, was removed to uncover two large rooms, loci 18 and 19, the two covering some 50 m<sup>2</sup> [Figs 2, 3]. A long wall some 0.40 m wide, now standing two courses high, closed the two rooms from the west. The masonry resembles that of other walls in the house: isodomonic courses of soft limestone blocks. The wall is not homogenous and may be indicative of two successive building phases, but the absence of doors speaks strongly in favour of it being the outer wall of House FB.

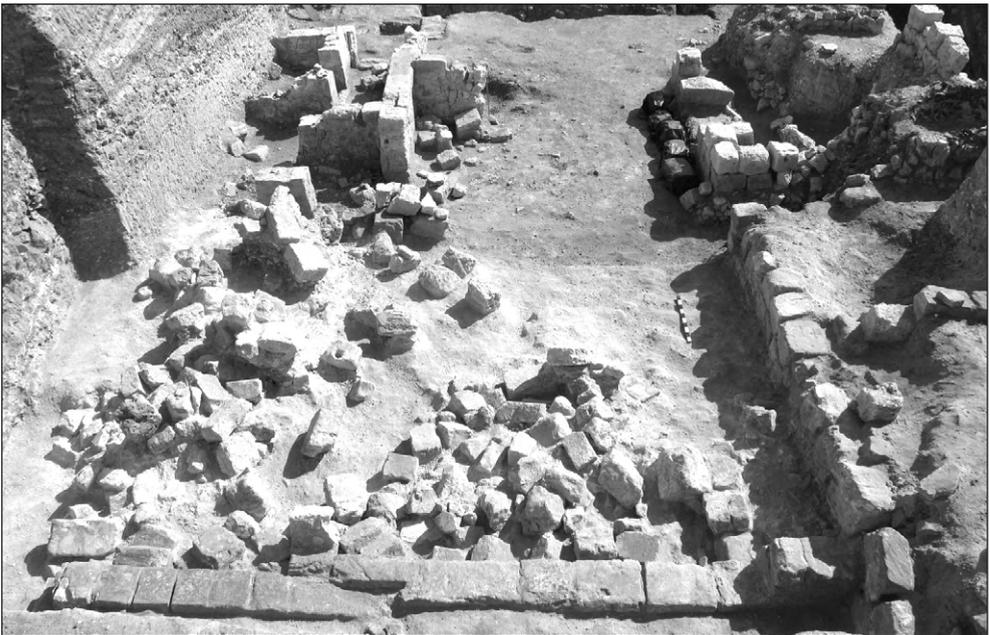
Fig. 3. House FB. Western wing, looking east  
(Photo G. Majcherek)

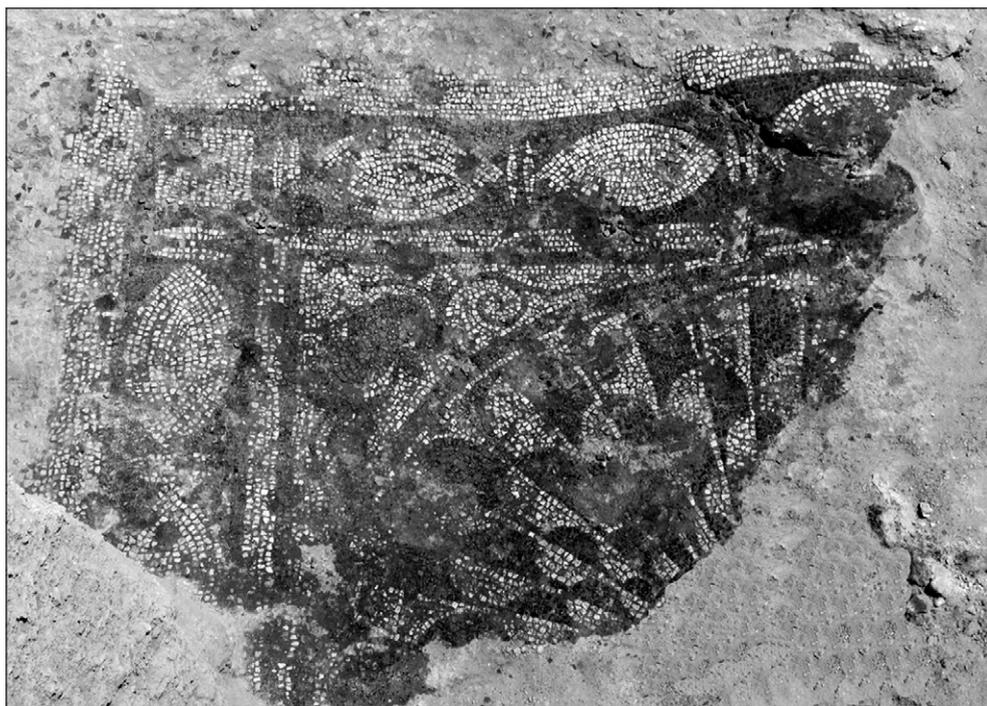
Fig. 4. Mosaic found in room 18 of house FB  
(Photo G. Majcherek)

Room 18 was accessible from the east, from room 14, via a tripartite entrance emphasizing its significance. A large fragment of floor mosaic was cleared in the southeastern part of the room [Fig. 4]. Although only about a quarter of its original surface has been preserved. The ample space along the eastern and northern edge was paved with small, irregular stones with no inherent pattern. The mosaic proper featured a geometric design with some floral elements. Simple border decoration consisted of a schematized astragal pattern in white on a black background. The central field (originally 2.70 m square) was framed by a narrow black band. A shield of bichrome, interchanging scales was inscribed in a square field (for a similar mosaic featuring a shield of interchanging black-and-white scales, discovered in the 1990s in House

MA, see Majcherek 2001: 29–32). The corners of the square were filled with ivy scroll and *hederae*. There is little doubt that the shield must have enclosed a rounded emblema (now lost). The size and location of the mosaic implies that room 18 must have originally extended well to the north (beyond the limits of the trench), and it must have originally measured some 6 m by 6 m. The overall layout of the mosaic floor, positioned centrally in the square room, is typical of an *oikos* rather than a *triclinium*.

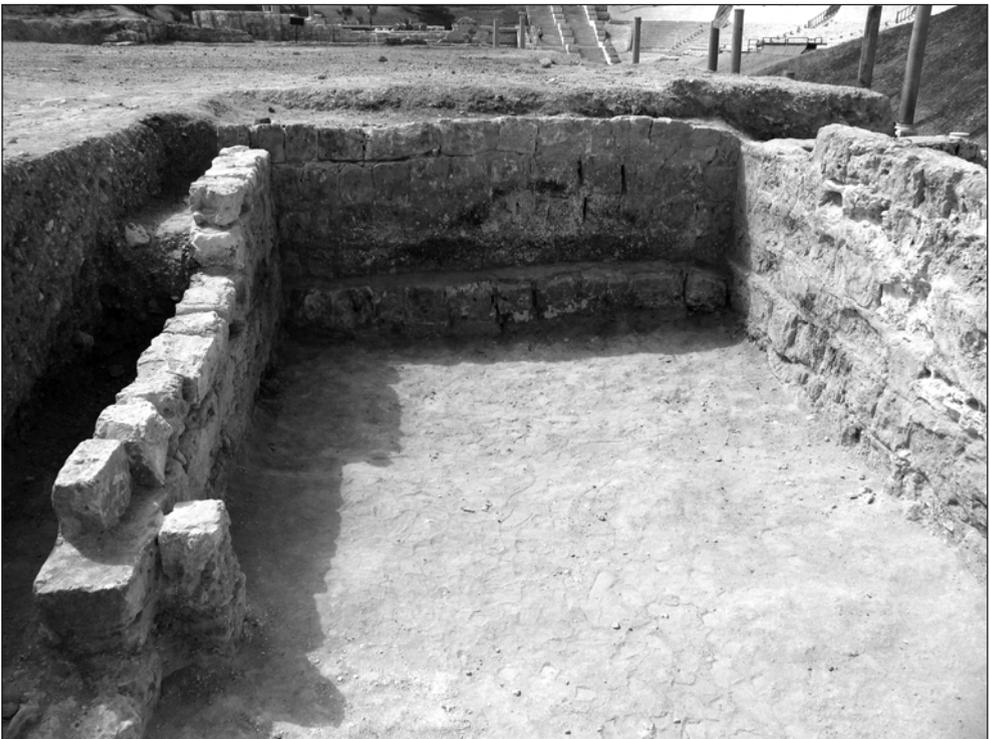
*Fig. 6. Auditorium E, looking south  
(Photo G. Majcherek)*

The last of the lecture halls located along the southern passage of the bath, Auditorium E, is roughly the same in size as neighboring auditorium D (12.30 m by 4 m). It shared lateral walls, structured in regular ashlars laid in isodomic courses, with adjacent auditoria D and F. No vestiges of the benches were preserved [Fig. 6], but their position can be deduced from the imprints visible on lateral walls. At least two levels of the benches can be inferred. There is no indication as to how the head of the auditorium was structured.

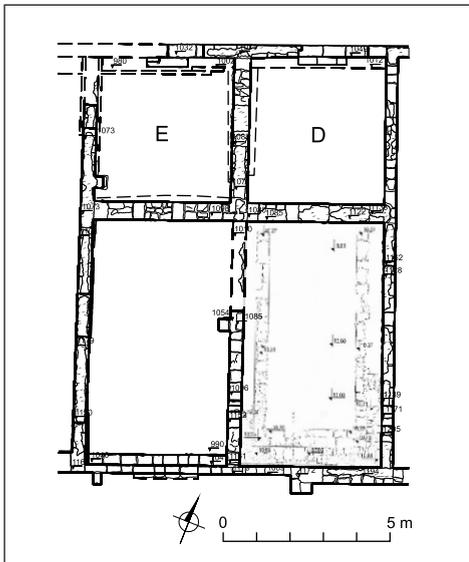
Fig. 7. Plan of lecture halls D and E, final phase from the early 7th century (Drawing D. Tarava, M. Soltys)

Auditorium E, like the adjacent hall D, appears to have been rebuilt substantially in the early 7th century. The benches were dismantled, completely as it turned out in the case of hall E, and the northern parts of the halls were transformed into something entirely different. The original entrances from the north were retained, but a new wall was installed at the southern end, shortening the available space to just 4.40 m [Fig. 7]. The new wall was built in

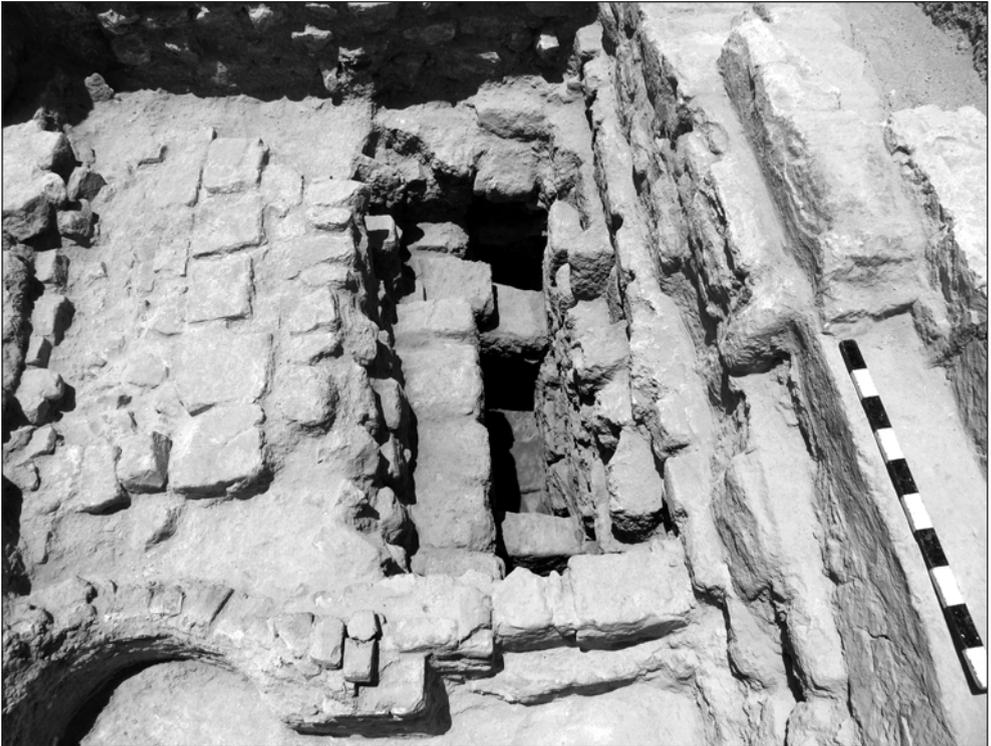
*Fig. 8. Latrine channel and lime kiln predating auditorium E (north facade wall of the hall at left) (Photo G. Majcherek)*

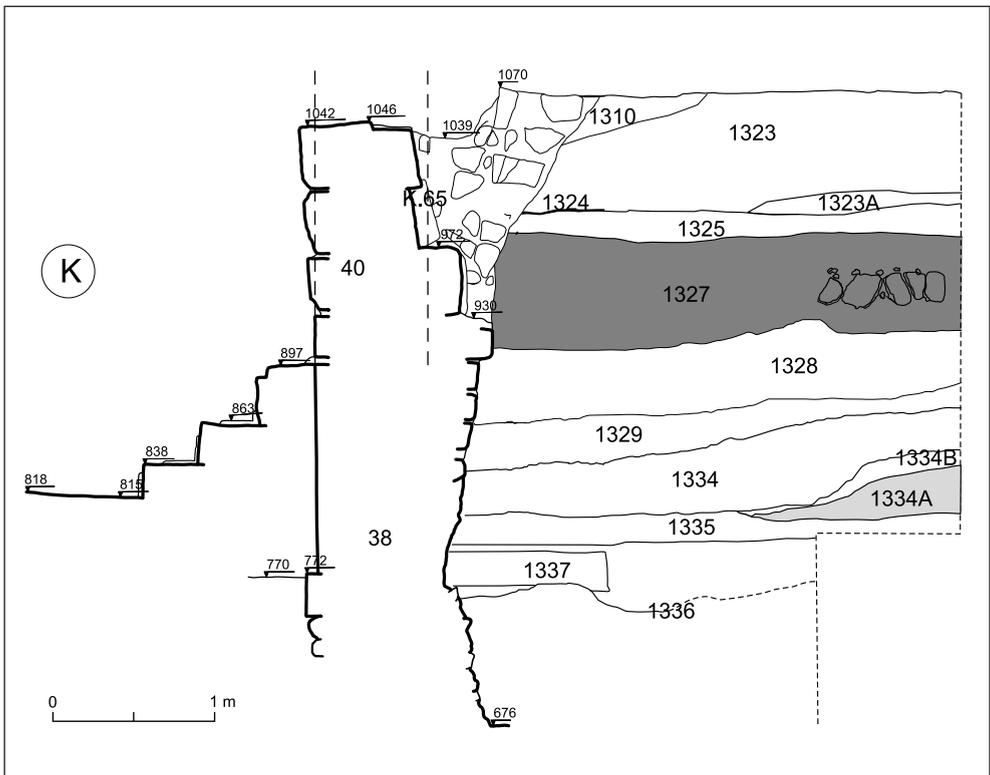
The trench K-east to the east of auditorium K revealed that the east wall of this hall was rather curious in its construction [*Fig. 9*]. The foundation, some 1.40 m below the floor level of the auditorium, was structured of small assorted stones. The inner facing (that is, inside the hall) and the upper section of the wall were built in isodomic masonry (standard blocks measuring 0.40 x 0.50

x 0.40 m). The outer facing on the other hand was made of stone rubble set in ash–lime mortar. The wall was apparently built in a narrow trench tightly filled with rubble. As a result its outer face is pitched substantially eastward. This is particularly clear in its upper section, where the rubble filling sits approximately 1 m off the line of the foundations. The reason for this curious construction appears to lie in an effort to counterbalance the heavy load of the rubbish dump accumulating behind this wall.

Fig. 9. Trial pit K-east, cross-section looking north  
(Drawing G. Karpińska, K. Lach)

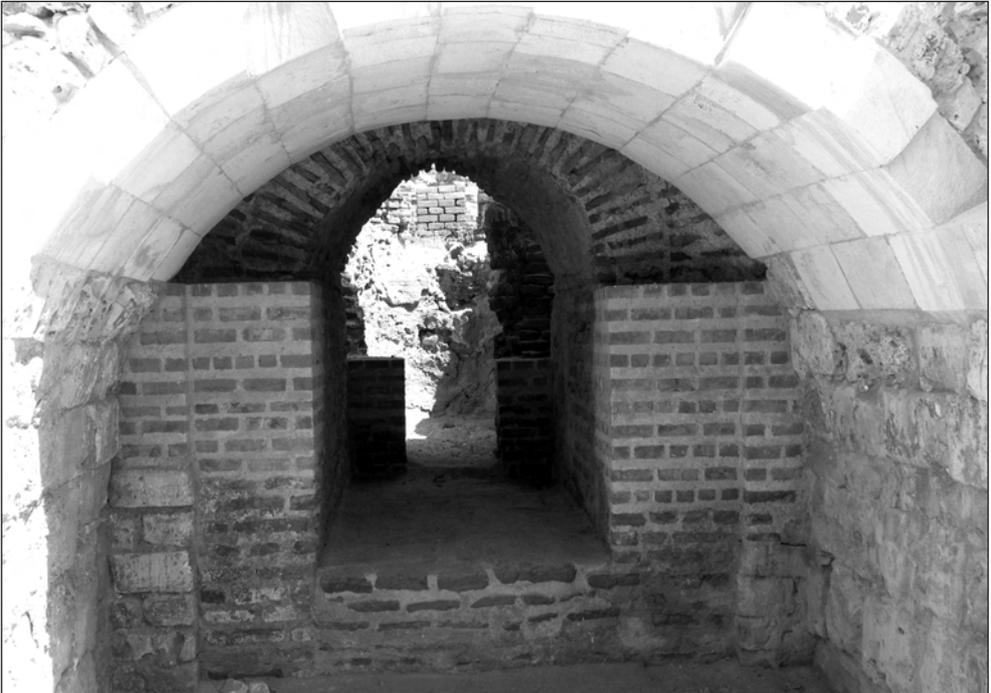
Fig. 10. Bath complex. Underground service area during the 2009 season conservation work (Photo A. Pisarzewski)

To provide a safe and serviceable means of access for future visitors, it was decided to build a modern stairway leading down to the bath cellar. Restoration of the lateral walls of the underground chamber were a prerequisite for this operation. The south wall survived as the lowermost course, while the north one had to be built from scratch, having been dismantled almost entirely already in late antiquity (Kołątaj 1992: 56–62). Walls were reconstituted in modern limestone blocks cut to proper size (50 x 40 x 30 cm) and set in isodomic courses, matching extant ancient walls. Both walls were restored for a distance of 6 m and to a height of 1.30 m. Higher up, slightly sloping retaining walls made of smaller assorted stones (10 courses) were

built. Their height reached ground level, thus creating a sort of casing, into which a stairway was subsequently introduced [Fig. 10].

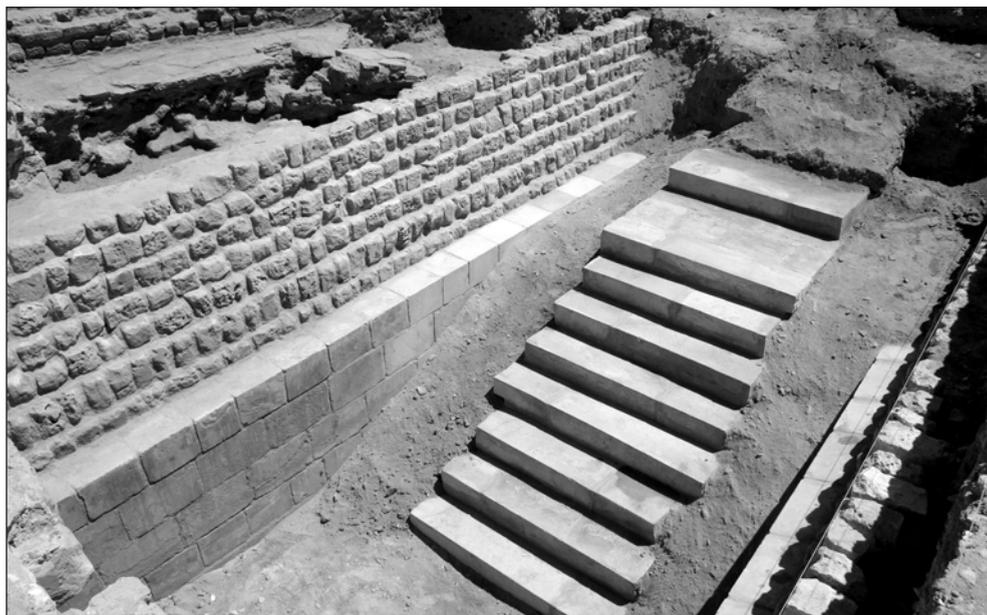
The design of this staircase had to take into consideration the vertical distance, more than 3 m, between the floor of the frigidarium and the cellar, as well as modern construction requirements. It was planned as an unobtrusive structure, separated from the ancient substance, but integrated visually with neighbouring monuments. The straight flight of stairs (approximately 5.70 m long and 1.60 m wide) has 15 rises with a wide landing halfway down. As stipulated by modern building standards, the pitch was set at 30 degrees [Fig. 11].

Fig. 11. Modern staircase leading to the underground service area of the baths  
(Photo A. Piszczewski)

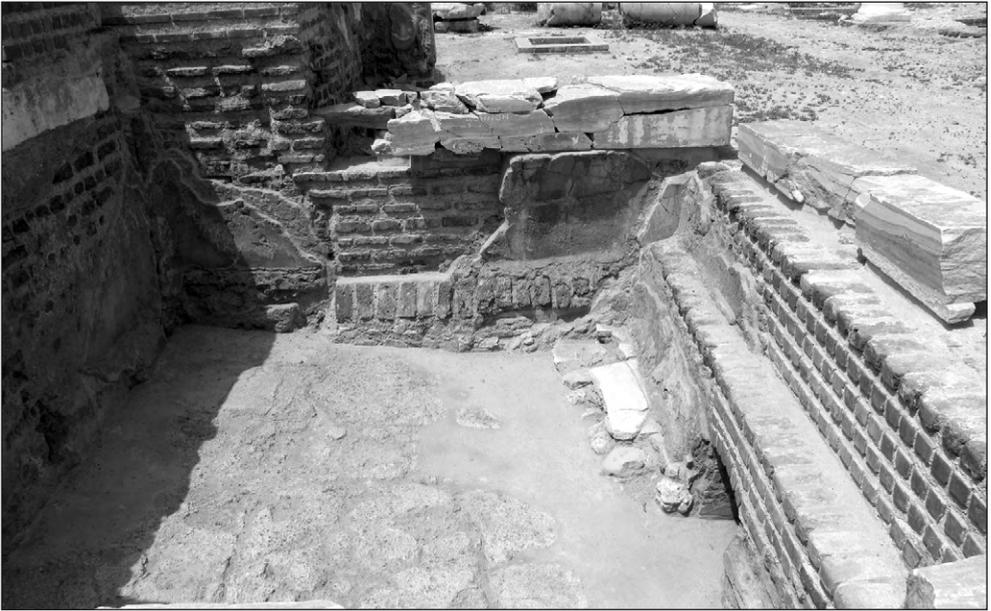
conservation of a large open-air pool located in the southwestern part of the frigidarium. The structure was excavated in the 1960s and provisionally secured (Kubiak 1967: Pl. VIB). The pool measuring approximately 4 m by 3.80 m (internal dimensions) was constructed combining two different techniques and materials. The walls and foundations (some 0.80 m wide) were built of bricks, while the *pluteus* was made of large green *cippolino* blocks. These blocks were apparently reused, most probably cut from large column shafts as evidenced by the spherical surface clearly visible in their bottom parts.

The outer brick facing of the pool having been treated in the previous season, work now proceeded on the conservation from within. The whole structure appeared to be in rather poor condition; some of the bricks were totally disintegrated, large patches of waterproof plaster were found detached from the walls and large cracks in the walls and floor added to the danger of water penetration. Several blocks of the *pluteus* had either subsided or been displaced.

*Fig. 12. Marble-lined pool in the frigidarium of the Imperial bath, state following restoration in 2009 (Photo G. Majcherek)*

Upon assessing all theoretical and practical considerations,<sup>2</sup> work started with an initial mechanical cleaning of all surfaces, followed by removal of old cement mortar patches and badly corroded steel rods introduced in the 1960s. The vertical cracks in the walls were filled with new lime mortar and damaged sections of walls were completed with new bricks. Edges of extant plastering were protected with lime mortar and their surfaces additionally treated with a 25% solution of polyvinyl alcohol. Missing fragments were completed with new mortar. Blocks of

the marble *pluteus* were dismantled where necessary and reassembled. Loose marble fragments were put together using epoxy resin (ARALDITE PY 1092) with brass rod reinforcements (ø 6 mm). The outlet of the pool located in its east wall was also cleaned and repaired in order to allow unimpeded evacuation of rainwater. Finally, missing fragments of the floor bedding (sunk some 0.60 m below ground level) were completed with new mortar, with some crushed bricks added [Fig. 12].

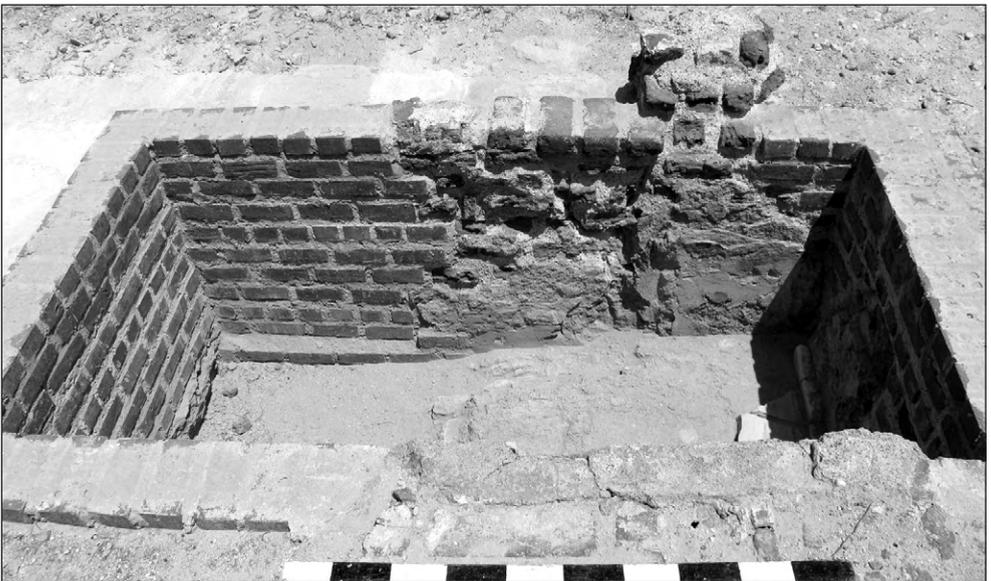
*Fig. 13. Small bathtub in the frigidarium of the bath, state following restoration In 2009 (Photo G. Majcherek)]*

Preservation work in the frigidarium of the bath also included the restoration of a rectangular brick-made bathtub located in the northern end of the area [Fig. 13]. Loose bricks were fixed with new mortar; missing fragments of walls were completed. A coping of new bricks was laid with an additional insulation layer. Several patches of marble and limestone flooring were consolidated and new protective edges installed.

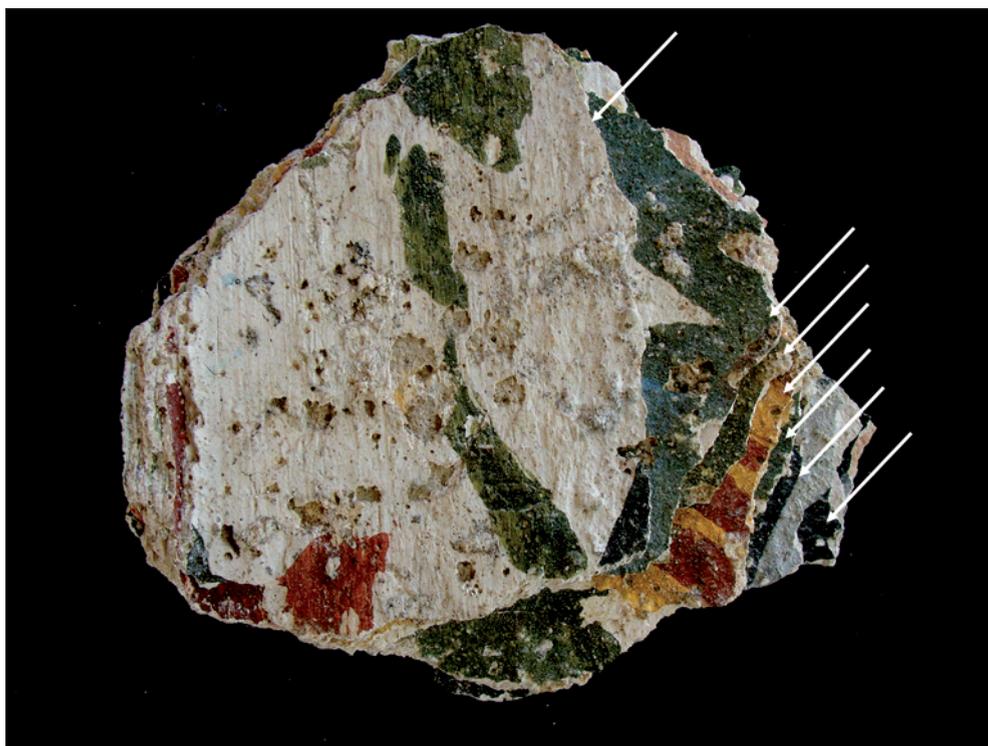
*Fig. 14. Superimposed coats of painted decoration on a piece of plaster from the fill of auditorium E (All photos by K. Lach)*

The wall plaster fragments were meticulously lifted and preserved. In most cases they represented several superimposed coats of painted decoration [Fig. 14]. The chief colors in use were white, yellow, shades of pink and black, as well as to a lesser extent red, blue and green. Most of the discovered fragments were no more than 10 cm across. The number of coats of painted decoration ranged from one to several.

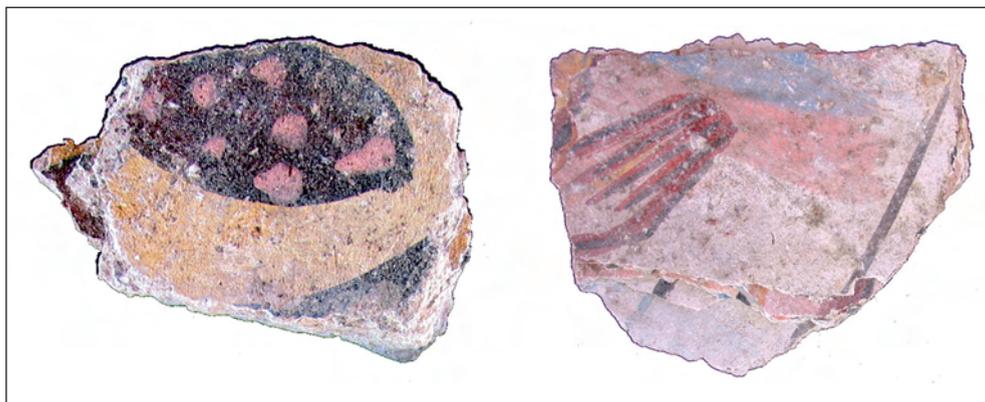
*Fig. 15. Fragments of wall plaster with decoration possibly from figural compositions*

The most frequent motifs of painted decoration consisted of irregular elements, which could have been part of figural compositions [Fig. 15]. The next group in terms of quantity were pieces of wall plaster with a uniform color background,

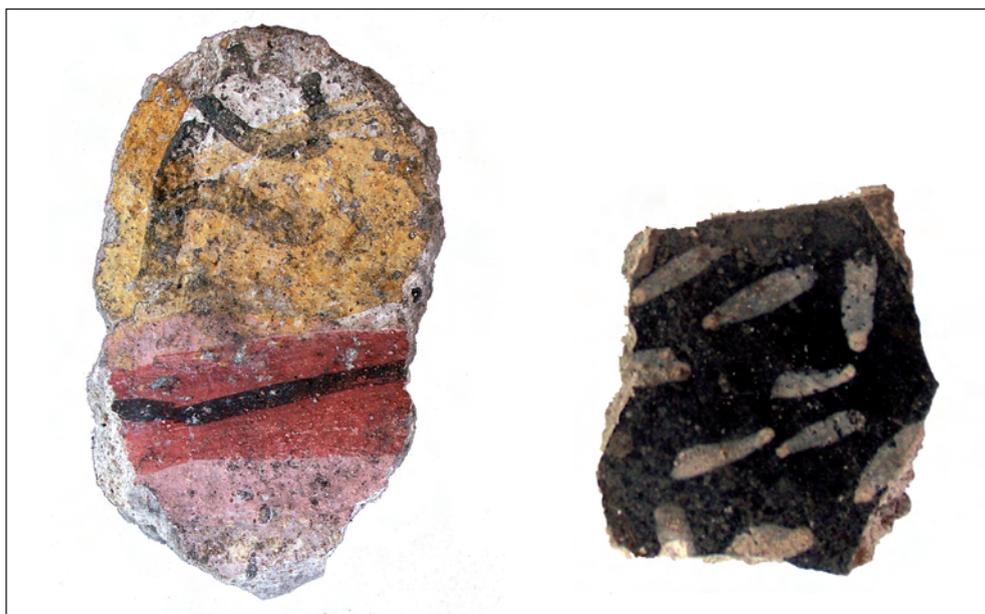
*Fig. 16. Fragments of wall plaster with uniform color background covered with irregular brushstrokes (left) or contrasting splashes*

covered with irregular brushstrokes or contrasting splashes [Fig. 16]. Vegetal motifs were suggested on some fragments, as well as geometric patterns [Fig. 17, top row]. Part of the assemblage bore lines and bands of different width and color [Fig. 17, bottom row].

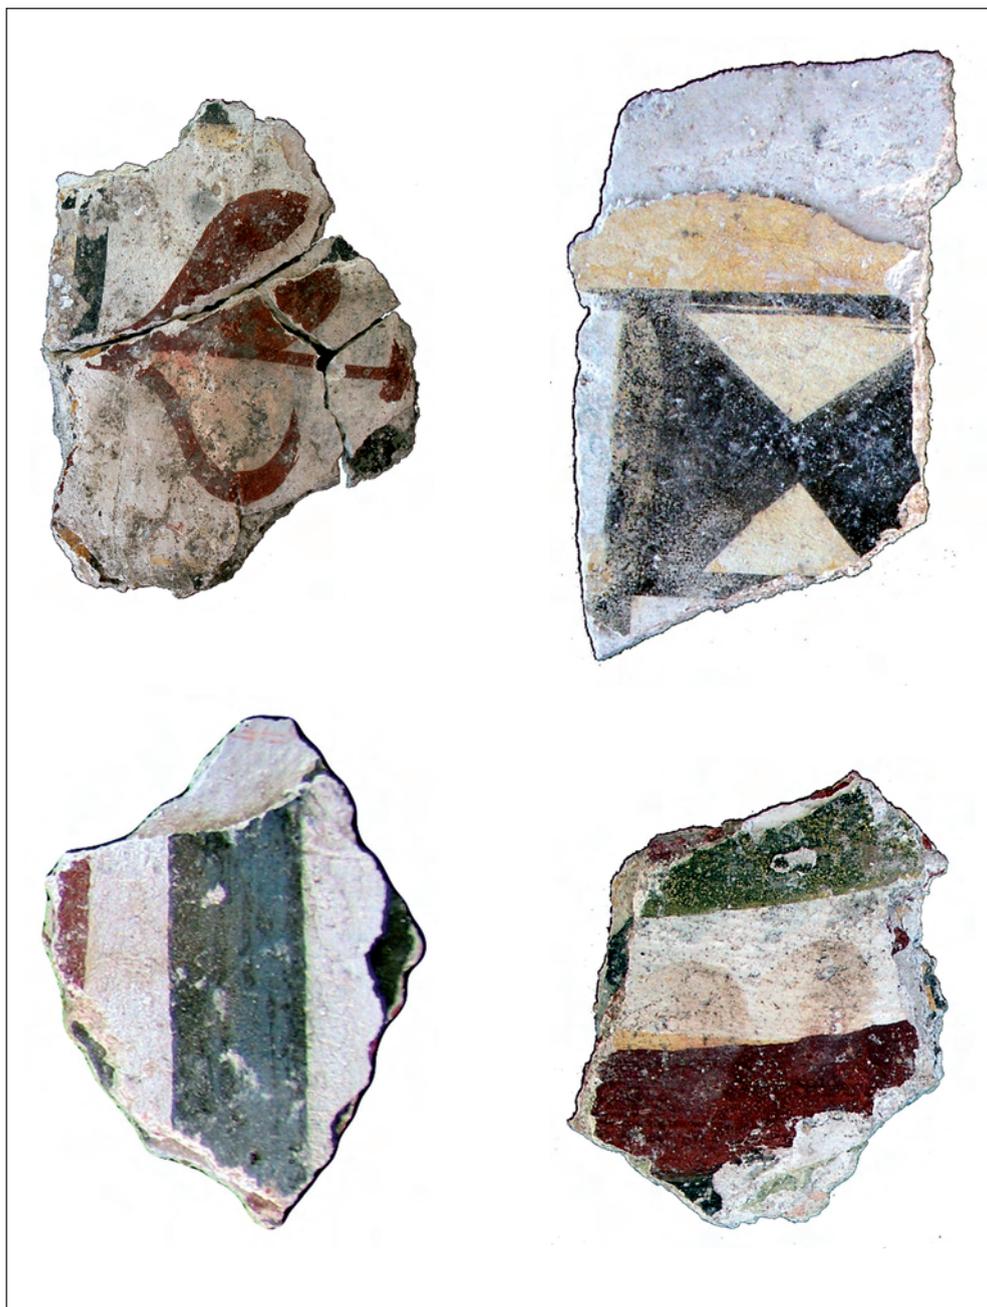
*Fig. 17. Fragments of wall plaster with vegetal (top left) and geometric motifs (top right) and color lines and bands (bottom row)*
