## **Banganarti and Selib: Season 2011**

Polish Archaeology in the Mediterranean 23/1, 323-342

# BANGANARTI AND SELIB: SEASON 2011

**Abstract:** The report summarizes work carried out during the 2011 season by the archaeological and restoration mission at Banganarti (Upper and Lower Churches, eastern tower of the fortifications, house SW1 in the southwestern part of the church enclosure) and at two sites in Selib: the church enclosure at Selib 1 and the Meroitic settlement at Selib 2. In the case of the earlier Selib church, inscriptions on the outer wall of the church have confirmed its dedication to St Menas. A baptistery tank associated with the oldest church on site and a lime-plastered rectangular tank approached by a flight of steps were also discovered. A large earthenware polylobed tray was recorded from the fill of the latest trench

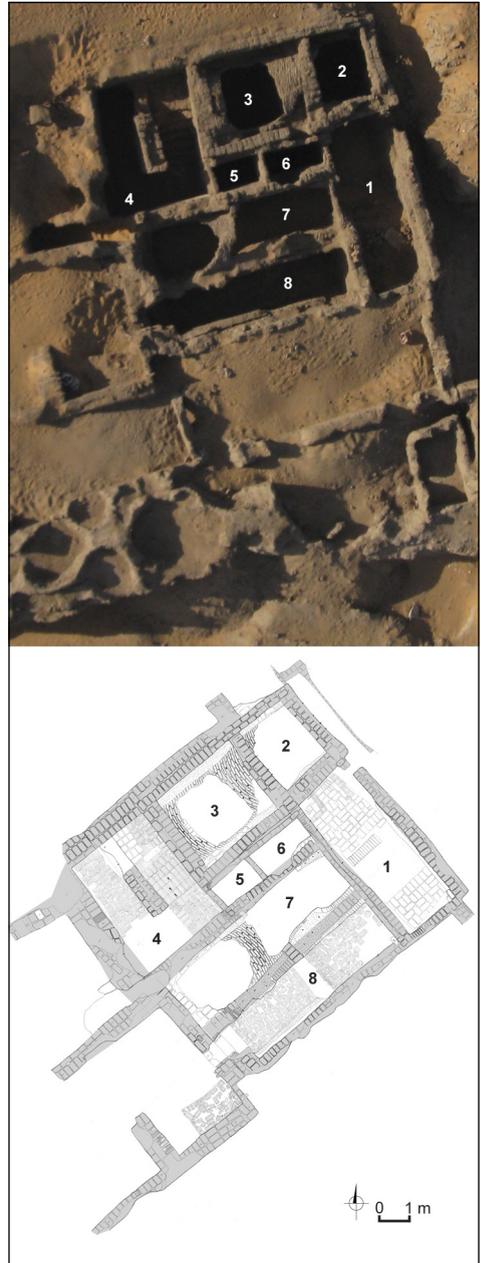
Fig. 2. House SW1: plan and top view (Drawing E. Skowrońska, K. Solarzka; aerial kite photo, early February 2011, B. Żurawski)

The original structure consisted of three rooms (1, 7, 8) and an entrance from the

south [Fig. 2]. Units 2 and 3 were added with an entrance from the north, sheltered additionally with a small brick L-shaped curtain wall, presumably protecting it against northern winds. Subsequently, room 4 (staircase) was added, from which a small yard was accessible through a “western” door. Parallel with the extension of the upper storey, the structure was reinforced with partition walls (thus forming rooms 5 and 6). The ground floor area including all the extensions covered approximately 78 m<sup>2</sup>.

A house in the southwestern part of the enclosure continued to be explored (trench supervisors E. Skowrońska, K. Solarzka). It adjoined a street running along the inner face of the defense walls and was thus one of the fronts in this street. A huge arched portal, found blocked with red brick in a later phase of its existence, originally gave access to the suite of rooms from the east and apparently formed a coherent unit constructed at roughly the same time as the house. It started to be excavated already in 2008 (Żurawski 2008: 278–281) [Fig. 2].

The entrance from the south led successively to units 8 → 7 → 1 or to the upper storey via narrow stairs. Passages between the successive interiors were in the form of plastered arched openings in walls. Room 8 originally consisted of two smaller vaulted interiors. Reused fired brick fragments were revealed at floor level (about 2.40 m below the preserved vault). A cooking pot with its rim even with the brick flooring was found in place underneath the floor in the north corner. A ceramic pipe ran across a section of the south wall (just underneath the vault), most probably for discharging outside water from the upper storey. In a later phase, the southern entrance “to the street” and to room 7 was walled, while room 8 was rebuilt to create one large space.

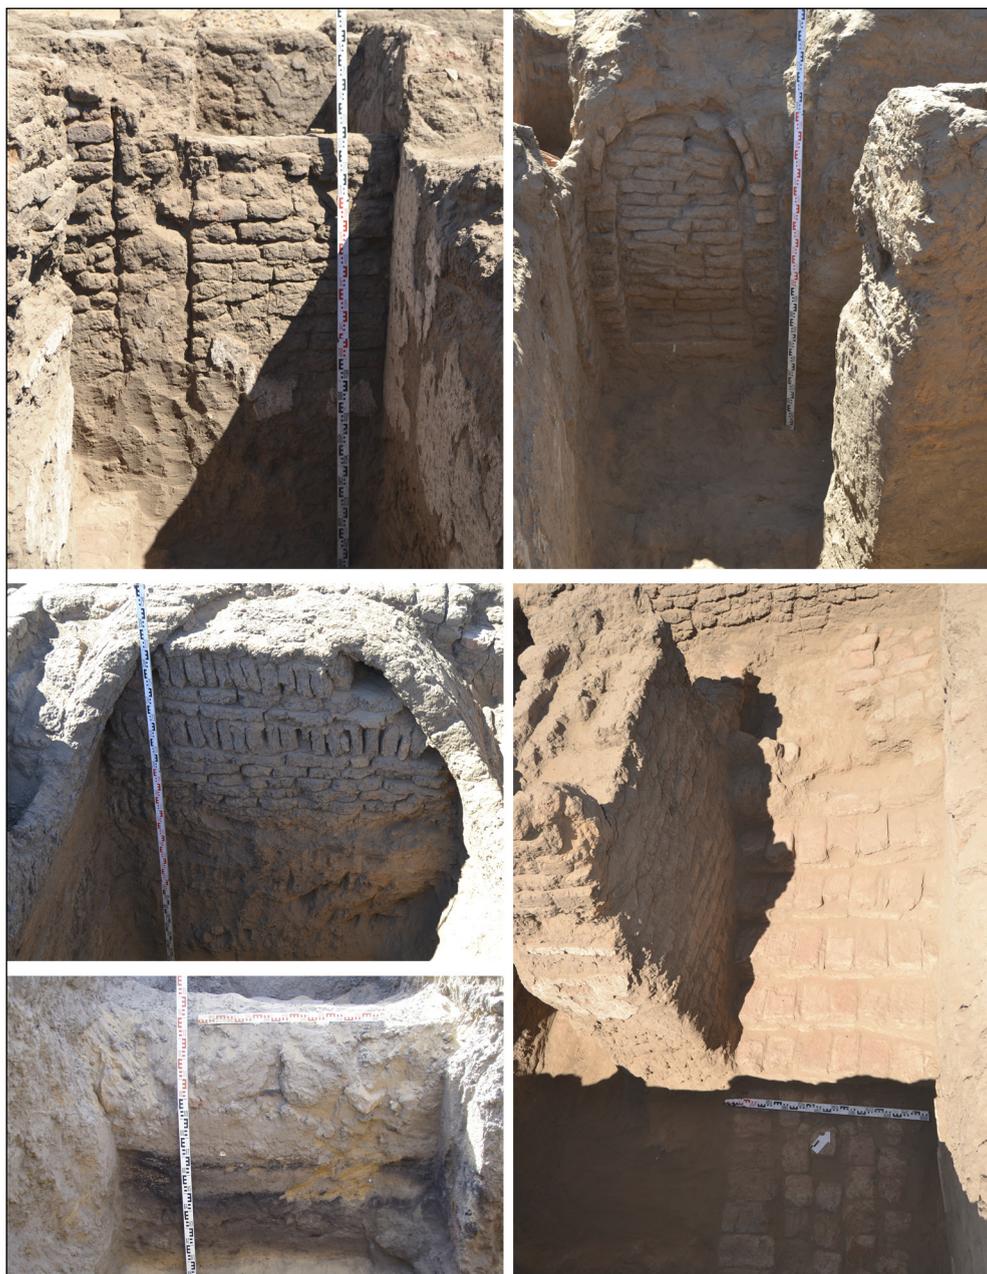
*Fig. 3. House SW1: clockwise from top left, room 5, northeast wall including partition wall; room 4, door jamb on the west side; stairs in room 4; section of the fill in room 1; bricklaying course beneath the vault of room 3 (Photos E. Skowrońska, M. Drzewiecki)*

made of fired bricks). After the original use of the room ceased, the doorway was walled up to the arch impost level, thus creating a small window opening of the “eyebrow” type. In the face of the wall, there was also a window measuring approximately 0.20 m by 0.50 m, preserved in its original state [see *Fig. 4*]. The opposite wall of the room represented an analogous situation, i.e., parallel to the front wall and below the vault, there was a rectangular window and an arched doorway, with semicircular arch, leading to room 3. The doorway and window opening were completely bricked up. In both areas remains of brick flooring were found at a level 2.60 m below the preserved top of the barrel vaulting (that is, roughly 152 m above sea level, measured from the datum point set up on the “threshold” of the Upper Church).

Rooms 5 and 6 were created by two partition walls, presumably erected to stabilize the upper storey. They appeared in a small passageway leading through a part of a later staircase to the west side exit. A staircase was located inside room 4 [see *Fig. 3*]. The steps and the flooring were made entirely of fired bricks. The staircase was divided by a pillar built of unfired mud bricks covered with plaster and whitewashed. Traces of whitewash were also visible on the walls of a niche located on the west side, below the level of the “landing” on the stairs. Three complete storage vessels and one cooking pot were left in this niche. In the western part of the staircase, remnants of a vault supported on the south and west walls, as well as on a pillar, were uncovered. In the west corner of the southern wall, a small passage had been walled up and a doorway was made in the west wall (similar to the doorways in rooms 2 and 3).

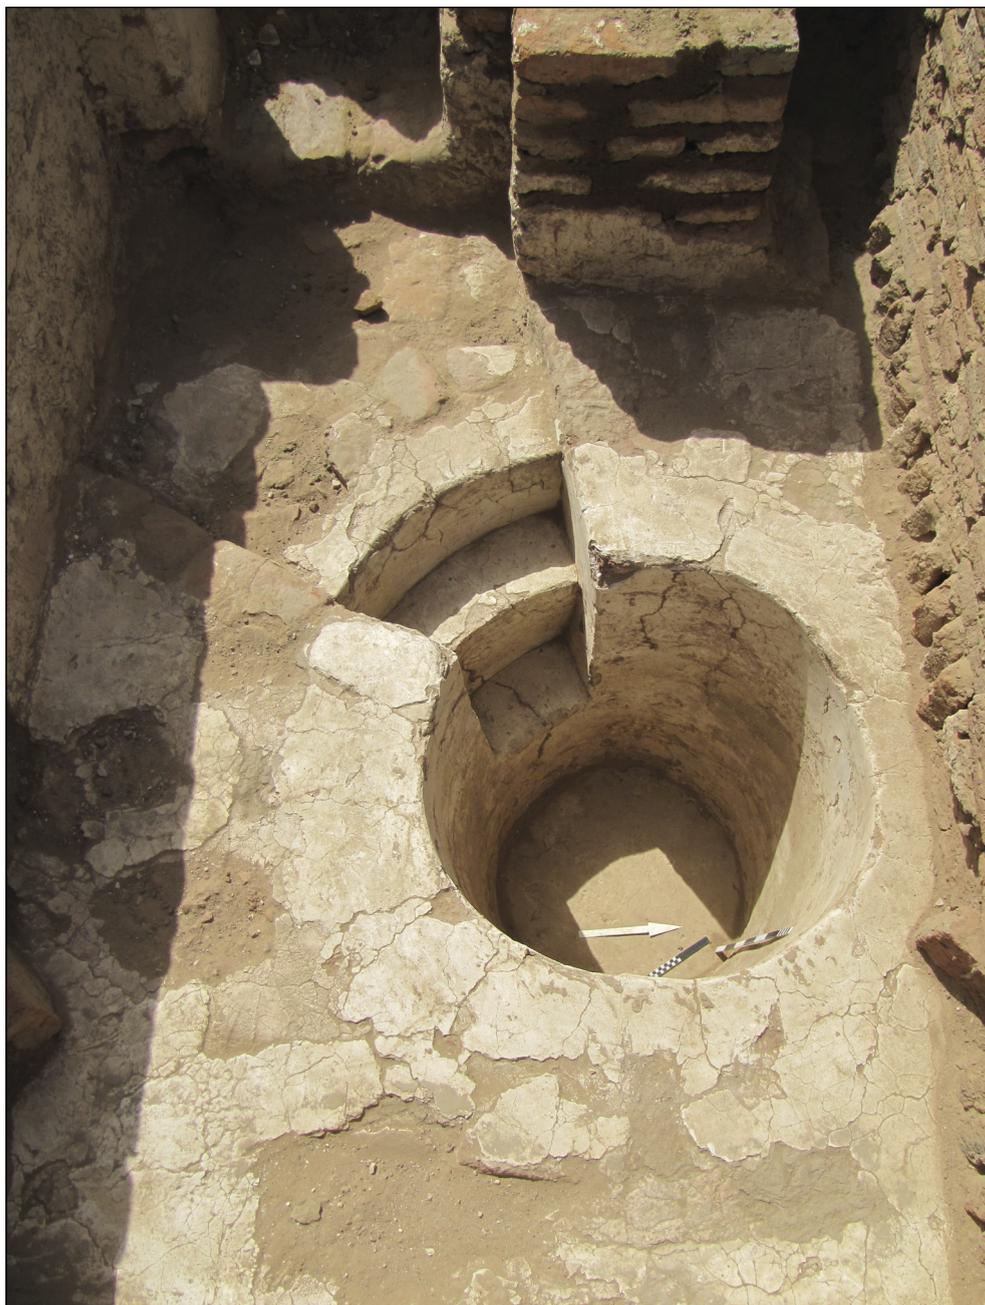
Excavations in trial pit 10 in the southeastern corner of the nave of the latest church revealed the baptistery of the Old Church [Fig. 6]. It was found in excellent condition, still covered on the inside with a layer of white lime plaster. The font was approached by a set of steps on the western side. Its depth was 1.10 m, the upper diameter of the font was 0.95 m. The baptistery of the second phase of the church was located in the diakonikon, on top of the demolished southeastern corner of the earlier church.

*Fig. 6. Top view of the baptistery tank of the Old Church  
(Photo A. Cedro)*

The baptistery tank from the Old Church discovered in trial pit 10 was well preserved, but still demonstrated some voids and cracking of the lime-plastered surface. The following treatment was applied: weakened parts like the cracked and crushed fragments of the upper edge were injected with a 10% solution of acrylic resin (MOWILITH) in water, the

voids and cracks inside the font were filled with a paste composed of lime and sand (1:3) with a 3% addition of acrylic resin. The floor of the baptistery was repaired with a composition of lime mixed with mud and sand (1: 1: 2). The upper tank (belonging to the second-phase church) was treated in similar fashion. Since its exposure to destructive factors had been greater than that of the lower one, its upper part was reconstructed with the use of red brick and lime mortar and covered with three layers of lime render.

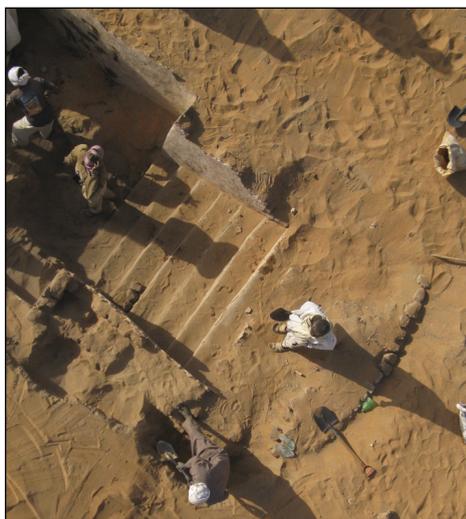
in a location 40 m from the southwestern corner of the enclosure wall, southwest of the church. A dense scattering of fragmented lime plaster was observed on the surface and walls of red brick appeared just below the surface. The structure turned out to be a subterranean tank, measuring internally 3 m by 3 m, approached from the west by a flight of eight steps (2.10 m wide) [Fig. 8]. The external dimensions were 4 m by 6 m. The interior was covered with a thick render of lime plaster. A curved wall made of half bricks outside the steps appeared to have sheltered the entrance to the basin from wind and sand. Objects from the fill included three fragments of window grille (W SEL 1/45-47/2011) differing considerably from the grilles found closer to the church. They may have originally belonged to the building that once stood above the basin.

Fig. 8. Subterranean tank: left, bird's eye view of the steps leading to the basin during exploration (Photo B. Żurawski)

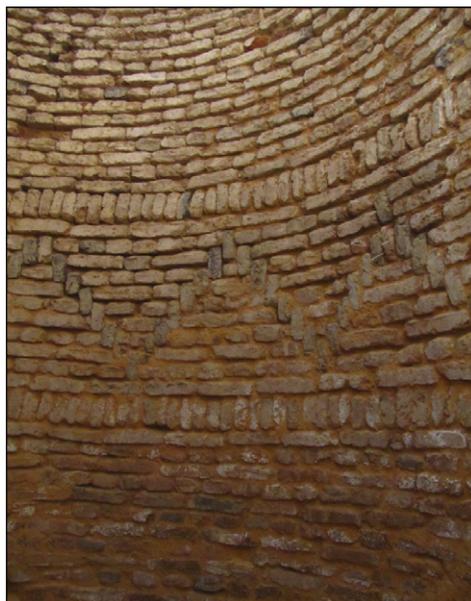
The windblown sand fill of the structure was removed down to a depth of 7.00–7.50 m beneath the surviving top of the red-brick facing wall. The sand contained fragments of red brick, broken *qawadis* and some fragments of window grilles of a pattern similar to those found near the church. The internal diameter of the well was 3.50 m. It was built of brick averaging  $34 \times 19 \times 8$  cm in size, set in a regular pattern of stretchers and headers. At a depth of 2.70 m the regular brick pattern was interrupted by a roll of stretchers set on edge that was followed, looking down, by a zigzag pattern made of stretchers laid on edge [Fig. 9]. Bordering the zigzag band was another course of stretchers on edge. Accentuating the differentiated brick pattern was brick quality, the bricks used for the decorative zigzag being overfired or even vitrified, therefore having a definitely different coloration and appearance.

Fig. 9. Interior of the well (*matara*) at Selib with zigzag pattern of bricks in the lower part (Photo A. Cedro)

The upper parts of the well shaft were reconstructed by a local bricklayer under the supervision of the project director.

This was done partly for the purpose of preservation of a historical monument and partly to keep the sand from blowing in again and to reduce the danger of animals and people falling into the deep hole. The reconstruction was done with the use of local materials (red brick) and mud mortar made of crushed mud brick taken from the debris heaps.

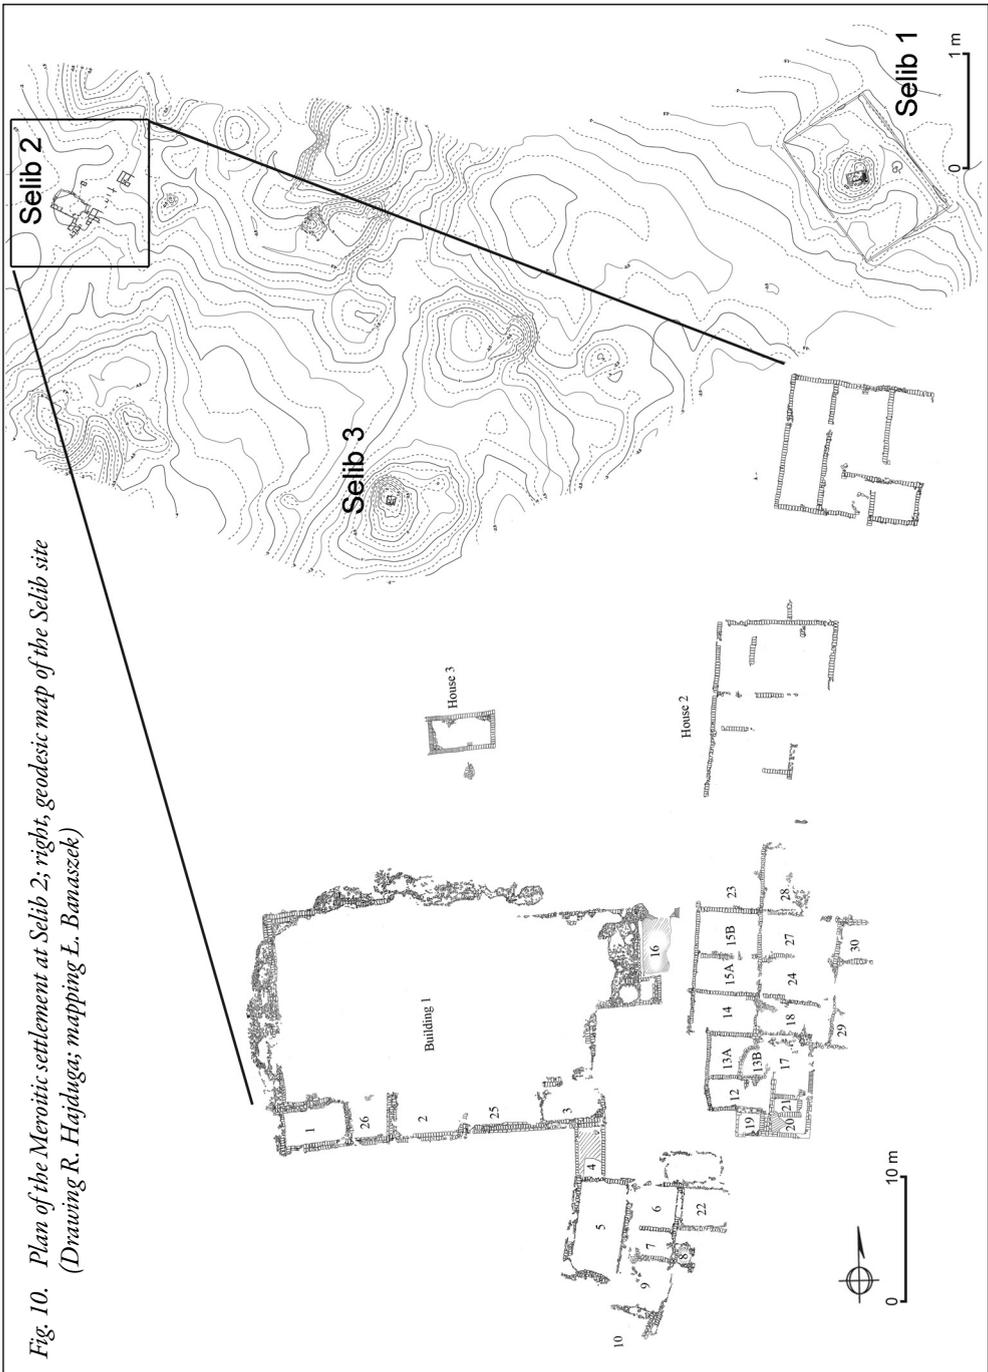
Two rooms were cleared in Building 1 at the site of Selib 2 (trench supervisor R. Hajduga; for previous work, see Żurawski 2013: \*\*\*-\*\*) [Fig. 10]. Fieldwork was focused on the central part of the storeroom and the structures in its immediate vicinity, especially a regular complex of two rows of rooms made

Fig. 10. Plan of the Meroitic settlement at Selib 2; right, geodesic map of the Selib site (Drawing R. Hajduga; mapping L. Banaszek)

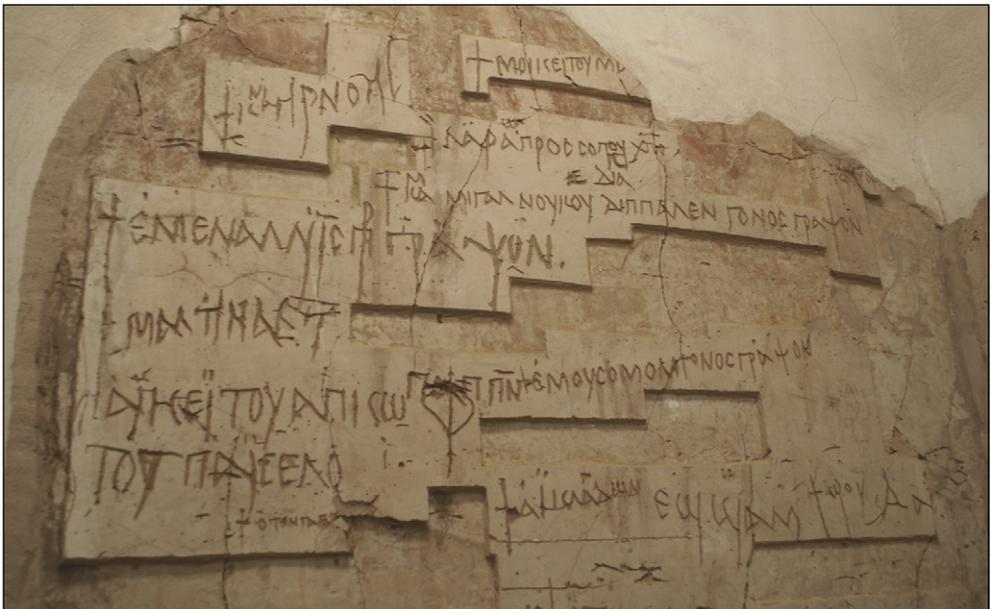
– painted), the painting hidden beneath the inscribed plaster on the south wall was exposed by removing plaster fragments between the texts [Fig. 13]. In sections where the adhesion of the painting layer to the background was weak, glue injections were applied. Then the whole surface was strengthened with a 3% solution of gum Arabic mixed with Lichenicide. In a similar way other murals (that were attacked by insects) were protected.

Fig. 13. Mural painted on the first layer of plaster in Banganarti, exposed by removing patches of plaster from the second layer between the inscriptions on the south wall of Room 13 (Photo B. Żurawski)
