THE EASTERN TOWER AT BANGANARTI 1

Abstract: In 2010 and 2011, excavations in the area of the eastern tower on the site of Banganarti 1 were carried out on archaeological layers altogether 4.50 m thick, comprising architectural remains and occupational layers associated with the tower and the nearby architecture. Two principal phases: wall I and wall II, were distinguished. A tower was observed in both phases. During the first phase the tower may have undergone some modification (subphases Ia and Ib), during the second, a new bigger tower was constructed on top of the earlier remains and a network of buildings interconnected by corridors, staircases and courtyards was constructed against the inside face of the wall.

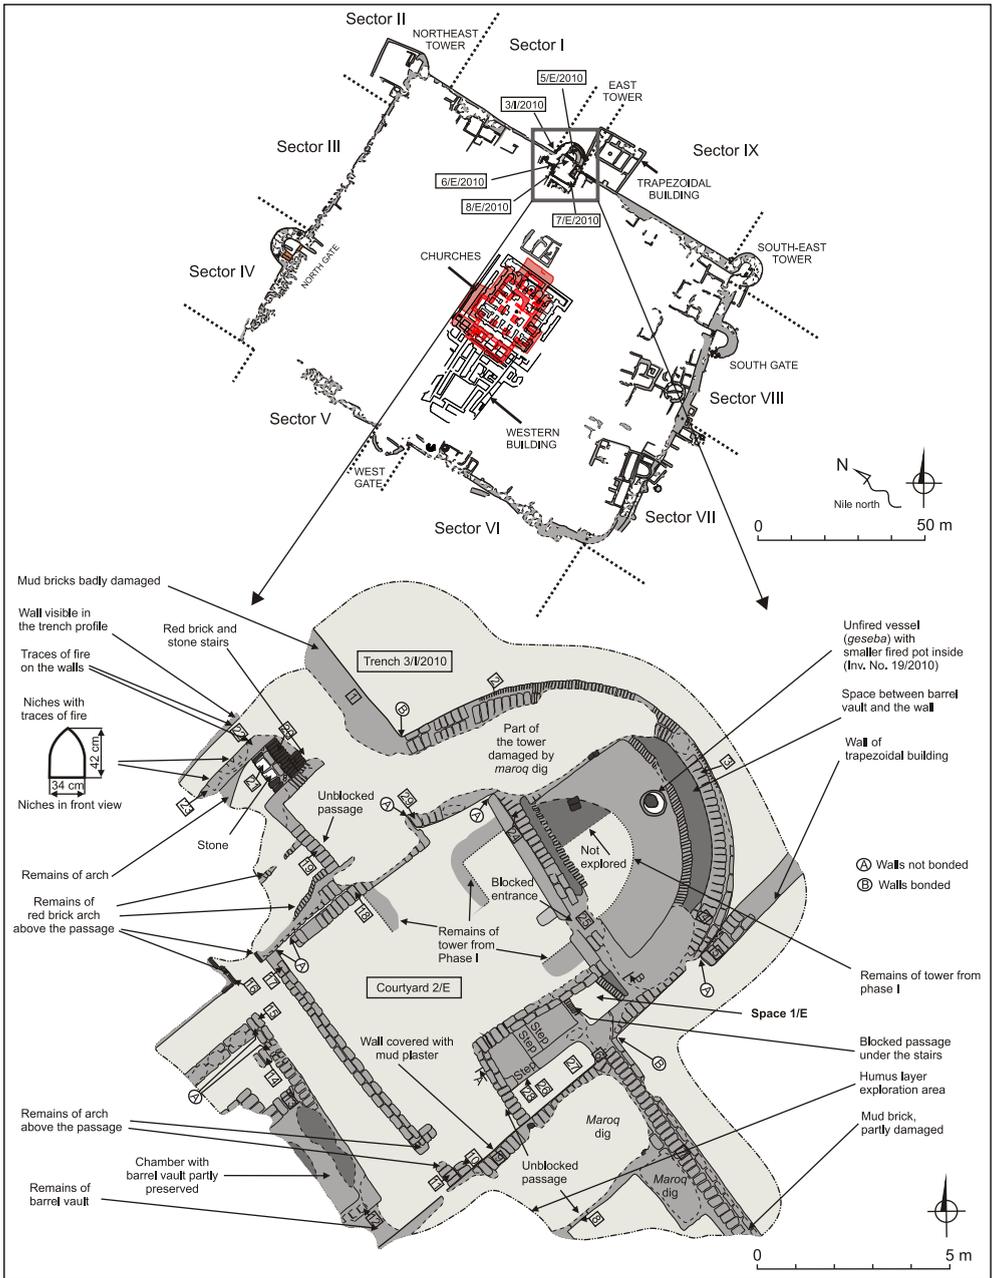
Fig. 1. Baganarti, site 1. Plan of architectural remains in the area of the eastern tower after the 2011 season; inset, plan of the site with architectural remains for the end of the season in 2010 (Drawing A. Cedro, M. Drzewiecki and R. Łopaciuk, M. Drzewiecki)

Excavations in 2010 were carried out inside and in the immediate surroundings of the eastern tower, which is considered a key architectural element of the Banganarti fortifications. The state of preservation of the architecture in this part of the complex turned out to be very good and the accumulations thick enough for the explorations to be continued in the 2011 season. The maximum thickness of archaeological layers was 4.50 m, whereas the architecture was preserved to a height of 4.20 m. Extensive evidence of repairs and rebuilding were recorded in the tower and the adjacent buildings [see Fig. 1].

The first trench (3/I/2010; 2.00 m by 1.50 m) was excavated on the spot where the eastern tower joined the curtain wall in sector I [see *Fig. 1*]. The top of a culturally sterile layer was reached at a depth of 4.20 m. Humus here was about 2.45 m thick, comprising loose yellow sand with potsherds and small quantities of organic material. The structure of this deposit created a continuous hazard of collapsing baulks, the falling sand damaging non-architectural layers uncovered below.

humus layer from the entire area of the tower was removed and only afterwards were small test pits planned. The actual testing was carried out for the most part in 2011, exploring four trenches: 5/E/2010 to 8/E/2010 [see *Fig. 1*; Drzewiecki 2013: Fig. 8 top). Only in 6/E/2010 was the top of a culturally sterile layer reached. Exploration proceeded in arbitrary levels, roughly 1 m thick in each case. Finds were counted and registered. Pottery underwent selection on site for the purposes of ceramological research (only complete or reconstructible forms, as well as unknown or atypical ones, plus ornamented and inscribed sherds).

One of the results of the rebuilding was a larger tower, which attained a diameter of about 9.50 m and projected from the circuit about 6.00–6.50 m [see *Fig. 6*]. The chamber that was formed inside the tower was of irregular shape [see *Fig. 1*]. It is not clear why this was so, especially as the architecture in this case was disturbed by a pit filled with yellow, humus sand, cutting through much of the tower. The chamber was furnished originally with a barrel vault and the walls rendered with mud plaster. The thickness of the walls (about 1 m) indicates the presence of an upper floor. The entrance to the chamber, which

Extensive mud-brick architecture was recorded on the inside of the fortifications of phase II [see *Figs 1–2*]. The tower chamber appears to have opened on a small L-shaped courtyard (2/E in *Fig. 1*). A staircase in the eastern corner of the courtyard may have ascended to the upper-

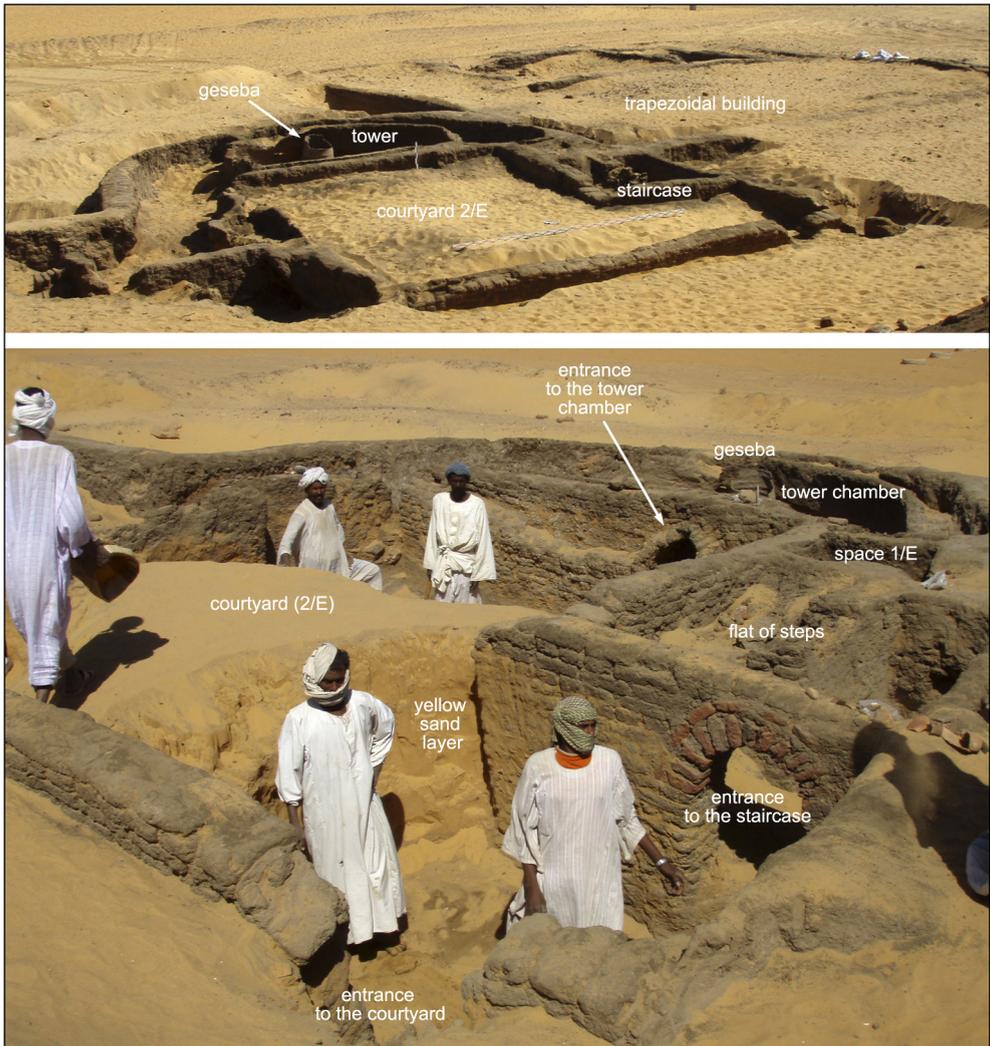
Fig. 2. Eastern tower after the tops of the walls had been cleared of sand; bottom, view during exploration of the humus layer inside the ruins in 2010 (Photo M. Drzewiecki)

Next, the interior of the tower started to be explored [*Fig. 2*, bottom]. To avoid problems with collapsing baulks, the

All recorded surface traces of the eastern tower [see *Fig. 2*, top] should be linked

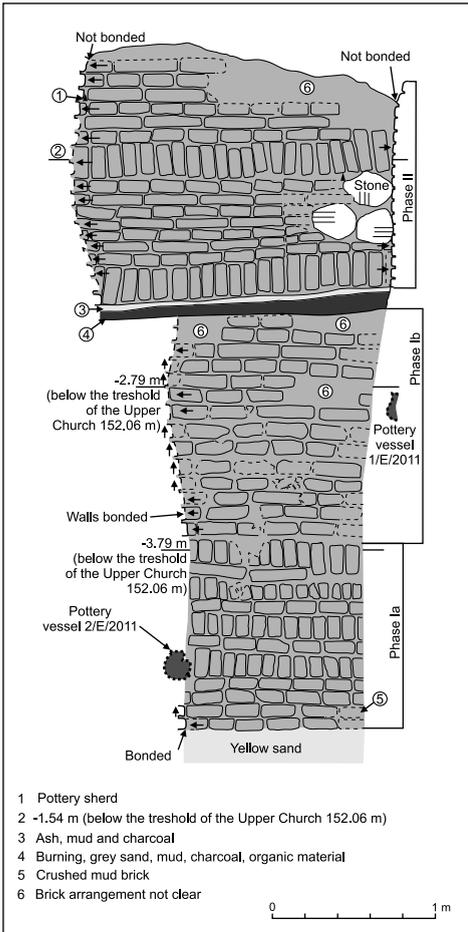
Fig. 3. Eastern tower, inside wall face (trench 6/E/2010) demonstrating tentative division into subphases Ia–Ib, II (Drawing R. Hajduga, A. Głab, M. Drzewiecki)

appeared in a successive subphase [see *Figs 3, 4*]. The presence of an interbonded cross-wall flush with what has been identified as the tower wall from subphase Ib and its absence in the section of the wall corresponding to subphase Ia corroborates this observation [see *Fig. 3*].

face of the wall from phase II [see *Fig. 7*] was recorded at 3.62 m below the benchmark (152.06 m a.s.l.) located on the threshold of the Upper Church. On the inside, this foundation stood on the ruins of the earlier structure and was found at a much higher level, at a level of approximately 2.44 m [see *Fig. 3*, phase II]. The remains of Wall II on the inside were preserved to a height of about 1.50 m; on the outside it was about 2.90 m, meaning that at the time of the construction of Wall II, there was a substantial difference in levels (about 1.17 m) between the inside of the eastern tower and the area outside the fortifications. The tower was built entirely of mud bricks sized an average 30–38 x 15–20 x 6–8 cm, laid in header–stretcher bond, interrupted in the outer face by three separate courses of bricks set on end at regular intervals of 0.60–0.70 m along the entire height of the wall [see *Fig. 5* left]. Two courses of bricks set on end were noted in the inside face of the wall [see *Fig. 3*], approximately corresponding to the level of the two lower courses of bricks set on end in the outer face.

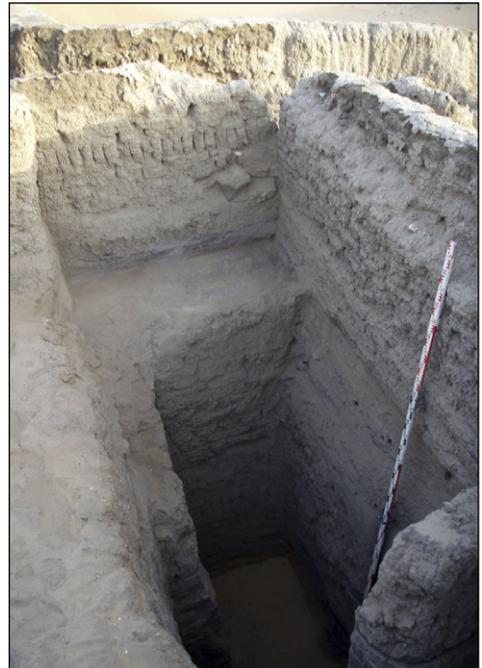
Fig. 4. Trench 6/E/2010, northwest and north-east (seen in Fig. 3) profile with level staff set against the wall face (Photo M. Drzewiecki)

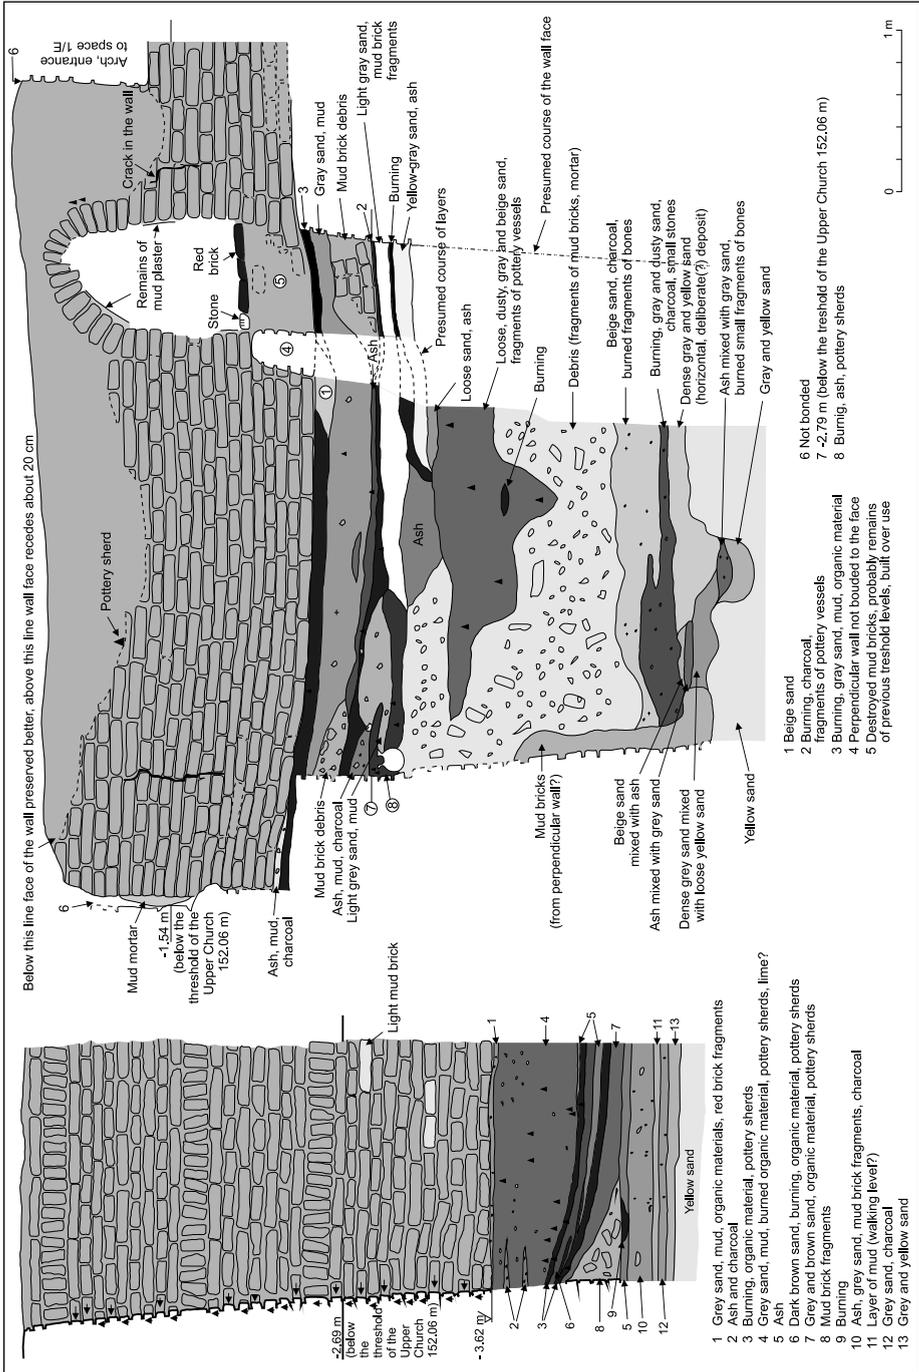
Fig. 5 Sections (in line) through the northeastern wall of trench 6/E/2010, looking northeast, and through the southwestern wall of trench 3/I/2010, looking southwest (Drawing, respectively, K. Solarska, R. Hajduga, M. Drzewiecki and M. Drzewiecki)

Settlement layers corresponding to the operation of the tower in the first phase were recorded in trenches 6/E/2010 and 3/I/2010 [Fig. 5]. No evidence of a floor,

arched entrance) may be evidence of efforts made to adapt the room to a new function. Three layers of burning were noted in the top part of the fill of this room. They covered the entire space of the interior uncovered in the trench. The uppermost layer was the thickest, exceeding 0.50 m [see *Fig. 5*]. New fortifications (Wall II) were raised directly on top of this layer.

On the exterior, layers contemporary with the early tower were 1.50 m thick [see *Fig. 5*, left]. The foundations of second-phase fortifications stood directly on top of the earlier remains. The top of a mud-brick structure was discovered approximately 0.50 m below the foundations of the second-phase wall. It was preserved to a height of about 0.45 m [see *Fig. 5*, left, layer 8]. Superimposed on it were thick layers of burning and ashes [see *Fig. 5*, left, layers 3, 5, 6]. The nature and function of this structure could not be determined. A layer of dense mud, 5–7 cm thick, was recorded at the bottom of the accumulations; it could have been a kind of tamped floor of clay [see *Fig. 5*, left, layer 11], formed when the fortifications were being constructed. Excess building material, like mud mortar, for example, could have been discarded on the ground, forming over time a hardened level that served as the first walking level around the fortifications.

the tower and by the layers of intensive burning. A layer of mud-brick rubble of considerable thickness [see *Fig. 5*] could be proof of the existence of an upper storey in the tower. Short-lived ephemeral construction in the ruins was attested by remains of cooking pots and provisional mud-brick walls. All this was heavily mixed with large quantities of ashes and burning. Evidence of destruction as well as layers of burning and ashes were noted also on the exterior side of the fortifications, where an ephemeral mud-brick structure was constructed as well [see *Figs 5* left, legend descriptions 3, 5, 6, 8].

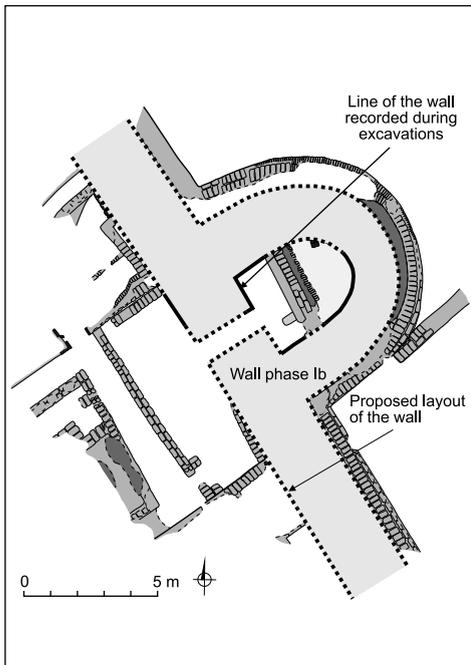
Fig. 6. Proposed line of the fortifications in the area of the eastern tower from wall phase Ib, based on currently available evidence (Drawing M. Drzewiecki)

only place where the division of the first-phase structure into subphases (Ia and Ib) was observed. The structure from this period was semi-elliptical in plan, roughly 7.60 m across (phase Ib) and projecting about 5.50 m from the face of the circuit wall [Fig. 6]. Wall thickness ranged from 1.70 to 2.50 m. The interior inside the tower followed the shape of a semi-ellipse, measuring approximately 4.00 m by 3.30 m. A fragment of the entrance to this chamber was excavated in trench 6/E/2010 but without any clue as to the kind of vault.

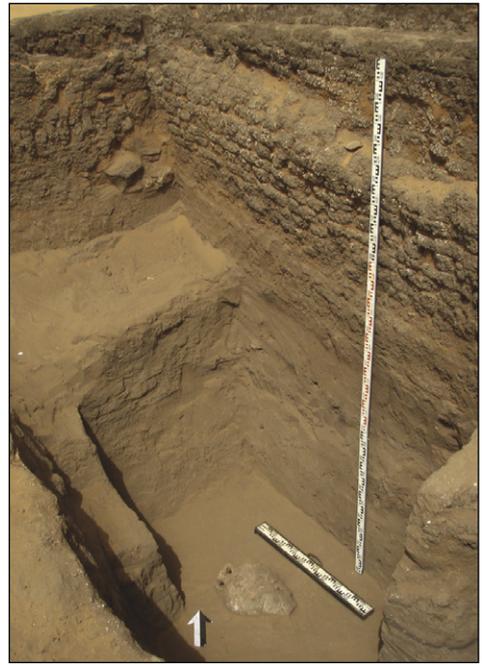
Fig. 7. Amphora (Inv. No. 65/2010) lying at the bottom of trench 6/E/2010 inside the eastern tower, below a level of debris (Photo M. Drzewiecki)

whether of clay or masonry, were noted inside the tower. A handmade, cooking pot (Inv. No. 2/E/2011) was noted next to the wall of phase Ia. A cracked but complete amphora lay on its side at the bottom of the fill [Fig. 7], under a layer of mud-brick rubble. Rubble filled the interior of this unit up to about half its height, that is, about 2.80 m below the benchmark. Superimposed on the rubble backfill were layers indicating reuse of the ruins [see Fig. 5 right]. A cooking pot (Inv. No. 1/E/2011, see Fig. 3 and Fig. 5, right) found on the remains of a hearth, could suggest the absence of roofing at this time. The ephemeral mud-brick structure (see Fig. 5, mud-brick debris below the

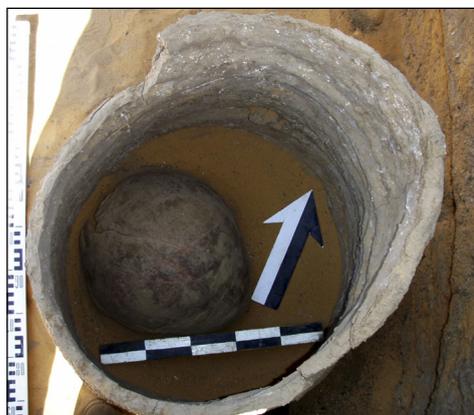
Fig. 8. Geseba container with another pot (Inv. No. 19/2010) inside it, found in the fill of the eastern tower chamber from the second phase (Photo M. Drzewiecki)

The remains of an unbaked clay container of the *geseba* type were recorded inside the chamber, standing directly against the chamber wall below the springing of the vault. In order for it to have been used, it would need some space above it for pouring in and taking out grain. Its position right below the spring of the vault in this chamber suggests that the vault had already collapsed by the time that it was placed in position. Another pot, this time fired, was found inside the *geseba*, presumably reused in this location [*Fig. 8*]. Seeds (to be examined by a specialist) were recorded in the fill inside the *geseba*.

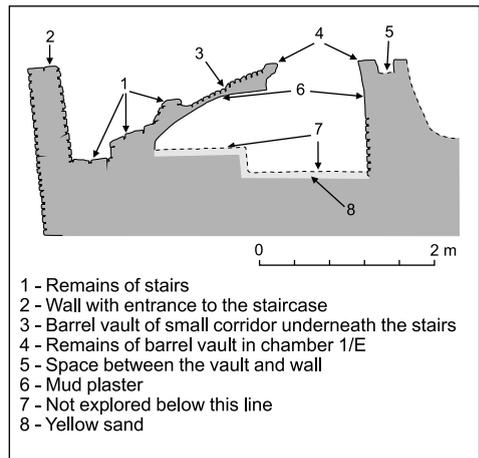
Fig. 9. Section through the staircase (marked AB in Fig. 1) (Drawing M. Drzewiecki)

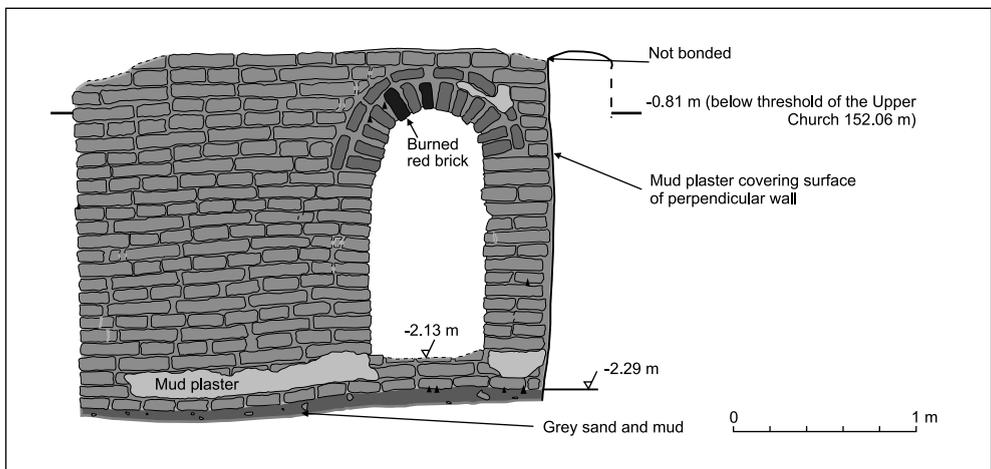
Fig. 10. Entrance to the staircase in the courtyard of the eastern tower (Drawing M. Drzewiecki)

had been rebuilt. Once the northeastern and southeastern walls of the courtyard had been constructed and rendered with mud plaster, the staircase was built. The entrance to the staircase was about 0.60 m wide and about 1.30 m high [Fig. 10]. The arch above it was built of red brick. Entering the courtyard one had to move left to reach the staircase; opposite the entrance there was a small niche [see Fig. 1]. The slant of the stairs depended on the height of the rooms under them [Fig. 9], comprising a dead-end corridor with oblique barrel vault and unit 1/E, also covered with a barrel vault. Chamber 1/E was connected with courtyard 2/E [see Figs 1, 11]. The fill of this small room yielded intensive evidence of fire in the form of a layer of ashes and organic matter. The walls bore traces of destruction and sooting due to the proximity of fire. Handmade pots blackened with soot found in the fill must have been used for cooking food. The blind corridor was entered from chamber 1/E, but

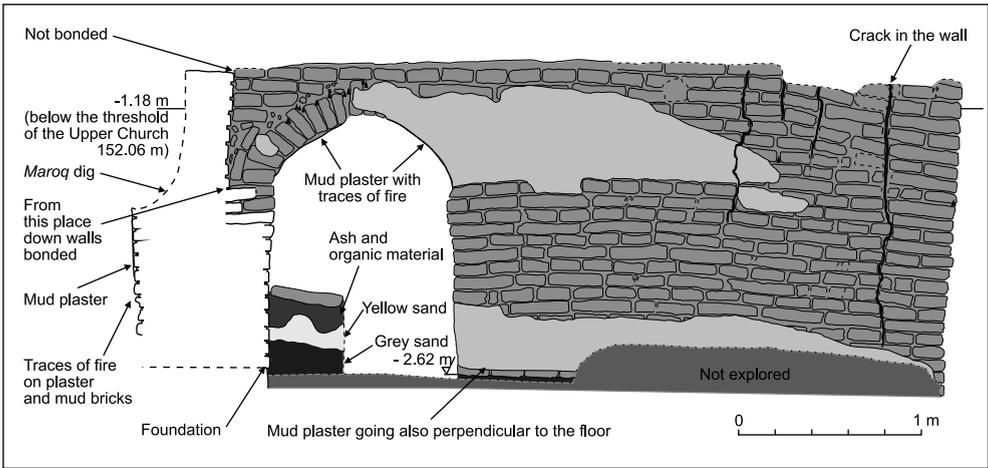
Fig. 11. Entrance to small chamber 1/E in the eastern tower
(Drawing M. Drzewiecki)

Figs 3, 4, 7]. With time the walls started to sink, resulting in cracks and fissures [see *Figs 5, 11*]. The reason for this was that the structure was raised partly on the remains of the first-phase fortification wall and partly on non-architectural layers. The effects of this process were well observed on the wall separating the chamber inside the tower from the courtyard [see *Fig. 5*]. They were also the reason for closing work in trenches 7/E/2010 and 8/E/2010, because stress caused by the exploration

The courtyard was filled with humus. No unambiguous traces of a clay level or floor could be found in the courtyard. The only place is the outer staircase wall where, in the foundation courses, the mud render appeared to run at right angle from the wall, for about 2–3 cm, as if there was a usage level in the courtyard at this time [see *Fig. 11*].

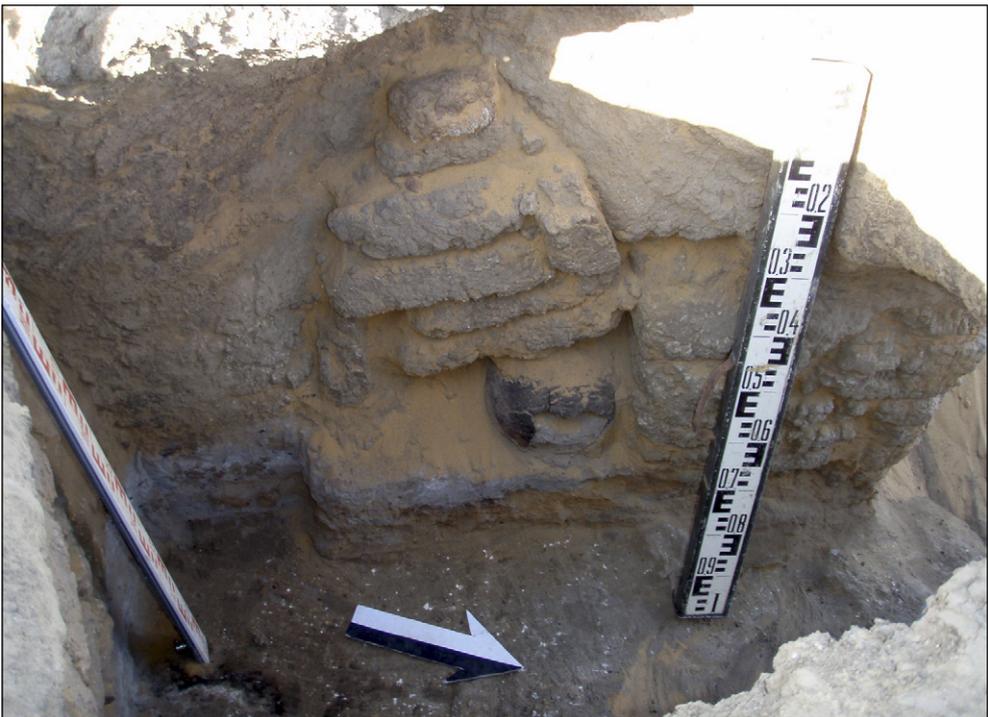
Fig. 12. Small chamber 1/E, blocked entrance to the corridor under the staircase
(Photo M. Drzewiecki)

the doorway was found blocked with a cooking vessel at the bottom and mud bricks above it [Fig. 12].
