Hippos (Sussita) : exploration of the North-West church complex (areas NWC and OPB) in 2002

**HIPPOS (SUSSITA): EXPLORATION OF THE NORTH-WEST CHURCH COMPLEX
(AREAS NWC AND OPB) IN 2002
(PL. 26-34)**

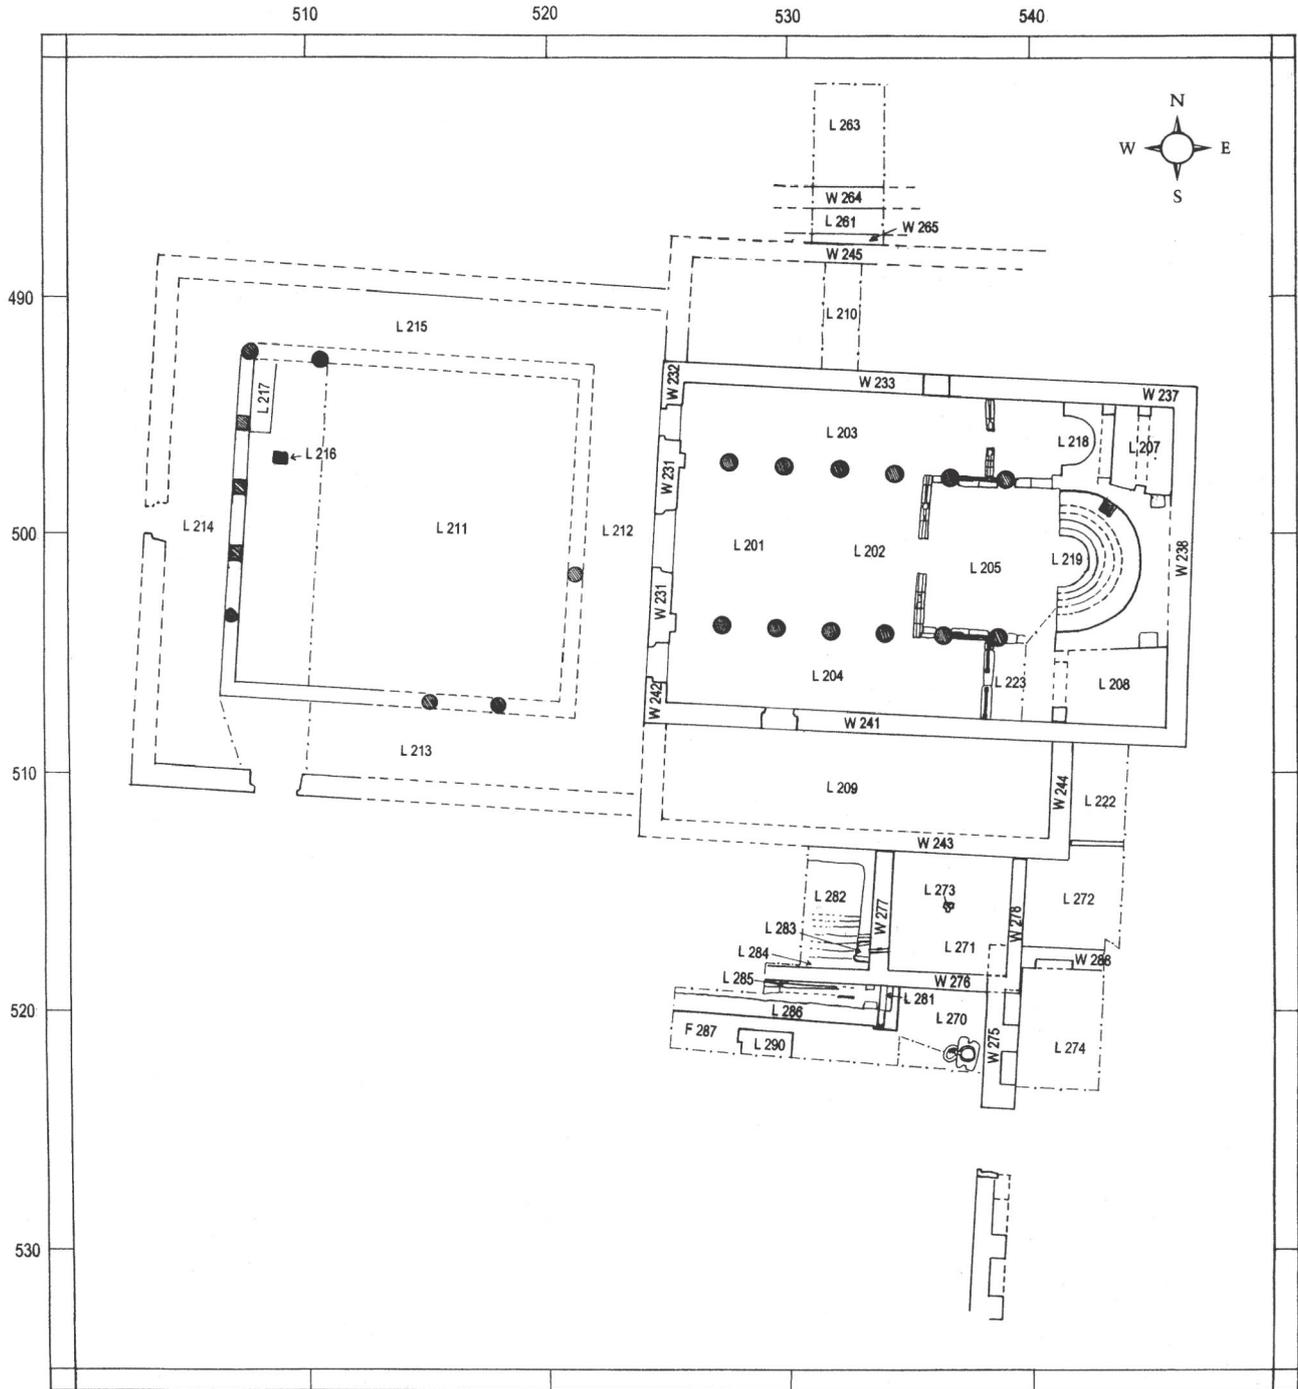
Fig. 1. Hippos (Sussita) 2002. Schematic plan of the North-western Church and its surroundings with numbering of walls and loci (drawn by M. Burdajewicz)

The exploration of this room was stopped at *ca.* 40 cm above the floor level and will be resumed in the next season. However, no indication of the existence of an apse that would close the southern aisle and correspond to the northern lateral apse (Loc. 218) has been found so far (Fig. 1). It is to be noted that such an asymmetrical arrangement during the second architectural phase of the church, with only one lateral (northern) apse, would be quite an unusual solution¹².

To the east of the winery's treading floor (Loc. 271) and of the oil press room (Loc. 270), the north-east part of an earlier room has been exposed (Loc. 274) (Fig. 1). It is limited by W 275 and W 288, both walls built of dressed basalt stones and constituting the corner

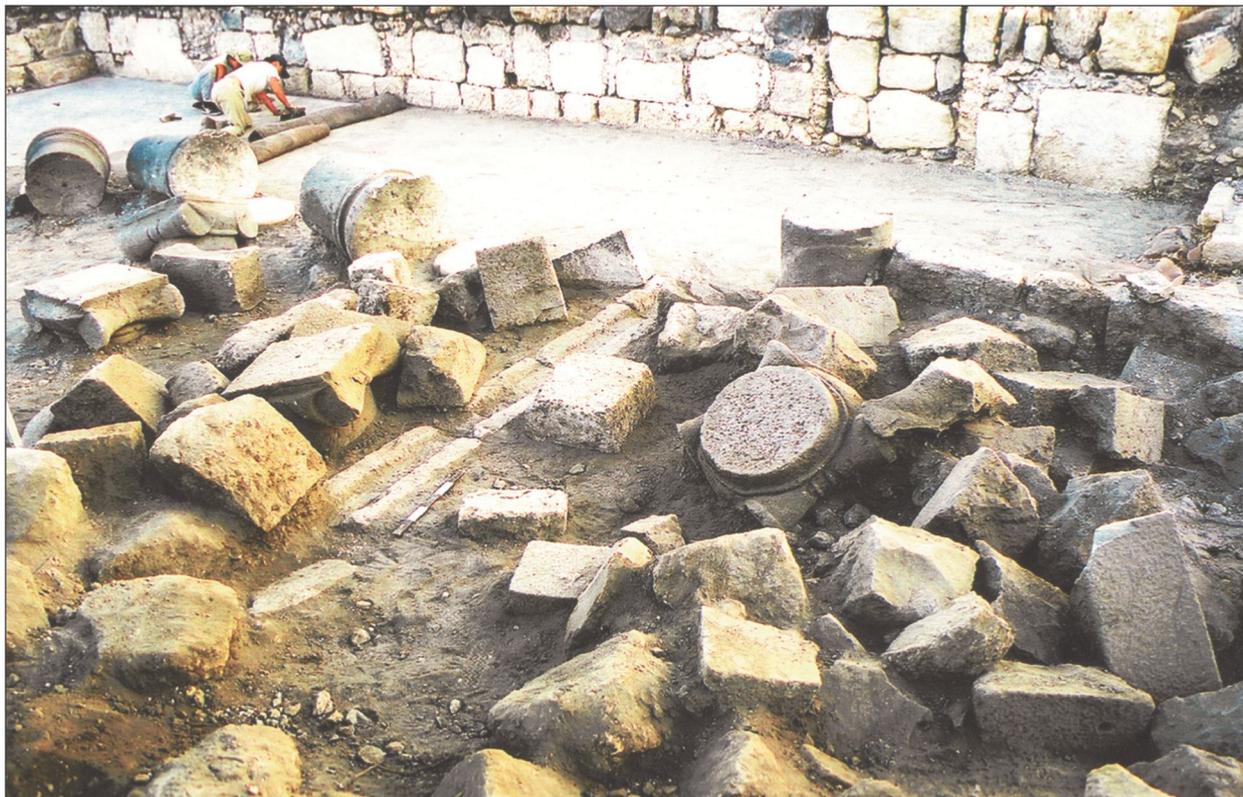
Fig. 2. NWC: Earthquake debris in the nave and chancel area seen from south-east. Note the base of a robbed-out western balustrade of the chancel (phot. J. Burdajewicz)

Similarly to what had been noted in the westernmost part of the church's nave (Loc. 201) during the 2000 season, also the remainder of the nave (Loc. 202), explored in 2002, was covered by earthquake debris consisting of basalt blocks, column drums and Ionic capitals (Fig. 2). Of the mosaic floor, once adorned with a network of rosettes and buds³ and framed by a rich quadriplaited guilloché⁴, only patches remain here and there (Fig. 3). The chancel area or *bema* (Loc. 205) which projects up to the middle of the fifth intercolumniation (counting from the west) was no less damaged. In several places the mosaic floor and its lime mortar bed were destroyed, exposing the substructure of small pieces of limestone. The only sculptured decoration (except for column fragments) were scattered pieces of entablature moulding of white marble with dentils, ovolo and astragal frieze, most probably of secondary use in the church. Not a single piece of chancel screens and/or posts has survived; only the chancel's limestone base was left in place (Fig. 2). The number of post-holes and slots in it indicates that on each side of the entrance (which is 1.40 m wide) there were two screens alternating with three posts.

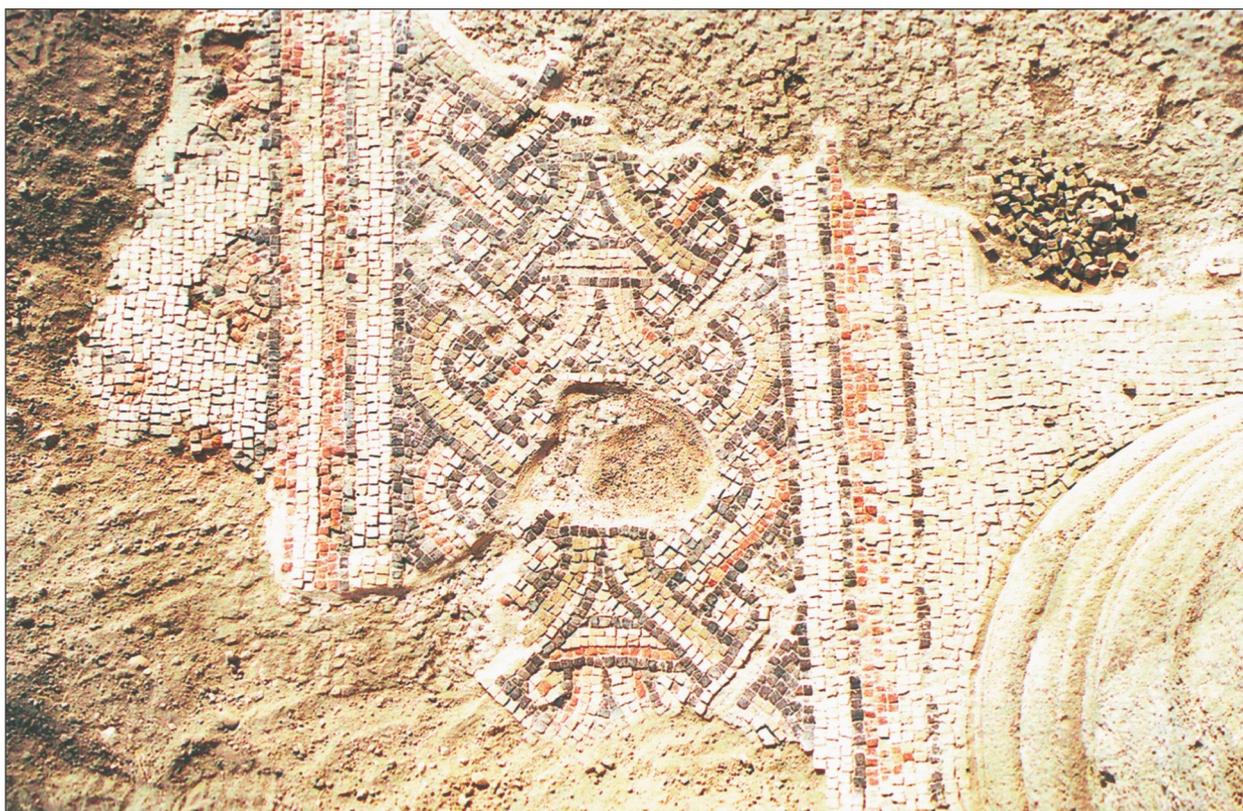
Fig. 3. NWC: Mosaic border of the nave (phot. J. Burdajewicz)

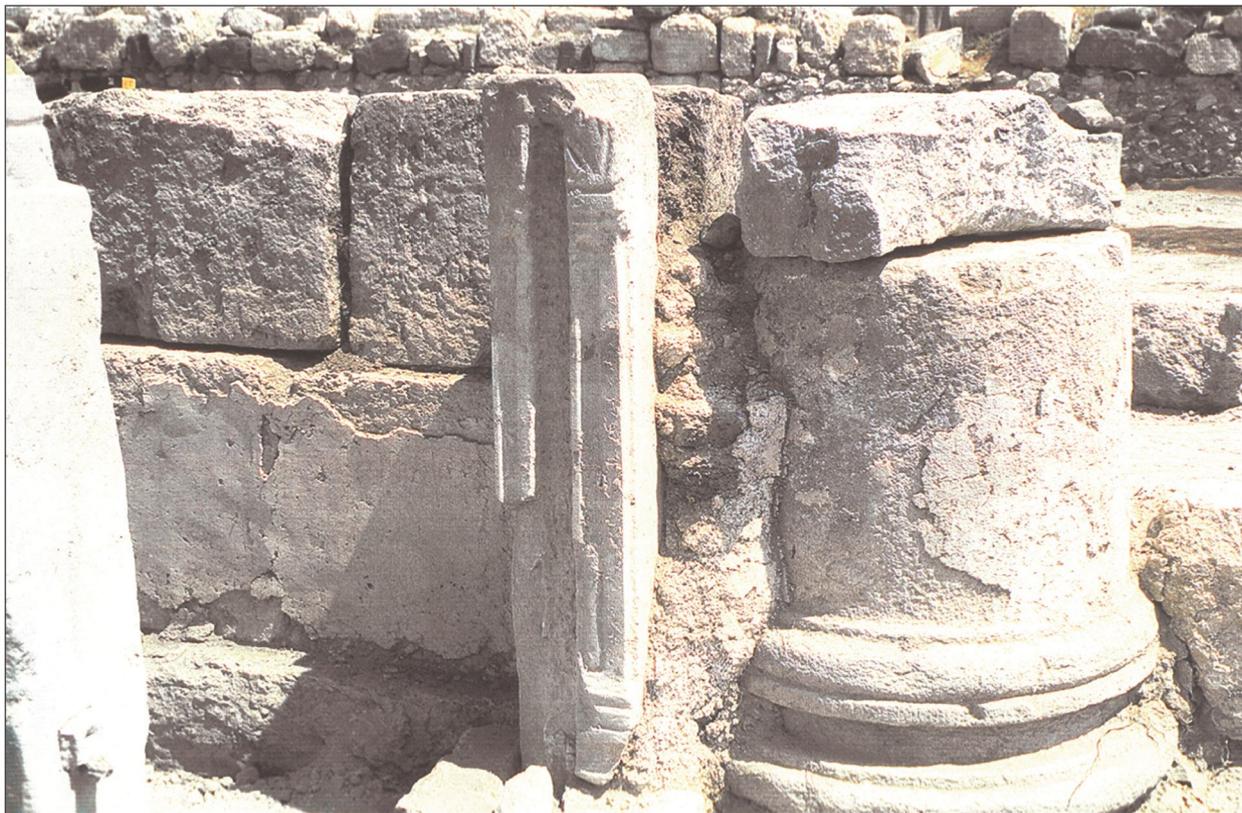
Fig. 4. NWC: The southern wall of the main chancel seen behind the marble chancel posts of the southern aisle, with column 33 to the right (phot. J. Młynarczyk)

The outer chancel posts, their height (92 cm) hardly exceeding that of the screens (90 cm), are reused small pillars with vertical flutings on one face and stylized acanthus capitals (**Fig. 4**); they could originally have belonged to some earlier balustrade. The inner monolithic posts, on the contrary, were considerably higher and of a different form. Their upper parts, from slightly above the level of the top of the screens, were shaped as colonnettes with moulded bases and „Corinthian” capitals. Together with a horizontal bar (of wood?) which they used to support, they formed a sort of gate, its total height amounting to 2 m (18 cm for the chancel base and 182 cm for the inner post-colonnettes) above the level of the mosaic floor (**Fig. 9**). The broken colonnettes were found in the debris with small votive crosses made of silver still affixed to their shafts with bronze pegs: three crosses (and holes to mount the fourth one) on the southern colonnette, two crosses (plus holes for a third) on the northern colonnette. The opening between the inner posts is *ca.* 63 cm wide. From their eastern faces there protrude iron rings fixed to lead pegs and destined to hold a low wooden door: two rings for hinges in the southern post and one for a hook in the northern post.

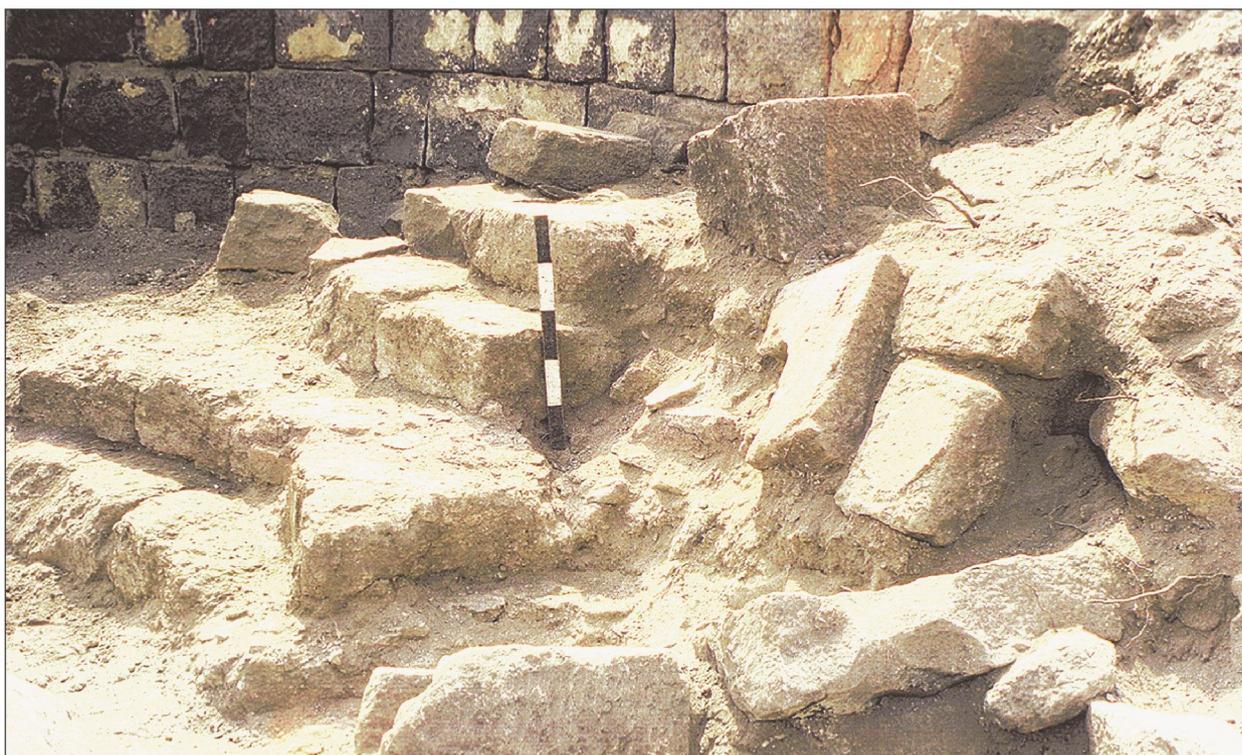
Fig. 5. NWC: The southern half of the synthronon in the central apse, its western end broken by collapsed blocks (phot. J. Młynarczyk)

In the main apse, the cleaning of the *synthronon* (Loc. 206) has been completed. The southern half has preserved four rows of limestone seats instead of the three present in the northern half. The benches, revetted with white plaster, surround a semicircular platform (110 cm in diameter) at floor level. The south-west end of the *synthronon* was entirely destroyed by a collapsing wall during an earthquake (Fig. 5).

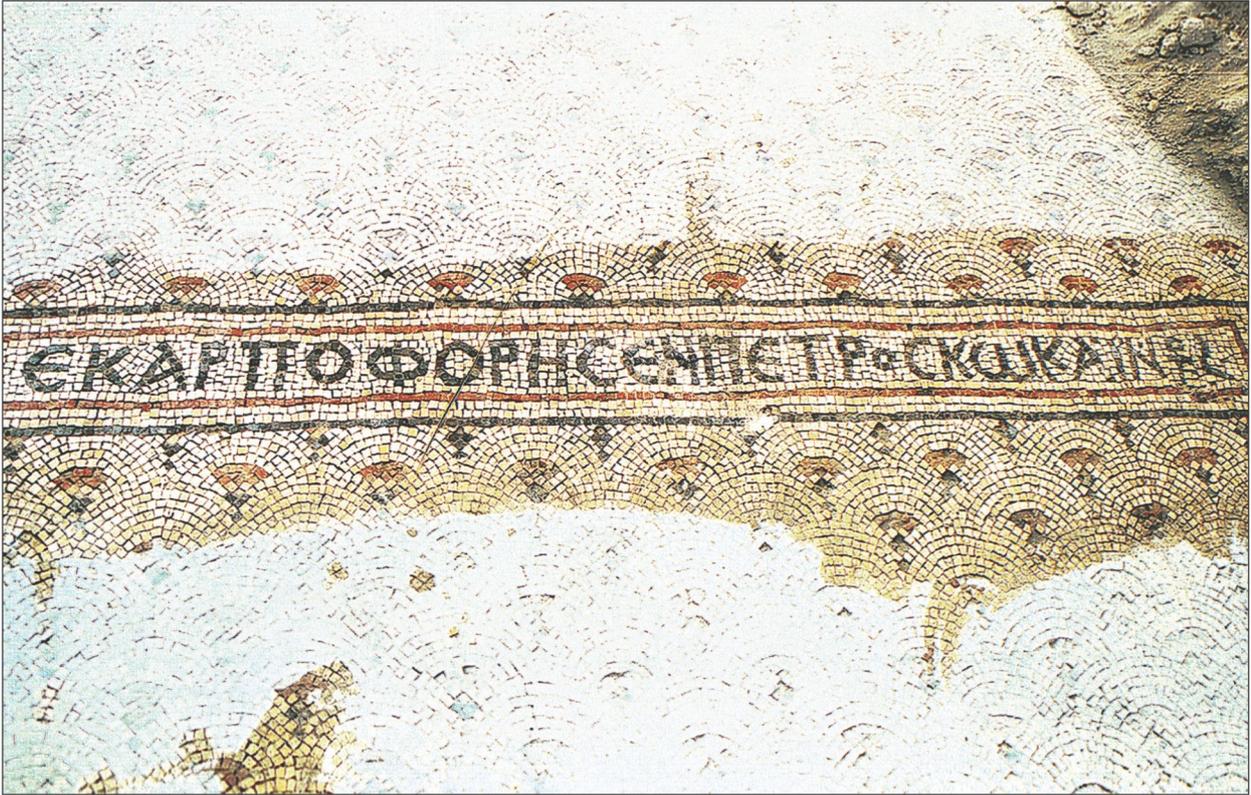
Fig. 6. NWC: Mosaic inscription in the southern aisle commemorating an offering made by Petros (phot. J. Burdajewicz)

The floor of this aisle contains also two mosaic inscriptions in Greek⁸. They sound rather similar, commemorating donations made by two individuals, doubtlessly members of the local community. A one-line inscription in a *tabula ansata*, extending across the aisle even with the fifth intercolumniation and facing west, commemorates an offering made by Petros (**Fig. 6**). Another inscription, also written in one line and mentioning a woman by the name of Hedora or perhaps He(lio)dora, is even more interesting for its location: it was placed at the inner edge of the aisle, in front of the third intercolumniation, but facing the nave, not the aisle.

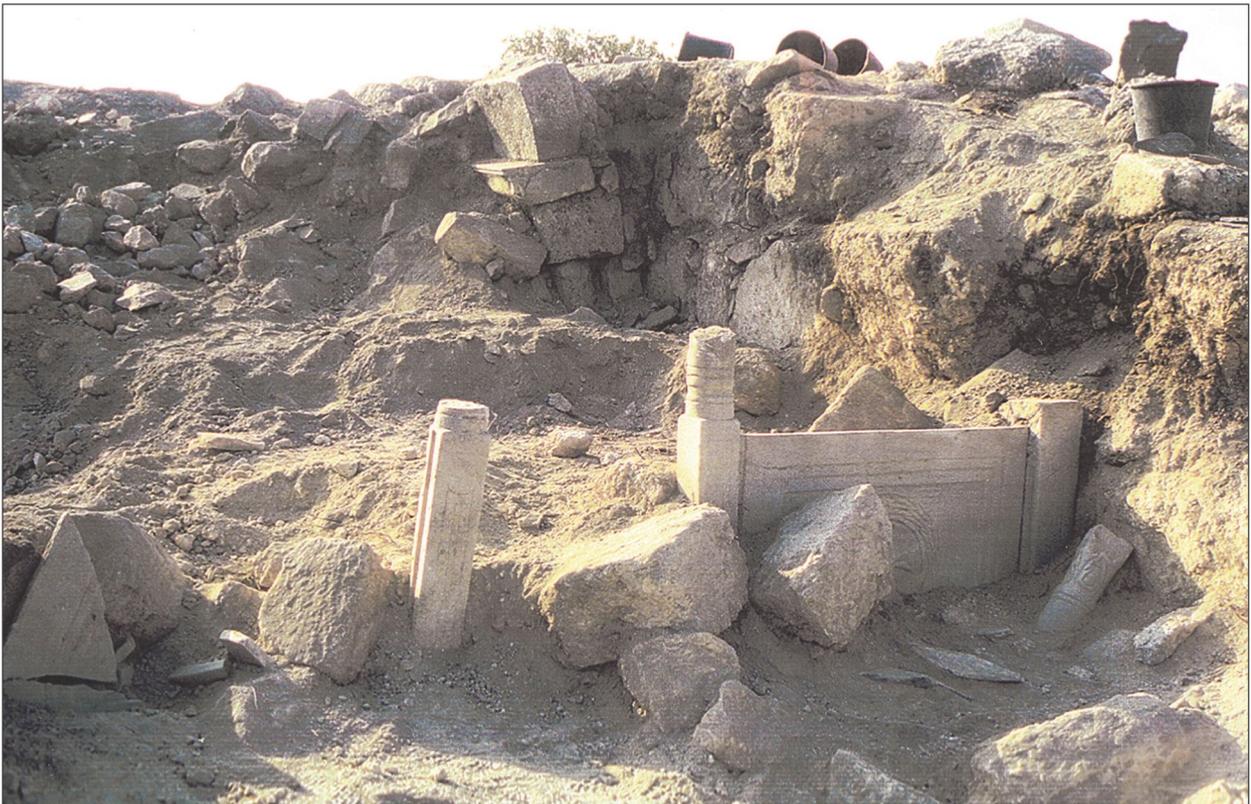
Fig. 7. NWC: The lateral chancel of the southern aisle with the posts and one of the screens still *in situ*, seen from the west. Note a pier supporting the arch of the entrance to the southern sacristy (phot. J. Młynarczyk)

The northern chancel screen was found broken into several pieces by stones fallen from the southern wall (**Fig. 7**). The western face of the screen is adorned with a „Maltese” cross in a wreath, differing from the other screen only in that the cross arms are not grooved and the wreath lacks a ring inside (**Fig. 9**). The back of the screen was left undecorated.

The eastern limit of Loc. 223 is marked by an engaged pier built against W 241, preserving the spring of an entrance arch to Loc. 208 (Fig. 7). The pier is crowned by a basalt corbel reused from an earlier building. Two more basalt blocks moulded with cavetto, dentils and ovolo were found in the debris, their sculptured decoration thickly covered with red plaster by the Byzantine masons (Fig. 11). Unlike the corresponding northern part of the church (Locs 218 and 207), direct communication between the southern chancel (Loc. 223) and the southern sacristy (Loc. 208) was apparently maintained until the last days of the church's existence.

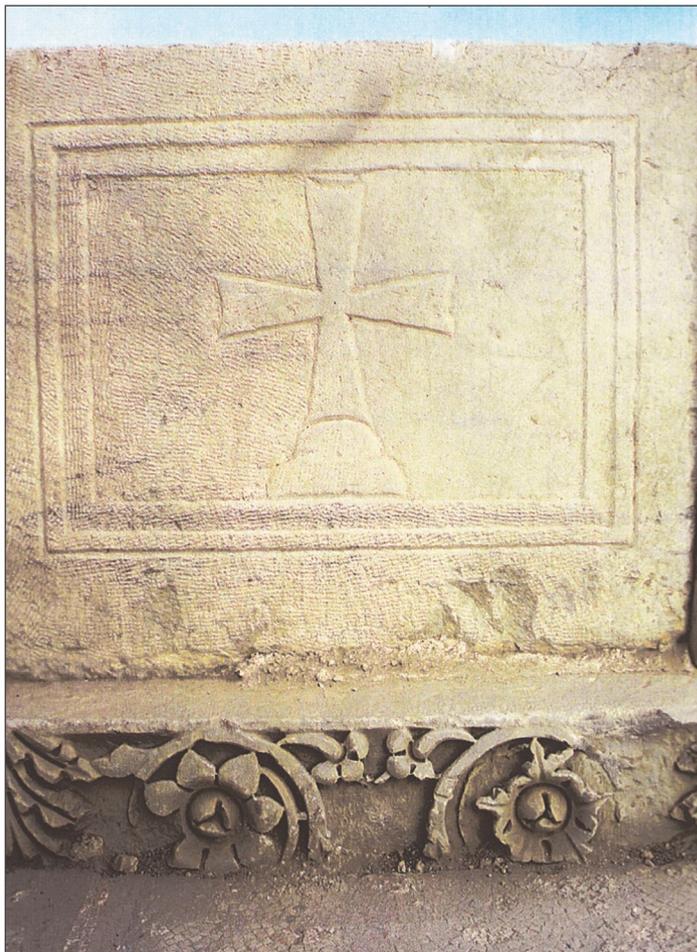
Fig. 8. NWC, Loc. 223: The southern screen of the lateral chancel with its base re-used from a Roman building, seen from the east (phot. J. Burdajewicz)

In a place even with the sixth column (no. 33), the aisle is closed by the marble balustrade of a lateral chancel (**Figs. 7-9**). It consists of two screens and four posts fixed to their base by pieces of lead. The base is made of marble blocks which originally belonged to a monumental building of Roman date (2nd century A.D.?), to judge by the remains of relief decoration on the eastern faces of the two long blocks. Of these, the southern one still preserves a deeply drilled ornament of acanthus scrolls with flowers (**Fig. 8**). The southern chancel screen was found standing *in situ* between two posts (**Fig. 7**). Its western face has a „Maltese” cross with grooved arms inside a simple ring and a bound laurel-leaf wreath below (**Fig. 9**). The screen's eastern face bears a similar cross (its arms, however, left ungrooved) surmounting the tripartite Golgotha mound (**Fig. 8**)⁹.

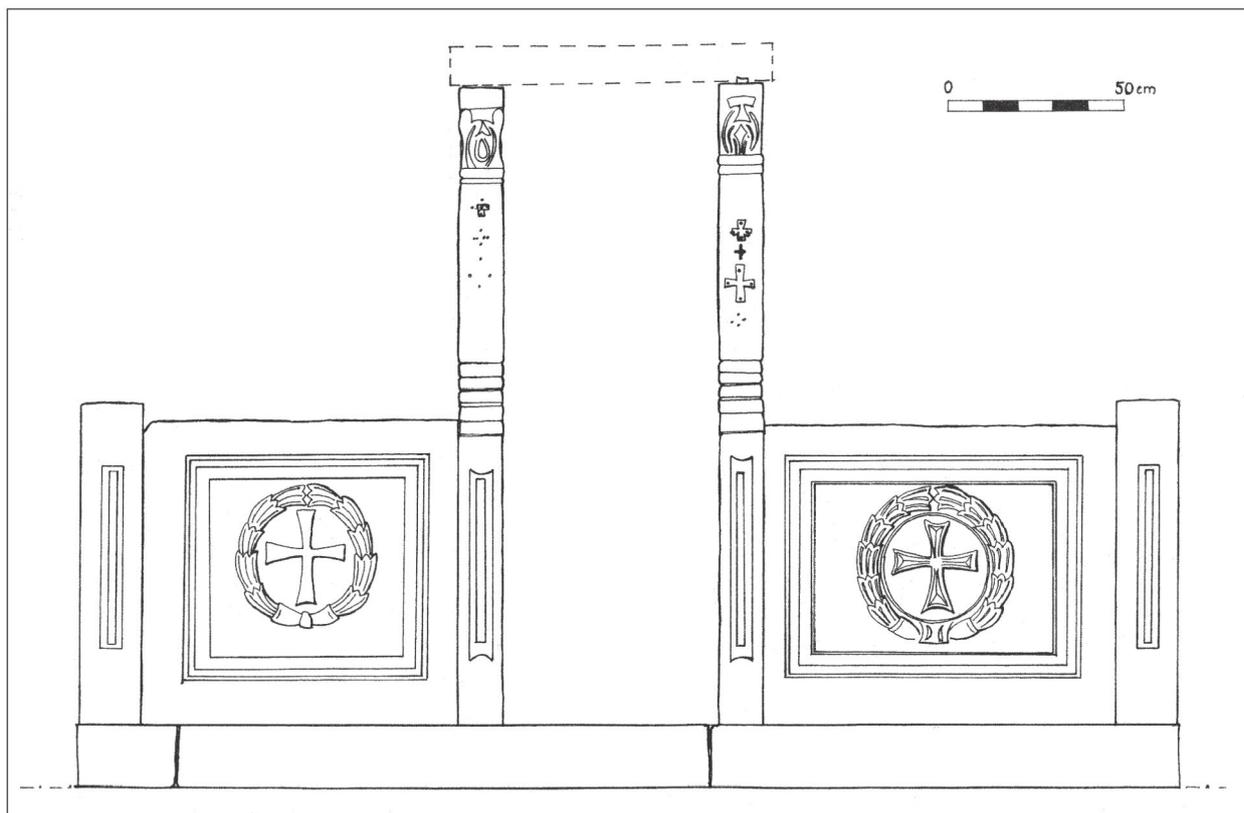
Fig. 9. NWC: Reconstruction of the southern chancel as seen from the west (drawn by M. Burdajewicz)

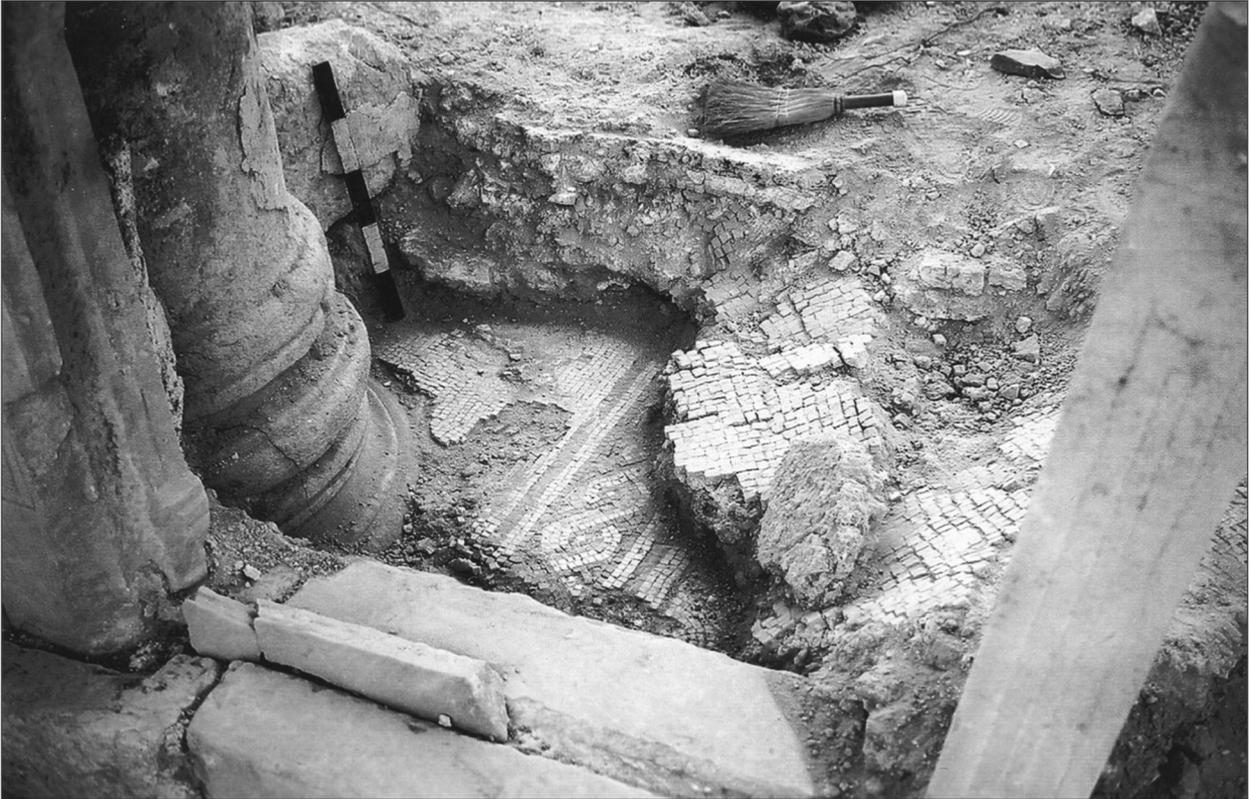
Fig. 10. NWC: Pieces of monochrome mosaic floor (lying upside down in the background) fallen from an upper storey onto the decorated floor of Loc. 223; seen from the east (phot. J. Burdajewicz)

On the eastern side of the chancel (Loc. 223), the mosaic floor continues eastwards with the same pattern as in Loc. 204. However, only a small section of it, right behind the chancel screen, could be explored during the 2002 season. At *ca.* 20 cm to 40 cm above this floor, large portions of monochrome mosaic from the upper storey were found, some of them fallen upside down (**Fig. 10**). The gallery floor, its total thickness amounting to 8.7-9 cm, consisted of three layers. The mosaic cubes (1.4 cm thick) were embedded in a layer of fine white plaster (3.5 cm thick), the latter resting upon a thick layer (3.5 to 3.8 cm) of lime mortar. Mixed with this mortar base there are chips of coloured stones (refuse of mosaic *tesserae*), pebbles and burnt pieces of reeds up to 4 cm of length and 0.5 cm in diameter.

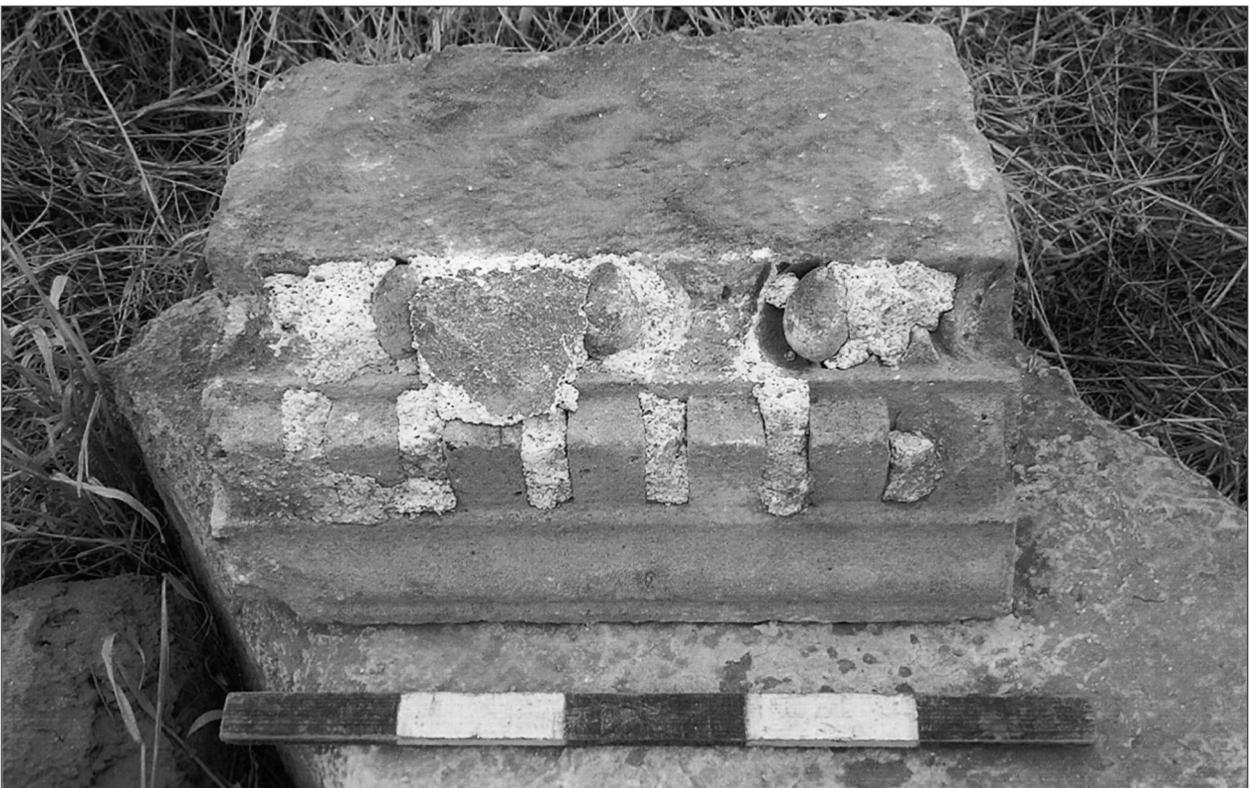
Fig. 11. NWC: Cornice block of basalt coming from a Roman building, re-used in the church (phot. M. Burdajewicz)

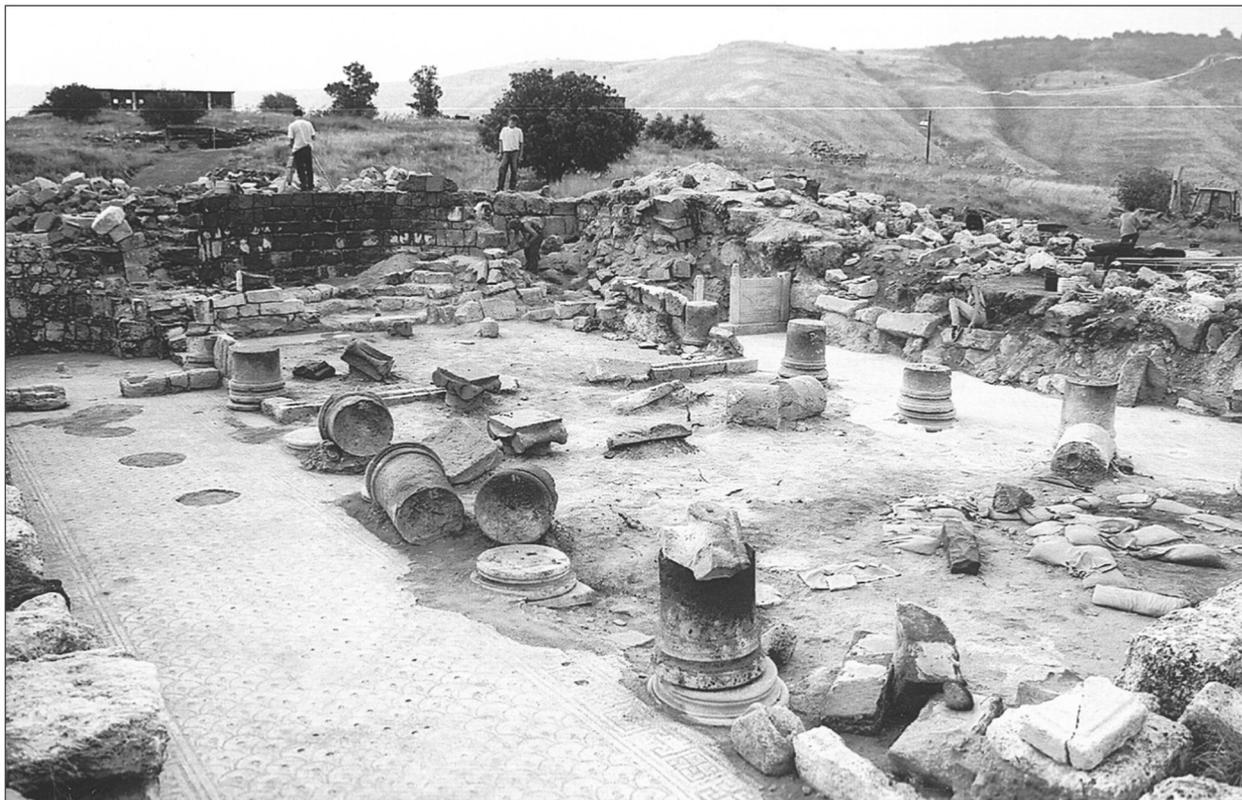
Fig. 12. NWC: The basilica as seen from the north-west (phot. J. Burdajewicz)

The final arrangement of the church is marked by the extension of the chancel area into the eastern parts of the aisles (Fig. 1, 12). The installation of the screens and posts with their base inserted into the mosaic floor is

The last years of the existence of the church are a mystery of sorts. If one takes into consideration the striking contrast between the nave completely stripped off its furniture and the well-preserved aisles (Fig. 12), one is inclined to believe that after the nave was abandoned (as a result of some destruction and lack of resources to have it restored), the aisles still continued to be used for religious service. It is perhaps noteworthy that the marble balustrade in the southern aisle survived unplundered, unlike the northern aisle which seemed to witness some removal and secondary storing of its marble furniture. To properly interpret these observations, however, more fieldwork is needed. The destruction deposit of the southern aisle yielded a complete terracotta lamp of an Umayyad-period type, actually identical to a lamp found in the northern aisle, in a closely matching spot: in front of the balustrade¹⁹. These lamps certainly date back to shortly before the final destruction of the church (and the entire town of Hippos) in the earthquake of A.D. 749²⁰.

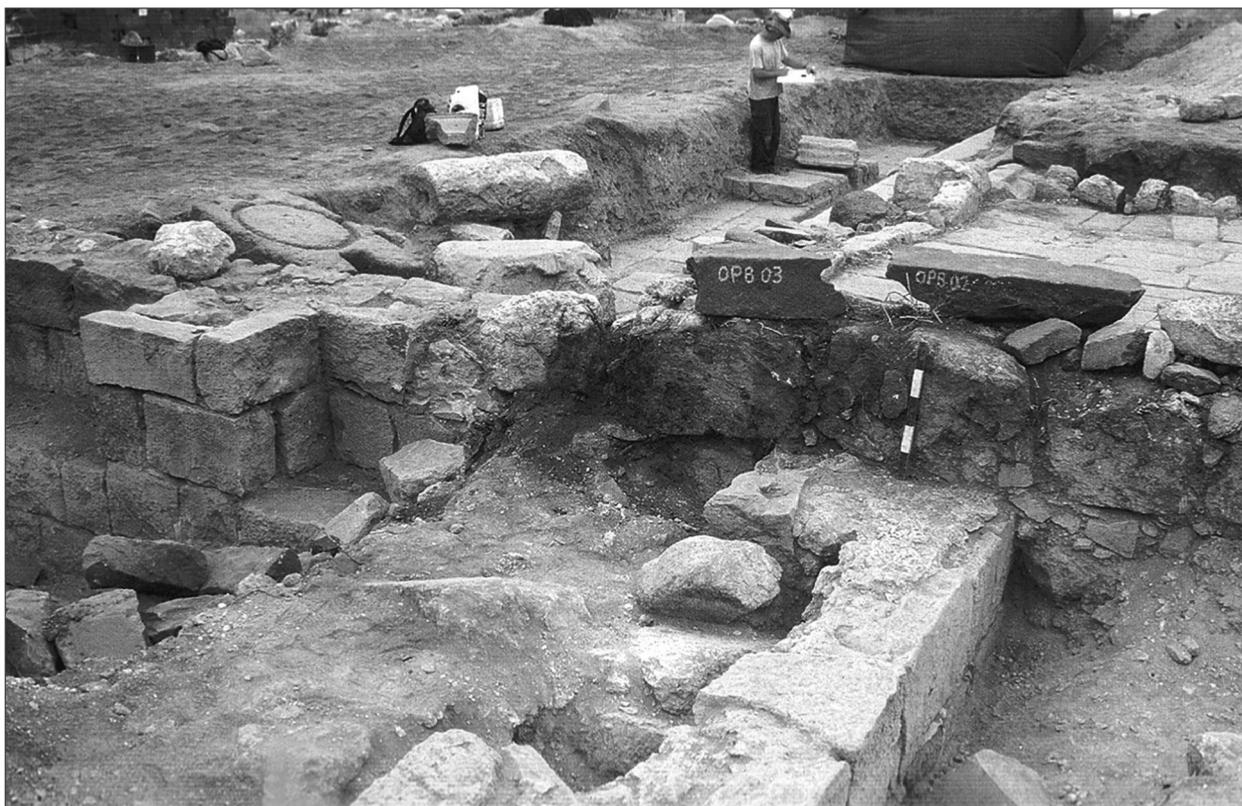
Fig. 13. OPB: Loc. 274 seen from the east, with an oil/wine press in the background. Note niches in the southern face of W 288 (foreground) and in the eastern face of W 275 (to the left) (phot. J. Młynarczyk)

of a building which antedates the installation of the oil/wine press (Fig. 13). Loc. 274 was filled with dense debris of big blocks of *nari* limestone, as well as some basalt ones. The uncovered stretch of W 275 has two niches (each 1.50 m long and 0.70 m wide) on its eastern side, the floor of the southern niche revetted with a layer of ochre-coloured clay. The exploration of Loc. 274 was stopped at ca. 0.55 m below the floor of the niche; the dense limestone debris, however, continues downward. The excavation will be resumed in 2003, the objective being to find the floor of the room.

The northern limit of Loc. 274 is W 288 (Fig. 13), ca. 0.90 m thick, which apparently meets W 275 under the treading floor of the wine press. W 288 has remains of white plaster both on its northern face and in a rectangular recess on its southern side, which is 1.50 m long like niches on the eastern side of W 275, but only 0.40 m wide²¹. The eastern wall of the winery's treading floor (W 278) crosses W 288 from above and stops at the corner of the treading floor without continuing southwards.

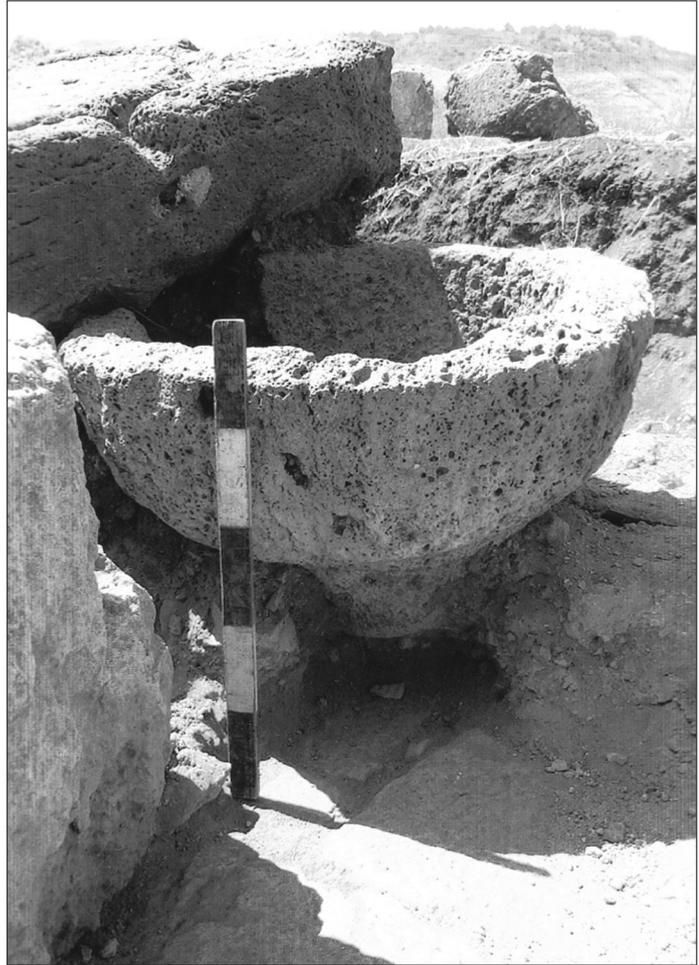
Fig. 14. OPB: An oil-pressing bed and the collecting vat seen from the north, with two floor levels (phot. M. Burdajewicz)

In Loc. 270, the exploration of which begun in 2001²², cleaning was resumed of the southern and western borders of the square. Two successive floors have been noted in this area. The upper one (F 279), only ca. 0.30 m below the present ground level and sloping slightly eastward, is made of tamped earth mixed with bits of lime mortar and limestone chips. The lower floor (F 280), found ca. 0.40 to 0.20 m below the upper one, is a pavement of basalt slabs, some of them irregular in shape. These floors apparently correspond to two phases of use of the oil pressing installation consisting of a pressing bed of basalt and a collecting vat carved of limestone in the shape of a footed chalice (Fig. 14). A limestone column shaft, lying upon the upper (earthen) floor and perhaps used for crushing olives, pertains to the second phase only. However, even the lower floor (F 280) is secondary in relation to W 275; actually, it forms a sort of a pathway on a N-S axis, just 2.50 m wide, separated from the western face of W 275 by a narrow unpaved space. The Corinthian capital of a huge limestone half-column, badly weathered but apparently corresponding to Type I of Hellenistic Alexandrian capitals²³, was found on this pavement; it was probably re-used as part of the oil press installations.

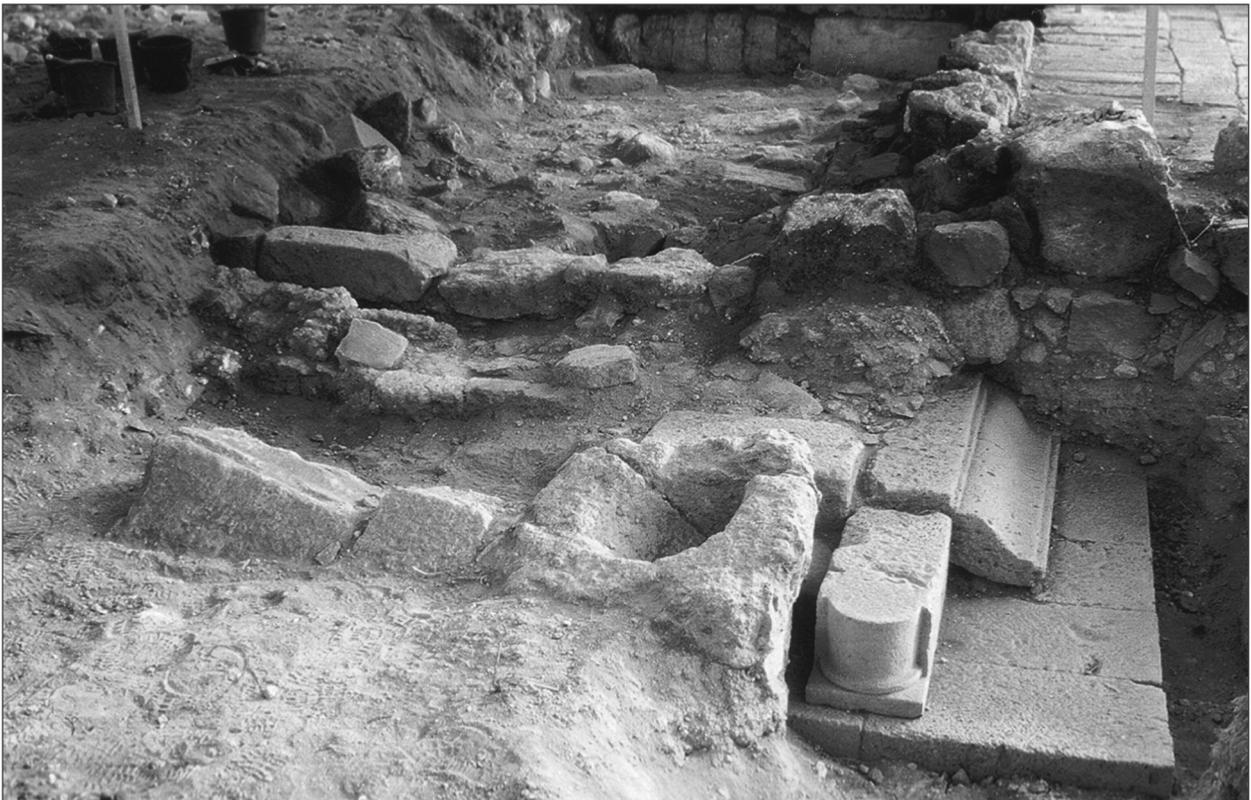
Fig. 15. OPB: The eastern anta of the Basalt Roman Building as seen from the south, with a limestone basin of the Byzantine/Umayyad industrial installations and the winery's treading floor at right in the background (phot. M. Burdajewicz)

A stretch of unpaved space *ca.* 0.50 m wide and free of stone debris divides F 280 from the eastern side of the podium of the Basalt Roman Building (Loc. 281) (Fig. 15-16). The podium's east wall, across which the southern wall of the winery (W 276) has been constructed (Fig. 15), consists of a row of moulded blocks (*cyma recta* mouldings) set on a low protruding platform built of ashlar. At its southern extremity, this layer of mouldings abuts onto an *anta* which ends in a slender engaged column.

To the north of Loc. 285 and of W 276, the installations of the winery were examined (Fig. 15, 17). The low western wall of the treading floor Loc. 270, built of irregular basalt stones (W 277), has been destroyed almost completely, exposing at its bottom a row of three limestone blocks, each 1.20-1.30 m long, possibly the wall of an earlier building(?). Adjacent from the west and abutting the southern wall of the church there is a very large collecting pool for the must (Loc. 282). Its length matches that of the treading floor (*ca.* 4.50 m); the width is not known yet; the depth from rim to bottom is *ca.* 1.40 m. The rim of the pool is situated 1.00 m below the level of the treading floor and forms a sort of a shelf *ca.* 0.55 m wide on the north and 0.30 m on the east. At the level of this shelf, near the southern end of W 277, there sits a small intermediary vat (Loc. 283), semicircular in outline (0.50 m wide), provided with plastered side walls and open at the front. It used to receive juice from the grapes trampled by foot on the treading floor to which it was connected by an open drain made of an inverted imbrex. On the northern side of the vat there is a carefully constructed outlet of a vaulted channel leading from below the centre of the treading floor where the pressing apparatus used to be installed. From this outlet, a plastered gutter sloping across the pool's rim directed the juice into the pool (Fig. 17).

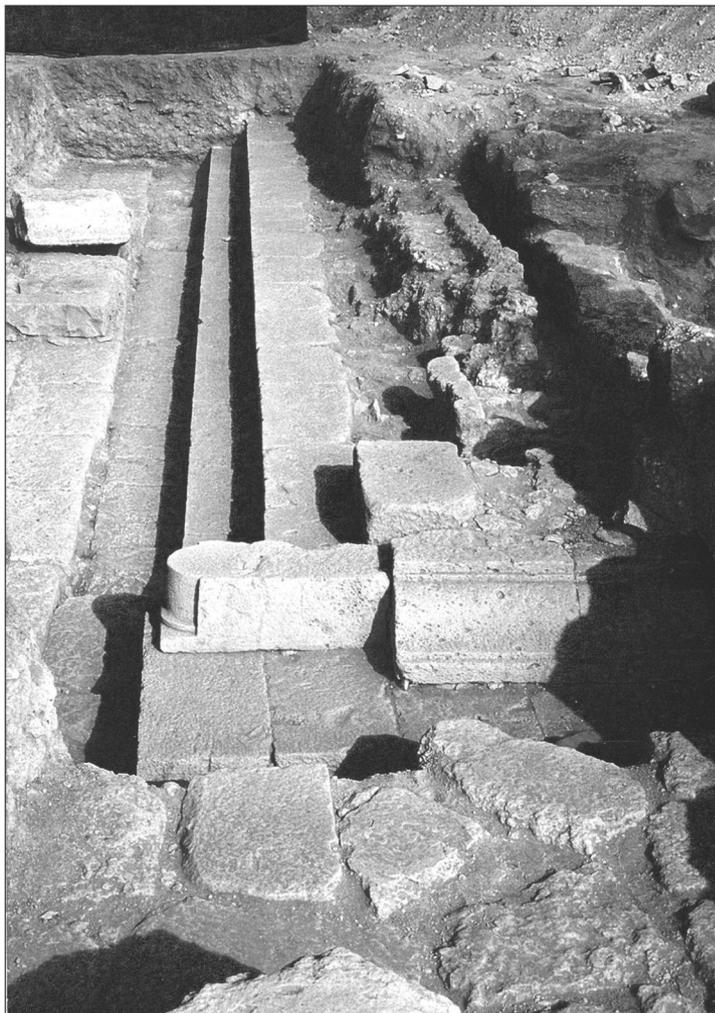
Fig. 16. OPB: The podium front of the Basalt Roman Building as seen from the east (phot. J. Młynarczyk)

The front of the podium (Loc. 286) is facing south and consists of two long steps with a single dressed block on top of the easternmost part, apparently relics of third, uppermost step (Fig. 16). The steps were comprised in between two *antae* of which the western one remains to be found, but it is already clear that the distance between them exceeds 8.5 m. In front of the steps there is a pavement (F 287) of carefully laid rectangular basalt slabs. Three rows of such slabs were discovered within the limits of the Polish sector, but the continuation of the same pavement was recorded by the Israeli team *ca.* 10 m to the south-west (F 423 in the area designated as N.NMP)²⁴. *Ca.* 3.40 m to the west from the eastern *anta* of the podium and only 0.45 m from the lower step, a rectangular pedestal of masonry (Loc. 290), just 0.18 m high, rises from the pavement. The E-W extent of the pedestal is 2.40 m, while the N-S one is yet to be established.

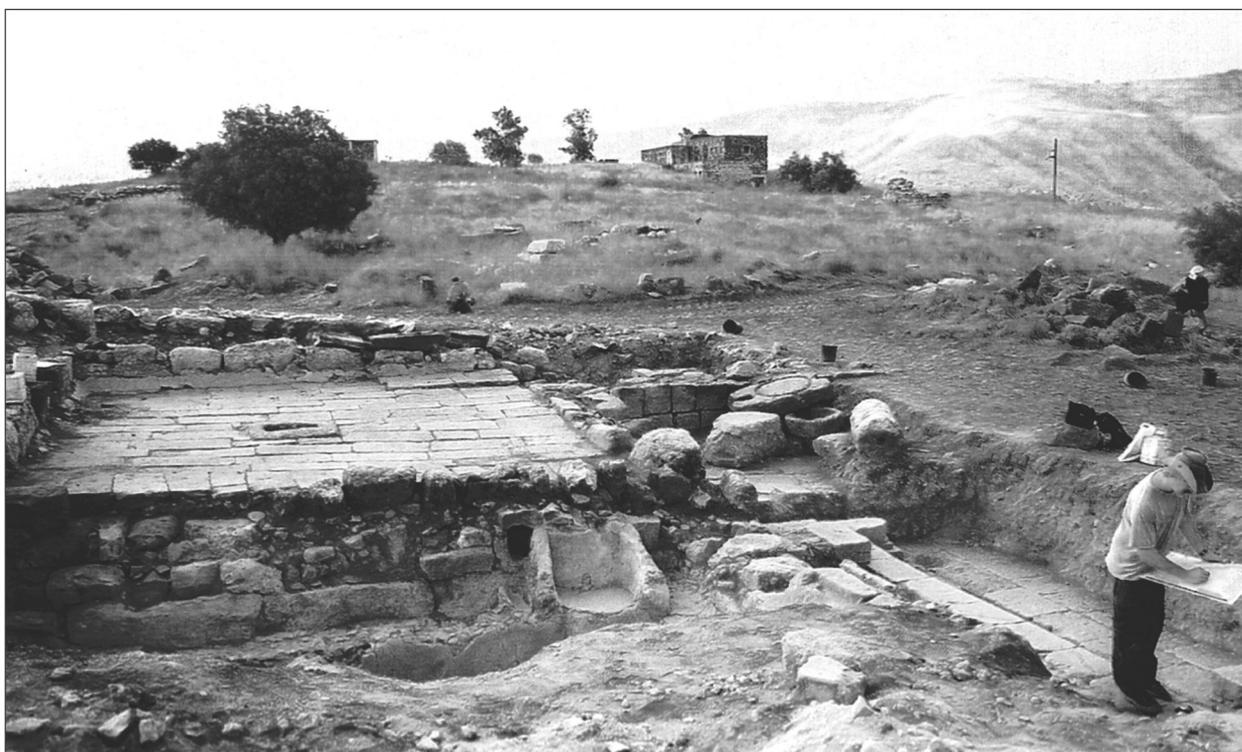
Fig. 17. OPB: The winery with its collecting pool to the left, the oil-press room to the right, and the podium of the Basalt Roman Building at lower right; view from the west (phot. J. Burdajewicz)
