## Roman military sentry posts in Crimea : new discoveries?

ROMAN MILITARY SENTRY POSTS IN CRIMEA. NEW DISCOVERIES?  
(PL. 124-129)

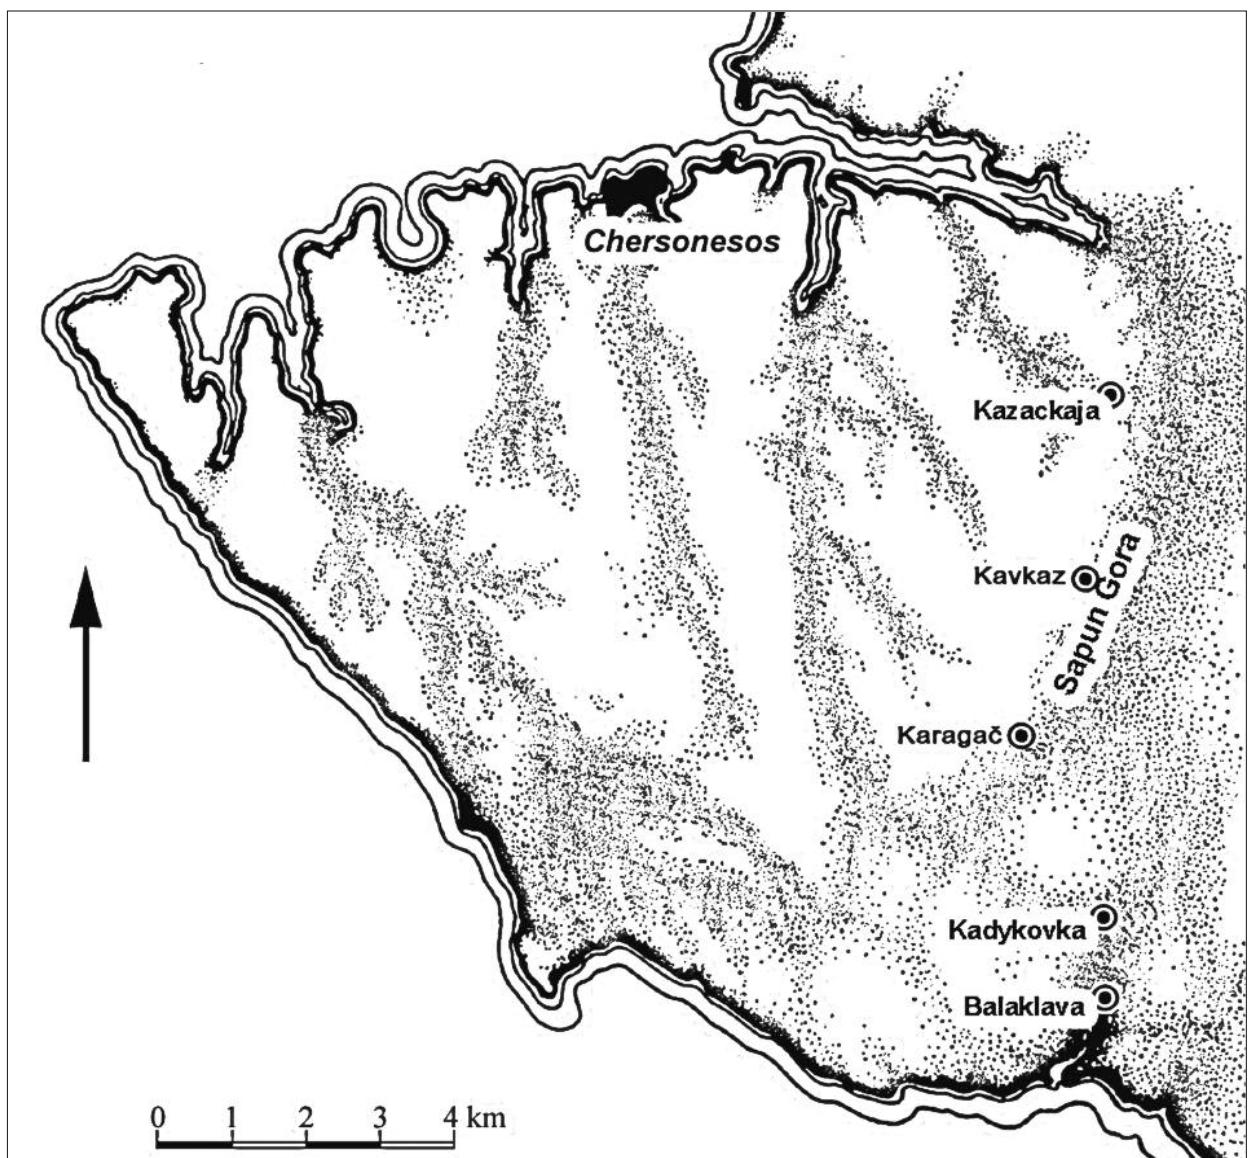
Fig. 3. Heraclean Peninsula – map (P. Zakrzewski). Location of Roman watchtowers: discovered ones (Kazatskaya Hill, Kavkaz Bair) and a putative one (Karagač)

The excavations have helped to discover several structures connected with the presence of Roman troops on the outskirts of the rural area (*chora*) of Tauric Chersonesos (Fig. 3). The temple to Jupiter Dolichenus has been explored (SARNOWSKI, SAVELJA 2000). The remains of two watchtowers have been unearthed on Sapun-gora (Fig. 5, 6). These two archaeological sites are referred to as Kazackaja Hill (SARNOWSKI, SAVELJA, KARASIEWICZ-SZCZYPORSKI 2002) and Kavkaz Bair (SARNOWSKI, SAVELJA, KARASIEWICZ-SZCZYPORSKI 2007).

From the above-mentioned data it could be inferred that the sentry posts on Kazackaja Hill and Kavkaz Bair were the neighbouring parts of the same “early warning system” established by the Romans in the Chersonesos borderland (Fig. 3).

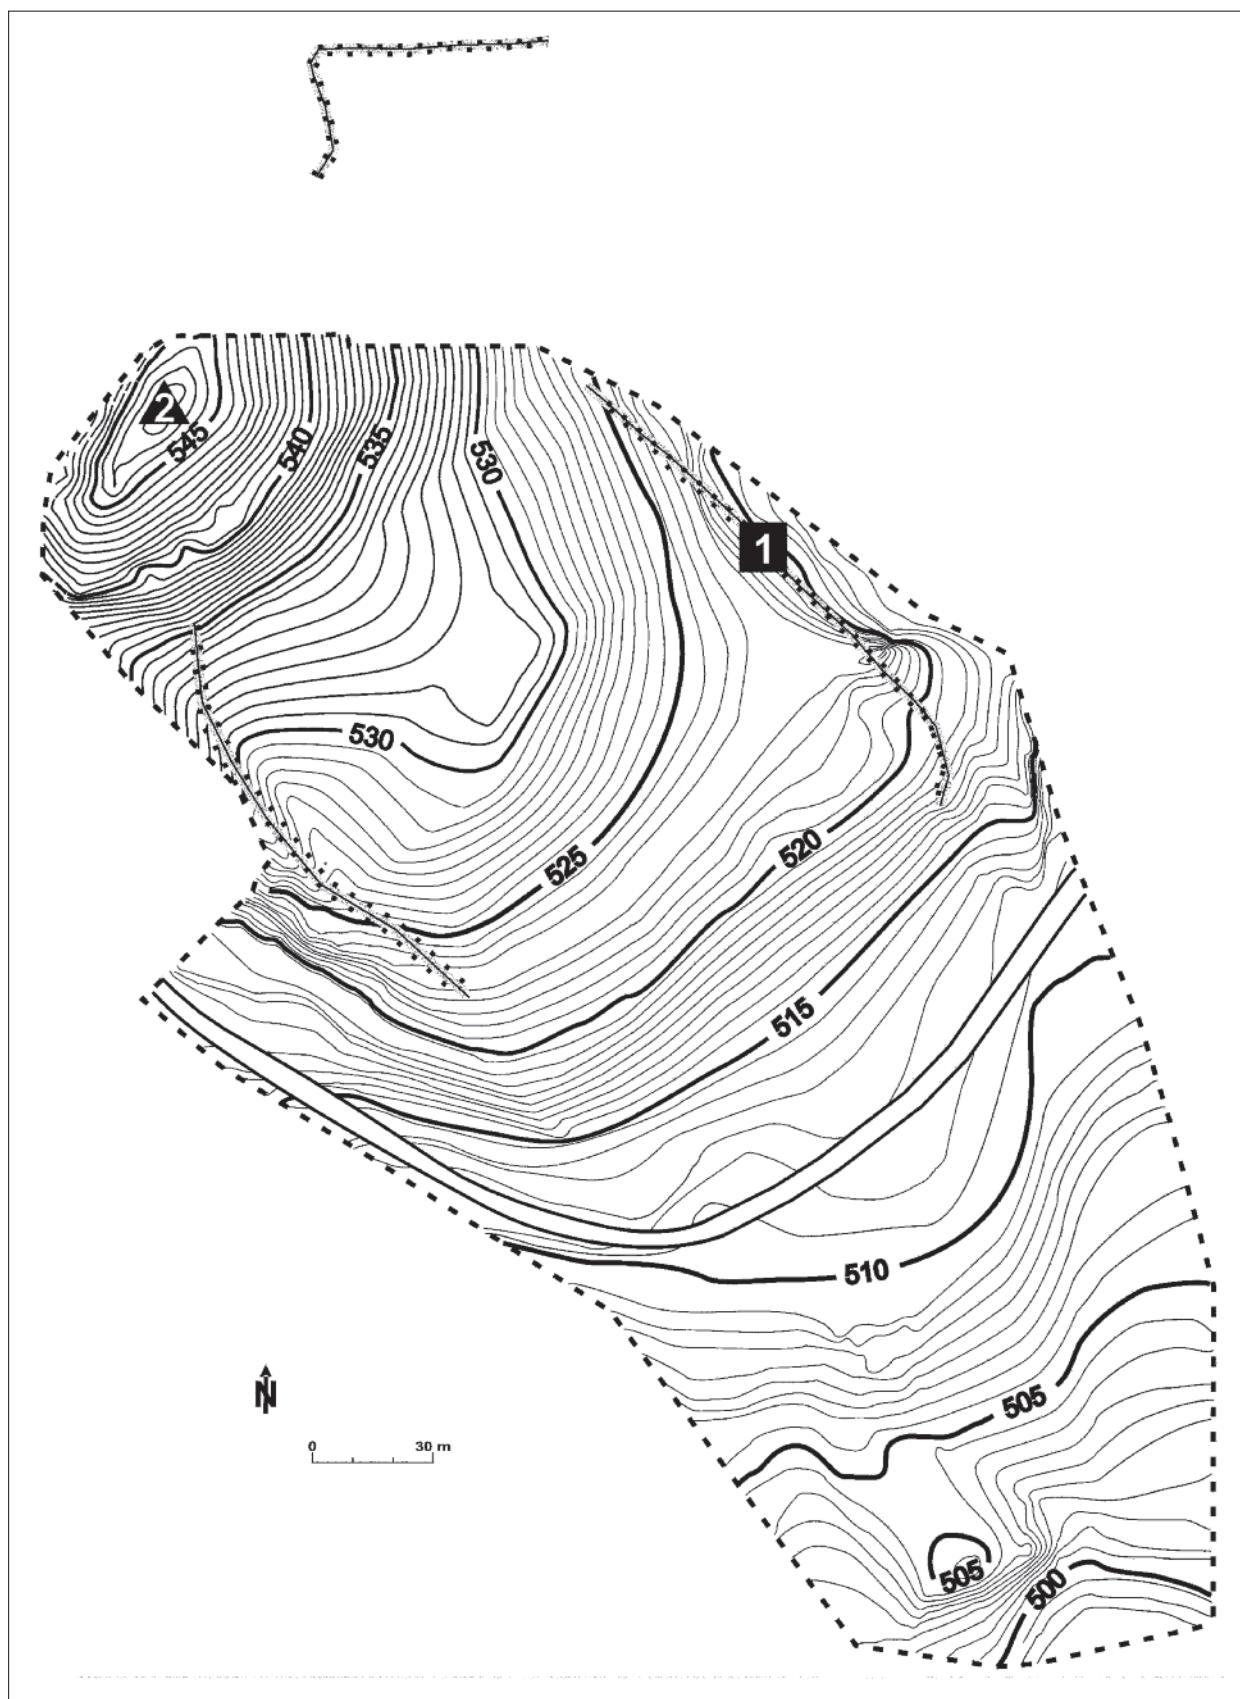
Fig. 4. Čatyrdag – contour map of the site with overlapping preserved sections of stone embankments. Point 1 – point of exposition face of the wall. Point 2 – the highest presumed point where fortification was located (P. Zakrzewski)

So far three stretches of the embankments have been classified as belonging to type 1 (**Fig. 10**). Because of their location they may have been fragments of the original enclosure wall. In all three cases they were found in places easy to defend, as the potential enemy would have to attack up the slope (**Fig. 4**). Most of the embankments of types 2 and 3 lack this important feature.

- The presumed highest point of the fortification is located on Čatyrdag burial site of the Ay-Todor type (**Fig. 4**).

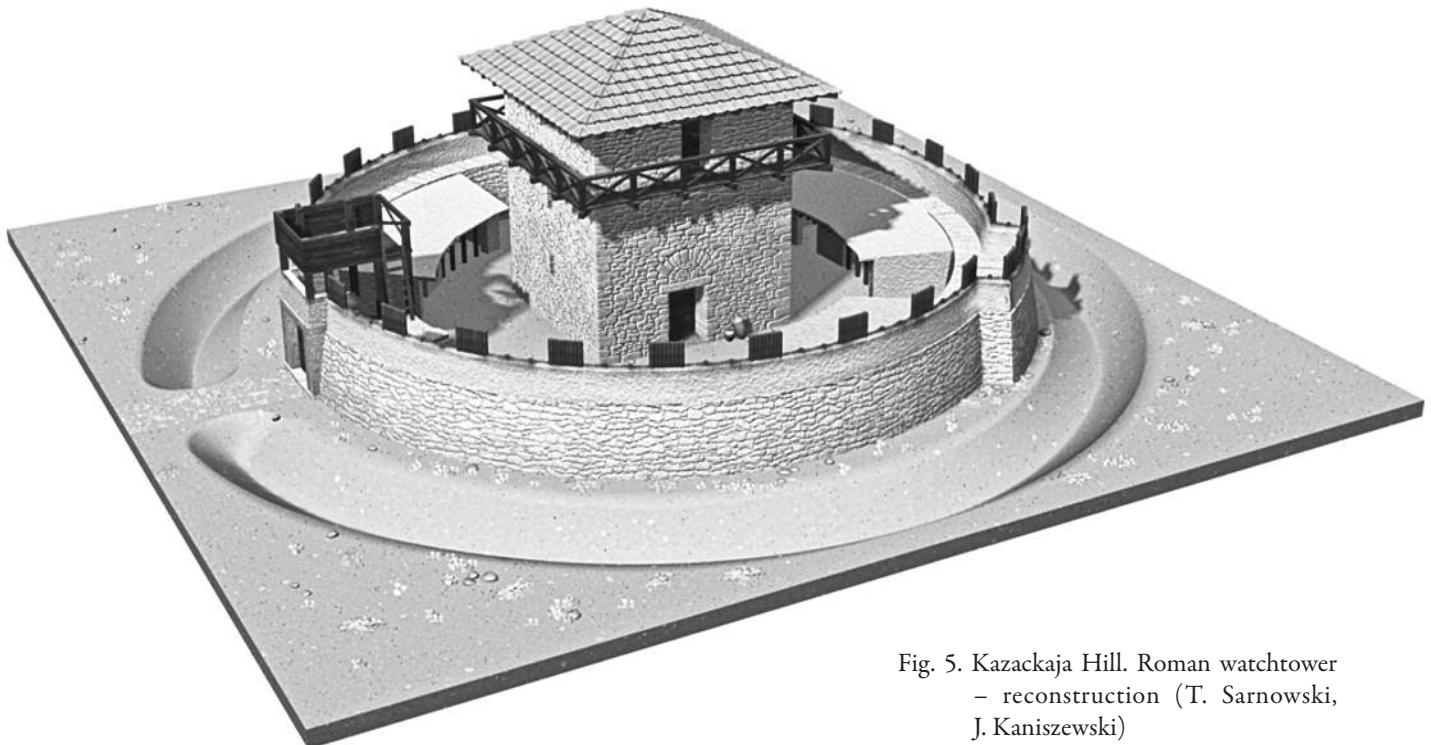
Fig. 5. Kazackaja Hill. Roman watchtower  
– reconstruction (T. Sarnowski,  
J. Kaniszewski)

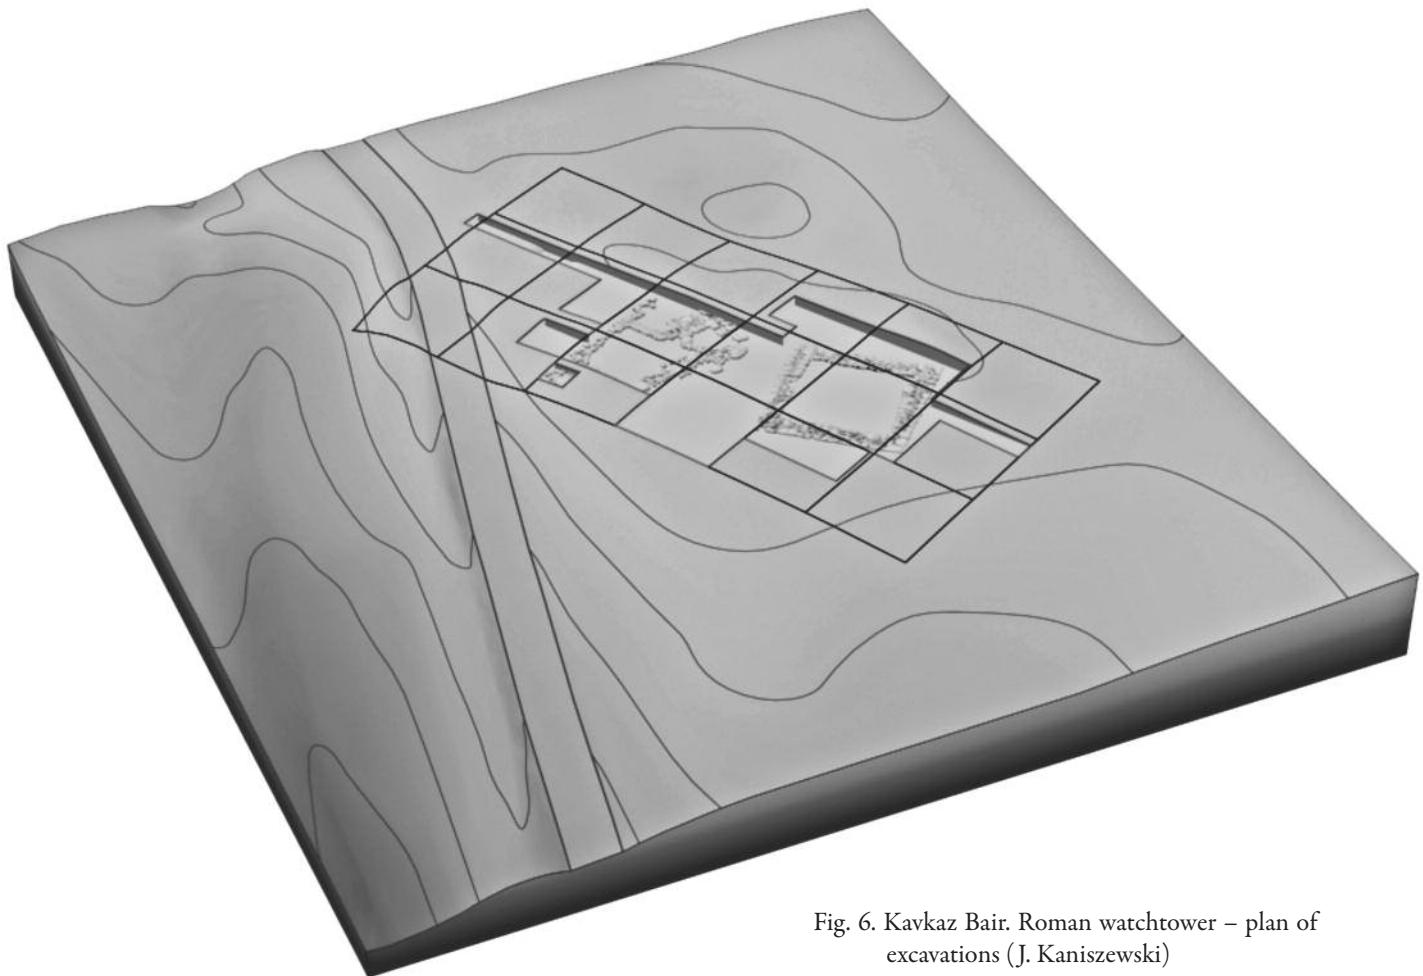
Fig. 6. Kavkaz Bair. Roman watchtower – plan of  
excavations (J. Kaniszewski)

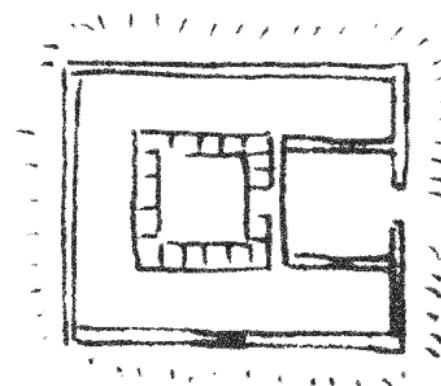
Fig. 7. Karagač. Ruins of the watchtower? Plan by Dubois de Montpereux  
(NIKOLAENKO 2001: 147)

de Montpréoux, a Swiss who travelled round Crimea in the 19<sup>th</sup> century, there were tower ruins surrounded by a wall in this area (DUBOIS DE MONTPÉREUX 1843: 189-190; **Fig. 7**). In order to make sending an alarm signal to Balaklava possible practically only one more watchtower should have been built, and it should have been located on Karagač. A post there would have provided the necessary eye contact with Balaklava. Nevertheless, we measured also the distance between Karagač and Gornaja, which again appeared to be... two Roman miles!

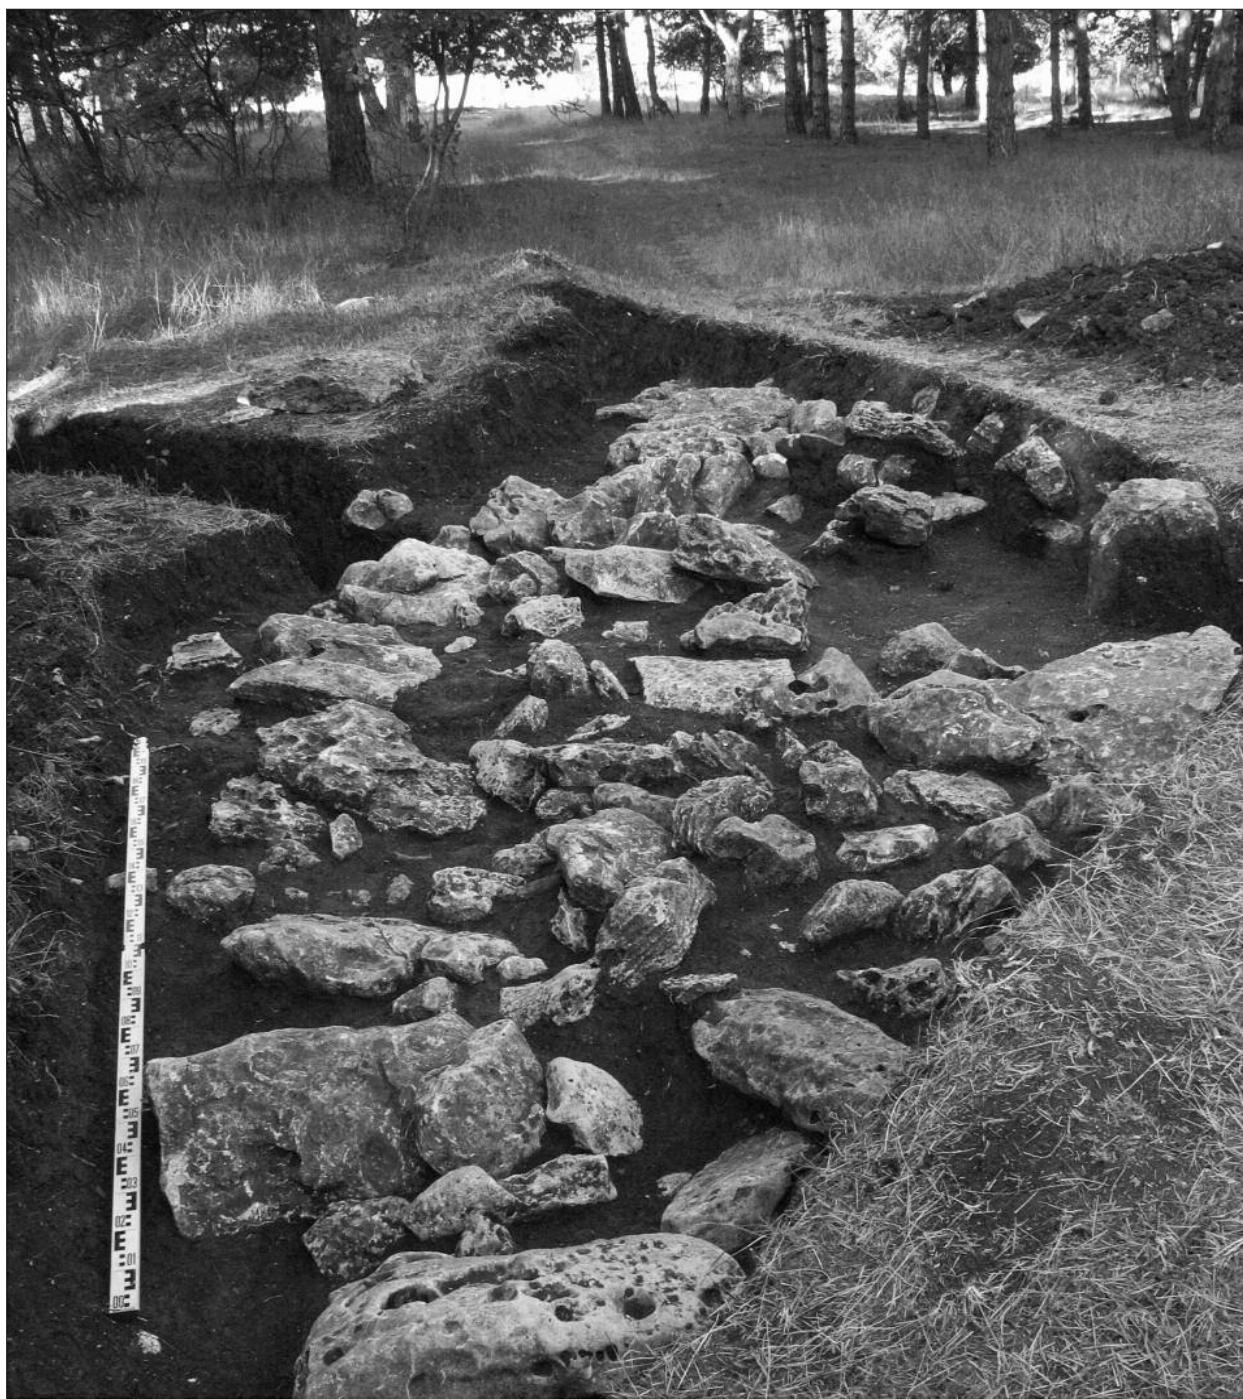
Fig. 8. Karagač. Summer 2008. Results of excavations.  
(R. Karasiewicz-Szczypiorski)

Owing to the dimensions of the tower (6 x 6 m.) the researchers decided to penetrate the site with a series of test pits which were one metre wide and dug in a 5 x 5 m. grid. The survey was carried out in 2008. It resulted in uncovering a poorly preserved stone structure made of irregular limestone blocks (**Fig. 8**). A few ceramics fragments found on the spot date the discovery back to the 8<sup>th</sup> - 9<sup>th</sup> cent. AD. Neither the building material nor the movable artefacts link the find to the Roman period. Apart from the shovel test pit, no other exploration techniques could be used on the site. The place is covered with pine forest and there are modern buildings in the vicinity. It is impossible to establish how far the structure mentioned by the Swiss traveller could be from the explored place. As the attempt to find the watchtower was unsuccessful, Francois Dubois de Montpréoux's account remains the most important argument in support of the above-mentioned theory.

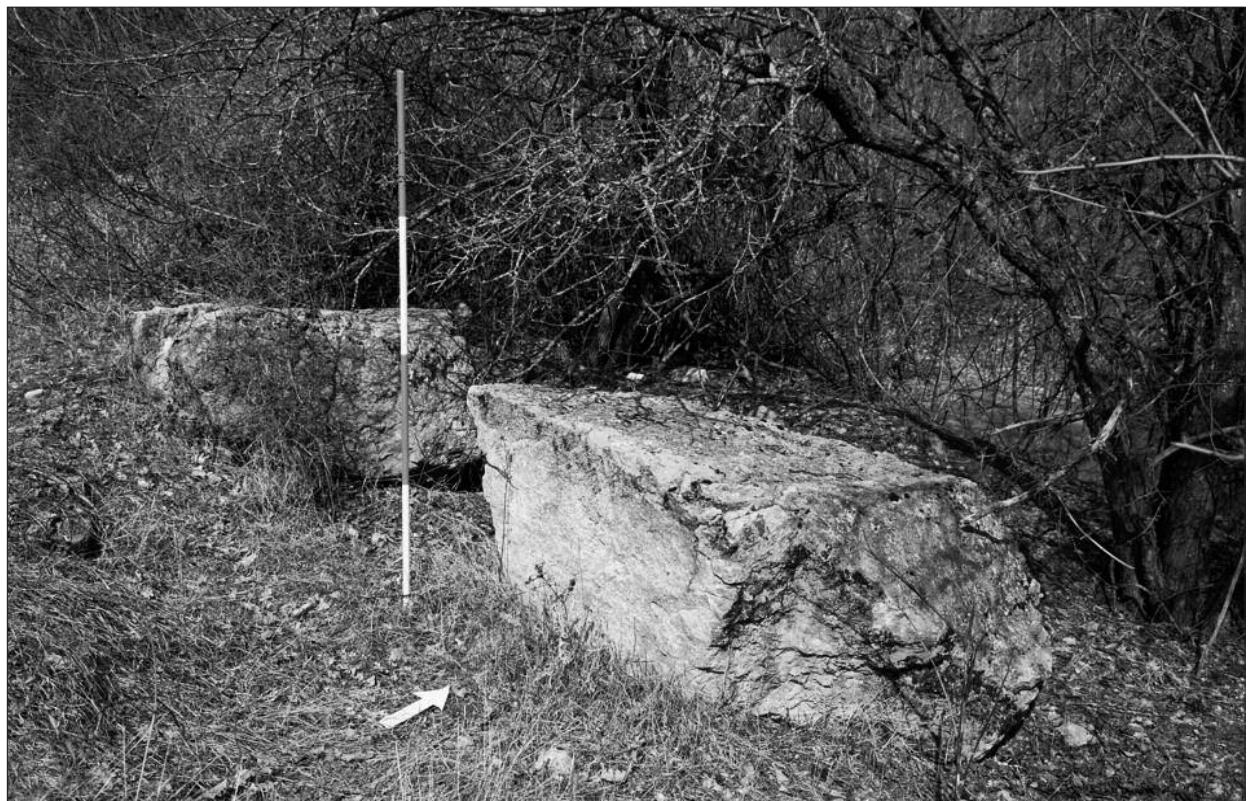
Fig. 9. One of the biggest stone blocks visible on surface (M. Bogacki). Situated to the north of Point 1 (see Fig. 4)

One difficulty in the study of the supposed defensive wall is the predominance of stones with no traces of processing. Only some of the blocks have one or two faces dressed. Probably the stones were hewn only when it was necessary to make the face of the wall even. However, single well dressed stones scattered round the preserved structure support the idea that the embankments are the remains of a defensive wall (**Fig. 9, 12**). These blocks are big and one of them was even prepared to be part of an obtuse angle construction (**Fig. 9**).

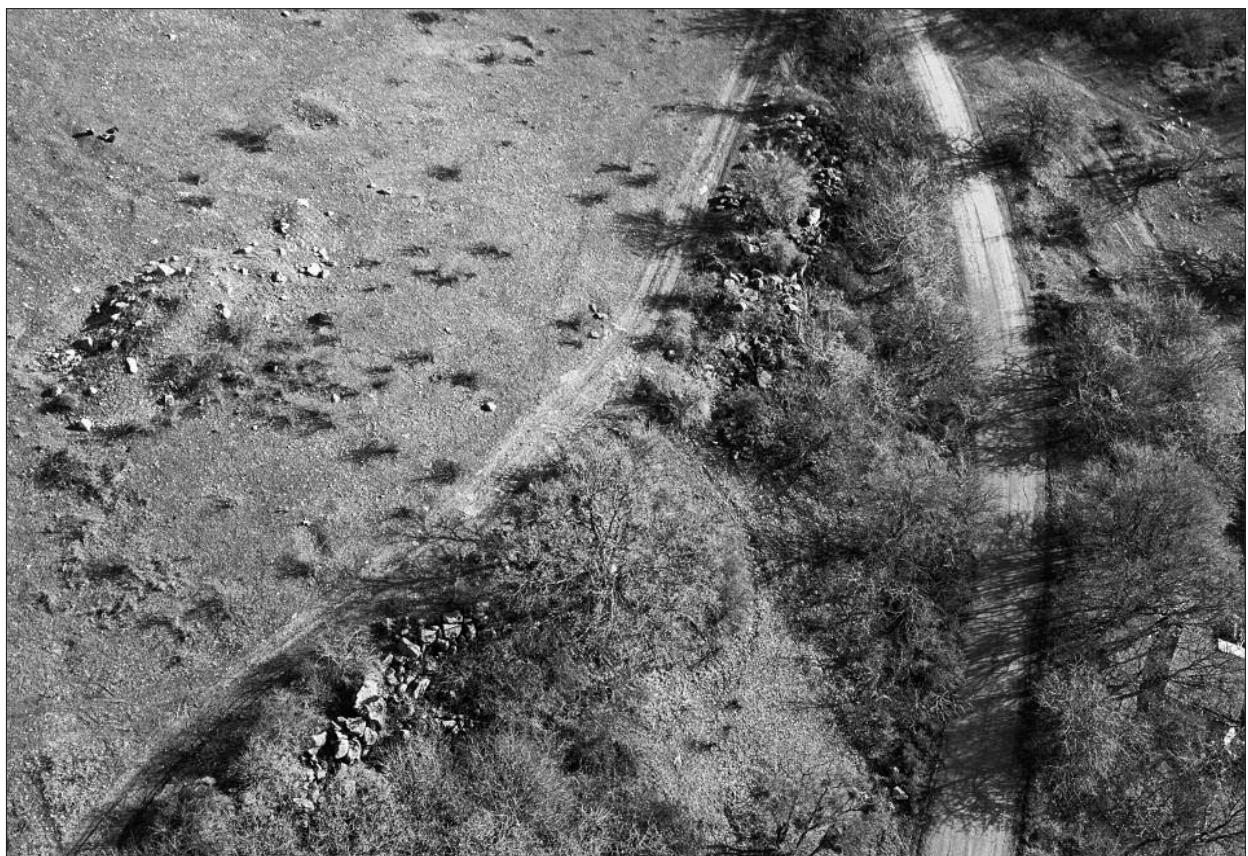
Fig. 10. Fragment of preserved wall – aerial view (M. Bogacki). Segment to the south of Point 2 (see Fig. 4)

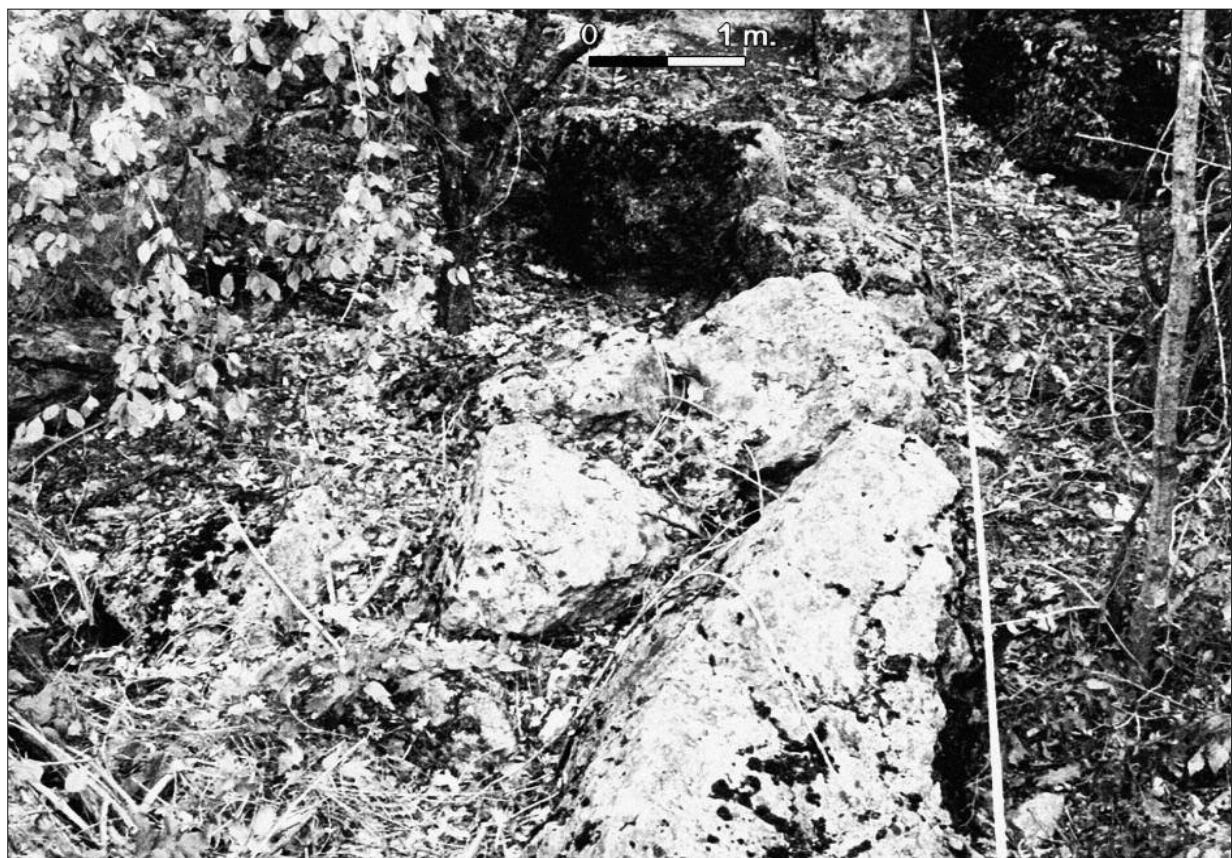
Fig. 11. Exposed face of the wall (R. Karasiewicz-Szczypiorski). Situated in the spot marked as Point 1 on the plan (see Fig. 4)

In the course of a new fieldwork season in summer 2008, the best preserved part of the defensive wall was distinguished (**Fig. 4, 11**). Turf, weed, and accumulated leaves from nearby trees were removed in the designated area. After the clearing the straight line of the wall face could be noticed (**Fig. 11**). In some places only one row of massive stones remained. However, in one stretch of the structure the second and third layer of stones was preserved. The embankment is very massive there. A more detailed analysis helped to determine a probable line of the other face of the wall and to estimate the original width of the curtain wall to be 3,5 m.

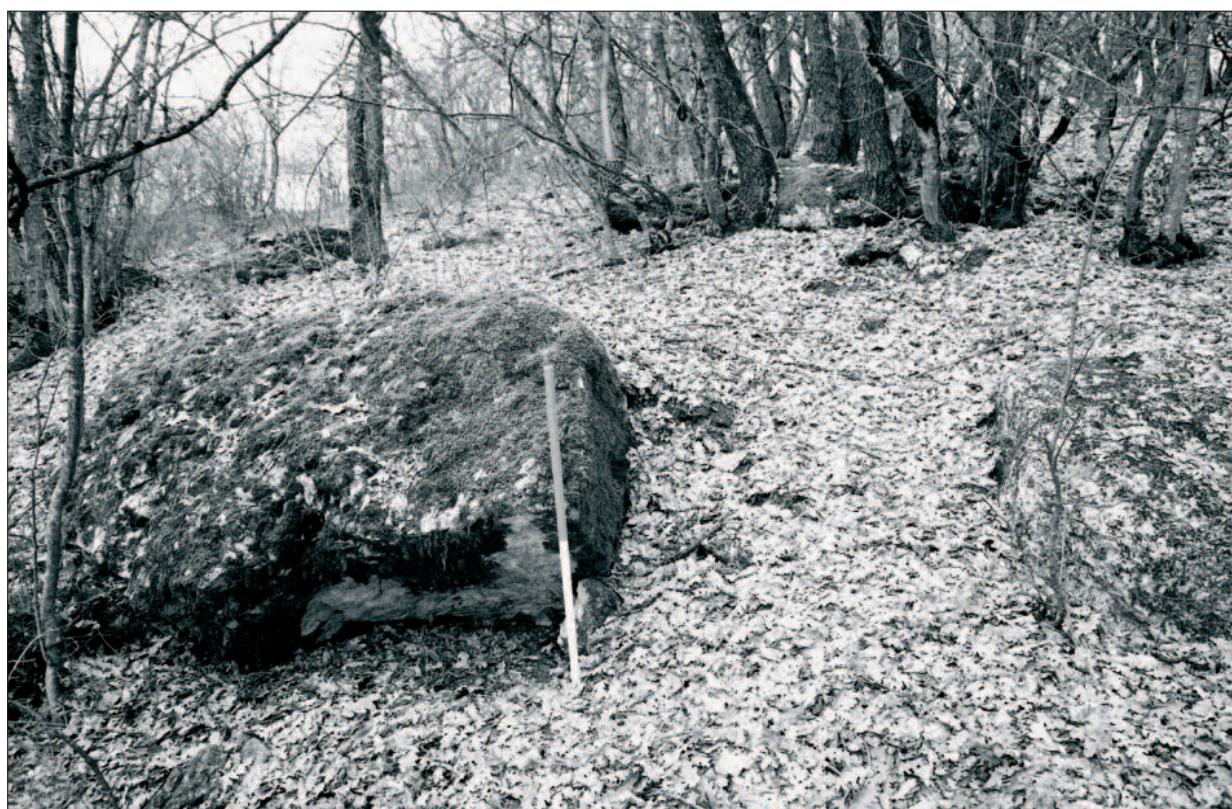
Fig. 12. Dressed stones blocks on the site (M. Bogacki). Situated near the spot marked as Point 2 on the plan (see Fig. 4)
