**POLISH ARCHAEOLOGICAL RESEARCH IN PTOLEMAIS (LIBYA) IN 2007–2009.
PRELIMINARY REPORT
(PLS. 1–33)**

Excavations

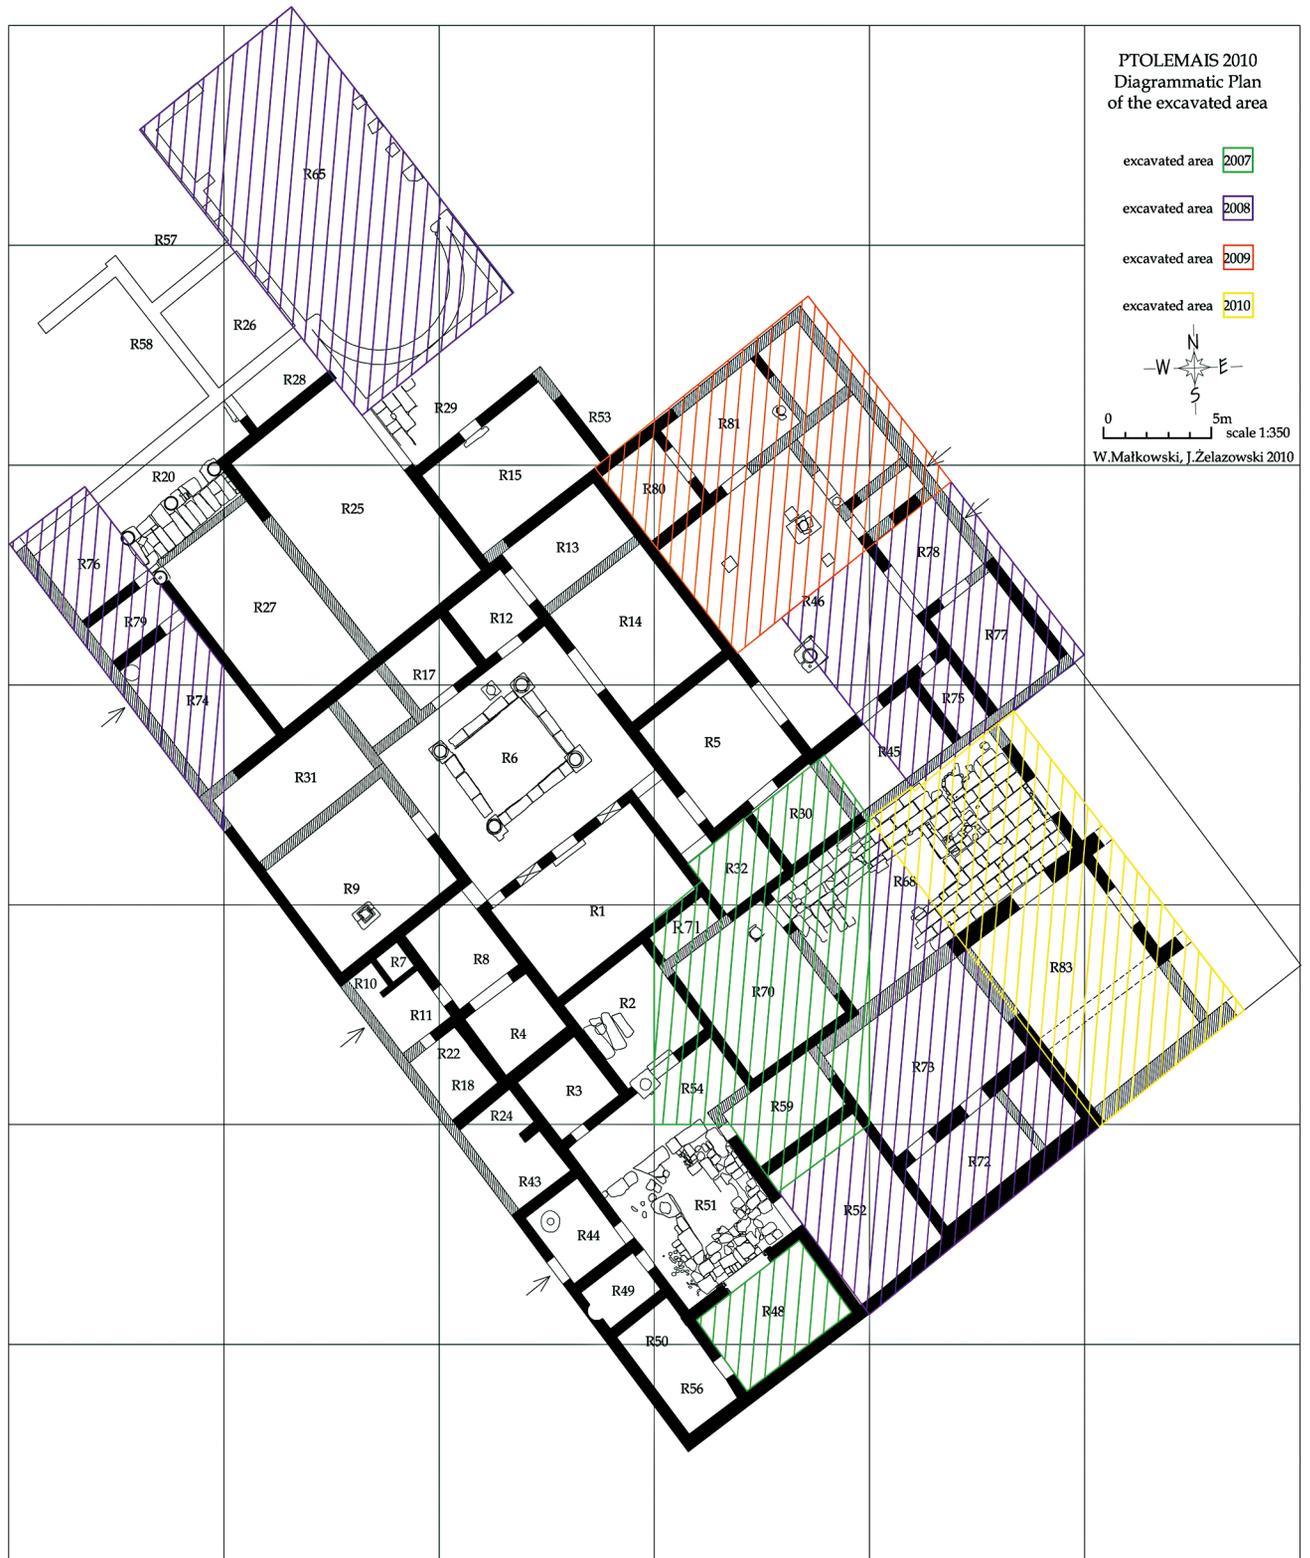
Fig. 3. Plan of the excavated area in 2007–2010 (by W. Małkowski, J. Żelazowski).

Archaeological explorations began in 2006 on the south side of the House of Leukaktios. They uncovered a small complex featuring a kind of paved atrium with an impluvium (Fig. 4).³ It occupied a higher occupational level, although there is evidence in the form of blocking (Fig. 5) in the south wall of the triclinium (R 1) and transformations in the late phases of use of this part of the insula, indicating simultaneous use of the two levels in different periods. Even so, when the House of Leukaktios was in use, the house with the impluvium, collecting rainwater into a cistern, operated independently with an entrance (R 44) from the western street (Fig. 6). The south walls of Rooms R 48, R 52 and R 56 were proved quickly to mark the limits of this house and the levelling as well, but the exploration of successive rooms continued. Moreover, the excavation method changed starting in 2006, replacing the square grid technique of exploration with room by room excavation and recording that is commonly practiced in the archaeology of ancient towns (Fig. 3).

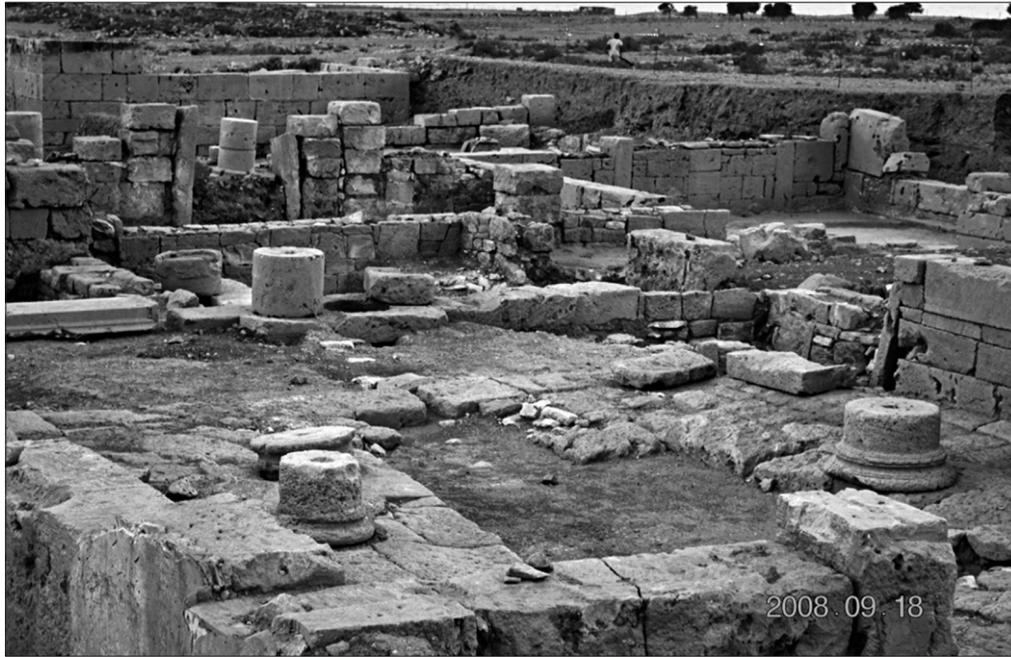
Fig. 11. View of the courtyard R 51 from the SW corner (Photo Polish Archaeological Mission to Ptolemais).

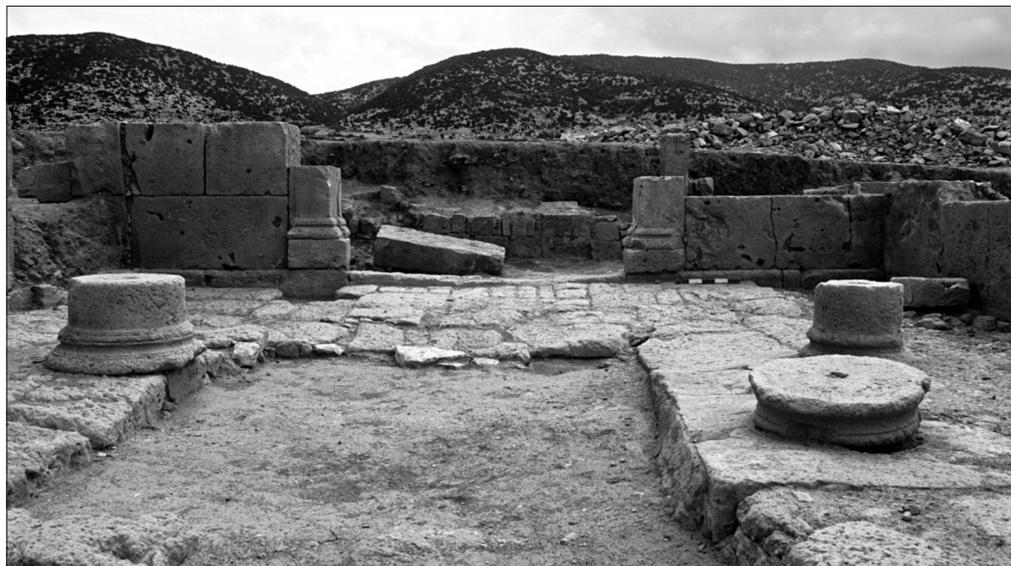
Fig. 13. Walls W 101 and W 102 with the entrance to Room R 48 from the courtyard R 51 (Photo Polish Archaeological Mission to Ptolemais).

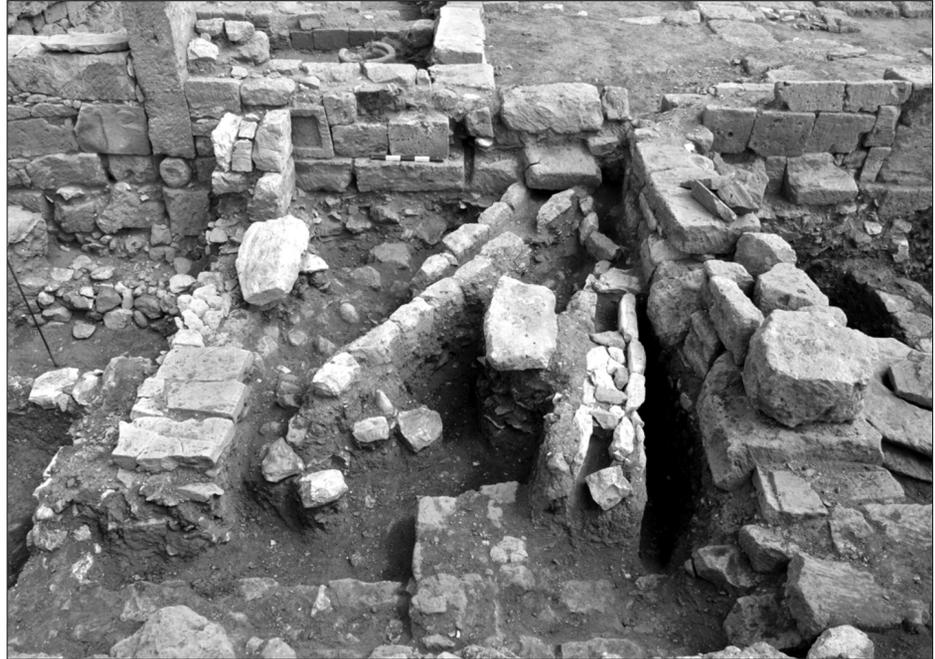
Fig. 15. Stone channels in Room R 43 (Photo Polish Archaeological Mission to Ptolemais).

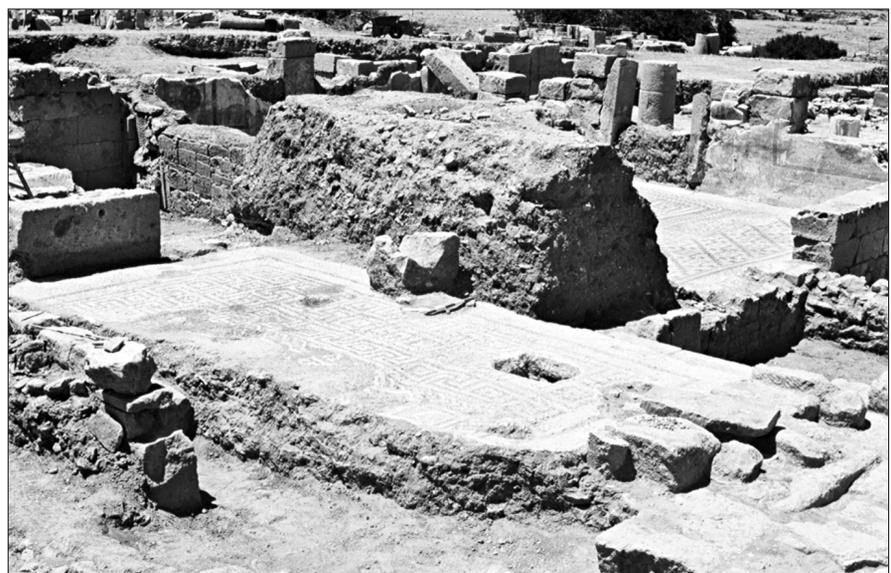
Fig. 23. Room R 70 with the mosaic floor (M 15) and the cistern mouth (C 6) (Photo Polish Archaeological Mission to Ptolemais).

opening (C 6) was found in the mosaic floor (M 15) opposite the entrance to the chamber. The cistern fill contained small quantities of heavily damaged potsherds, including three full Mid-Roman vessel forms (Unit 19/07). The exploration of Room R 70 (Unit 20/07) uncovered on the floor (29.03 m a.s.l.) a mosaic made of blue and white tesserae (M 15). The design of the border suggested the size of the room which was delimited on the south by Wall W 137. Even so, the mosaic floor broke off suddenly in the middle of the room, revealing Wall W 142 below (28.86 m a.s.l.), situated at right angle to Wall W 144. Its presence must have been due to a later rebuilding event in the southern part of R 70 (Fig. 24).

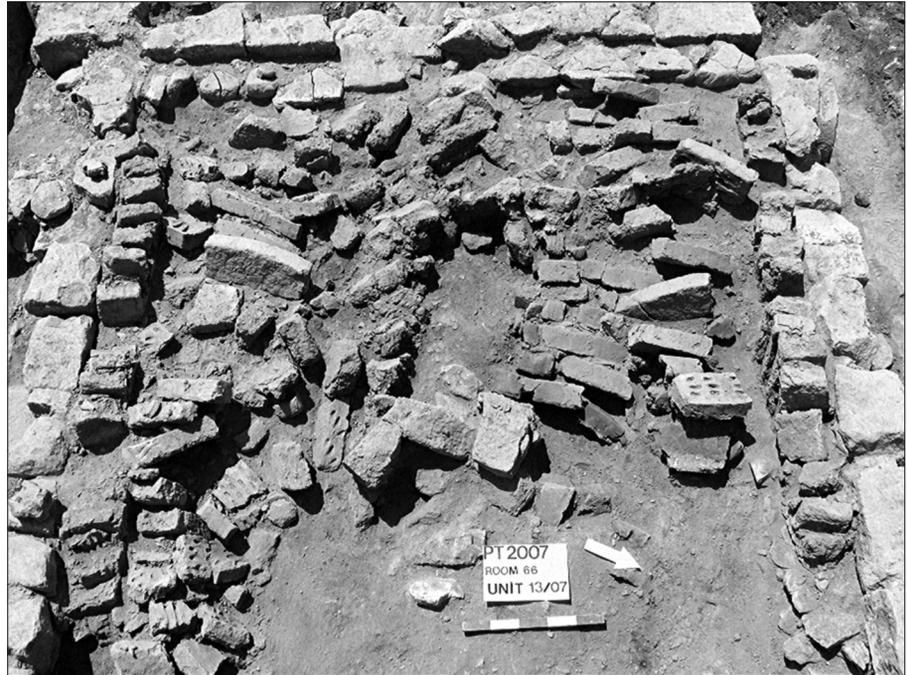
Fig. 27. Kiln (K 3) after the exploration (Photo Polish Archaeological Mission to Ptolemais).

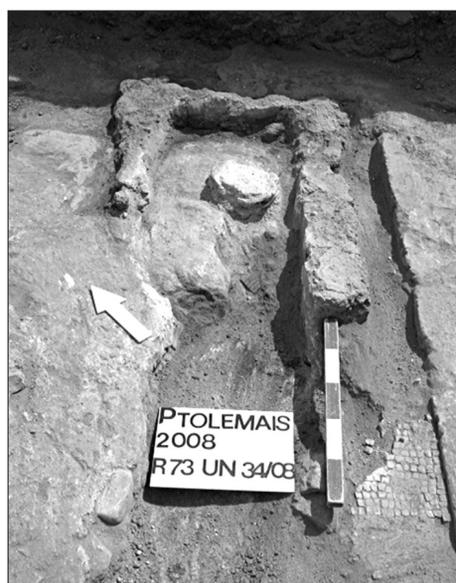
Fig. 41. Lime-burning kiln between the cistern (C 8) and Wall W 151 (Photo Polish Archaeological Mission to Ptolemais).

A small lime-burning kiln (Fig. 41) was also recorded between the cistern and Wall W 151. It proved to be partly damaged on the western side, but even so, it was clear that it was originally rectangular (1.2×0.85 m) and was constructed principally of mud bricks (approx. 0.2×0.15 m). A layer of lime 0.15 m thick (Unit 34/08) was found inside the kiln, including small pieces of marble coming possibly from floor revetment. The mixed assemblage also included glass vessel fragments, terra sigillata and relatively numerous sherds of cooking ware.

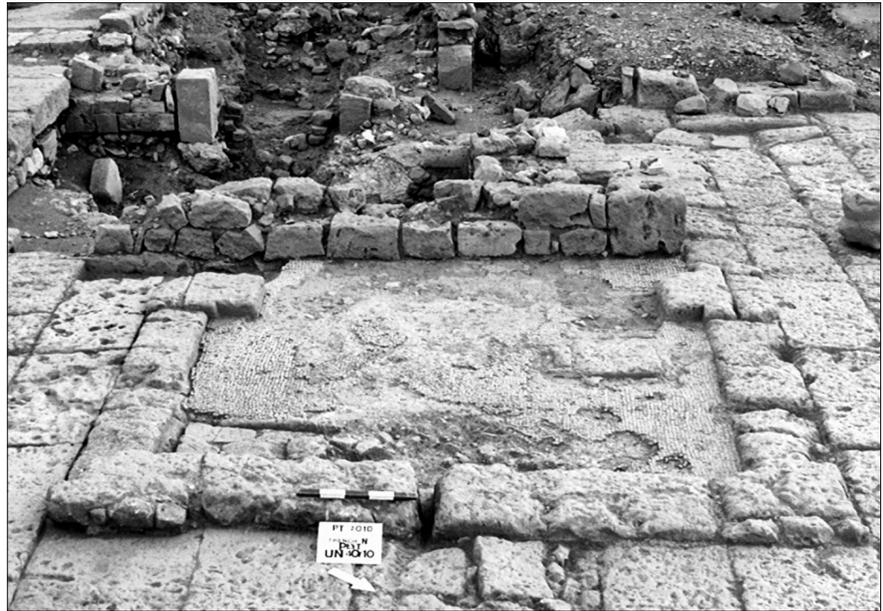
Fig. 44. Rectangular pool (impluvium) lined with mosaic (M 16) in the courtyard (R 68) (Photo Polish Archaeological Mission to Ptolemais).

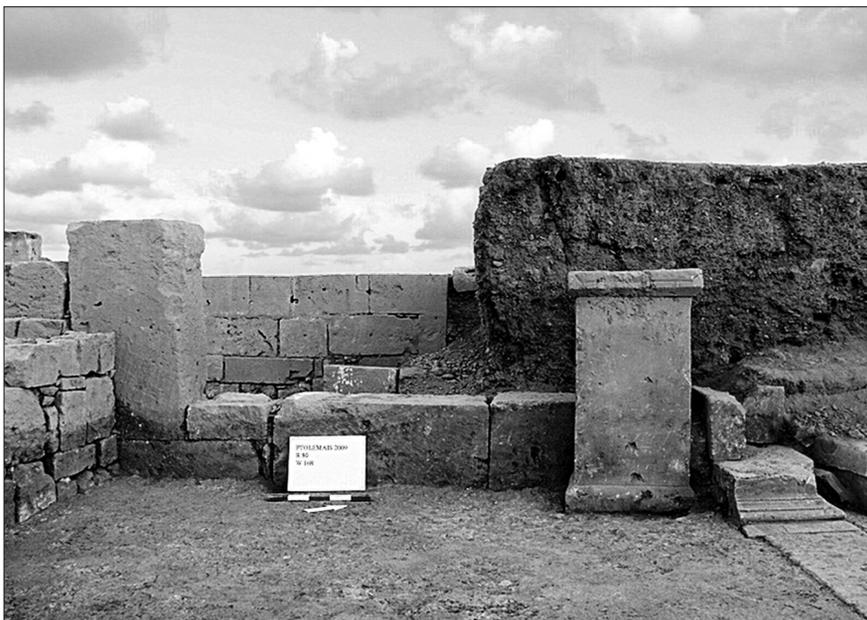
Fig. 61. Room R 80 with a profiled base (Photo Polish Archaeological Mission to Ptolemais).

The accumulation unit (55/09) immediately above the floor of *opus signinum* yielded finds in the form of few potsherds, 2 pieces of lamps, a small metal object and a few stone blocks (inv. Nos A/280, A/282). A profiled base (inv. No. A/281, dimensions: 1.12×0.47×0.6 m) in the north-eastern corner may have been used for a statue (**Fig. 61**).

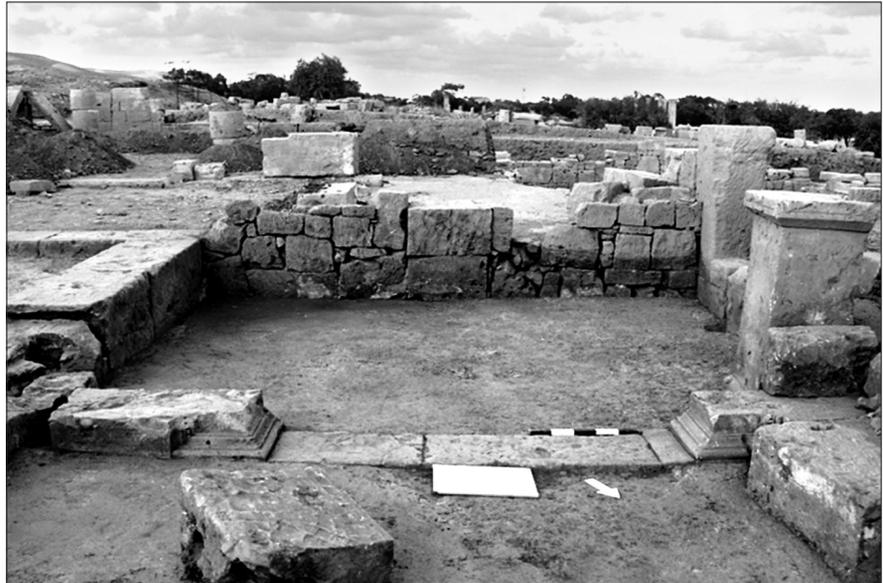
Fig. 62. Doorway between Rooms R 80 and R 81 (Photo Polish Archaeological Mission to Ptolemais).

The doorway between R 80 and R 81 (**Fig. 62**) consisted of two decorated blocks (inv. Nos A/1009, A/1010) with a *denticuli* ornament along the inner edge and a moulding on the outer edge (view from R 81), forming the lower part of the jambs in situ. The width of the entrance suggested an arch instead of a simple flat lintel. Wall W 167 separated the two rooms (R 80 and R 81) from the courtyard R 46. Two stone doorway thresholds have survived in position, but the one blocked by Wall W 171 belonged to an earlier phase.

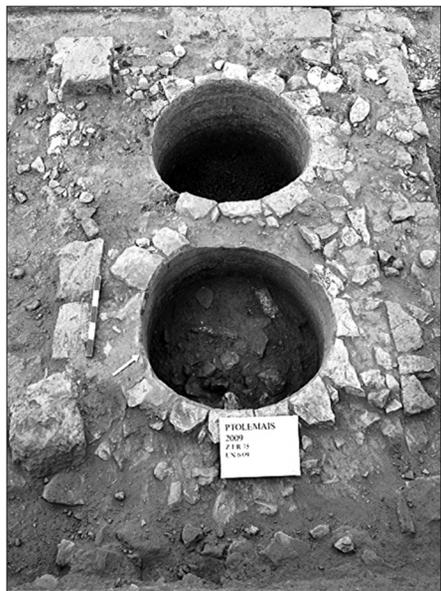
Fig. 65. Storage Vats V 1 and V 2 in Room R 75 (Photo Polish Archaeological Mission to Ptolemais).

Excavations by the Polish team in the different houses occupying the insula have uncovered to date seven circular storage vats sunk into the floors of various rooms (Fig. 25). They are located in the eastern part of the House of Leukaktios: one (V 3) in the big courtyard, R 46 (Fig. 64), two (V 1, V 2) in the adjacent Room R 75 (Figs. 65, 66) and four in two adjoining rooms: two (V 4, V 5) in R 52 (Fig. 67) and two (V 6, V 7) in R 59 (Fig. 8) of the so-called House of the Atrium. The storage vats were found in 2007–2008 and their fill was explored mainly in 2009. The numbering of the storage vats reflects the order in which they were excavated.

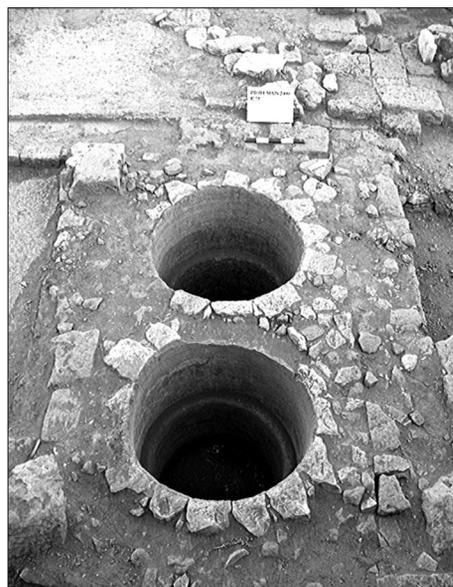
Fig. 66. Storage Vats V 1 and V 2 in Room R 75 after the exploration (Photo Polish Archaeological Mission to Ptolemais).

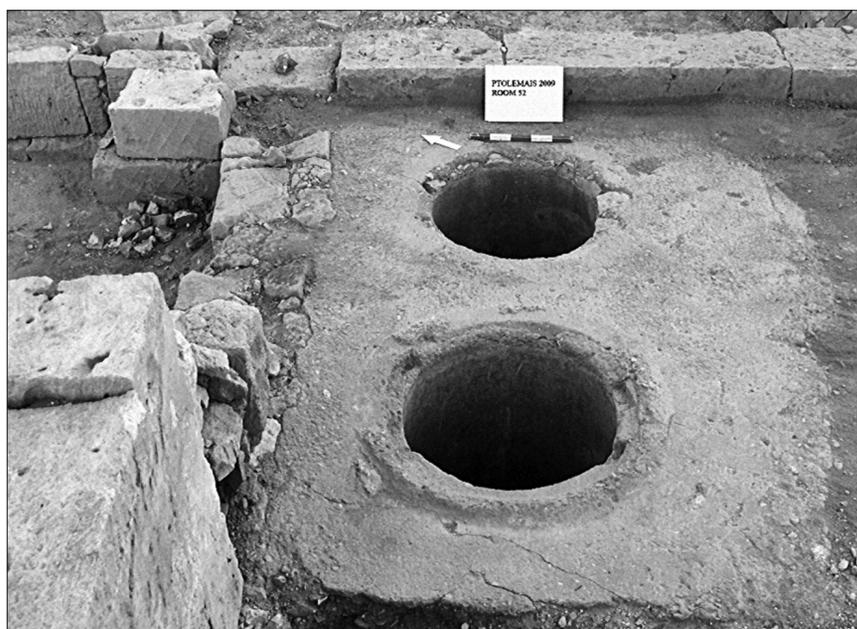
Fig. 67. Storage Vats V 4 and V 5 in Room R 52 (Photo Polish Archaeological Mission to Ptolemais).

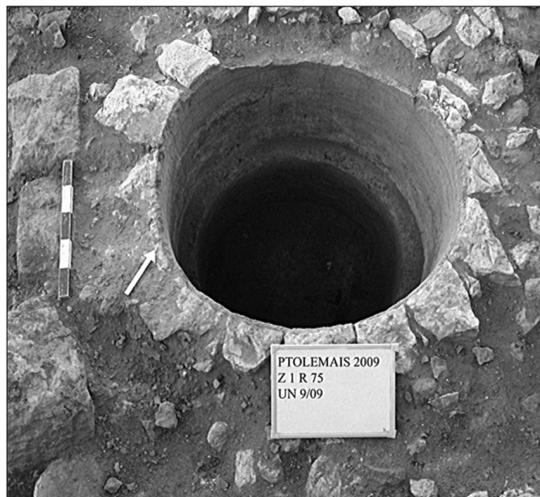
Fig. 70. Storage Vat V 1 (Photo Polish Archaeological Mission to Ptolemais).

The next layer was a thin deposit of soil mixed with ashes and lumps of charcoal (Unit 09/09, 27.53–27.38 m. a.s.l., **Fig. 70**). The assemblage consisted of a few dozen potsherds, mostly from Mid-Roman vessels bearing evidence of burning, as well as two pot stands (cf. D 959), fragment of a metal object and an intact oil lamp (inv. No. 1/013/09, **Fig. 69:10**), presumably locally made in the late period.

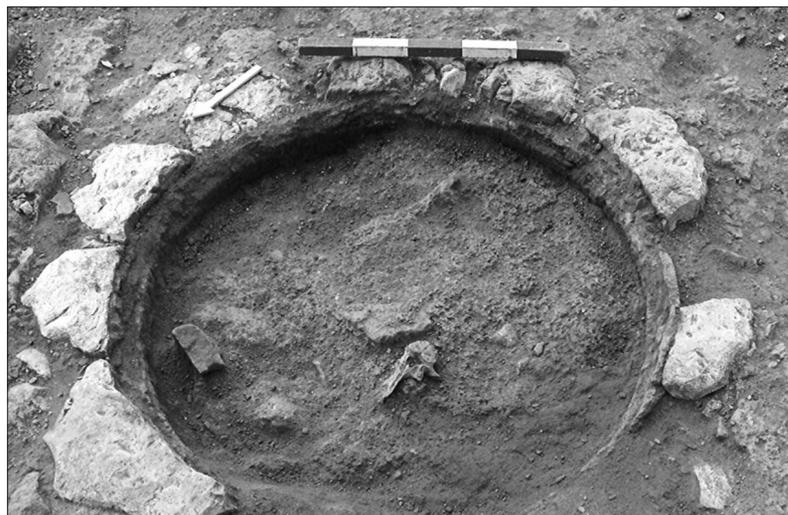
Fig. 72. Storage Vat V 3 at the beginning of exploration (Photo Polish Archaeological Mission to Ptolemais).

The fill of Storage Vat V 3 (Unit 16/09) from the courtyard (**Figs. 72, 73**), situated directly by the entrance from the street, consisted of a number of layers. The latest (Unit 11/09) was characterized by large irregular stones and a small quantity of coarse pottery as well as two late antique coins (inv. Nos.: Cn/024/09, Cn/032/09). The next accumulation (Unit 20/09) contained, more or less at mid-height of the storage vat, ashes and many animal bones situated above two large stone blocks (inv. Nos.: 278, 279). Underlying this was greenish soil (Unit 21/09) with traces of clay, remains of charcoal, two bone pins and dice (inv. No. Oth/011/09, **Fig. 69:11**), as well as numerous pottery, glass fragments, marble facing, lamps. The next layer (Unit 23/09) was immediately above the bottom of the storage vat (26.45 m a.s.l.) and contained many fragments of pottery, a bone pin (inv. No. B/008/09, **Fig. 69:13**) and small pieces of mortar along with an almost completely preserved lamp.

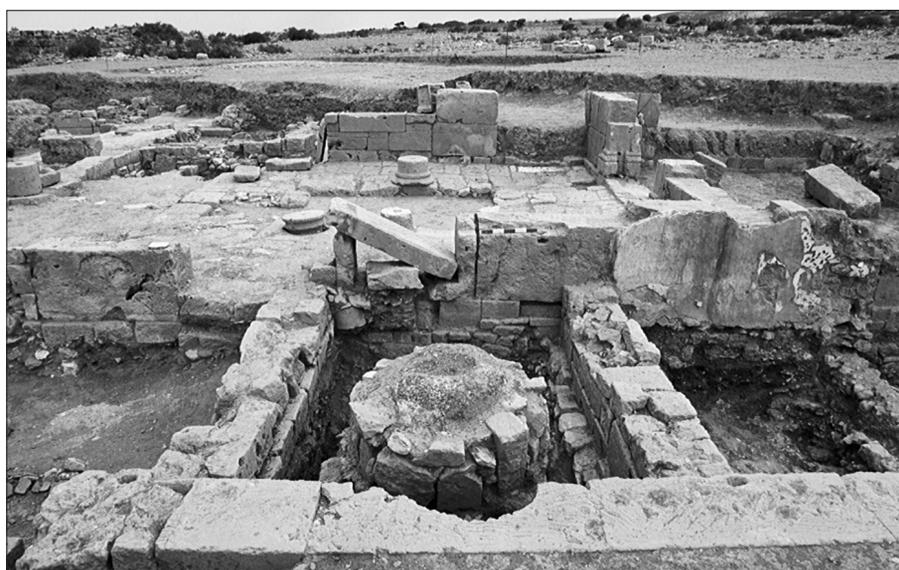
Fig. 76. Room R 44 with a terracotta dolium (Photo Polish Archaeological Mission to Ptolemais).

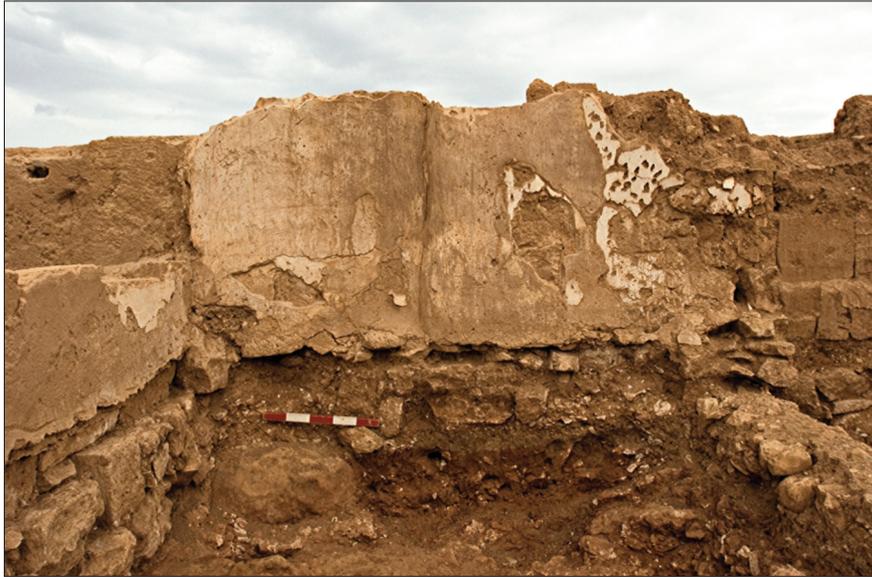
Fig. 77. Remains of the decoration on the east wall (W 98) in Room R 50 (Photo Polish Archaeological Mission to Ptolemais).

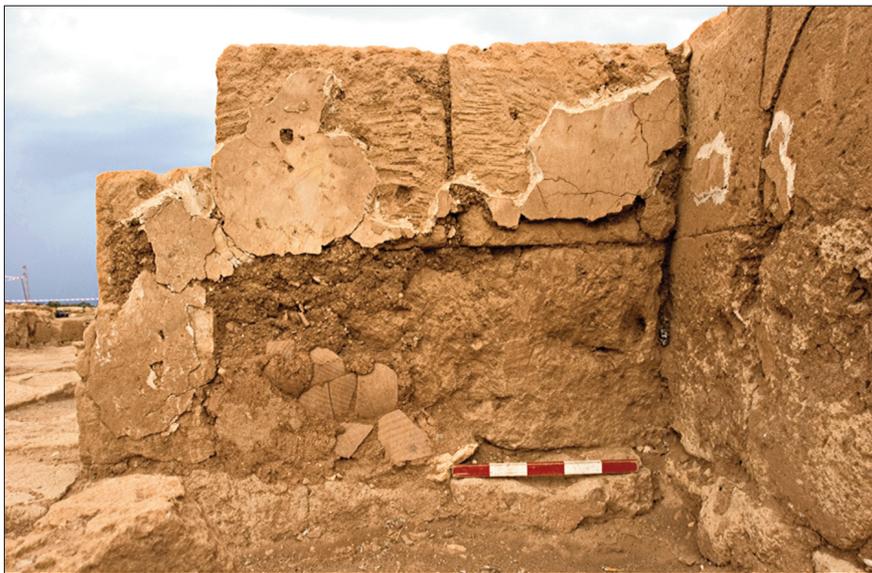
Fig. 78. Remains of the decoration on the wall (W 102) to the east of the entrance to Room R 48 (Photo Polish Archaeological Mission to Ptolemais).

The plaster on the wall to the east of the doorway has been preserved all the way to the corner (W 102) for 110 cm above the footing of the wall (**Figs. 78, 79**). The remains of the first painted layer can be observed with heavy pitting for the second layer of which very little has survived. Starting from the doorway there is a wide panel with irregular dark yellow, white and blue lines and splotches against a yellow background. The panel in the room corner (37 cm wide) featured a purple background with white and yellow dots, set off by a vertical yellow line (0.5 cm wide). Separating the two panels is a white band containing a sequence of vertical dark red and dark blue lines.

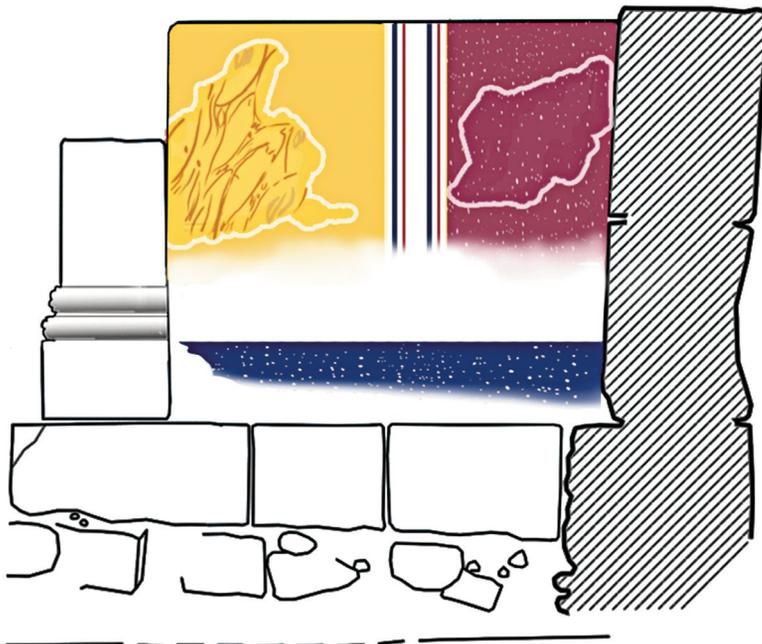
Fig. 79. Reconstruction of paintings (1st phase) on Wall W 102 (elaborated by R. Tusznió).

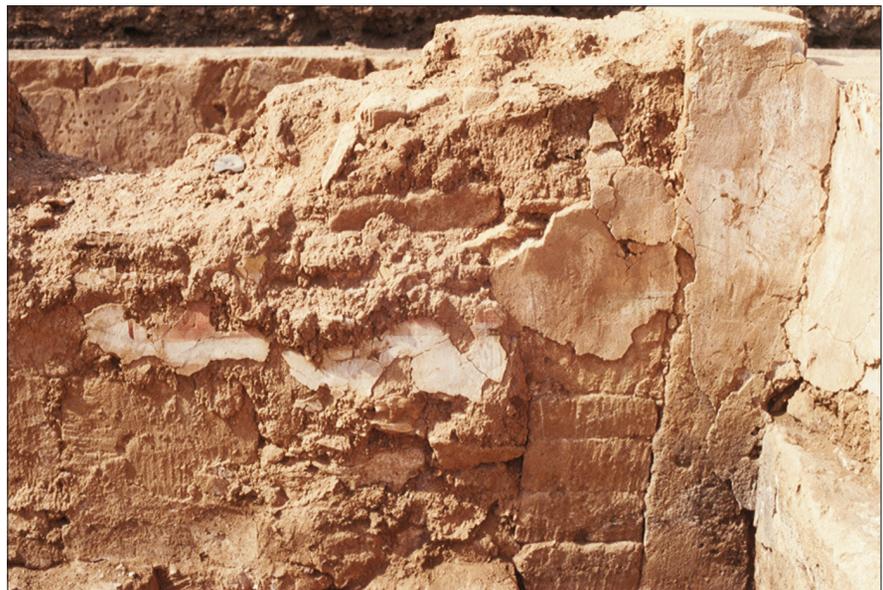
Fig. 82. Remains of the decoration on the west wall (W 132) in Room R 48 (Photo Polish Archaeological Mission to Ptolemais).

Remains of painted decoration on the west wall of Room R 48, to the north of the door to R 50, have been preserved for approximately 1 m above the floor in the north-western corner (Fig. 82). The second painted layer has been preserved on this wall, because of a continuation of the above described decoration on the north wall of the room, but here it appears to have been applied directly to the blocks. It could mean that the first layer was removed completely.

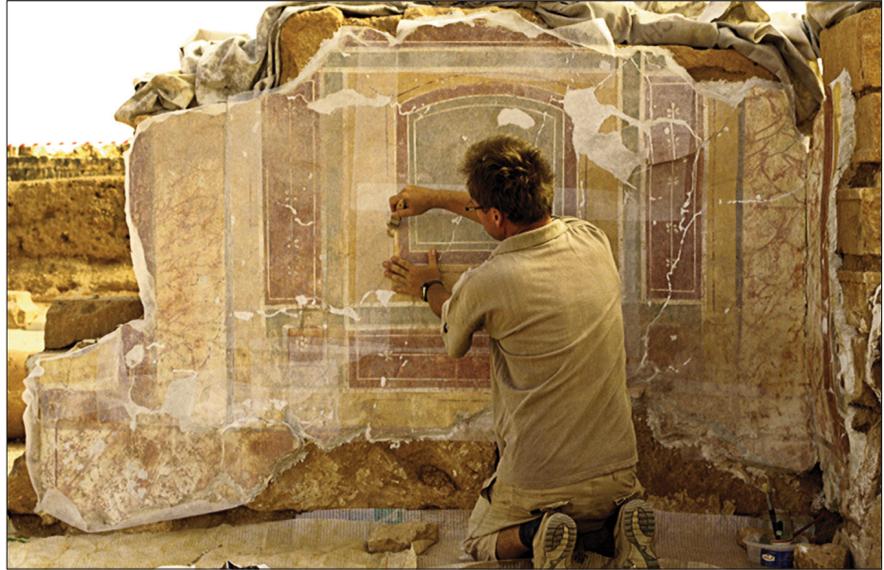
Fig. 86. Cutting away and transferring of the painting (W 3 in the corner of R 9) (Photo Polish Archaeological Mission to Ptolemais).

The paintings were taken down by the stacco method (Fig. 86). Saws, knives, machetes, and long flat metal bars hammered in were used to cut away the paintings from the walls. This was done gradually with new tools inserted into gaps that became available. A board with a sponge lining, measured to fit, was placed against each transfer section and after the section had been cut away completely it was gently lowered to the ground. In the end each transfer section was resting face down on a separate board. The wall paintings were transported to safe storage in the Tolmeita (Ptolemais) Museum. The boards were set one on top of the other on wooden blocks that ensured proper space between each successive layer.
