## Nea Paphos: Excavating below the Mosaic of the Southern Portico in the Villa of Theseus

Polish Archaeology in the Mediterranean 8, 122-131

### EXCAVATING BELOW THE MOSAIC OF THE SOUTHERN PORTICO IN THE VILLA OF THESEUS

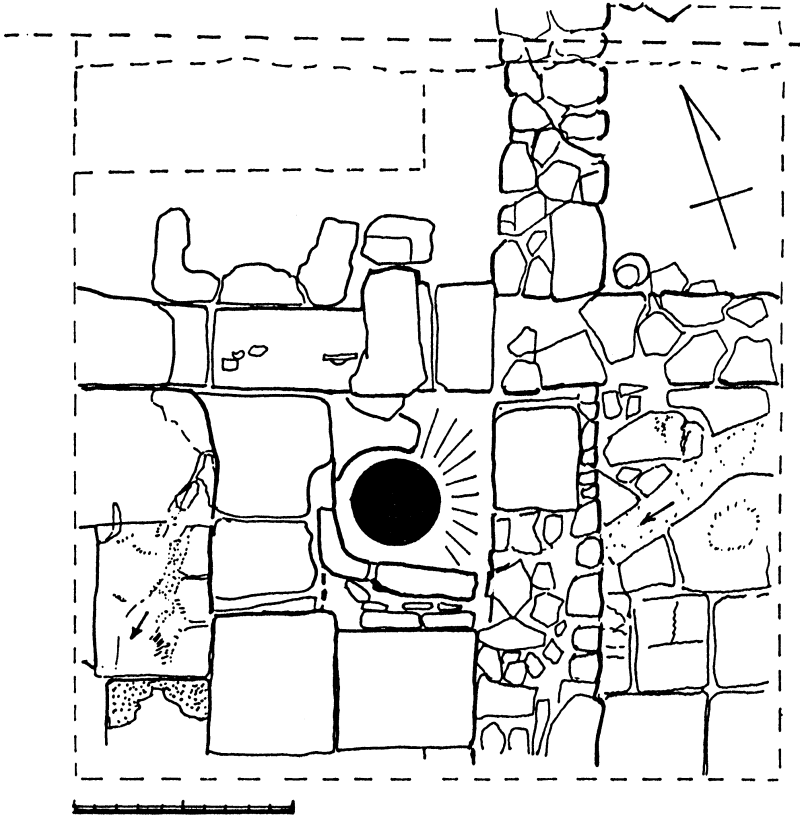
*Fig. 1. Plan of a trench in the southern portico (R.25) of the Villa of Theseus.*

The wellhead was built in the corner of two walls, of which the E-W one to the north of it (S.13) was probably a continuation of the wall uncovered in 1970 near the eastern cistern entrance. The other wall is perpendicular to it and lines the east side (S.8). The wellhead consists of a semicircular parapet (S.2) on the west, and a straight wall on the south. Whether another semicircle existed on the east is not clear. The access to the cistern itself is a narrow circular shaft cut in the calcareous bedrock. The cistern is partly filled with soil and debris; the bottom is currently at a depth of 4.80 m below the mosaic.

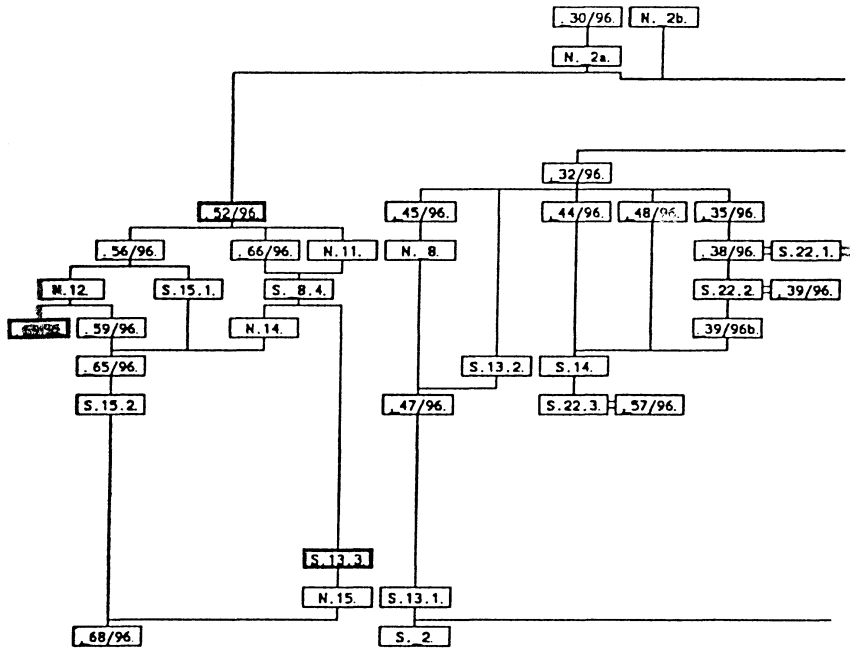
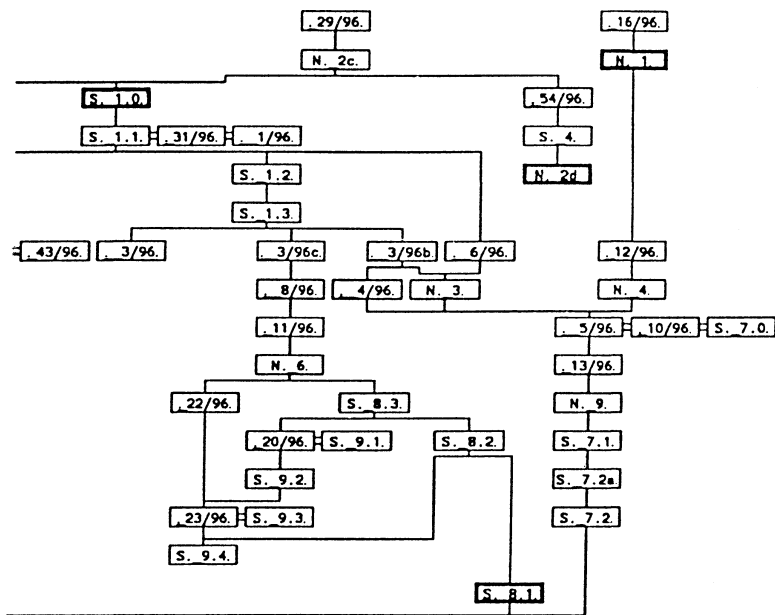
Fig. 2. Stratigraphic diagram of the trench in the southern portico (R. 25) of the Villa of Theseus.

- N.1 Hole in mosaic S.1 over west entry to S.2
- N.2a Mosaic S.1 damage in NE trench corner
- N.2b Mosaic S.1 damage by west trench edge
- N.2c Mosaic S.1 damage along the stylobate S.4
- N.2d Trench for stylobate S.4 foundation(?)
- N.3 Damaged pavement S.7 in SW trench corner
- N.4 Cut through floor/accumulation below S.7.1&2
- N.6 Erosion(?) of upper layers of S.9
- N.8 Removal of block in S.13 behind S.14
- N.9 Cut in pavement S.7, at west edge
- N.11 Cut in N-S wall S.8.4, in east face
- N.12 Pit for cooking pot in NE corner S.8 & S.13
- N.14 Trench (?) N-S for wall S.8.4
- N.15 Trench (?) E-W for wall S.13, east part

- S.1.0 opus tessellatum mosaic in R.25
- S.1.1 Waterproof(?) bedding with ceramic grog
- S.1.2 Leveling plaster of mosaic S.1
- S.1.3 Bedding for mosaic of fist-size stones

- S.2 Cistern below R.25 - wellhead
- S.4 Stylobate of south portico (R.25) of VT
- S.7.0 Hard-packed daub floor on slabs west of S.2
- S.7.1 West pavement of rectangular slabs, with gutter

- S.7.2 Pavement west of S.2, below wellhead
- S.7.2a Plaster floor/surface over pavement S.7.2
- S.8.1 NS wall along east side of S.2 wellhead
- S.8.2 NS wall - south extension + east face
