West Saqqara: Funerary Chapel of Meref-Nebef : Preliminary Report on the Recordings of the Decoration

FUNERARY CHAPEL OF MEREF-NEBEF

Preliminary report on the recording of the decoration

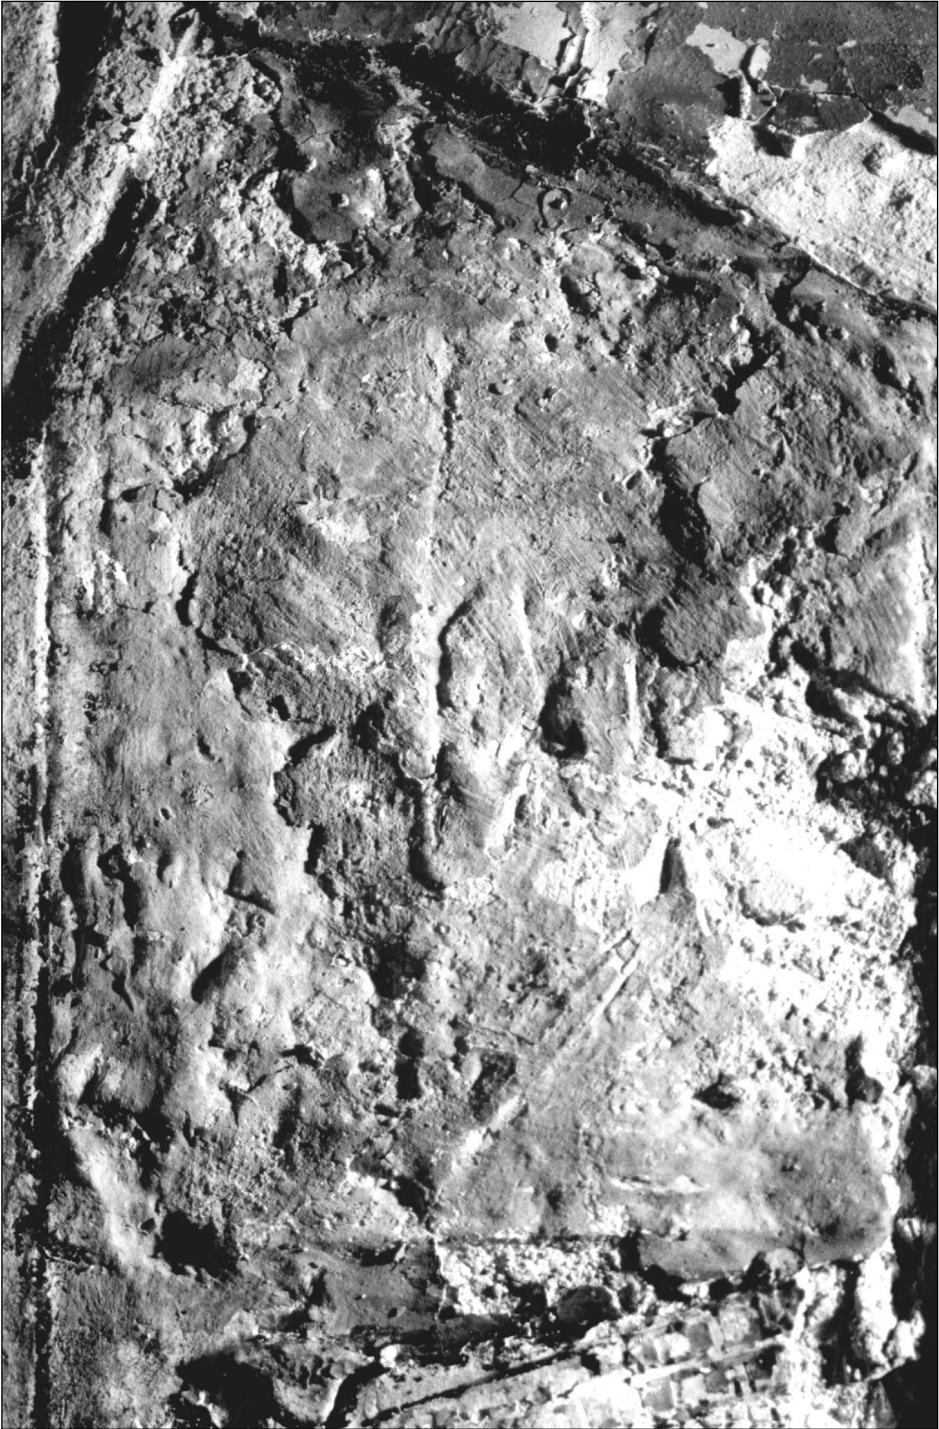
Fig. 2. A damaged and overpainted inscription in the hunting scene on the eastern wall of the chapel, mentioning the pyramid and the *mrrt* temple of king Teti (Photo Z. Kosić)

Certain parts of the damaged decoration were painted over (e.g. scenes in the bottom parts of the lateral walls in the entrance or some parts of the hunting scene on the eastern wall of the chapel – *Fig. 2*). Since there is no evidence of intentional destruction (no traces of chiselling) in damages of this kind, it may be assumed that they resulted from natural surface friability and the overpainting was designed to mask the problem.

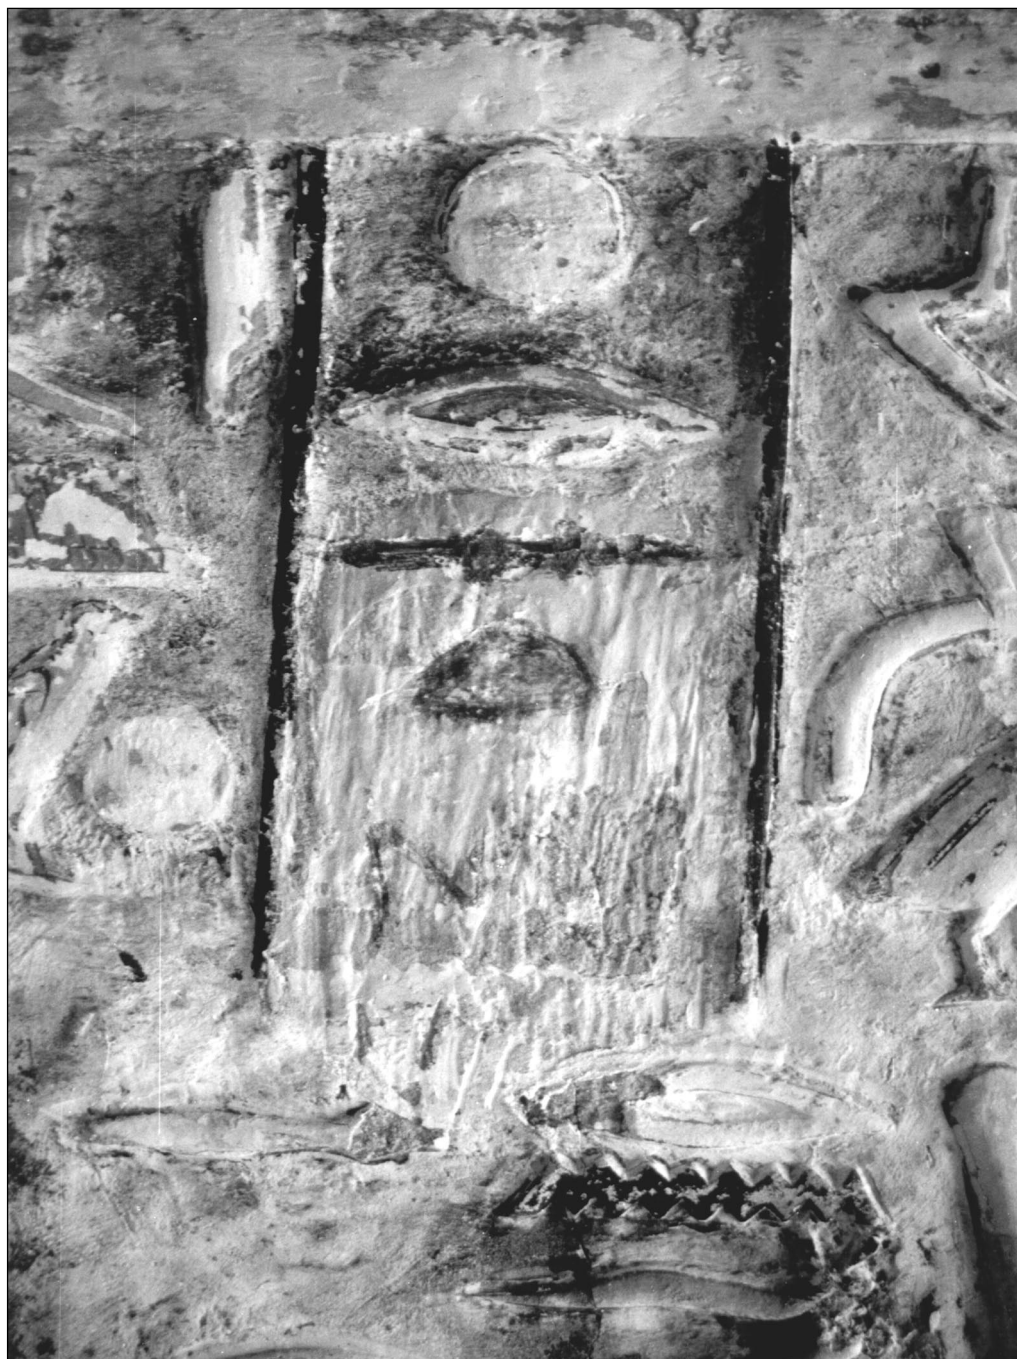
Fig. 4. Fragment of the inscription in scene 25: the chiseled out word *nswt* in the formula *im3hw hr...* and the word *smit* painted in its place (Photo Z. Kości)

However, certain elements (the word *nswt* in the formula *imꜣhw hr nswt* (cf. *Fig. 4*), the figures, names and titles of two or three sons of Meref-nebef) were intentionally chiseled out in ancient times (there are clear traces of a chisel with a cutting edge of c. 9 mm). While the previously described damages show definite care in their masking, no effort was made to conceal parts that had been chiseled out; they were neither painted nor covered with plaster. Solely in the scene on the southern wall of the entrance the word *smit* was painted in black in a place where the original *nswt* had been chiselled out. Nonetheless, the surface had not been evened out, the damage was not concealed and the painted hieroglyphs themselves are quite careless (*Figs. 3-4*).
