Deir El-Bahari Cliff Mission, 1999

DEIR EL-BAHARI

CLIFF MISSION, 1999

Andrzej Niwiński et al.

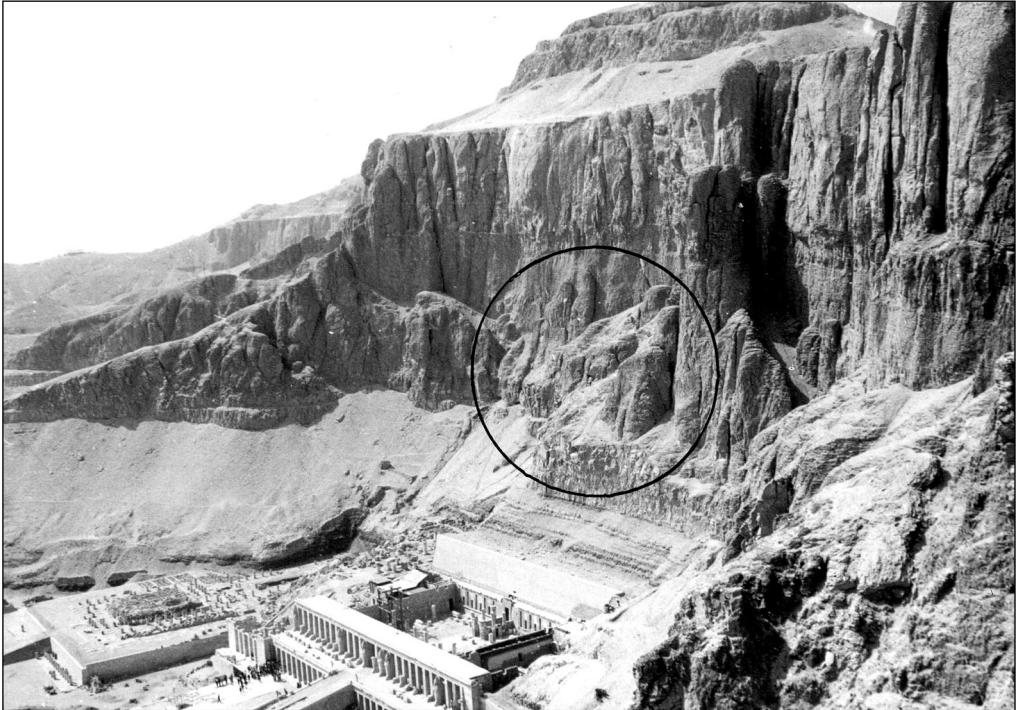
*Fig. 1. General location of the site
(Photo A. Niwiński)*

The cliff closing the Deir el-Bahari circus from the west and separating this area from the Valley of Kings features three levels which are clearly separated one from the other by horizontal shelves, now covered with weathered rock debris (*Fig. 1*). The first level corresponds to the lower part of the limestone Thebes Formation positioned directly on top of the Esna-Shales – this is the fissured wall overhanging the Hatshepsut temple. Rising some 100 m above the lower terrace of the Hatshepsut temple is the middle level, which is topped by a broad shelf covered with debris that is several meters thick in places. The third level comprises the vertical rocks of the uppermost part of the massif. Work concen-

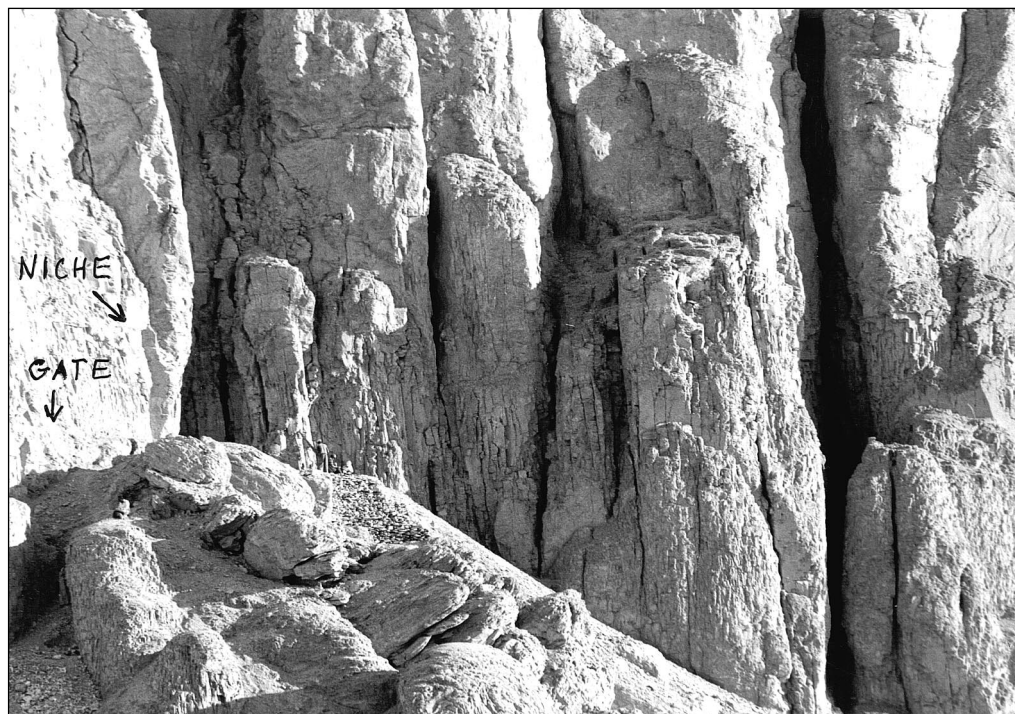
Fig. 2. The investigated area showing the position of the "gate", "niche" and "crevice"
(Photo A. Niwiński)

trated this season on the southern part of the middle shelf, limited on the north by the mace-like gigantic piece of the cliff that looms over the Hatshepsut temple. The southern limit of the researched area was constituted by the climbing "chimney" positioned over the temple of Mentuhotep (*Fig. 2 and 3*),

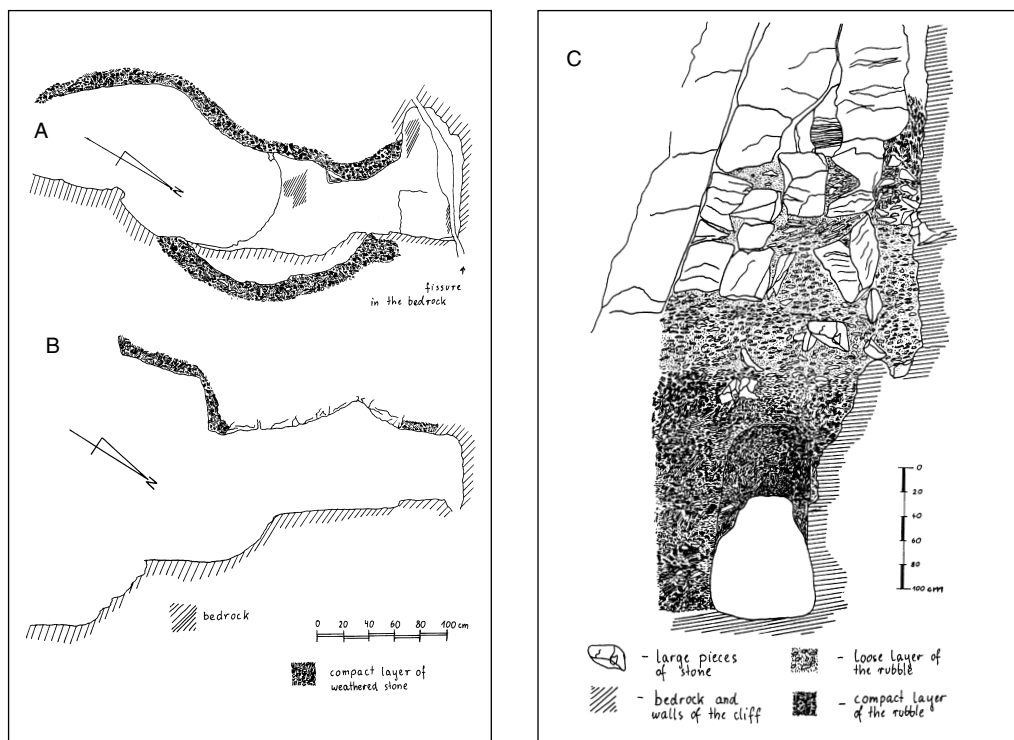
Fig. 7. Robbers' tunnel: A - horizontal section; B - side-view, C - vertical section through the rubble accumulation at the southern end of the "niche" (Drawing M. Budzanowski)

A tunnel, 80 cm wide and of a similar height, was discovered south of the niche. It was excavated in the compact rubble accumulation immediately above bedrock and stops after about 2.50 m, evidently unfinished (*Figs. 6 and 7*). This tunnel, apparently the work of ancient thieves, appears to have been posterior to the collapse of the large stones, as the entrance to it was located among the boulders; moreover, the combined weight of the falling rock would have probably destroyed such a tunnel.

Once the whole niche was excavated down to bedrock, a fissure was discovered in the rock in the middle of the niche. It is well visible inside the robbers' tunnel, continuing upwards in the layers of the rubble. Since it does not appear in the adjacent cliff walls, it should be construed as the effect of falling rocks.
