## Kom El-Dikka: Preservation Work, 1998

## PRESERVATION WORK, 1998/99

Wojciech Kołataj

*On account of the ARCE/EAP Conservation Project (USAID Grant no. 263-G-00-00089-00) aimed at the conservation and display of Roman mosaics on Kom el-Dikka, partly uncovered in previous years by the Polish Archaeological Mission, restoration works were carried out continuously from July 1, 1998, through June 30, 1999.<sup>1)</sup>*

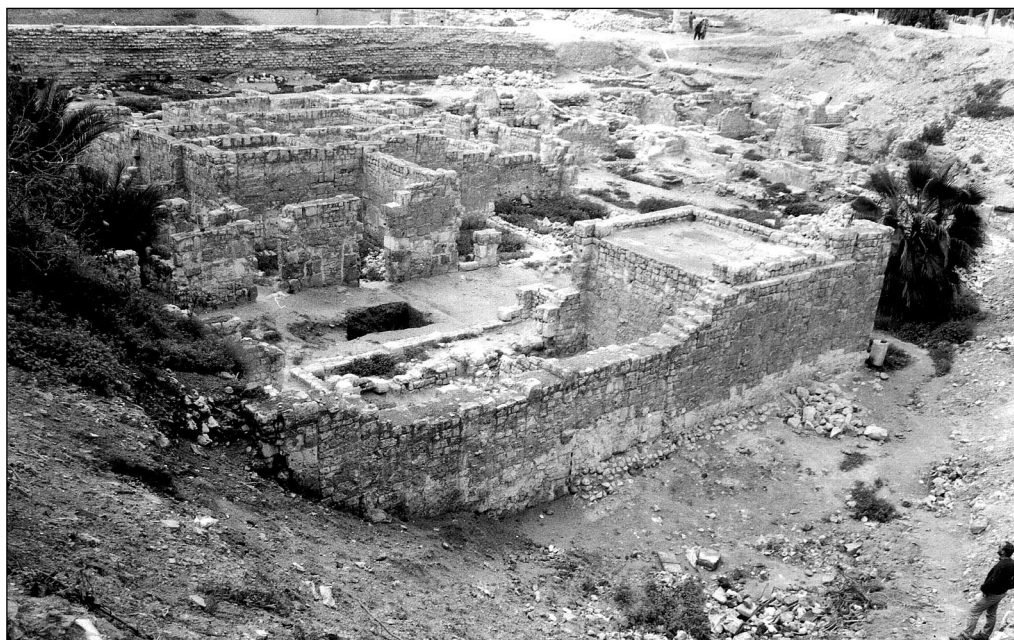
*Fig. 1. Roman residential quarter. Site of the mosaics before the construction of the shelter  
(Photo W. Kołtątaj)*

The four mosaics (panels with representations of birds, a rosette, a panther and the *opus sectile* pavement) selected for this project belonged to an Early Roman villa (1st-2nd cent. AD) situated in the Roman residential quarter, in the southeastern corner of the site (close to Saphia Zaghloul street) (Fig. 1, 2). The mosaics, which display different subjects and techniques of execution, and which testify to subsequent phases of occupation, are located c. 4.5 m above sea level. They were first excavated in the 1970s, protected provisionally and covered.<sup>2)</sup> The present project entailed the conservation of the mosaics, partial rebuilding of enclosing walls, and erection of a specially designed shelter over the mosaics (15 x 12 m) complete with an access path to the building and information displays for the public.

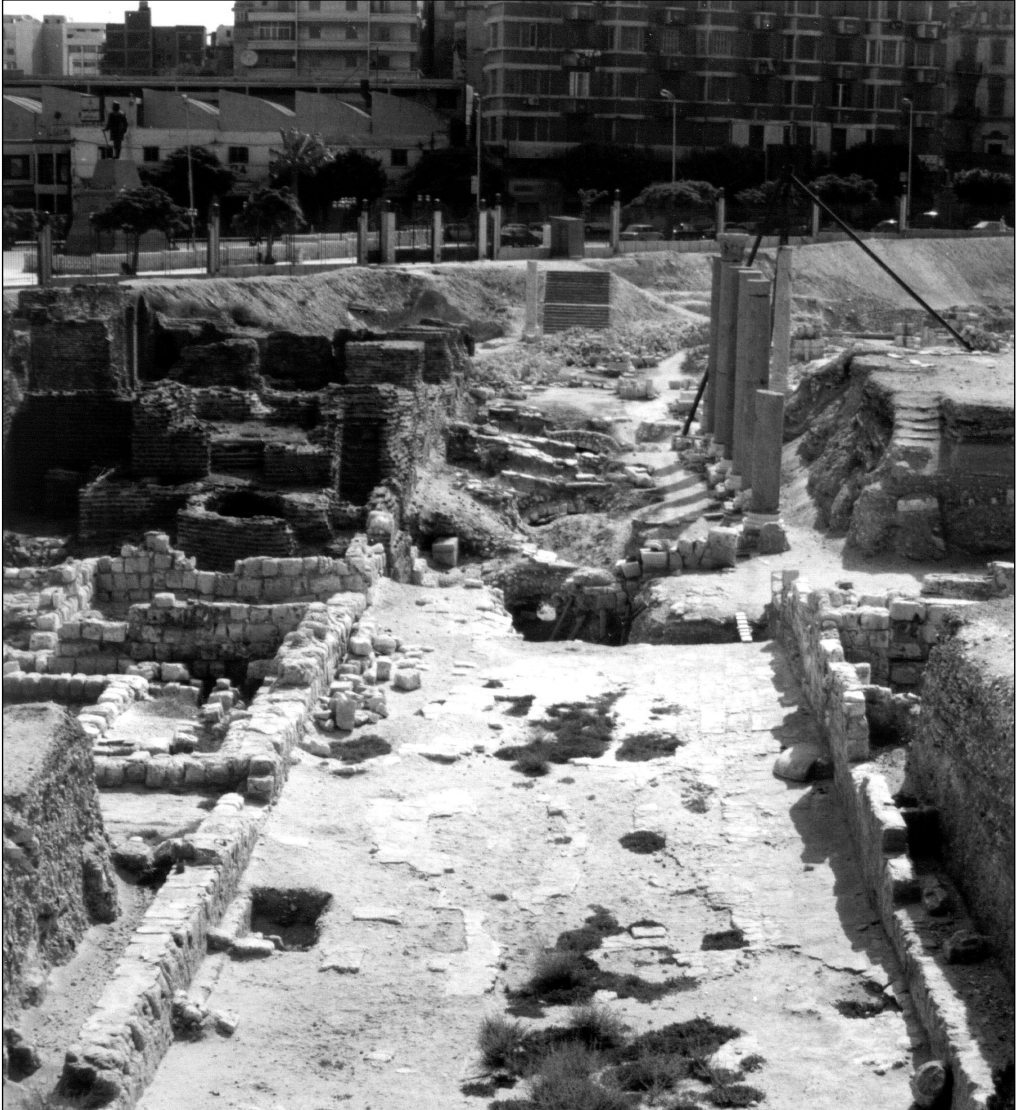
*Fig. 4. Southern passage of the baths  
(Photo W. Kotgatj)*

Landscaping operations along Saphia Zaghloul Street required new steps to be constructed from the main gate on this side to the southern passage of the baths,

which will constitute the main tourist path of the Archaeological Park to be created soon at the site (*Fig. 4*). A section of the foundation wall of the main bath entrance

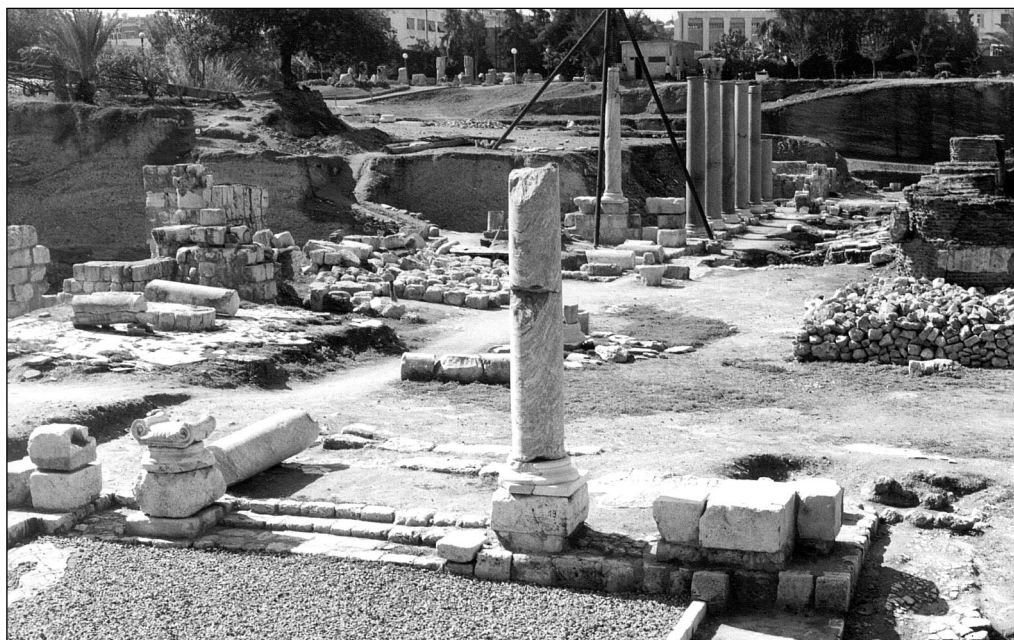
*Fig. 5. Eastern edge (entrance) to the southern passage of the baths  
(Photo W. Kołtątaj)*

from street R 4 was reconstructed (*Fig. 5*). The anastylosis of a marble column at the corner of the southern gymnasium was completed (*Fig. 6*). Conservation work in the cisterns has nearly been completed. The northern facade was accorded top priority. A badly damaged and eroded fragment of the original wall (c. 15 m<sup>2</sup>) was carefully dismantled and reassembled following conservation treatment of particular blocks. The reconstruction of missing parts of the facade was also initiated. A new foundation wall was prepared along the entire facade (c. 23 m long), and several courses in the wall were restored

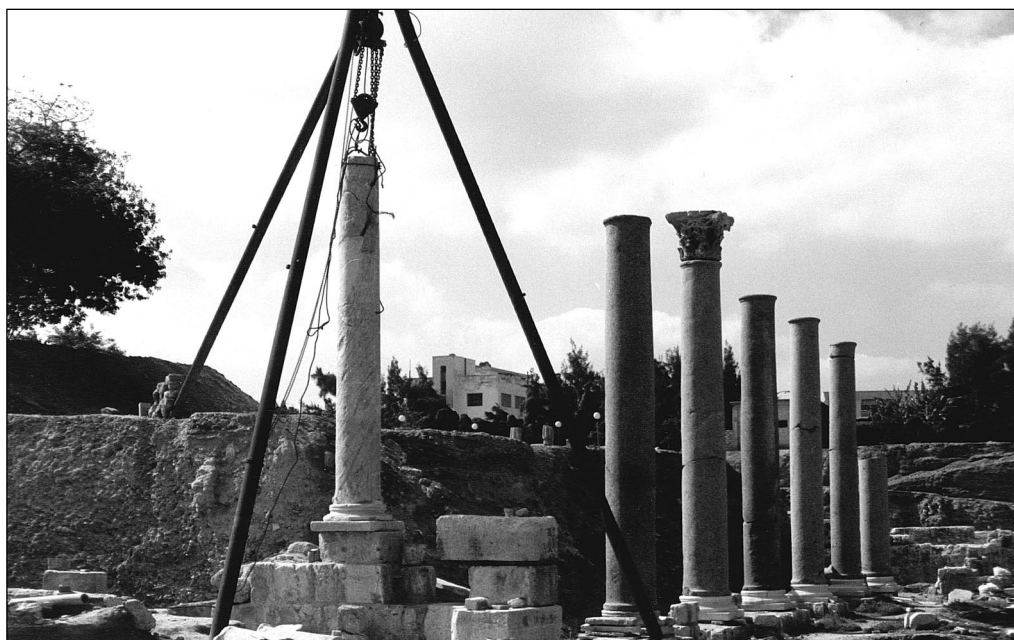
*Fig. 6. Anastylosis of a marble column from the southern gymnasium  
(Photo W. Kołtątaj)*

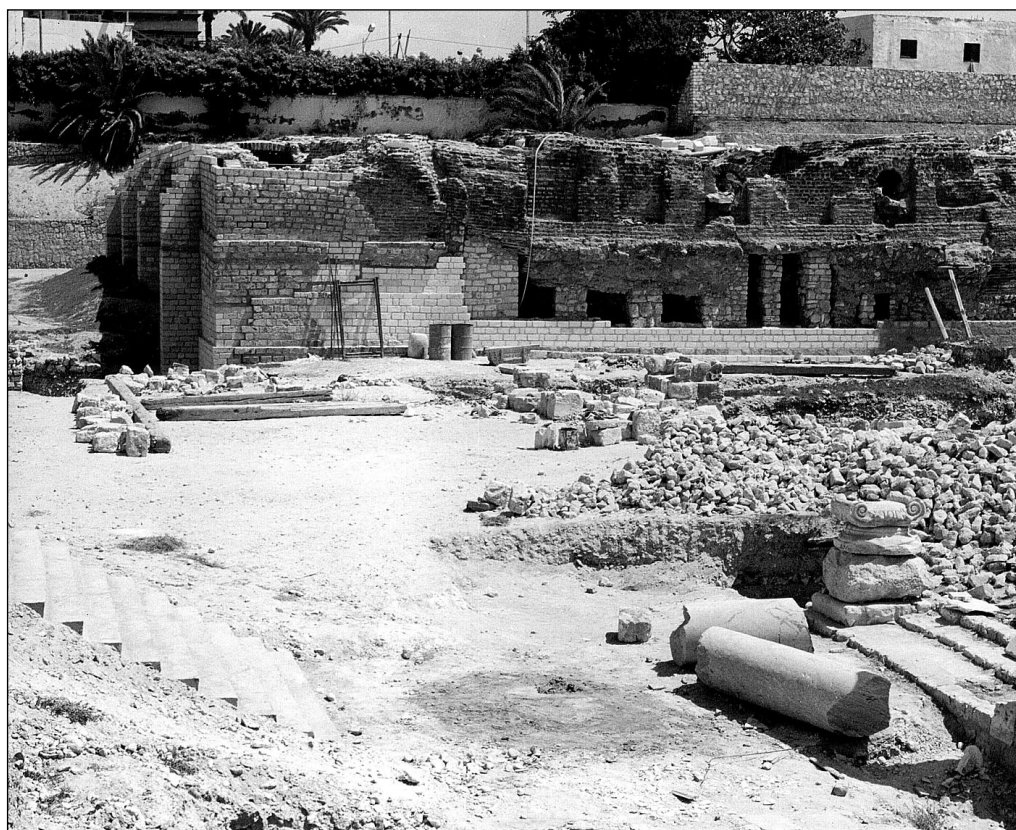
*Fig. 7. Cistern. The northern facade during reconstruction works (Photo W. Kolqataj)*

(c. 18 m<sup>2</sup>). Serious delays in the supply of building materials precluded the completion of some of these operations (*Fig. 7*). A long-term operation for removing c. 15,000 m<sup>3</sup> of earth and debris overlying the Theater Portico has left the area open to archaeological excavations, which have begun in the southern end. The discovery of yet another fallen column of the portico prompted the decision to execute new bases for the columns with a view to completing the planned reconstruction. In preparation for the anastylosis of the Portico in the next season, two bases were cut of Helwan limestone.
