## Deir El-Bahari: The Temple of Tuthmosis III : Season 2000

Polish Archaeology in the Mediterranean 12, 215-219

## THE TEMPLE OF TUTHMOSIS III SEASON 2000

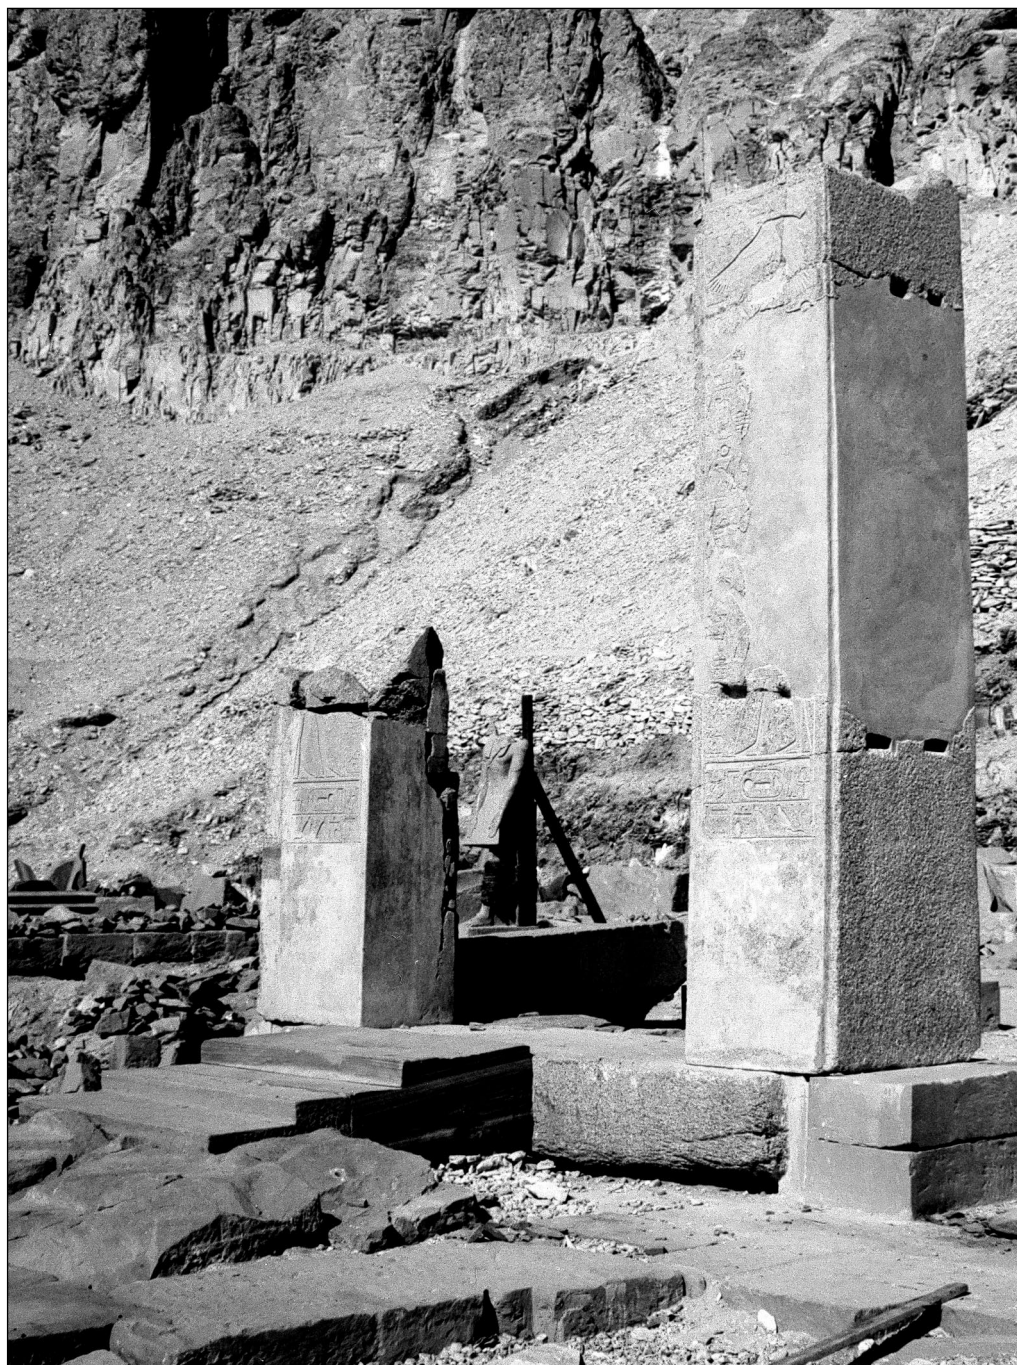
The most important task of the season was completing the restoration of the northern jamb of the granite doorway leading once from the Hypostyle Hall to the Bark Shrine (*Fig. 2*).<sup>2)</sup> The reconstruction (comprising all loose pieces coming from the excavations in the 1960s) and re-erection of the jamb were carried out in 1996.<sup>3)</sup> The jamb is 3.9 m high, 0.80 m wide and 0.95 m deep. Originally, it leaned 0°13'26" southwards and 2°6' westwards. The westward inclination has increased slightly since antiquity and now is 2°58'48"; it was decided nevertheless to leave the jamb in the present position, as the inclination does not affect its stability. Due to a shortage of time in 1996, the jamb had to be left unfinished and its bare

*Fig. 2. The Granite Doorway. State in April 2000  
(Photo J. Aksamit)*

reinforced-concrete core remained visible where no original granite surface had been preserved. In 2000 the gaps between the original surface and the core were filled in with limestone chips bound together with white cement mortar. The filler was then covered with plaster tinted with crushed sandstone. The color thus obtained resembles that of the ancient plaster restoration visible in the lower part of the jamb's northeastern edge.<sup>4)</sup> The reconstructed jamb illustrates very well the original dimensions of the whole doorway. The upper part of the southern jamb (unfortunately, almost devoid of decoration, which was hacked away already in antiquity, during the demolition of the temple), preserved as a two-ton block of

granite (1.96 m high, 1.0 m wide and 0.82 m deep), awaits re-erection; the complete documentation necessary to carry out this project has already been prepared.

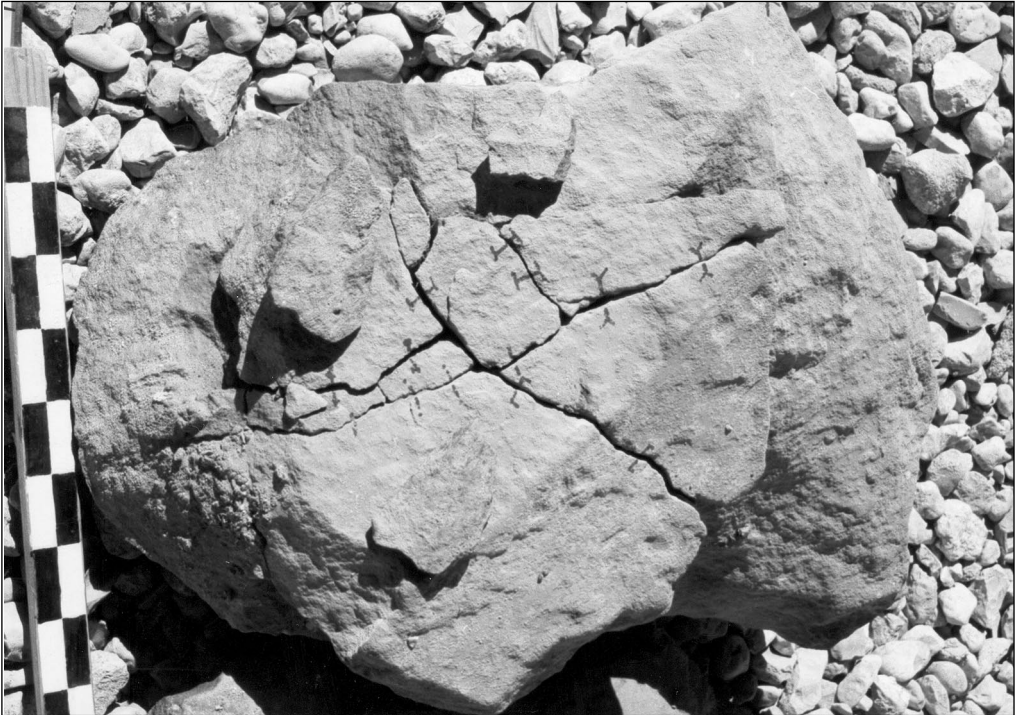
Two large pieces (each of them measuring c. 0.55 x 0.9 x 1.25 m) and several smaller fragments of sandstone remained of base D-2. Base E-2 originally consisted of two sandstone blocks, but only one of them –

Fig. 3. Fragment of base D-2, before conservation  
(Photo J. Aksamit)

damaged were temporarily dismantled and consolidated with ethyl silicate (*Fig. 3*). Underneath both bases new foundations were made in the form of c. 10-cm thick reinforced-concrete slabs. Each slab was placed on a layer of gravel. In the next step the loose elements of the bases were put back in their original position. Where necessary they were glued together with epoxy resin (Araldite) or simply built up with mortar based on white cement. The gaps were then filled with small pieces of stone bound together with mortar of lime

and white cement, and the surface of the fillings was covered with colored mortar. The missing parts of base D-2 were reconstructed out of new sandstone blocks (0.55 x 0.35 x 0.7 m and 0.55 x 0.6 x 0.55 m). A place was left on the new foundation slab of base E-2 for the future reconstruction of its missing part. The inscribed sandstone drum of a column, which was put on top of column B-2 and temporarily supported with wooden pegs in 1993, was now fixed in place with stone and mortar.
