MAREA

SECOND INTERIM REPORT, 2001

Hanna Szymańska, Krzysztof Babraj

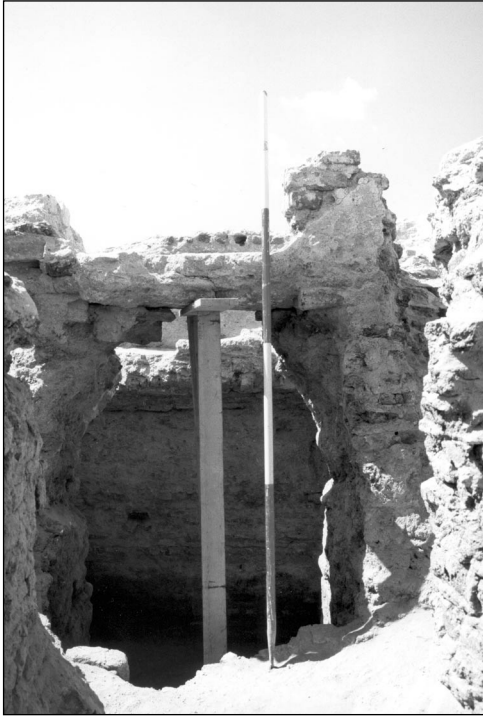
independent parts, A1 and A2. A doorway connected the two parts, a partly surviving threshold in this doorway (*Fig. 2*), consisting of a marble slab with a circular hole for mounting the door pivot and thickly plastered side walls of brick.

Fig. 2. Doorway with surviving threshold between rooms A1 and A2 (supported by the scaffolding), view from the east (Photo T. Kalarus)

The division between chambers A1 and A2 was repeated on the cellar level with a vaulted passage connecting the space under unit A2 with the hypocaust cellar under room A1 (cf. *Fig. 2*). Yet another vaulted passage in the northern wall of the space under room A2 connected it with the yet unexplored cellar under *apodyterium* B (entered last year through furnace O, but left unexplored). A third passage in the southern wall of this space turned out to be an arched exit that had been blocked with clay and earth. Outside it, indeed already outside the bath building, a low irregular wall had been built of stones, forming a kind of rounded bulkhead protecting this entrance (cf. *Fig. 12*). The space itself was of considerable height (all of 3 m) and had a regular brick-laid floor.

the space under chamber A2 (*Fig. 13*), as well as in the entrances to the cellars under chambers B and A1 (cf. *Fig. 2*); finally, also under the extant section of floor uncovered in the northern end of the hypocaust cellar under A1.

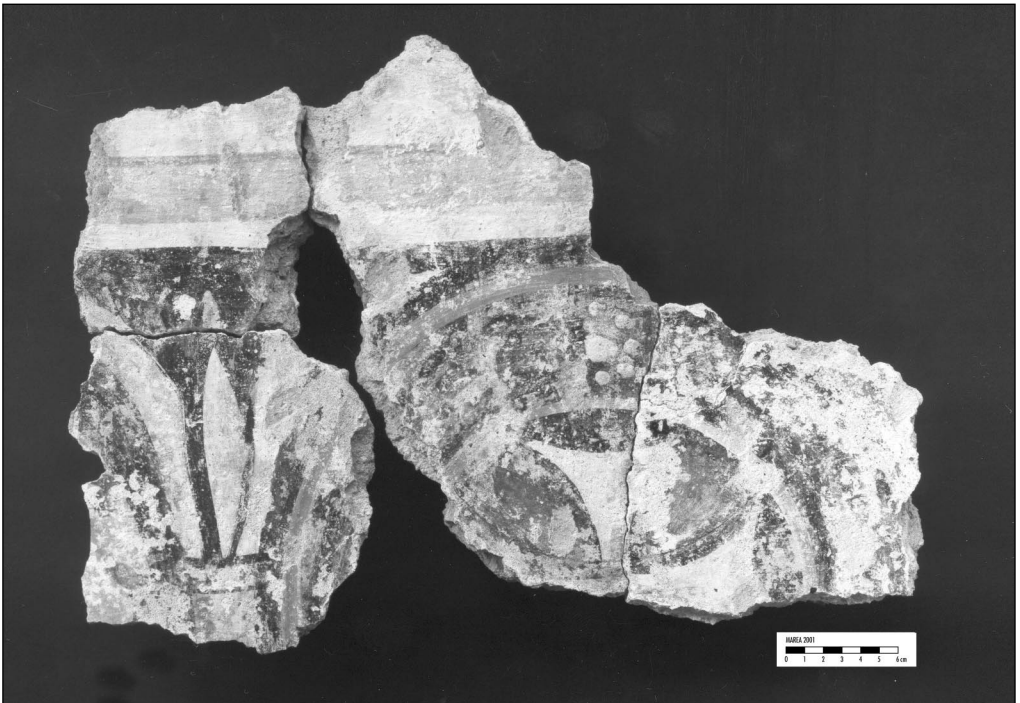
Fig. 5. Fragments of painted mural decoration from chamber A2 (Photo T. Kalarus)

In room A2 (2.20 by 3.70 m) marble flagging was recorded as imprints in the floor bedding only in the northern end of the room, directly by the entrance from room B (the presumed *apodyterium*, otherwise cloakroom, excavated last year). The debris filling this space yielded enough painted plaster fragments – the colors surviving in excellent condition – for a vegetal ornament to be reconstructed (*Fig. 5*). The colors, which range from yellow and red to black and white, represent the preferred pigments used in decorating Coptic ceramics.

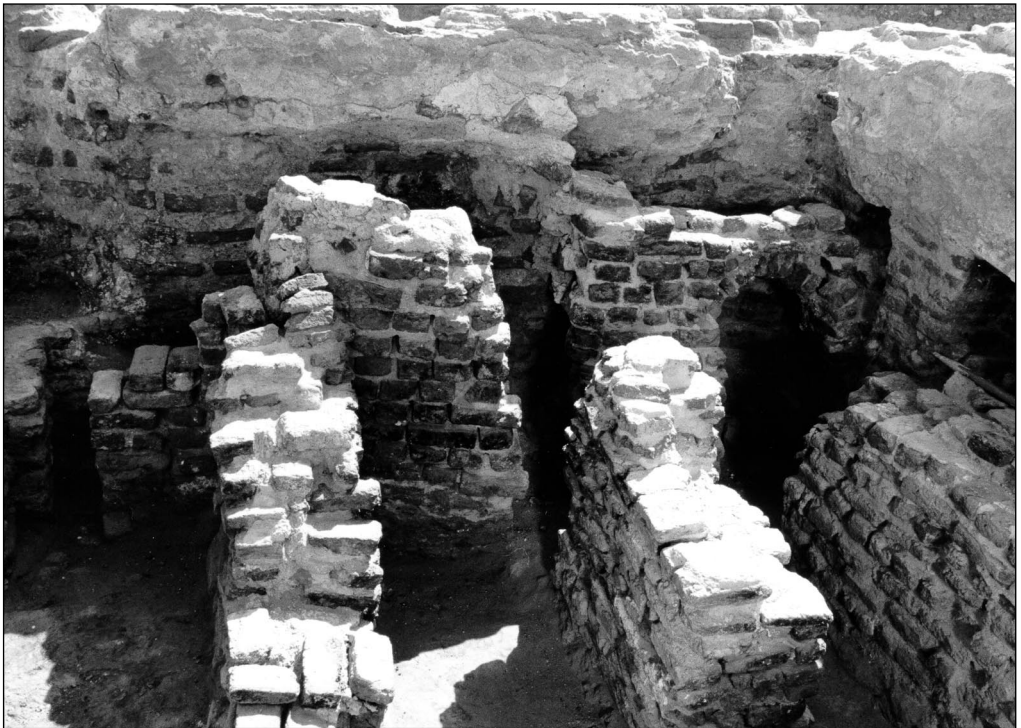
The hypocaust cellar under the floor of room A1 (*Fig. 6*) was also furnished with a brick-laid floor, upon which there stood three brick walls, all oriented east-west, supporting the floor of the room above on vaults. The bricks used for the construction of these walls were flat, measuring 23.5 x 19 x 3 cm, laid in alternate header/stretcher bond. Clay was used instead of lime mortar as bonding (similarly in the lateral walls of the cellar) in order to prevent heat-induced cracking – clay when mixed with greasy soot forms an elastic, stretching mass. The center wall (3.80 m long) had a passage through it at about one-third of its length. Fragments of the vaults (assuring proper circulation of warm air throughout the cellar) have survived between the south wall of the

*Fig. 6. Hypocaust cellar under room A1, view from the west
(Photo T. Kalarus)*

cellar and the southernmost of the hypocaust walls, altogether in five places along this section.

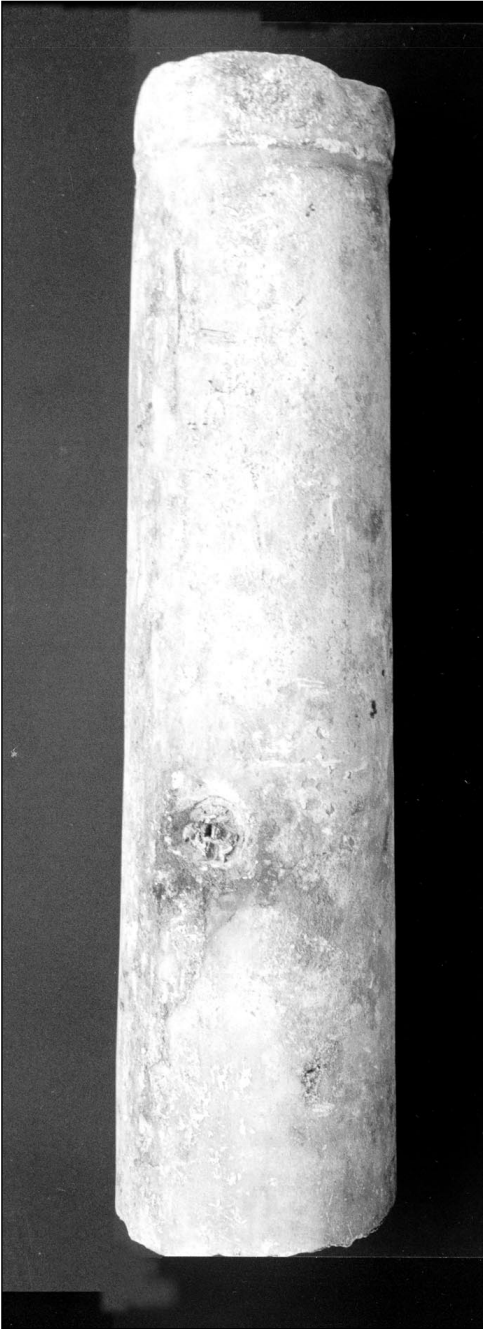
Fig. 7. *Marble column shaft with two rods attached for suspending lamps*
(Photo T. Kalarus)

The debris filling chamber A1 yielded interesting data on the putative roof of the bath and the interior decoration. One example is the shaft of a marble column, 18 cm in diameter, and a Corinthian capital measuring 19 cm across at the base, the two perhaps belonging together. At approximately mid-height, the column shaft had two small bronze rods attached with mortar (Fig. 7). The column could not have served any structural purpose, while the soot on the capital, assuming the two pieces were a set, would suggest that lamps may have once been suspended from the rods. A similar but slightly smaller Corinthian capital (16.5 cm in diameter at the base) was discovered in chamber L, and a marble column base (27 cm in bottom diameter) at the bottom of the adjacent pool R; the latter piece resembles the base uncovered last year in chamber A1. All these architectural elements must have belonged to the interior decoration of the bath. Interestingly, the brick debris from east of the entrance to chamber A1 yielded two pieces of brick wall with heart-shaped openings cut through the thickness. These openings had once been paned – indeed, a piece of green glass has survived, plastered to the edge of the aperture (Fig. 8; see also p. 70 below). These two surviving fragments must have constituted a structural part – either of the wall or vault – of a passage leading from the *tepidarium* (A2) to chamber A1.

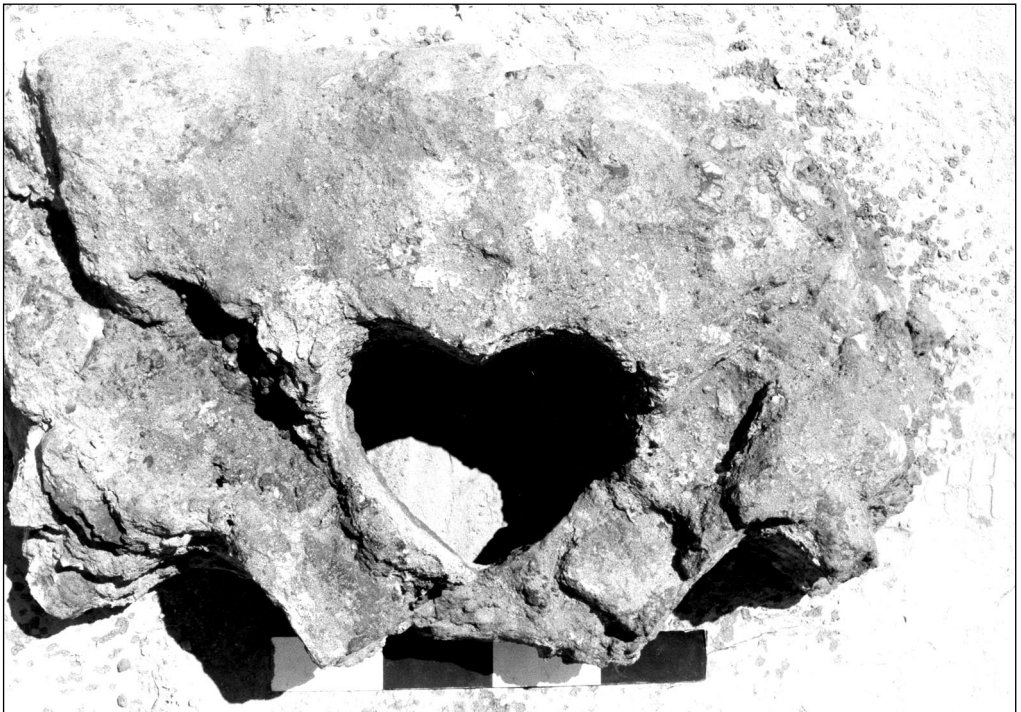
*Fig. 8. Wall fragment with paned opening
(Photo T. Kalarus)*

as in the entire southern part of the trench, shards of window panes were found in quantity, some of them still embedded in plaster (cf. below, *Figs. 2:8-9; 3* on pp. 67-68). Some have plaster attached in such a way that they must have been used as wall revetment, imitating the mosaic decoration so common in ancient architecture. Few such finds have been noted in the archaeological record to date⁵⁾ and their significance for studies of lighting in public buildings of Late Antiquity cannot be underestimated.

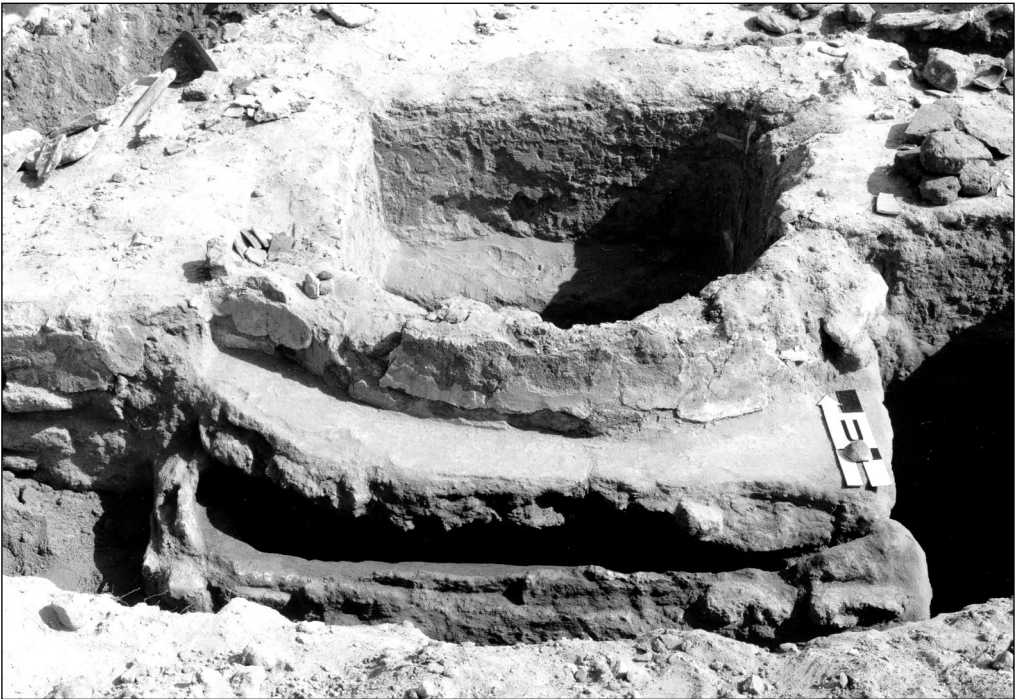
walls, the footing of the south wall of the bath was recorded at a depth of 214 cm below the occupational level of the bath. Still further east two pools were uncovered superposed on the structure of this wall. The first of the pools, U, was semicircular in shape (1.27 m deep) and furnished with the mandatory three steps. It was rebuilt at one point, confirming yet again the two-phased building sequence already established elsewhere in the bath. The new pool was smaller, built into the older one, the voids filled in with clay (*Fig. 9*). A smaller pool W, almost square in shape (0.90 by 0.88 m, 1.25 m deep) and also furnished with steps, was found next to it. At the eastern end of the uncovered section of the south wall of the bath a drainpipe of triangular section was found. It had

Fig. 9. Pool U in the southern part of the bath, view from the south (Photo T. Kalarus)

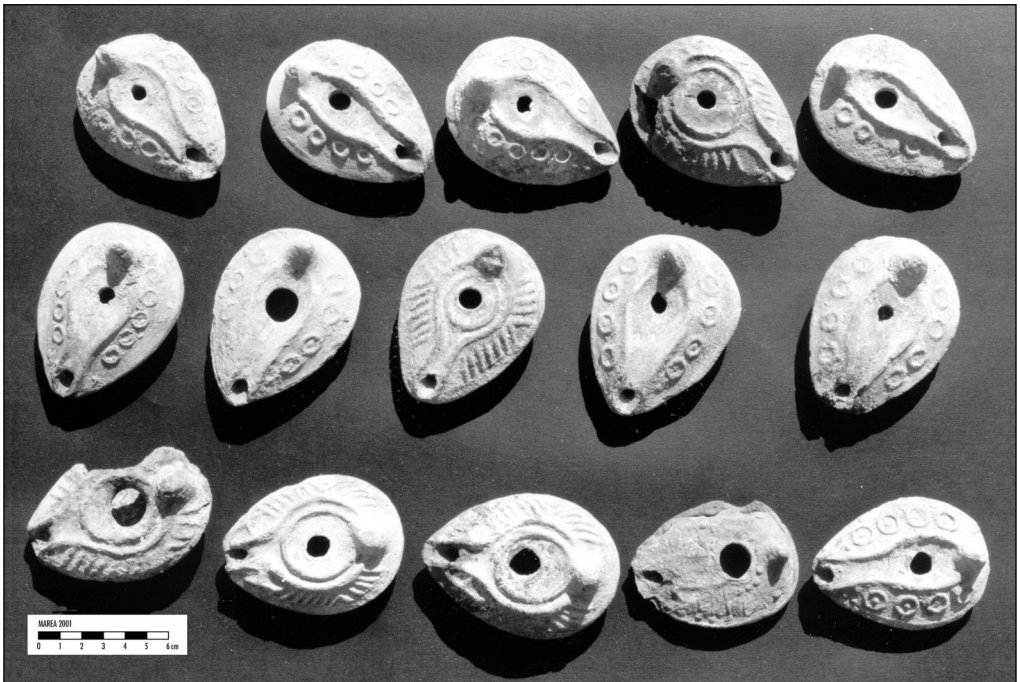
The fill accumulated at the northern end of channel Q1 yielded 20 oil lamps (a few from the same mould!) and another 15 came from the area around the northern end of Q3. These are highly typical Byzantine lamps with rays or relief circles, or grapevine clusters on the shoulders, dated principally to the years AD 550-650 (Fig. 11).⁶⁾

Fig. 11. Oil lamps found inside channel Q1
(Photo T. Kalarus)

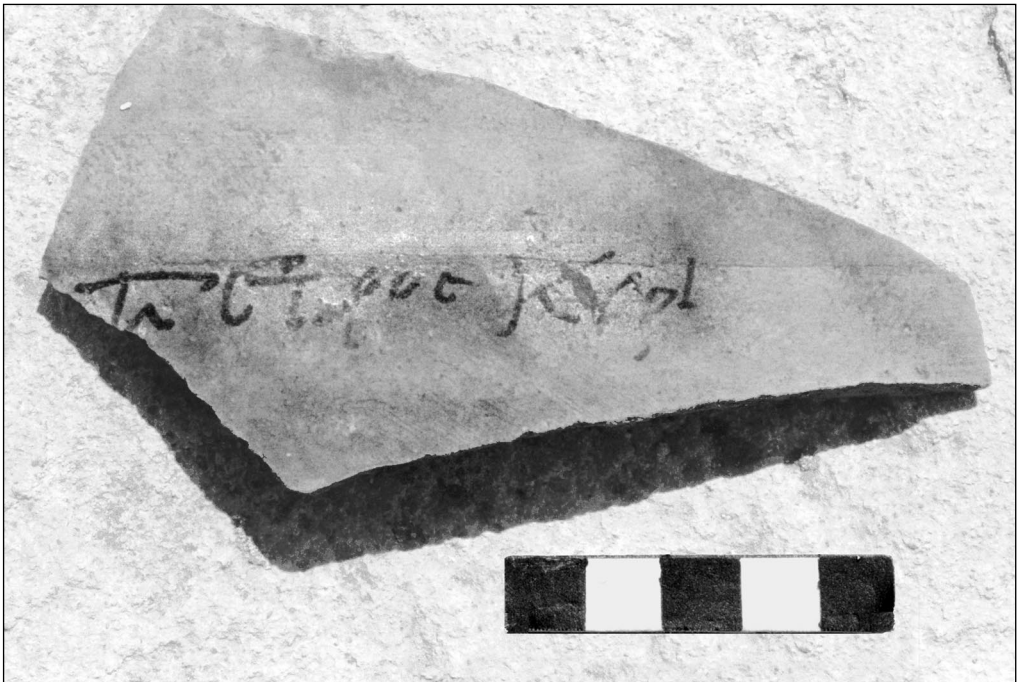
Greek: Πετρος κυρι(ος) (*Petros kyrios*), found in chamber E1 (*Fig. 12*); it should probably be referred to the last phase in the operation of the bath, that is, the mid-7th century.⁷⁾ A total of 50 bronze coins, mostly heavily corroded, were recovered from the fill of the pool discharge conduits. Those that could be read (before cleaning by a conservator) are attributable to the 7th-century Byzantine emperors, from Heraclius II to Justinian II.

*Fig. 12. Ostrakon with Greek inscription
(Photo T. Kalarus)*
