Polish Archaeology in the Mediterranean 14, 230-236

THE MONASTERY CHURCH ON KOM H IN OLD DONGOLA 2002

Daniel Gazda

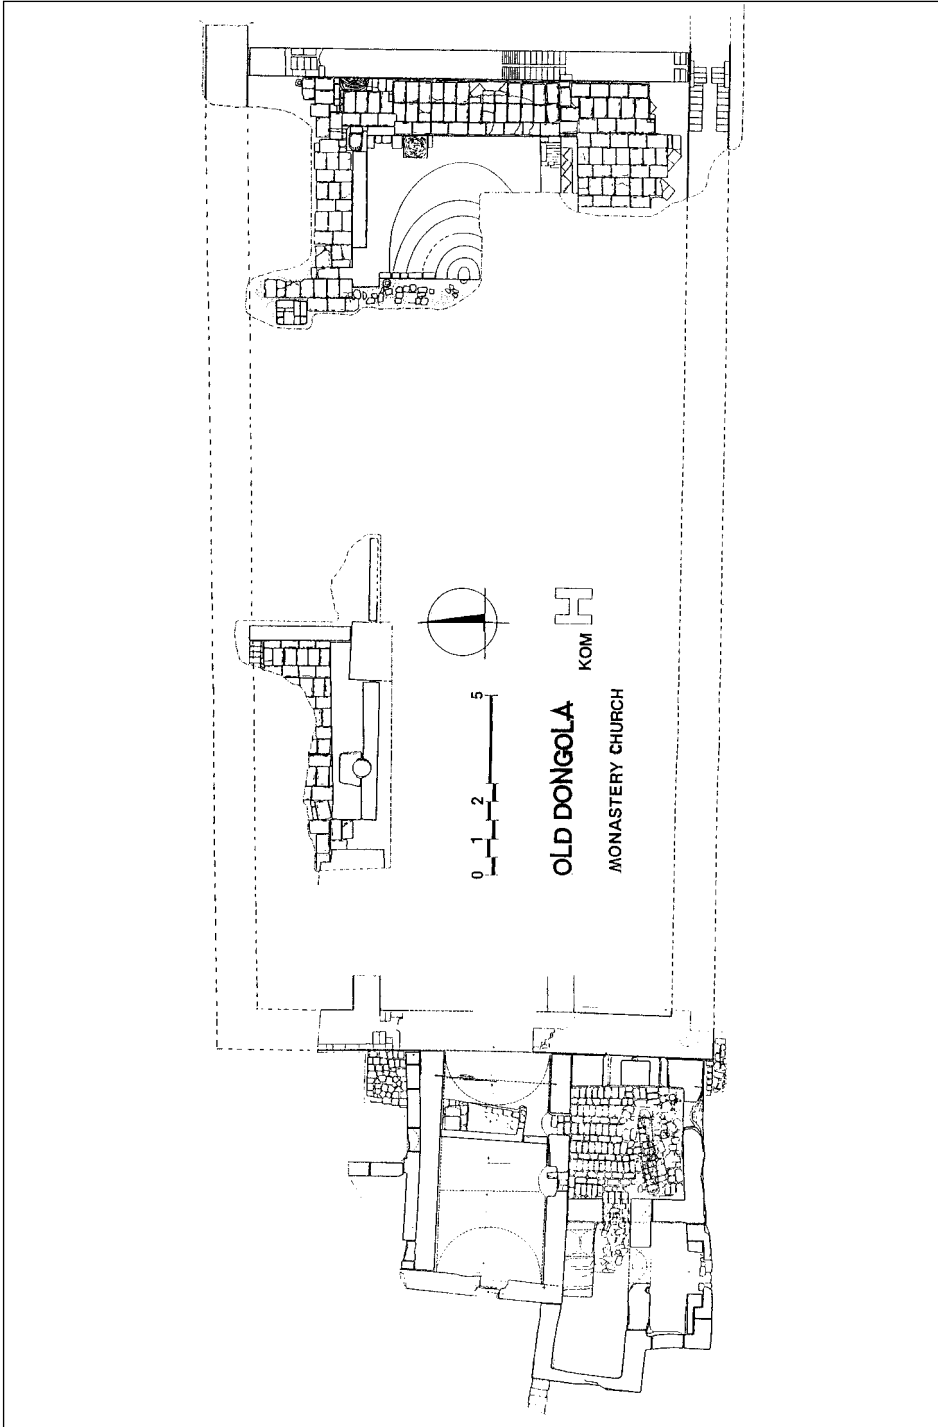
Fig. 1. Plan of the Monastery Church with Unit S rooms adjoining it on the west
(Drawing, based partly on earlier documentation, M. Wiewióra)

In 2002, during two field seasons in January-February and in November 2002 through January 2003, some testing was carried out in the area of this structure. A fragment of the apse was uncovered and work was continued in the eastern end of the building and in the western part of the north aisle (*Fig. 1*).

To sum up, the church was obviously three-aisled, the inside measurements being 25 by 12 m. It must have been erected in the 7th century at the latest and remained in use until the 13th century for sure. Three phases of rebuilding have been recorded. During the last phase, in the 11th century, the interior underwent some alterations and murals were introduced in the vestibule. Of the two recorded floors, the earlier one was connected with the building of the apse, while the second ceramic tile paving dates most certainly from before the 11th-century rebuilding. Further excavations should verify these conclusions.

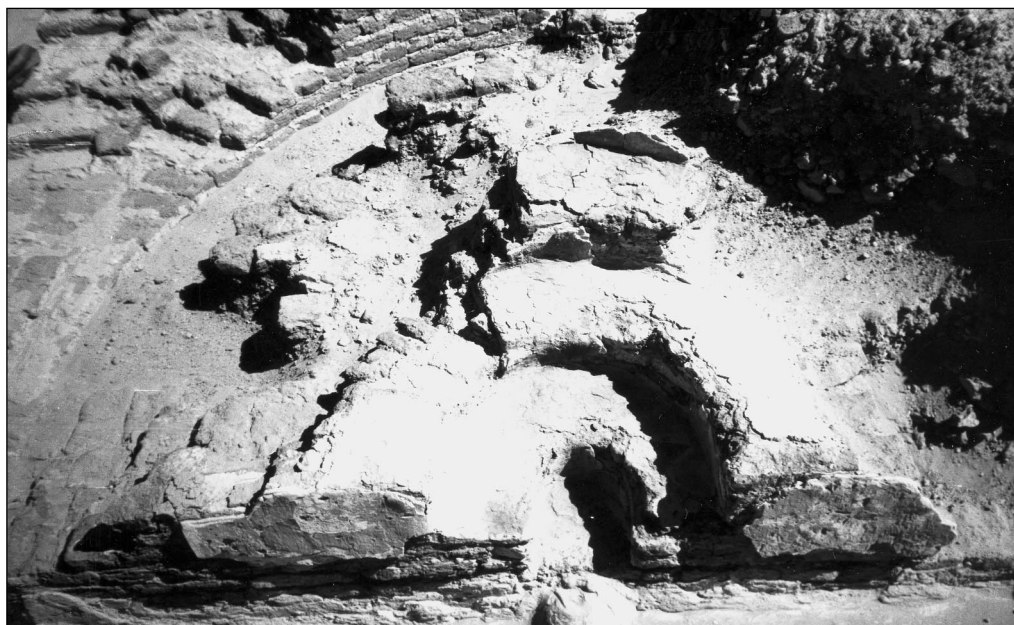
Fig. 2. *The apse with the synthronon, viewed from the west*
(Photo D. Gazda)

The apse uncovered in the eastern end of the building was rectangular, measuring 5.10 by 4.10 m with a *synthronon*, of which the three lower steps have been preserved (originally six-stepped?) (*Fig. 2*). Two *mastabas* had been built, one on the north side of the apse (0.43-0.46 by 3.14 m), the other on the south (0.43 m wide, length

unexcavated as yet). In the east wall of the apse, close to the northeastern corner, a heavily sooted niche for lamps, 0.63 by 0.64 m, was recorded. Behind the apse there runs a passage 1.35 m wide, which was not separated from the lateral pastophoria.

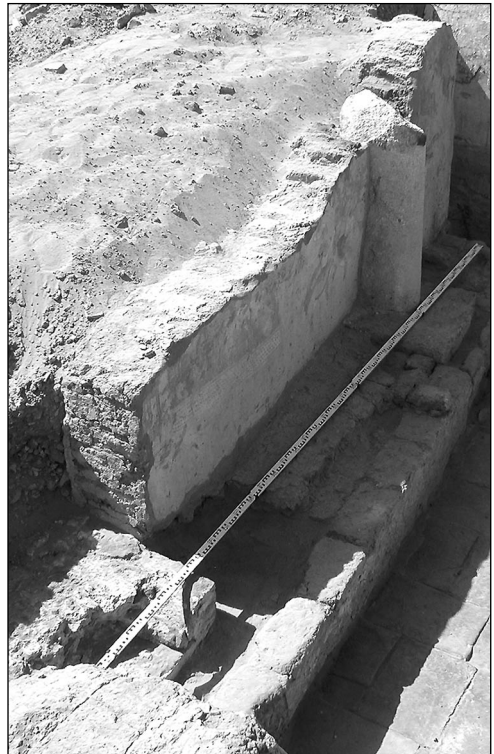
Fig. 4. The so-called vestibule, viewed from the east (Photo S. Jakobielski)

In the north aisle fragments of two piers were uncovered, as well as a wall on the south separating the lateral aisle from the nave, a passage between the aisles and a wall in the east partitioning the north aisle, part of a floor and a *mastaba* adjoining

these walls (*Fig. 4*). This part of the church may be presumed as a kind of entrance vestibule measuring c. 4.50 by 3.00 m. The mud-brick wall partitioning the side aisle measured 2.35 by 0.40 m and started from a pier that stood between the aisle and nave, measuring 1.55 by 1.55 (?) m. Two other walls also joined the pier. The section of E-W wall to the west of the pier, 0.40 m wide and running for a length of 3.75 m, featured a column of gray granite of a diameter close to 0.48 m built into it. A rectangular structure, 0.80 by 0.58 m, was built around the bottom of this column. A *mastaba* 0.73 m wide ran im-

mediately next to this wall. The floor in the vestibule was made of ceramic tiles of the same kind and size as in the pastophoria. Bricks in vertical bondwork preserved in the northeastern corner of the vestibule, by the north wall of the church, may be indicative of a stone threshold from the church entrance.

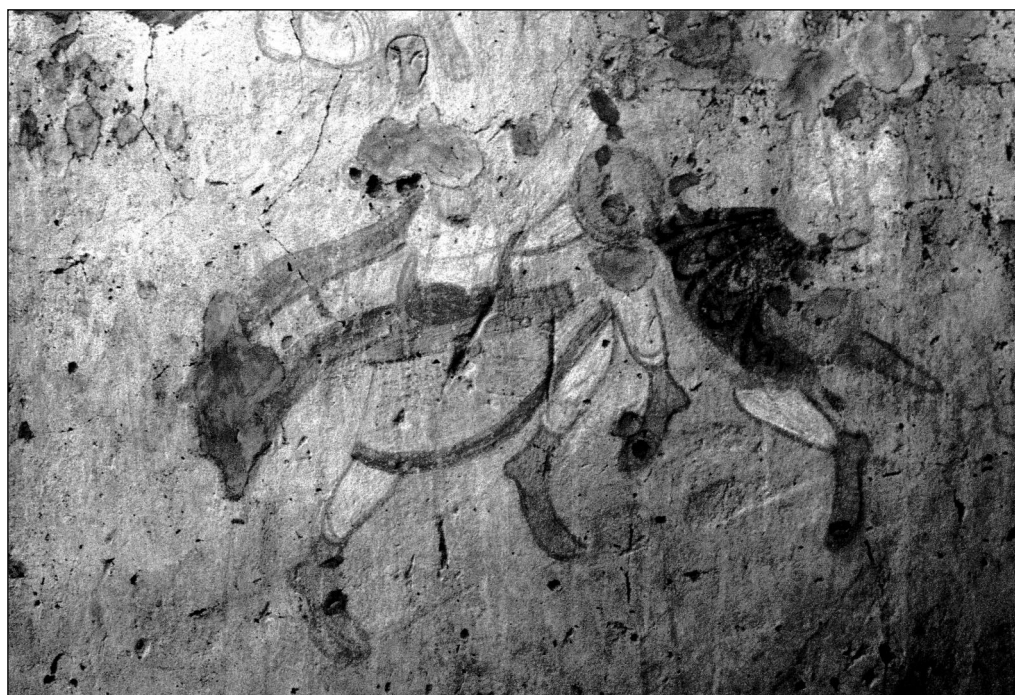
Fig. 5. Detail of the Nativity mural depicting Herod's soldiers
(Photo M. Wiewióra)

The vestibule near a monumental northern entrance had been decorated with murals. Opposite the entrance, on the south wall, there was a great composition of the Nativity. The bottom part has been preserved with traces of the Virgin's bed on the left, next to a kneeling Salome, then two of Herod's soldiers in the center (Fig. 5). The sole other alleged occurrence

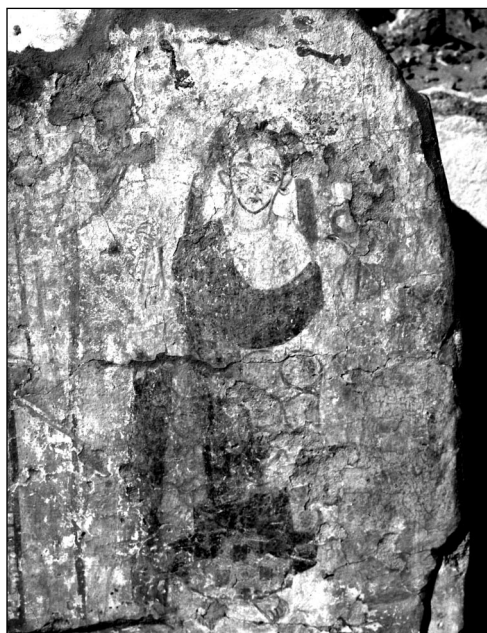
Fig. 6. Detail of the mural of the Holy Trinity depicting a royal figure in a veil (Photo S. Jakobielski)

next to the passage into the nave. The three figures were shown seated on a throne (Fig. 7). A small figure in the dress of royalty and a veil under the crown, possibly a queen (Fig. 6), was depicted to the right of the representation. To the left, there seems to have been an analogous figure (of which the head has not been preserved) dressed in robes and with the pouch typical of royalty slung across the left shoulder. The kings and eparchs of Nubia were thus depicted in the late period. This composition was executed on a mud plaster coating, while the style and colors date it to the 11th/12th century.

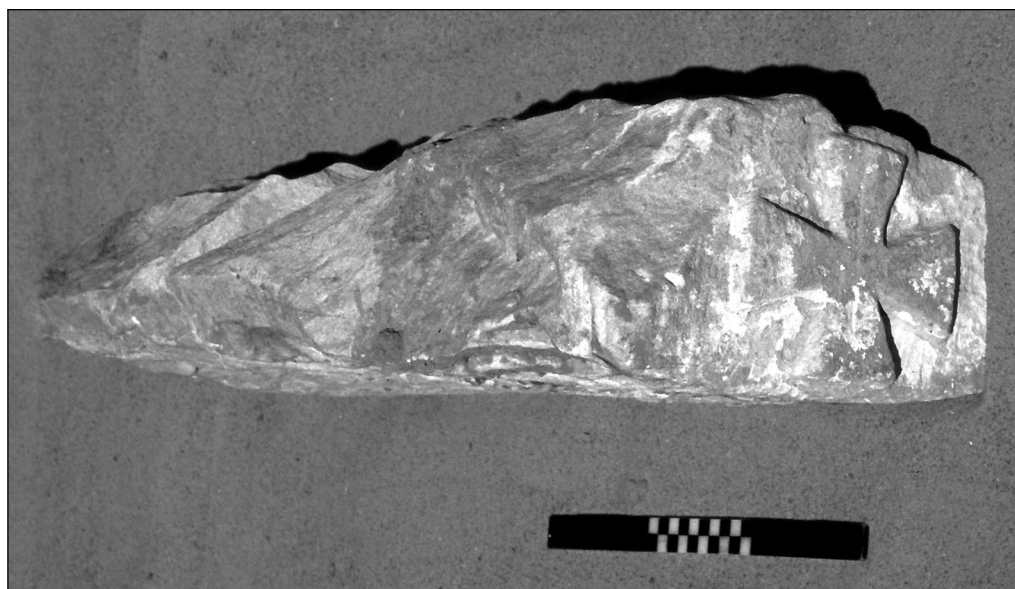
*Fig. 8. Stone block with carved cross
(Photo S. Jakobielski)*

found in quantity in the rubble. In the apse two layers of plastering were noted. As for architectural decoration, the pieces discovered in the rubble included a particularly noteworthy relief carving of a rosette and a cross on a keystone (*Fig. 8*), a slab from the altar screen, several sandstone voussoirs from the presumed monumental northern church entrance. Pottery recovered from the rubble fill dates from the 7th to the 13th-14th centuries. Other finds included window grilles, as well as a ring and lamp hook found in the niche in the apse wall, a metal key from the smaller basin in the north pastophorium, a small bell from the presbytery, a sickle from the vestibule.
