## West Saqqara: Conservation Activities, 2003

Polish Archaeology in the Mediterranean 15, 126-130

# CONSERVATION ACTIVITIES, 2003

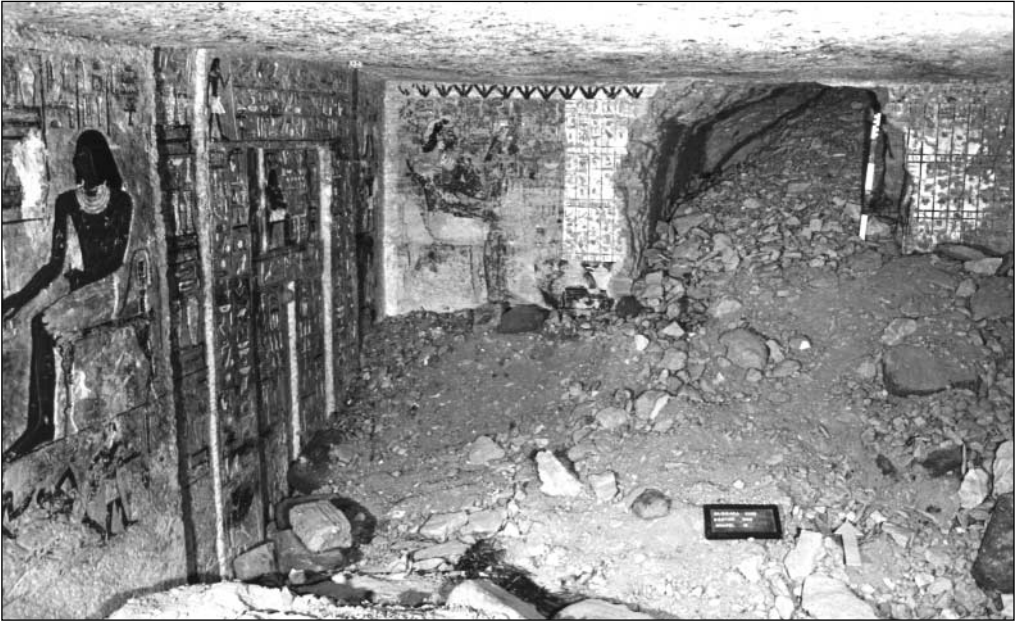
The polychromy found on the west wall just north of the entrance to the newly discovered chapel is fairly well preserved, except for some detachments and peeling of the painted layer. Large sections of the relief decorating other walls of the chapel have lost their original polychromy, bits of the painted decoration being found on the surface of the fill. The decoration of the north wall was damaged extensively, the rock here having collapsed because of a later shaft cut too close on the other side (*Figs. 1,2*). Parts of an offering list decorating this wall lay in the debris. The remains of the polychromy on the surface of these fragments were secured with a solution of PARALOID B72 in acetone with alcohol added. A reconstruction of the decoration will be attempted. On the east wall of the chapel the remains of painting are insignificant and found only in the northern end. The decoration on the south wall was never completed, the sketch lines still being visible.

*Fig. 1. Cult chapel of Ny-ankeb-Nefertem, north section upon discovery  
(Photo M. Jawornicki)*

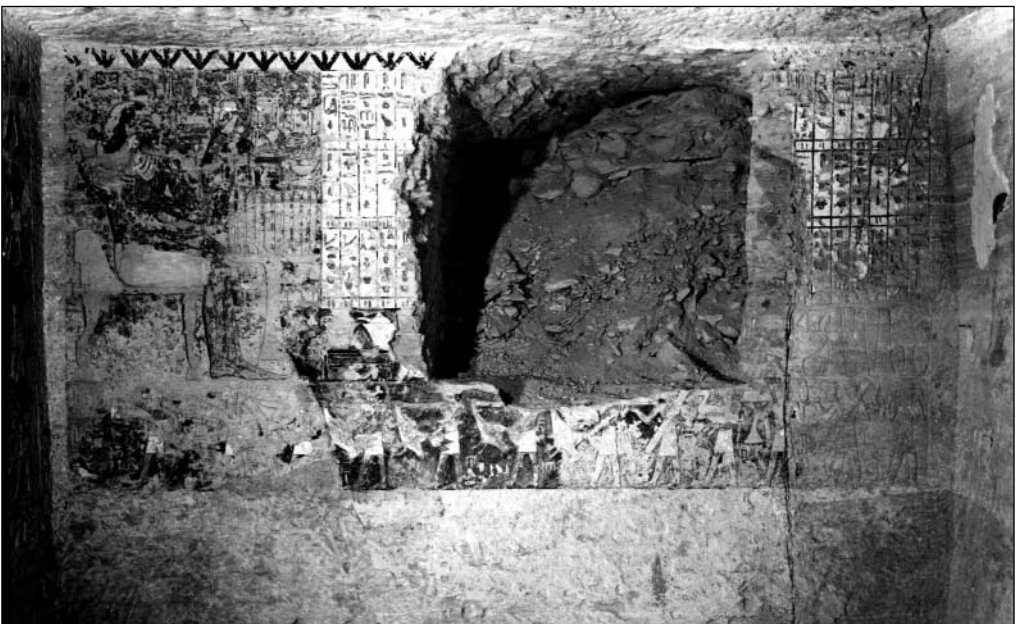
*Fig. 2. Cult chapel of Ny-ankeb-Nefertem, north section after preliminary conservation  
(Photo M. Jawornicki)*

The detached and disintegrating layers of painting had to be treated first. A solution of PARALOID B-72 (5-7%) in acetone with alcohol was dripped in. Melinex was then applied and the endangered parts of the polychromy pressed to the wall to mount them in place. This procedure was repeated several times as required. The mortar in particular had to be treated. The reinforced parts of the decoration had to be stuck to a matrix (as needed) using a water solution of PRIMAL E330 (6-8%) or AC-33 (10-12%). Each application of PRIMAL was preceded by dampening the area in question with a water solution of alcohol (1:1).

Detached edges of decoration executed in the mortar filling (sticking c. 0.2-0.5 mm away from the matrix) were secured with bands made of lute having PRIMAL AC-33 (10-12%) as the base and calcium carbonate chalk, fine-grained sand

(1.5:1.5:1) and pigments as fillers. The same kind of substance was used for filling easily and safely accessible voids under the surface of the mortar.
