Banganarti: SDRS Season 2003

BANGANARTI

SDRS SEASON 2003

Bogdan Żurawski

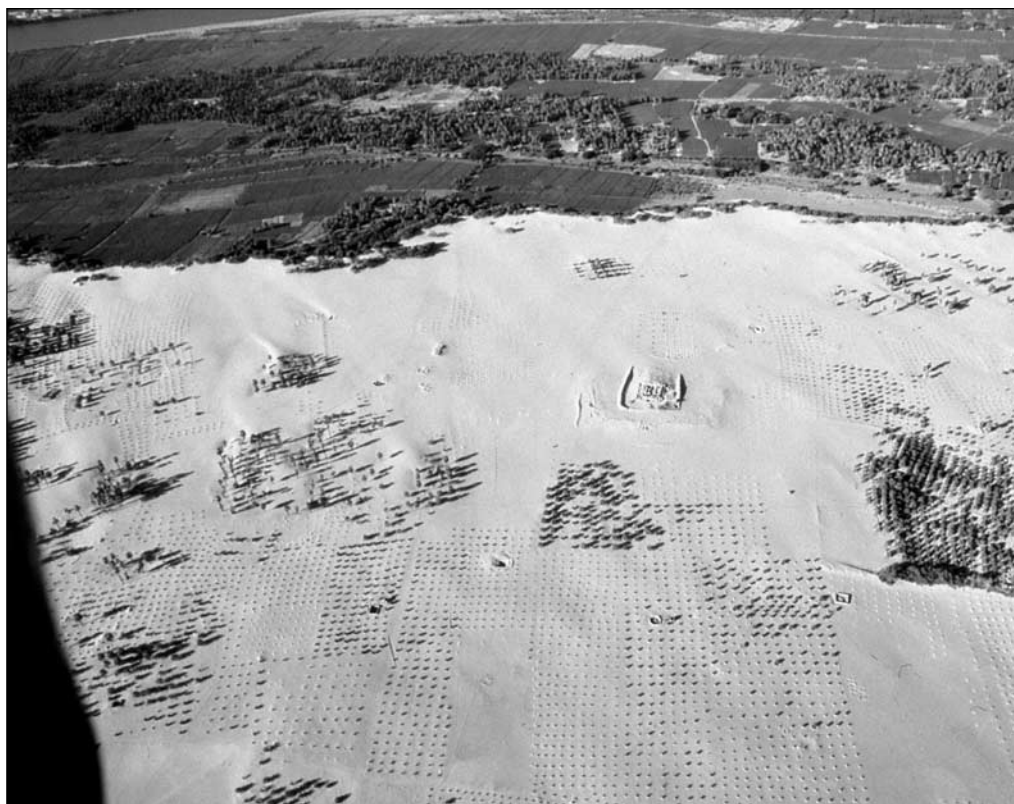
Fig. 1. Aerial view of the Banganarti site looking west. Tangasi Island in the background (Photo B. Żurawski)

The excavation program ran concurrently with an aerial reconnaissance in the Fourth Cataract region combined with photographing the entire SDRS concession from above (Figs. 1, 2). The flight, organized jointly with the Sudan Archaeological Research Society Mission to the Fourth Cataract region (Amri-Kirbekan Survey) and the German Mission at Naga, was approved by the National Corporation for Antiquities and Museums. The AN-2 plane was provided by the Sudana-PZL crop-dusting company, based at Hassa Heissa.

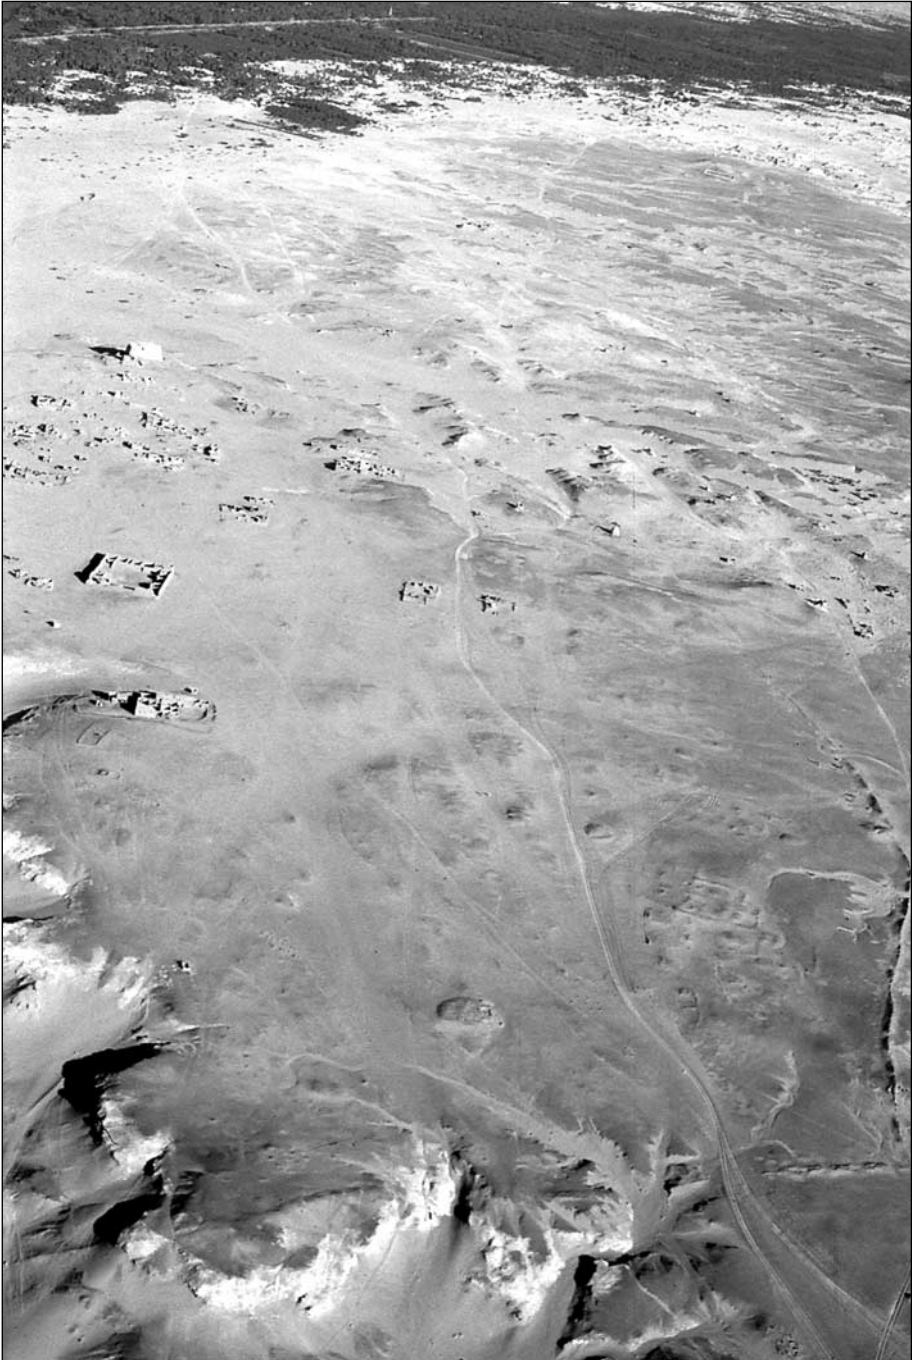
Fig. 2. Aerial view of the Great Enclosure Wall at Old Dongola (at extreme right), 19th-century fort and the Mosque in the left background (Photo B. Żurawski)

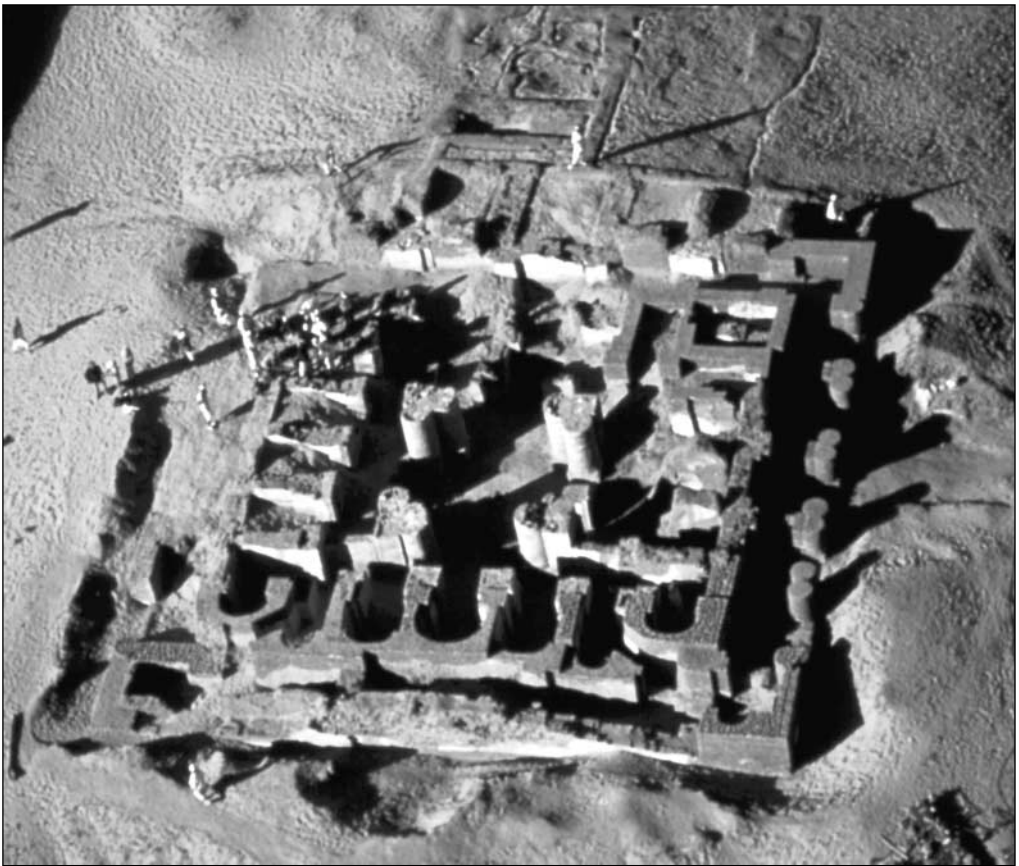
Fig. 3. Aerial view of the Baganarti church seen close-up from the east, with excavations proceeding in the southern part of the architectural complex (Photo B. Żurawski)

Field activity began with the removal of the protective sand cover.³⁾ Excavations continued in the eastern part of the church before shifting to the west and north. A test pit was dug outside the church and later continued to the south in order to section the entire mound along its N-S axis (Figs. 3, 4). Digging between the northern

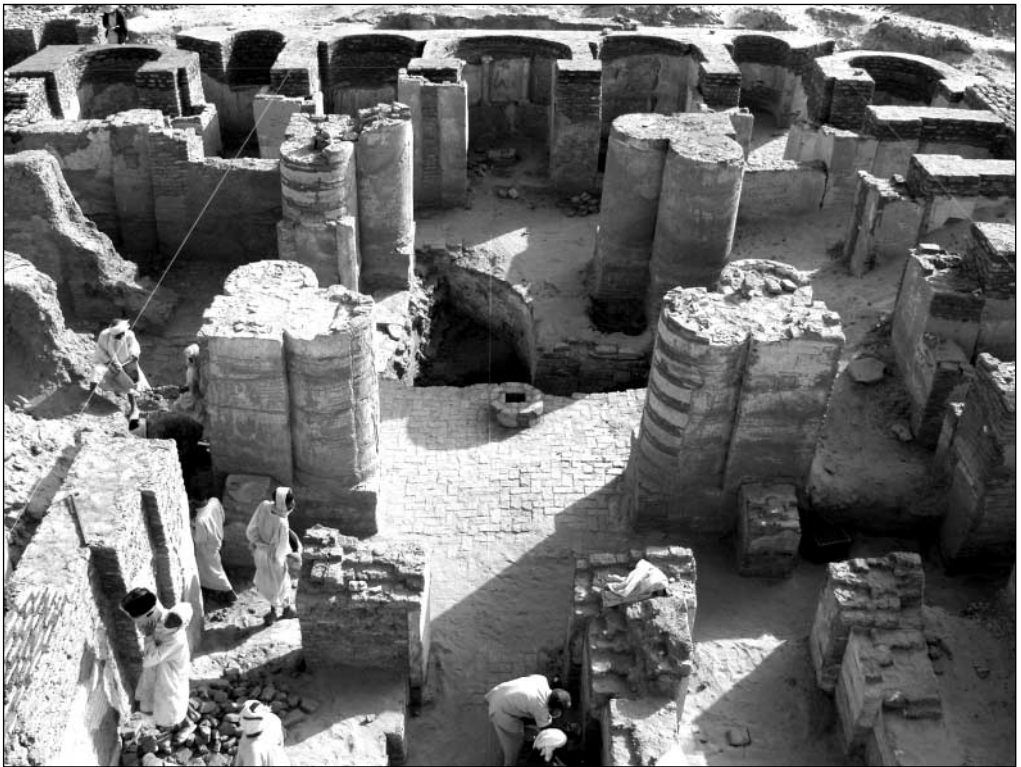
Fig. 4. View of the central part of the Upper Church during excavations, seen from the west (pulpit concealed behind the pillar on the left) (Photo B. Żurawski)

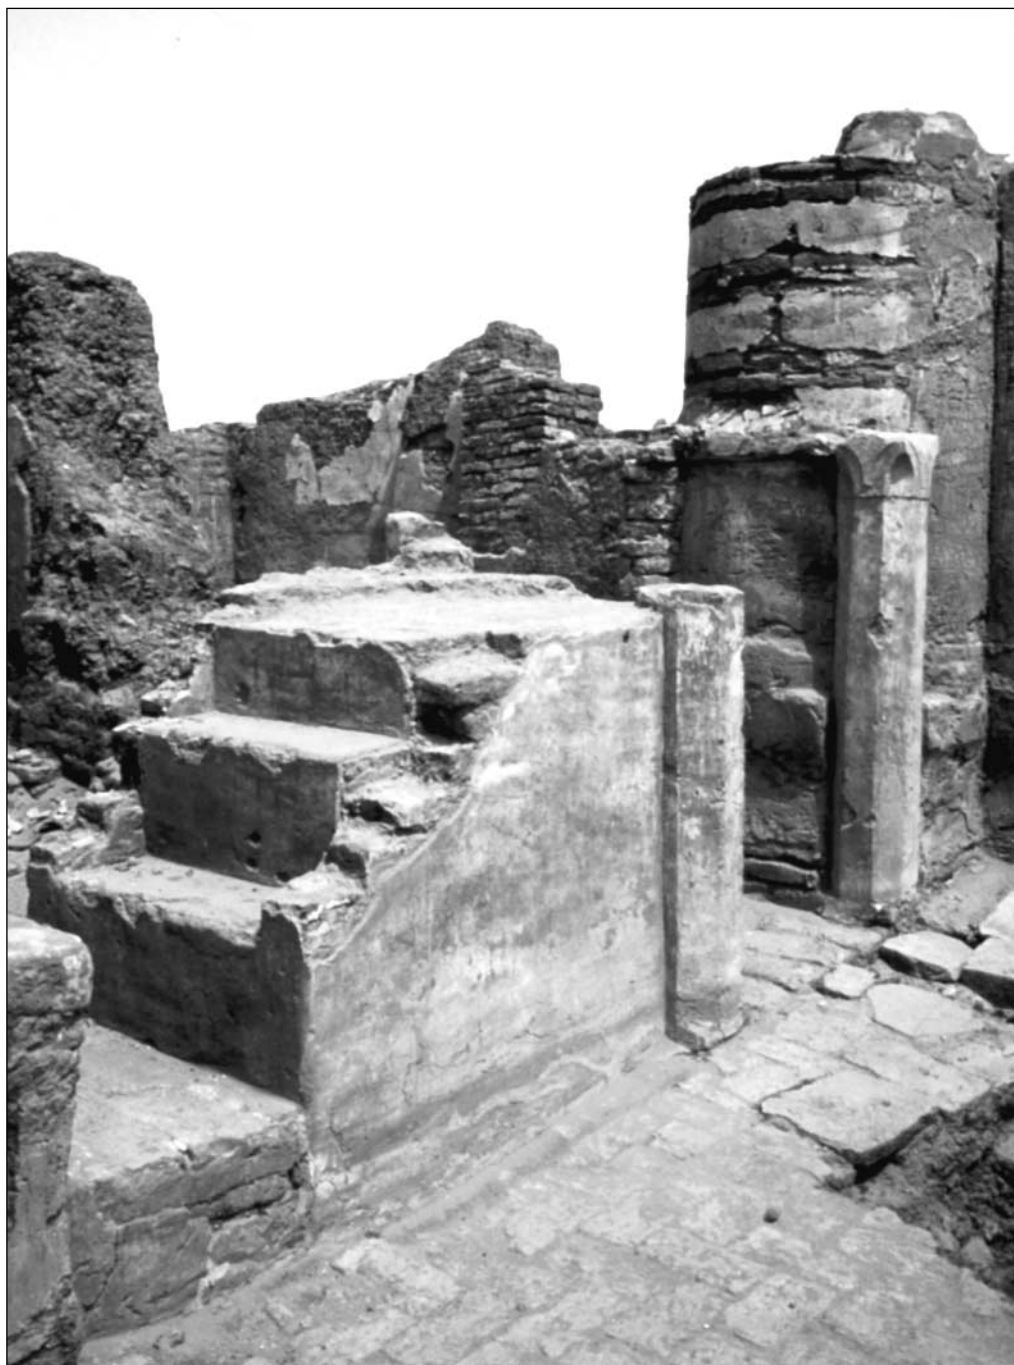
*Fig. 5. Pulpit between the northern dome supports of the Upper Church
(Photo B. Żurawski)*

dome supports brought to light an elaborate pulpit raised on four pillars with accompanying stairs (Fig. 5).

The Upper Church, already in its first phase, was furnished with a pulpit between two northern piers. It is composed of massive stairs and two octagonal pillars set

against the northeastern pier (cf. *Fig. 5*). Both the stairs and the pillars once supported the horizontal platform that is now missing. Nonetheless, it provides some measure of the original height of the building, calculated as more than 12 m under the dome.

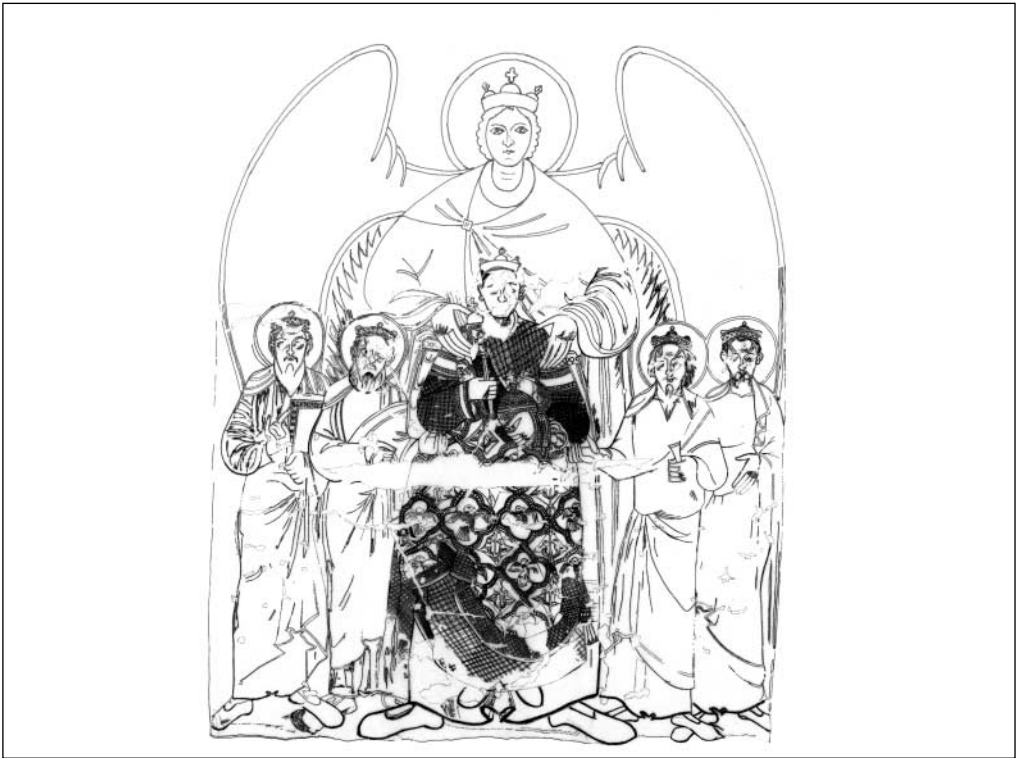
Fig. 8. Reconstruction drawing of the painted composition representing a Nubian monarch under the holy patronage of the Archangel Raphael in Chapel 3 (upper part of the archangel reconstructed based on analogies from Kom H in Old Dongola (Drawing W. Chmiel)

The original hypothesis that the Upper Church was dedicated to the Archangel Raphael (*Fig. 8*) has been massively built up by a plethora of inscriptions with references to Raphael. Significantly enough, the Lower Church also seems to have been dedicated to Raphael as the inscriptions found so far might suggest. The Archangel Raphael is the most common addressee of the invocations and prayers recorded on the walls of both the Upper and Lower Church, including the

The Upper Church was planned and executed with significant consideration for the set of graves located along the eastern wall of the Lower Church. It was raised in such a way that the row of seven chapels was constructed directly above them. It is on the walls of these chapels that the portraits of the Nubian kings and high dignitaries (*begemones*) were painted.
