Polish Archaeology in the Mediterranean 15, 39-42

MOSAIC CONSERVATION AT KOM EL-DIKKA IN ALEXANDRIA IN 2002

Joanna Lis

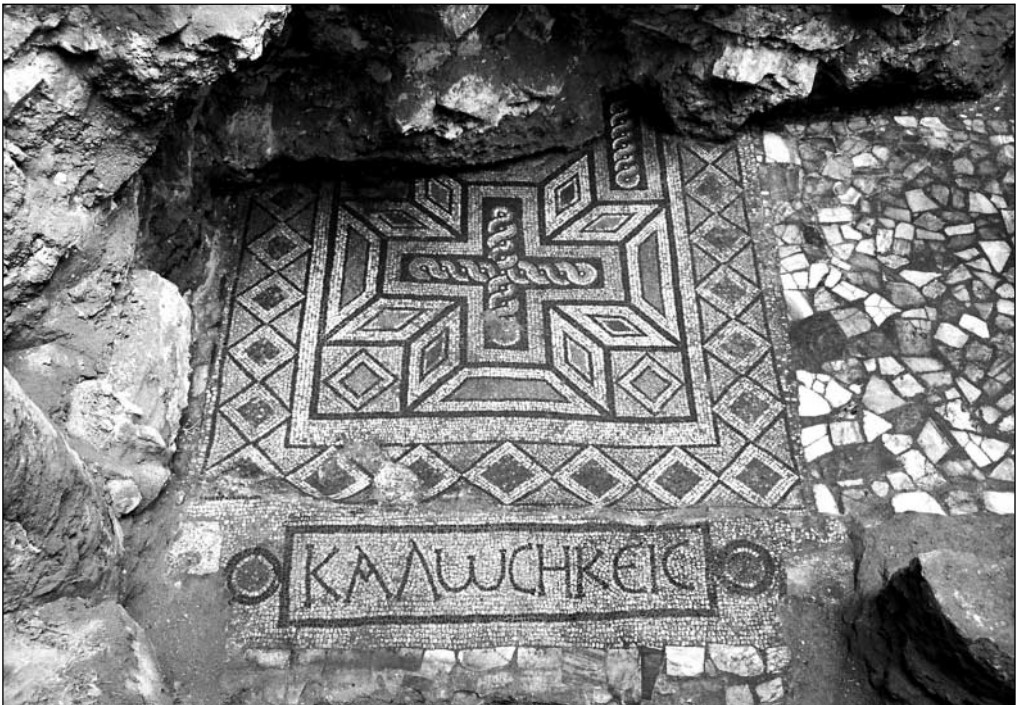
Fig. 1. Mosaic floor after preliminary cleaning of the surface
(Photo J. Lis)

The first step in the conservation process was to remove the protective layers of earth, sand and cloth that had been applied upon discovery (*Fig. 1*). Photo-

graphic documentation of the condition of the floor before and during conservation was regularly made. The surface was cleared of loose dirt and salt efflorescence. Wet sponges were then used to clean the surface and the losses were filled with lime mortar. Water with ammonia and acetone was then used to clean and degrease the surface. Following some testing of adhesives for the layer protecting the top face of the mosaic, PVA (WINAVIL) of Egyptian production was used. Cotton gauze was applied on the edges of the cracking.

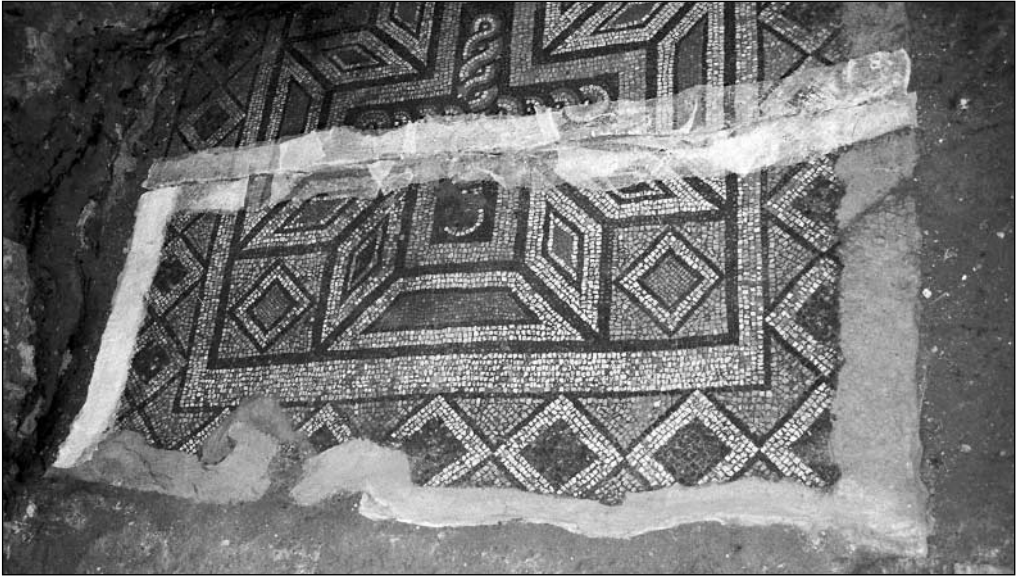
*Fig. 2. Mosaic floor divided into sections in preparation for lifting
(Photo J. Lis)*

For the transfer the pavement was divided into three major sections, two smaller ones and the tondo (*Fig. 2*). The natural crack was taken advantage of as one of the division lines, while the others were traced across the floor. The three major sections measured 210-212 cm in length by from 56 to 90 in width. The smaller ones around the tondo were 54 by 37 cm and 46 by 15 cm respectively. The tondo was 64 cm in diameter. The *opus sectile* border frame was left in place. The face of the mosaic was protected with two layers of cotton gauze and a layer of thicker cloth. The next step was to cut away the surface layer of the mosaic section by section,

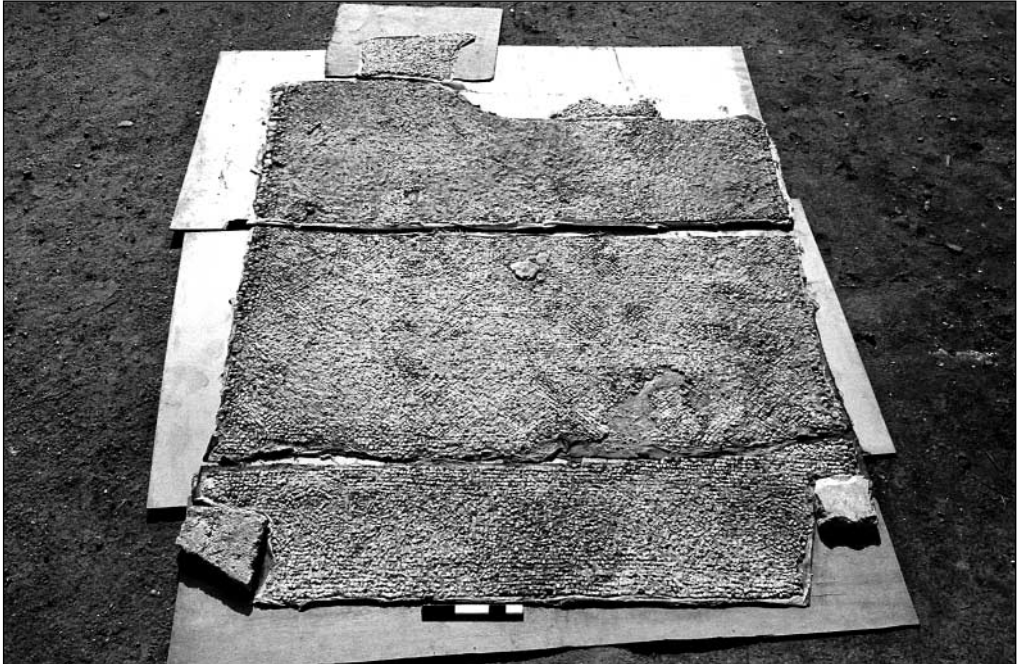
*Fig. 3. Back of the mosaic floor after cleaning
(Photo J. Lis)*

In an on-site field conservation lab, the mosaic sections were laid face down and the remnants of the bedding, consisting of lime mortar and original floor substructure, were removed (Fig. 3). Cubes that had stuck loosely and had been displaced along the line of the crack were removed, cleaned and secured back in place. The cleaned back of the mosaic sections was then sprayed with an impregnating 7% solution of PRIMAL AC 33 of Italian manufacture. Everything was prepared for introducing a new lime bedding, consol-
