Building G in Naqlun : Material, Construction, Furnishing

Polish Archaeology in the Mediterranean 17, 206-218

BUILDING G IN NAQLUN: MATERIAL, CONSTRUCTION, FURNISHING

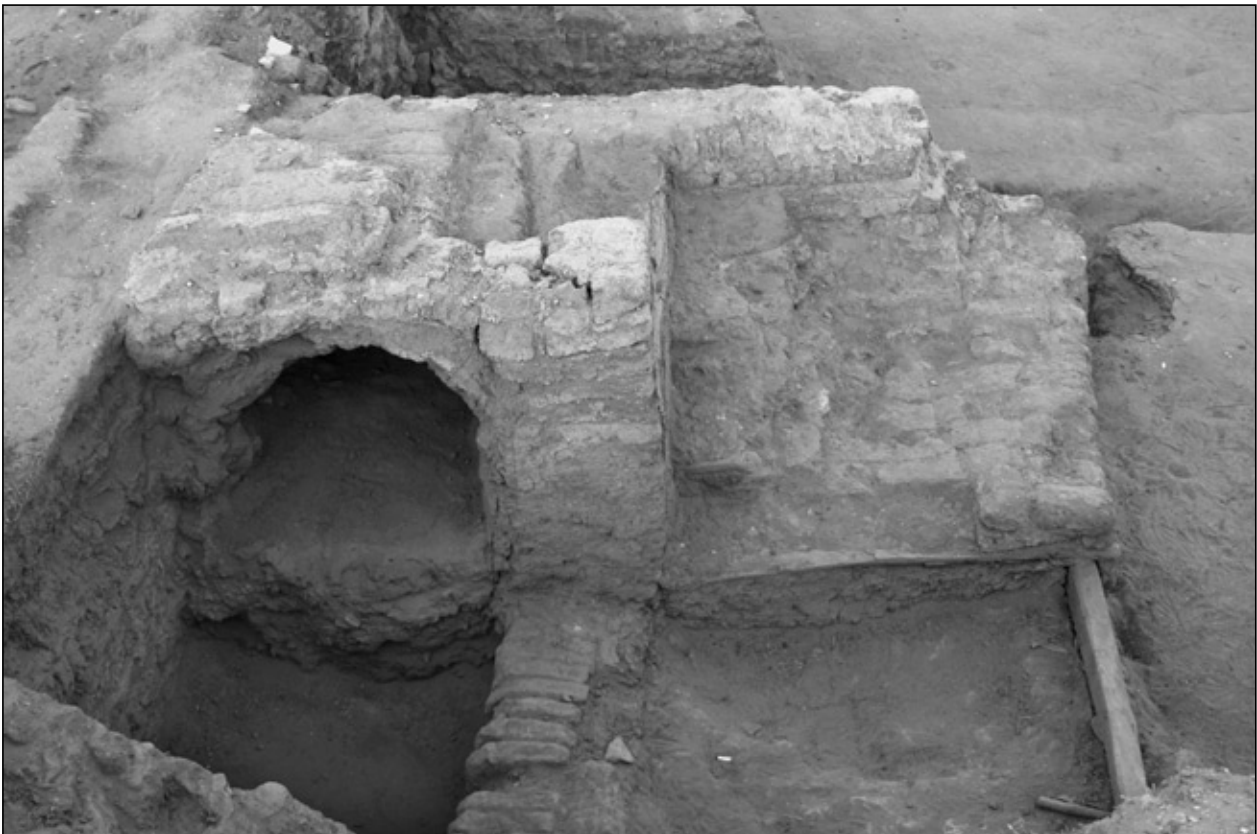
Fig. 5. Staircase in room G.10, view from the east
(Photo W. Godlewski)

The staircase in room G.10²³ was entered from the north through a door 78 cm wide. A wooden beam in the threshold rested on a row of baked bricks (24-25 x 10-11 x 6-6.5 cm) set on edge [Fig. 5]. The door socket on the inside of the threshold indicates that the door opened inside. The steps started directly to the right of the door, while the space under the steps could be accessed from behind a low wall opposite the entrance. The stairs were 0.70-0.73 m wide. Fragments of five steps and two landings have survived. Each step was 12-14 cm high, the edges reinforced with wooden beams. The staircase was likely connected with room G.11 and

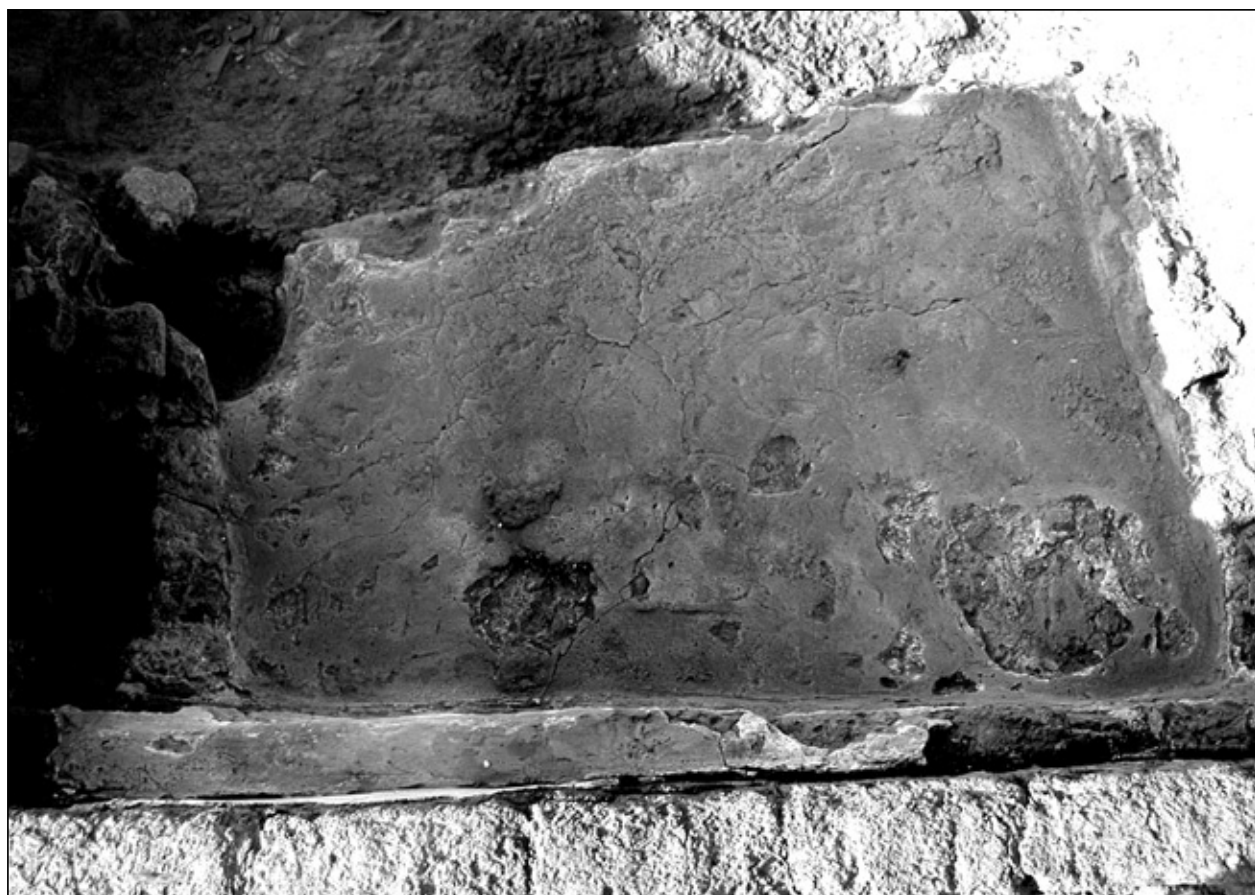
Fig. 7. Basin in G.2, note round depression at top left
(Photo W. Godlewski)

The basin in room G.2²⁴ took on trapezoid shape, measuring 1.10 by 1.80 m. The side walls were from 0.13 to 0.16 m thick. The floor sloped away slightly toward a round depression (0.36 m in diameter; 0.24 m deep) in the northwestern corner [Figs 6,7]. The walls and floor of the basin were constructed of baked brick laid flat and coated with a thick layer of hard white lime mortar. A much thinner, 0.6 cm thick coating of lime plaster on a mud-plaster ground was used for the walls around the basin.²⁵
