TUNA EL-GEBEL

THE 'EGYPTIAN HOUSE' MURALS CONSERVATION PROJECT FIRST SEASON IN 2005

Robert Rogal

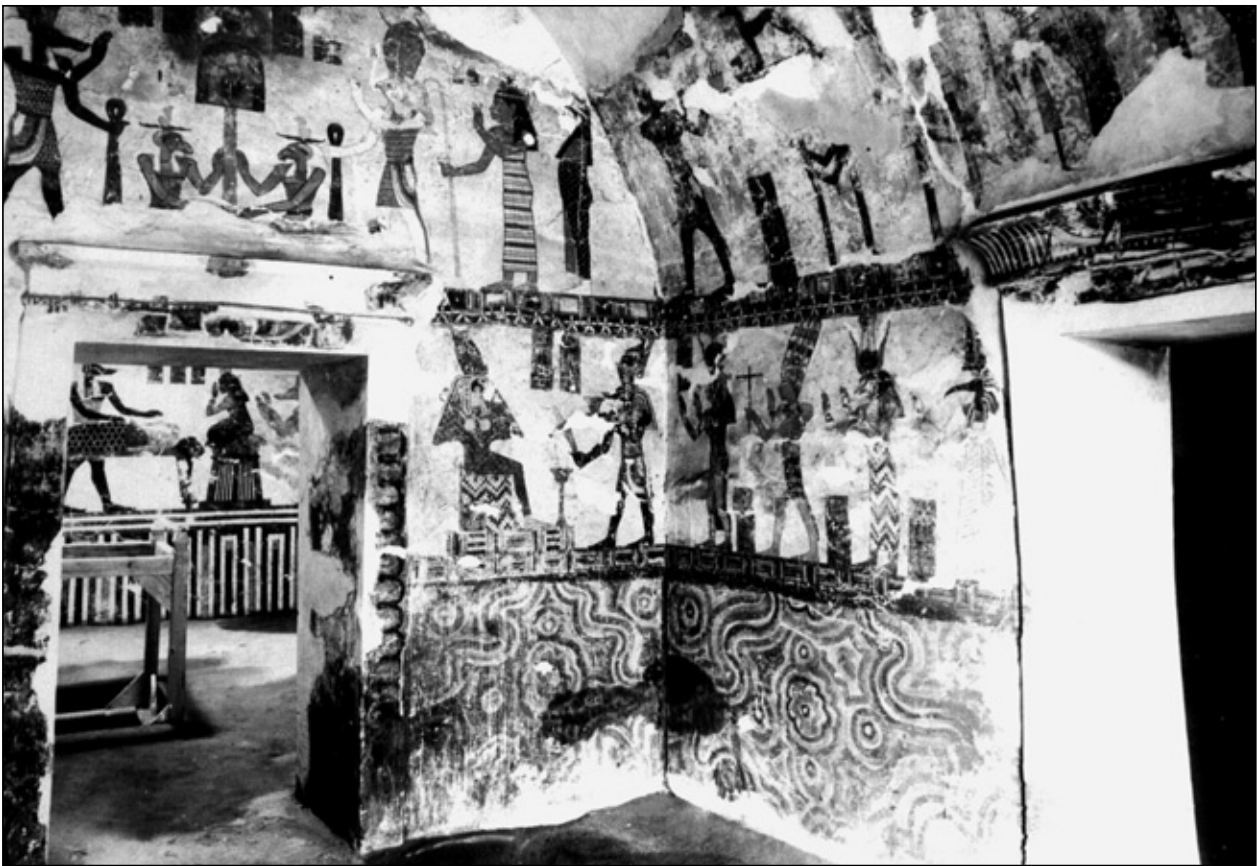
Fig. 1. Interior of Tomb No. 21 (after S. Gabra, *Rapport sur les fouilles d'Hermoupolis Ouest* (Touna el Gebel, Le Caire 1941, Pl. X)

When the tomb was discovered in 1935, its vaults were destroyed. To reconstruct them, the inside of the tomb was filled with sand, the vaults were bricked-up and then the sand was removed.³ Some bricks with traces of color, coming presumably from the original vault, are still in store in one of the rooms of the tomb. Gabra's photographs of the conditions inside the tomb upon discovery reveal the murals inside and the facade plaster to be in very good condition [*Fig. 1*].

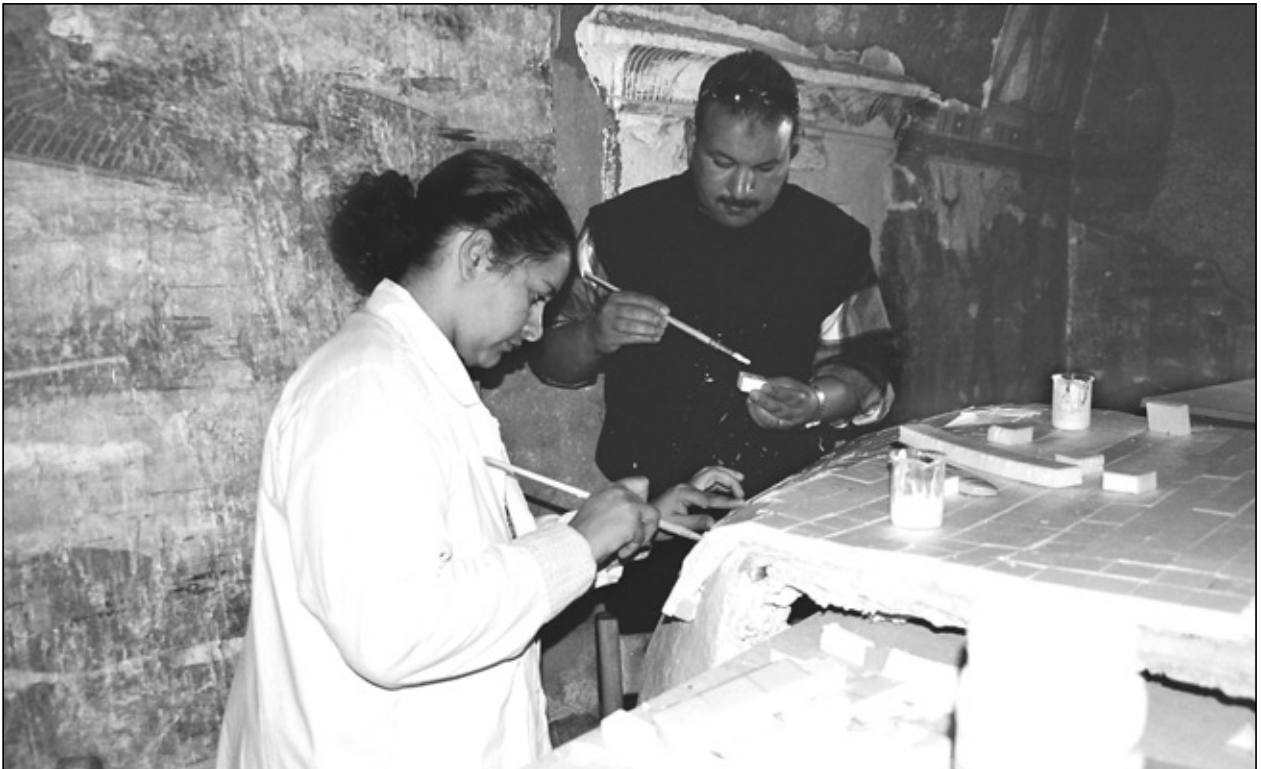
*Fig. 2. Fragment of painting during conservation
(Photo R. Rogal)*

The paintings without supports demanded full conservation treatment [Fig. 2]. Their back was cleaned of residual ancient mud mortar and the excessive mortar and plaster-of-Paris applied in the past to fill in the gaps. The reverses were subsequently consolidated with 3% solution of PARALOID B-72 (Rohm & Haas, USA) in toluene. A polypropylene net was attached as a lining layer, using lime-and-sand mortar with PRIMAL AC-33 (Rohm & Haas, USA). The intervention layer consisted of polystyrene foam (ADREFOAM, product of Advechems, Egypt) attached with a water dispersion of PVA (OKAY, product of Siag Chemicals Co., Egypt). Sandwich-structured supports were built up on the reverses. The cladding was made of 450-grade fiberglass mats reinforced with epoxy resin KEMAPOXY 31/150 (CMB, Egypt). The cores were made of 4 mm FIRET COREMAT XX (Lantor BV, Holland), reinforced with the same resin as the cladding. The applied technology allowed for quick building of supports of complicated shapes and required thickness. Moreover, supports of this kind are resistant to climate and biological factors.⁵

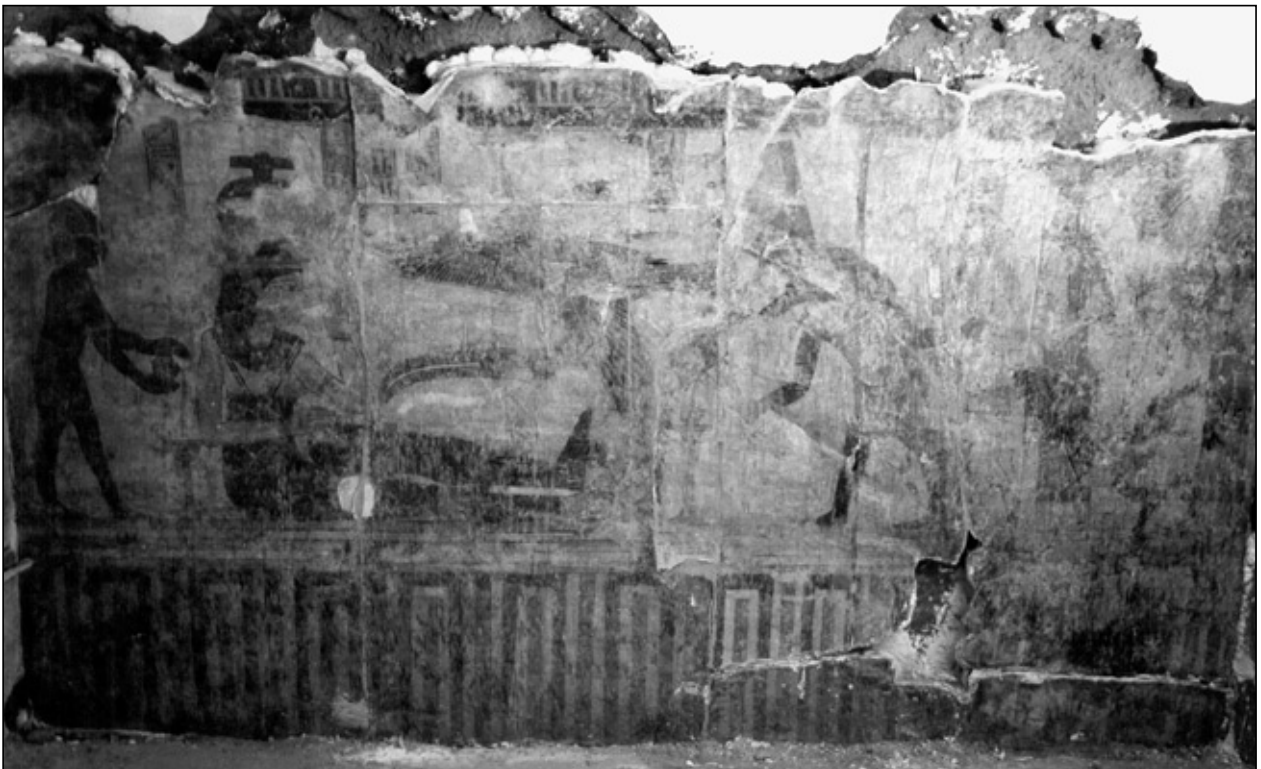
*Fig. 3. West wall of the sanctuary after remounting of the mural paintings. Condition in 2005
before removal of the facing (Photo R. Rogal)*

All the preserved paintings from the sanctuary have now been remounted in their original location [Fig. 3]. To mount paintings attached to supports made of plaster-of-Paris both the plaster and polyurethane foam (FUROFOAM, product of Den Braven Sealants, The Netherlands) were used. Paintings on sandwich-type supports were mounted with screws and foam. The protective facing has been left in

place until the repairs on the vault will be completed. The paintings from the ante-room are in various stages of conservation. Some of them, lying in several layers on the floor in the Beit el-Serir, have to be separated, which is a difficult task, requiring further time-consuming work. Other fragments have reached the stage of the treatment when the intervention layer will be applied.
