# OLD DONGOLA

## KOM A (ACROPOLIS), 2005

Włodzimierz Godlewski

*Excavations of site SWN on the citadel of Old Dongola were continued in the winter season of 2005 (January 27-March 3) by a PCMA expedition headed by Prof. Dr. Włodzimierz Godlewski.<sup>1</sup> The main objectives of work in the southwestern part of the citadel (Fig. 1)<sup>2</sup> included establishing the extent of Palace B.I, especially to the northeast, and determining the nature of the occupation of the ground-floor rooms in the southwestern part of the complex. The trench of 2003 was extended to the south and east of Building B.III. In the end effect, three main stages of development were distinguished for palace B.I and the post-Makurian phase of architecture in the eastern part of the palace was examined more thoroughly. Investigations inside B.III were also completed. To the south of the structure, the northwestern corner of yet another monumental building was uncovered (B.V). The southern part of B.II, a fortified enclosure erected to protect B.I and B.III on the river side, was further explored.*

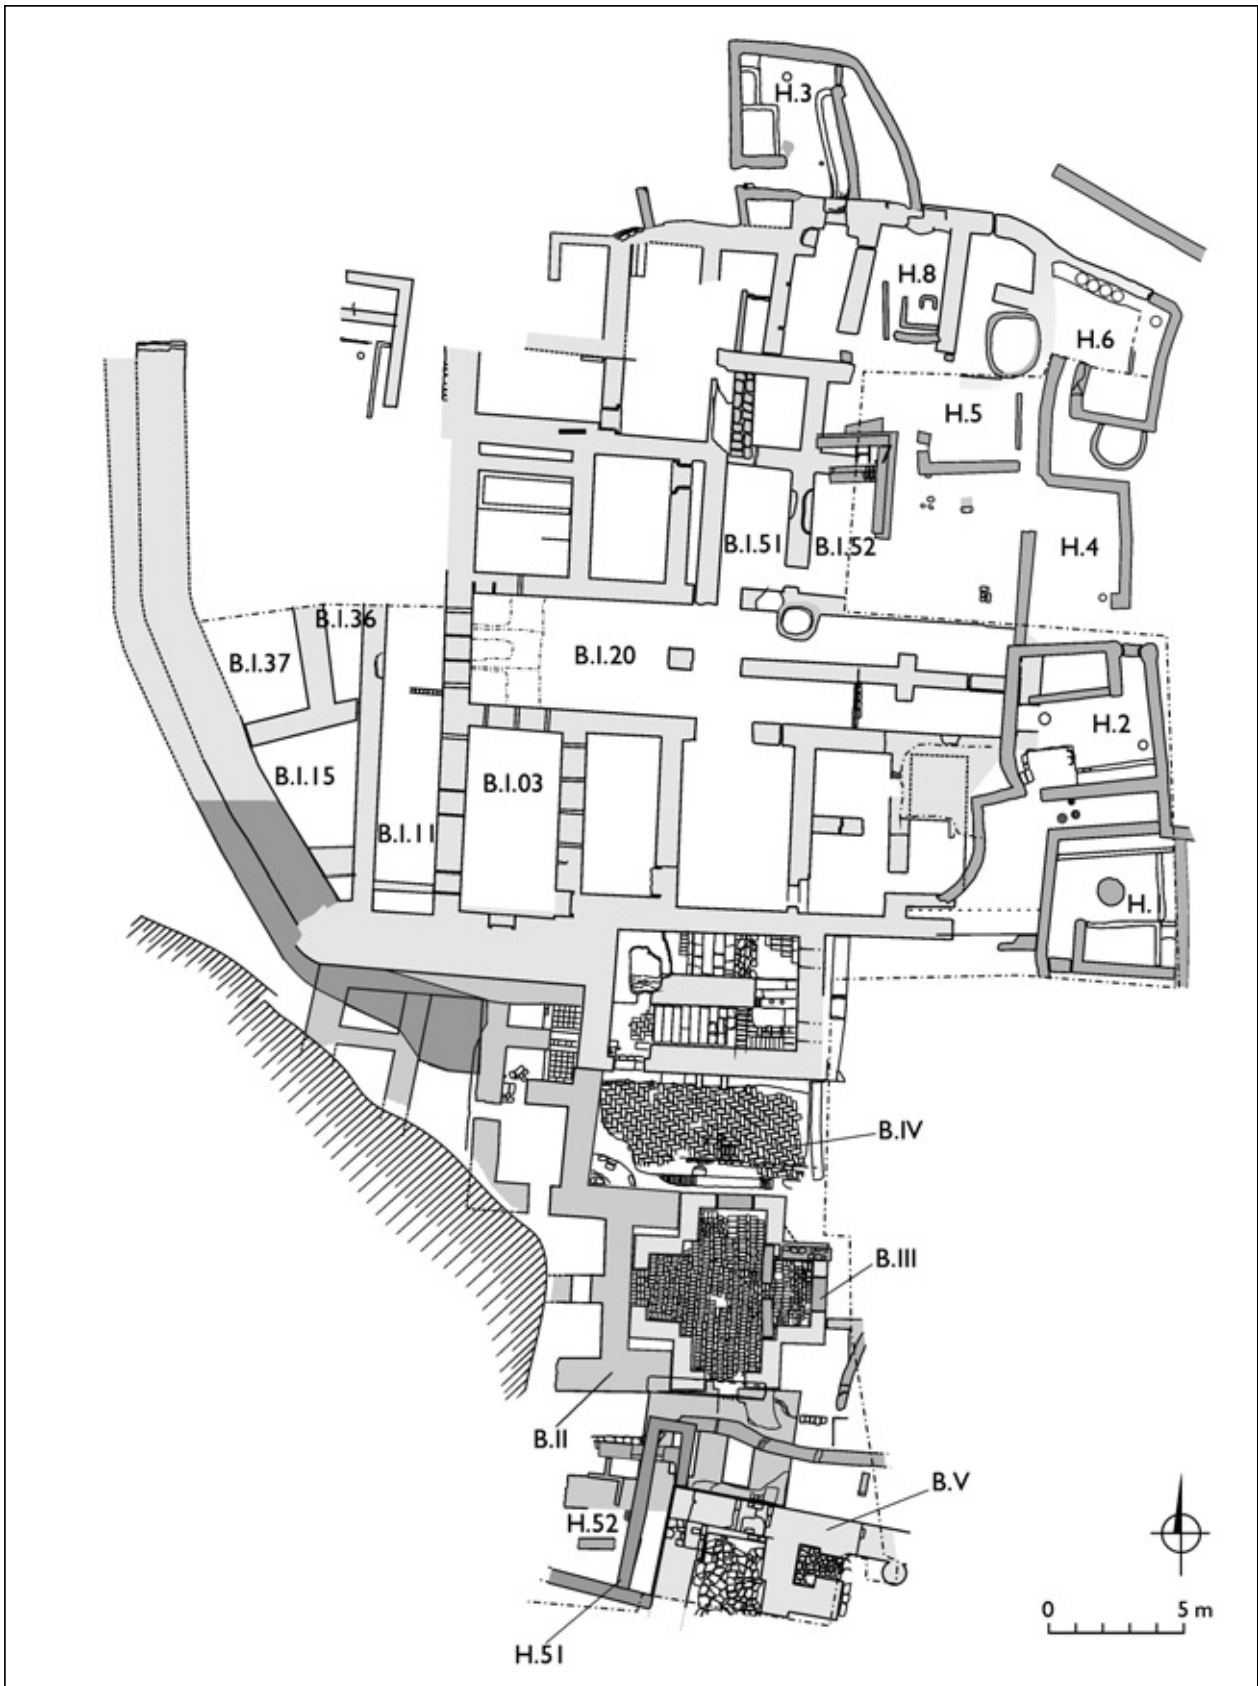
Fig. 1. Plan of buildings uncovered on site SWN on the citadel of Dongola, 2005  
(Drawing W. Godlewski, M. Puzkarski, D. Zielińska)

Excavations inside the big palatial structure, which covers at least 1000 m<sup>2</sup>, were concentrated on the central and eastern parts [cf. *Fig. 1*]. Post-Makurian architecture was uncovered and development in this part of the complex examined, revealing alterations of the palace interiors on the first floor made during the last phase of occupation of the building in the 14th century. In the southwestern part of the complex, ground-floor rooms B.I.20, B.I.03, B.I.11 were investigated, as well as B.I.36 and 37 by the inner wall of the fortification, to the north of B.I.15, which contained the depository of a toilet located on the first floor of the palace.

The search for the east outer wall of the building on the town side was encumbered by post-Makurian architecture surviving in this area. Some of the new structures (Houses H.1-H.2 and H.4-H.7) were founded on the rubble fill of the original palace interiors [cf. Fig. 1]. It seems, however, that the walls of the original phase were even better preserved in this part than in the west, where they had disappeared together with the post-Makurian architecture.

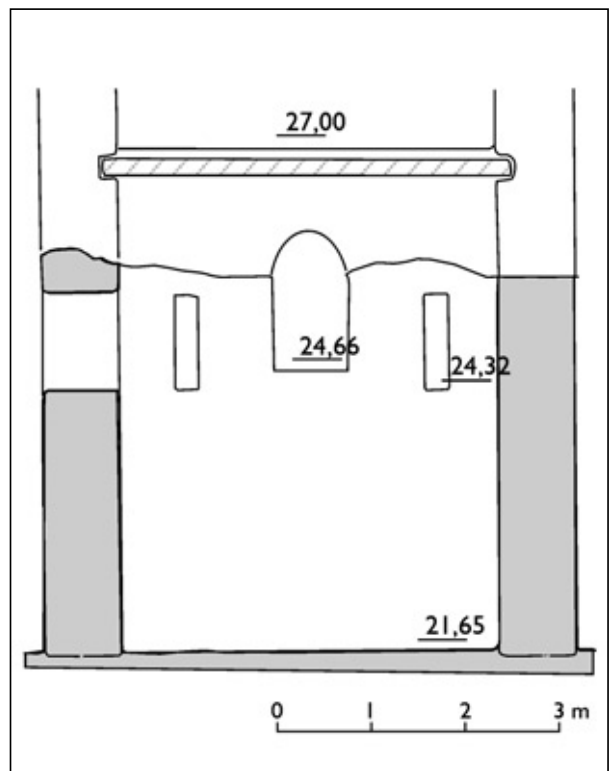
*Fig. 2. West wall of room B.I.20  
(Drawing W. Godlewski, D. Zielińska)*

B.I.20 were furnished with several narrow slit windows (W. 0.11-0.15 m, H. 1.10 m), located high up on the wall (2.60 m above walking level) ensuring air flow between the rooms. Similar slit windows were discovered also in the walls of the corridor on the ground floor of House A.105 in the northwestern part of the citadel.<sup>5</sup> Both rooms also had big arched windows on the western side, 0.90 m wide and about 2 m high, the sills on the same level as the slit windows; these were blocked as a result of the second-phase alterations in this part of the building [Fig. 2].

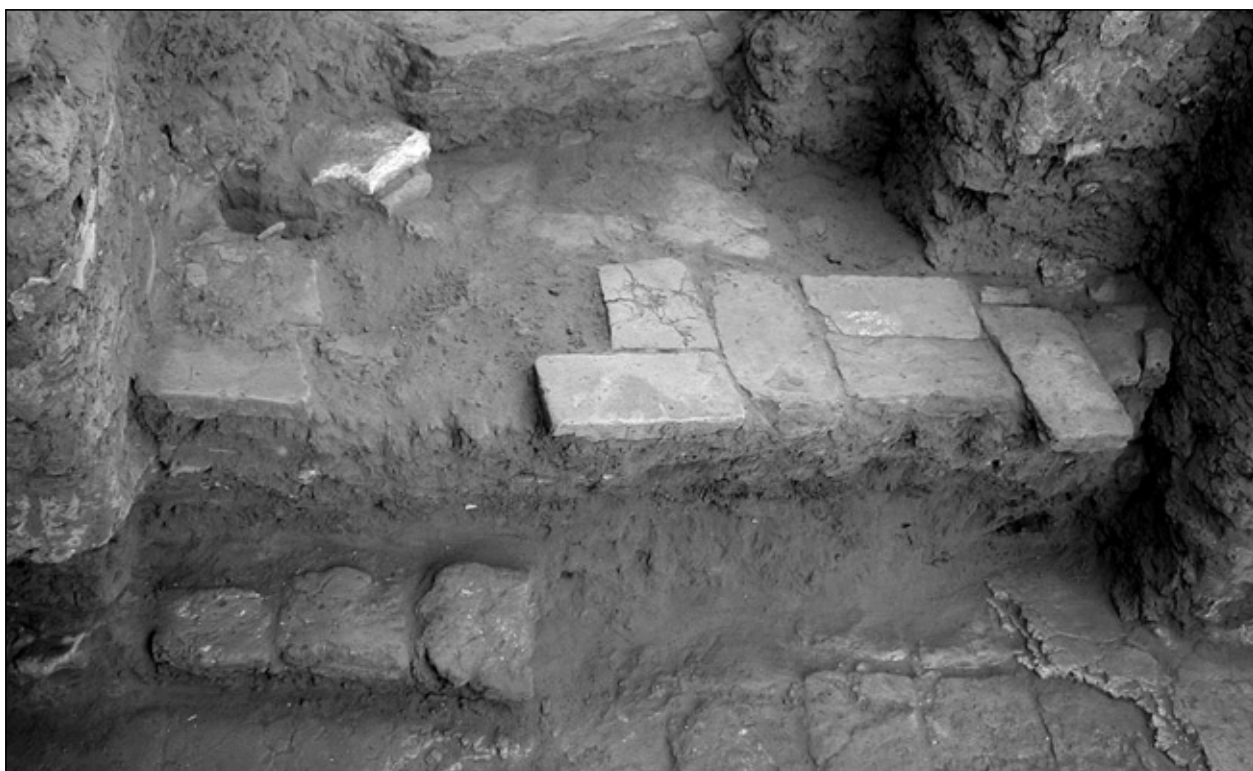
*Fig. 5. South entrance to Building B.III. Threshold beam in the entrance  
(Photo W. Godlewski)*

Removal of the floor in the southern entrance revealed a kind of foundation deposit located carefully under the floor. It consisted of a large storage vessel (Add.05.225) standing upright in a pit that cut through the lower floor of B.III and a small cup used as a lamp (Add.05.224), placed inside the neck of the storage pot [Figs 5,6]. The vessel was half-filled with sand, containing also remains of a substance consumed by insects.

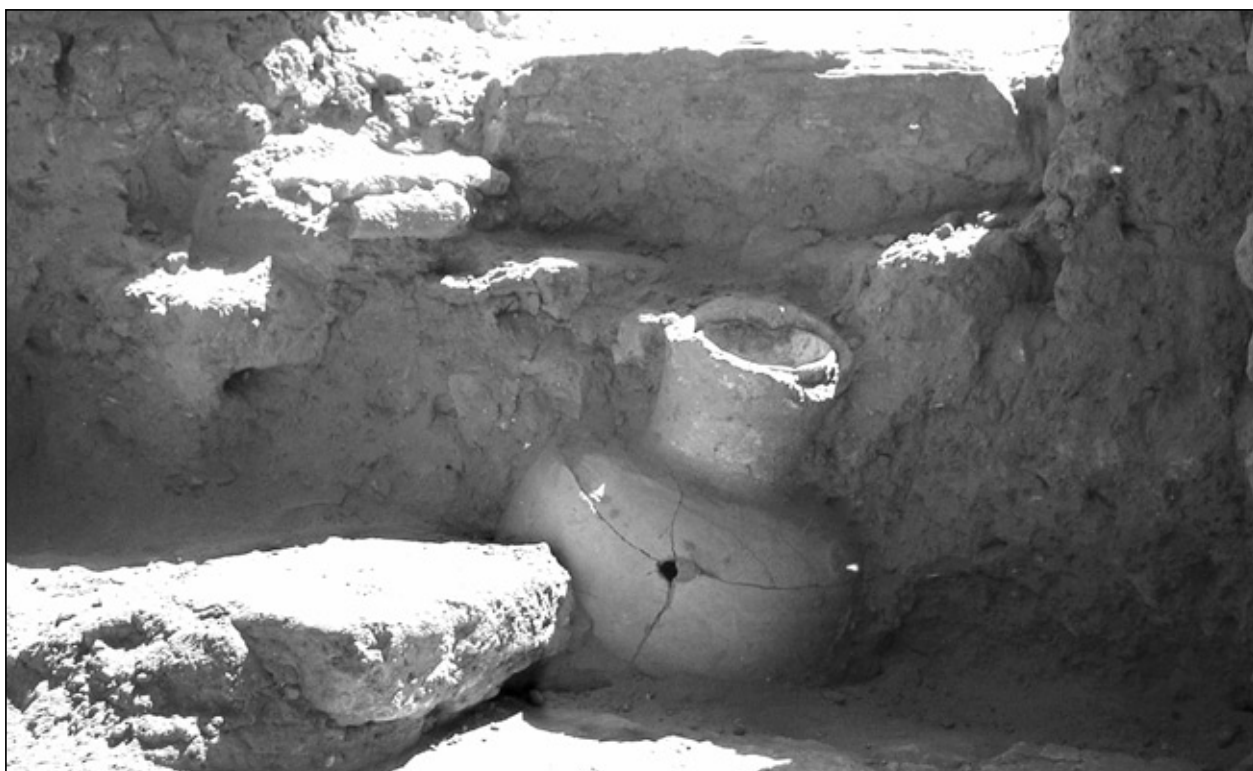
*Fig. 6. South entrance to Building B.III. Ceramic deposit found below the threshold  
(Photo W. Godlewski)*

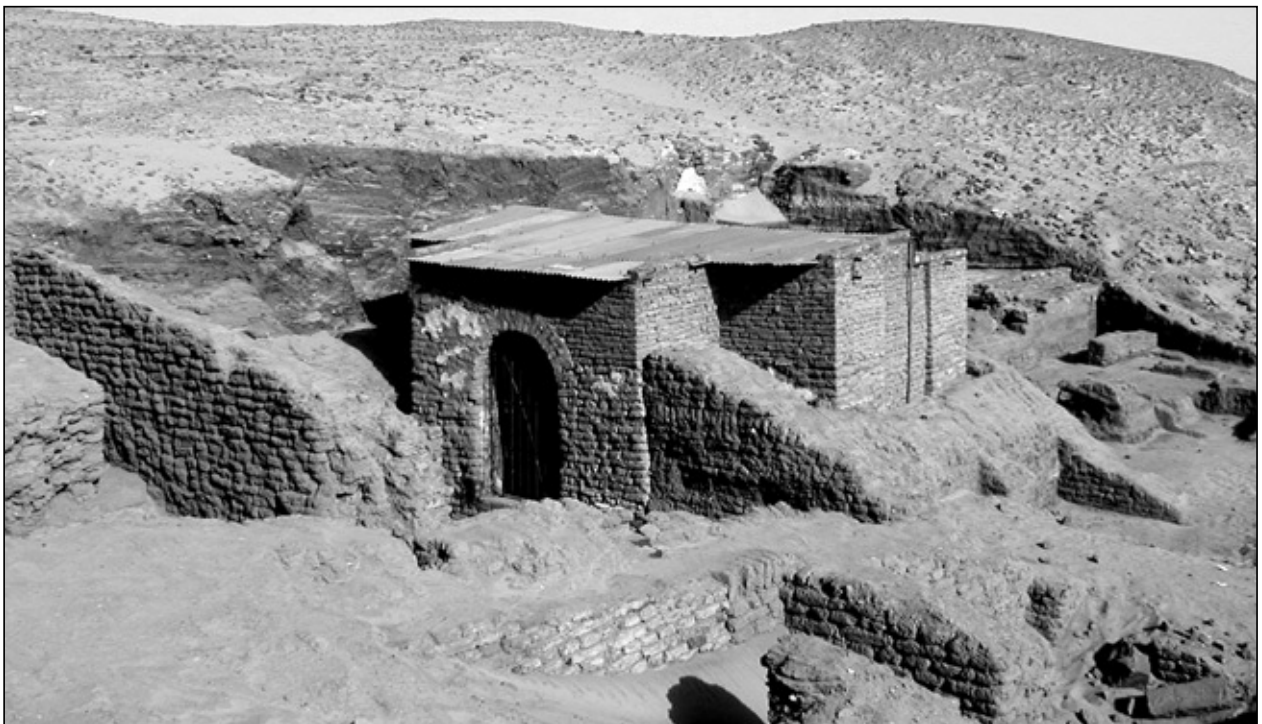
Fig. 7. *Building B.III. New shelter roof, view from the northwest*  
(Photo W. Godlewski)

*The conservation effort included repairs on the roof shelter constructed over Building B.III in 2003<sup>4</sup> and damaged during recent high winds (cf. Fig. 7). Inside Building B.V, the wall tops were protected.*

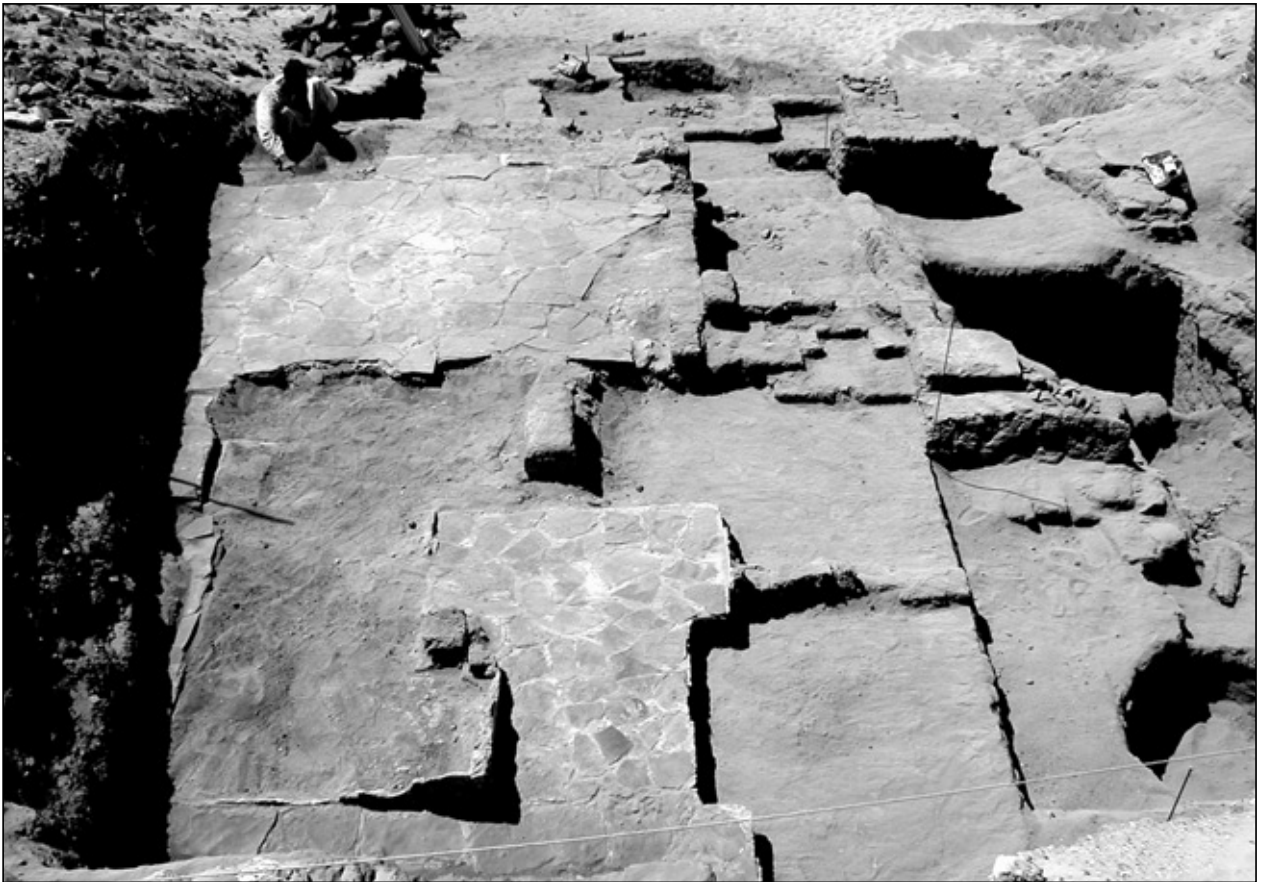
*Fig. 8. Building B.V, northwestern corner, view from above  
(Photo W. Godlewski)*

Building B.V was erected just 4.00 m from the southern arm of B.III, on a high platform of undressed blocks of stone from local quarries [Fig. 8]. In the northwestern corner, the platform was all of 2.00 m high, the purpose being presumably to level the ground under the new structure. It was constructed of red brick with outer walls 1.20 m wide and vaults supported on pillars and pilasters built of brick, the latter almost fully circular in section. The stone pavement laid of undressed slabs bonded in lime mortar was found on a level 2.50 m above the pavement of the neighboring cruciform structure (B.III).

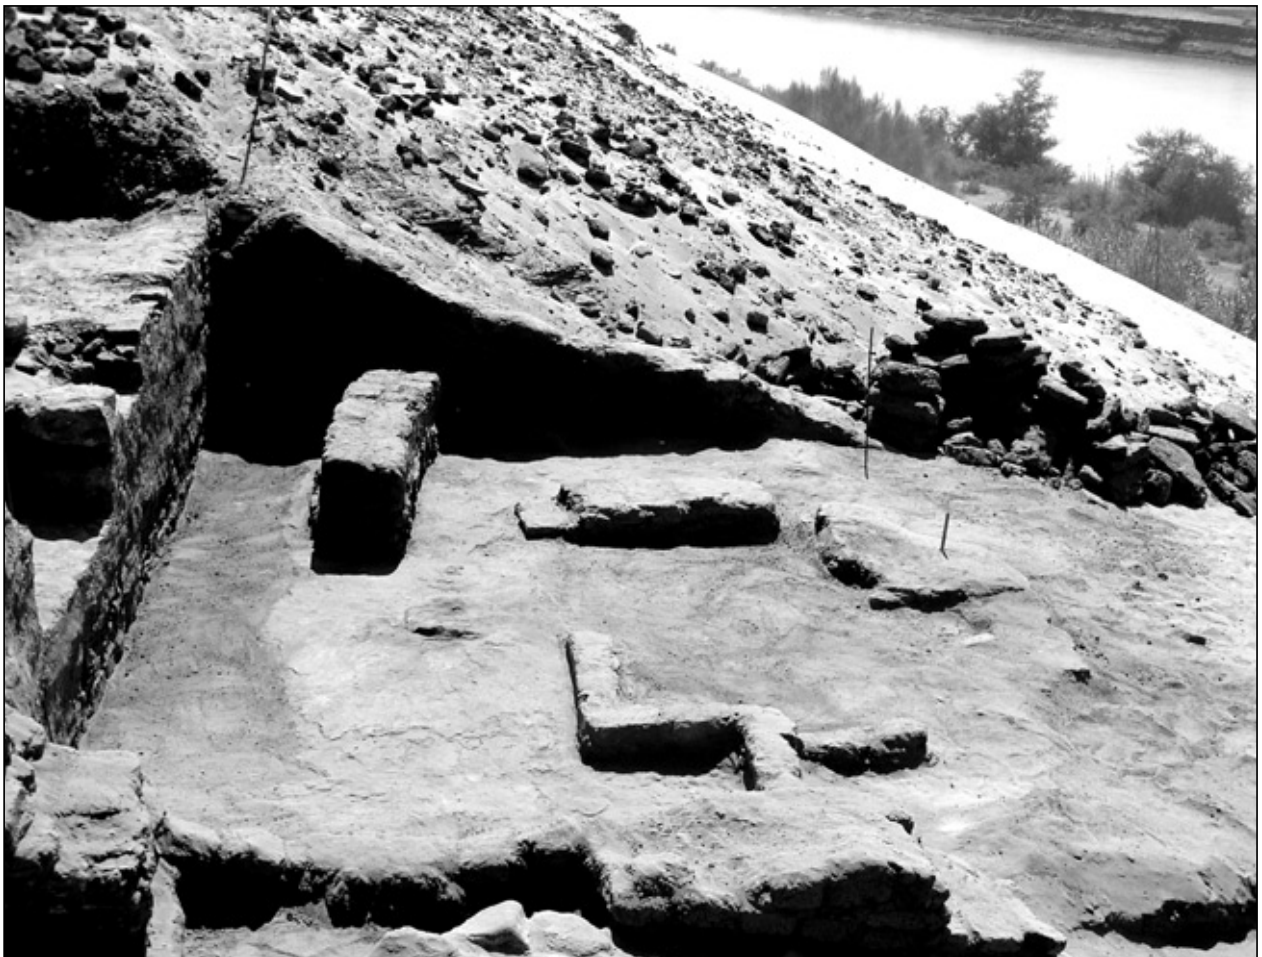
*Fig. 13. House H.52, view from above*  
(Photo W. Godlewski)

An earlier house (H.52) was preserved by the western face of the platform under Building B.V. It was erected presumably in the 15th-16th century, above the destroyed walls of Building B.II. The suggested dating is based on the stratigraphy of the architecture established for this spot [*Fig. 13*].
