**Restoration Work in the Solar Cult  
Complex of the Temple of Hatshepsut  
in Deir El-Bahari**

Polish Archaeology in the Mediterranean 19, 278-284

# RESTORATION WORK IN THE SOLAR CULT COMPLEX OF THE TEMPLE OF HATSHEPSUT IN DEIR EL-BAHARI

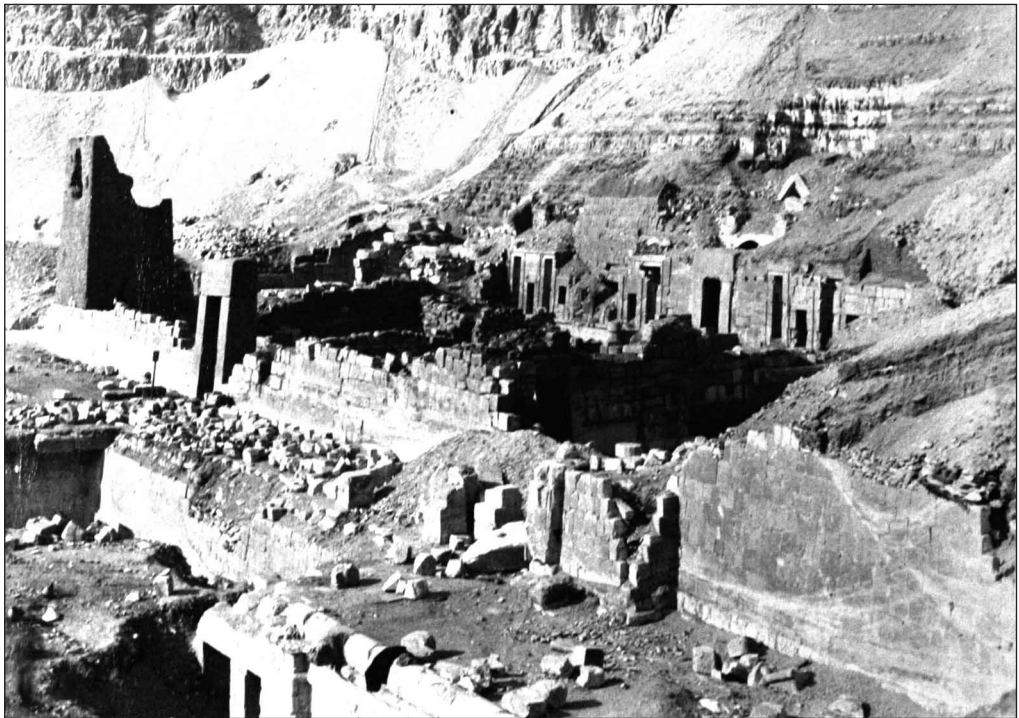
*Fig. 1. The Upper Terrace of the Temple of Hatshepsut in the end of the 19th century (Photo courtesy of the Metropolitan Museum of Art in New York)*

The north wall furnished with a niche *in situ*, preserved to just above the lintel of the niche, that is about 3 m high,<sup>1</sup> was restored to its full height of 5.85 m under the previous head of the mission, Franciszek Pawlicki, in 1994/5 [Fig. 1]. Red brick (with a plaster coating) was used for the purpose, introducing sequences of fragmentary stone blocks in their original position. Architrave sockets were marked in their theoretical emplacements. The same procedure was adopted for the south and east walls which had been preserved, the south wall (including the entrance portal leading into the complex) to a height of 4.20 m and the east wall to about 2.00 m. The reconstruction of these two walls to 5.75 m was necessitated, according to extant conservation documen-tation, by

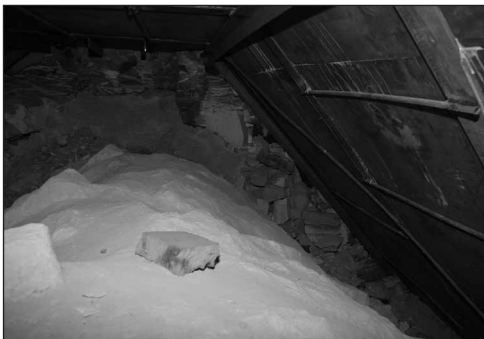
The steel frames were filled with monolithic ribbed plates 14 cm thick, reinforced with smooth steel of A0 class, 8 mm in diameter and with a span of 15 cm [Figs 4, 5]. The edge panel of the reinforced-concrete slab on the side of the rock slope is supported on a steel frame and continuous groove cut in the rock. The steel structure was given a rustproof coating. B20 monolithic concrete was used (C16/20). Slabs were poured in traditional formwork of galvanized steel sheets, the latter also protecting the top surfaces of the shrine's vault from the wet concrete mass. The top surface of the roof shelter was covered with two layers of a bitumen mass, additionally protecting against water and damp. Once the concrete achieved full strength, the roof shelter was covered with rock detritus, which was designed to act additionally as a shock-absorbing layer for dynamic rockfalls from considerable heights.

Fig. 4. View of the protected vault following the present work (Photo M. Jawornicki)

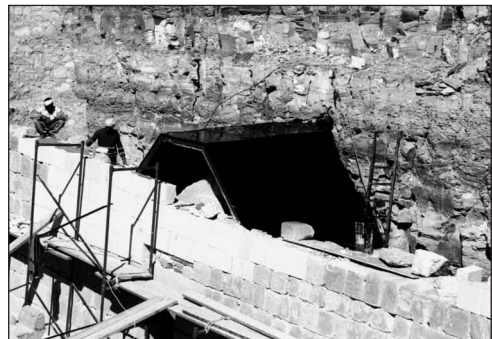
Fig. 5. Shrine of Anubis and the north wall of the court during the project (Photo T. Kaczor)

Work on the north wall of the court proceeded concurrently with structural work on the Shrine [Fig. 5]. In line with the program guidelines, stone blocks of specific dimensions according to the historic courses were prepared. They were laid in a lime-cement mortar. Above the ancient vault of the shrine, one of the blocks was mounted in a movable position in order to assure continuous monitoring of the original vault, this in line with the ICOMOS Charter of 2003 (pt. 3.21) which says that “checks and monitoring during and after the intervention should be carried out to ascertain the efficacy of the results”.

In order to isolate the roof shelter of the shrine and eliminate any additional load, a reinforced concrete beam (20/24 cm) was mounted in the wall above the shelter.

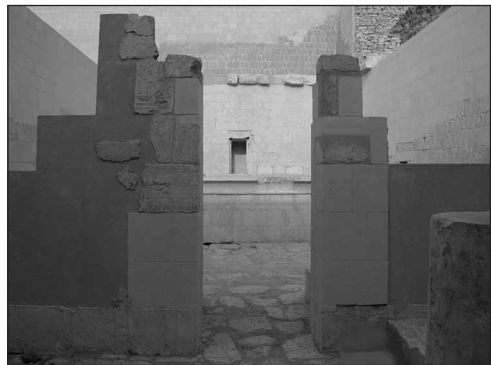
The original blocks from the wall between the vestibule and court were protected in the 2002 season. The portal in this wall and fragments on either side were recreated in the form of a permanent ruin [Fig. 6]. The joining of this non-existent wall with the north wall of the complex was arranged in a way to present ancient wall-building techniques. The joining with the south wall was shown as traces modeled in mortar.

Fig. 6. Vestibule wall with portal opening onto the court (Photo M. Jawornicki)

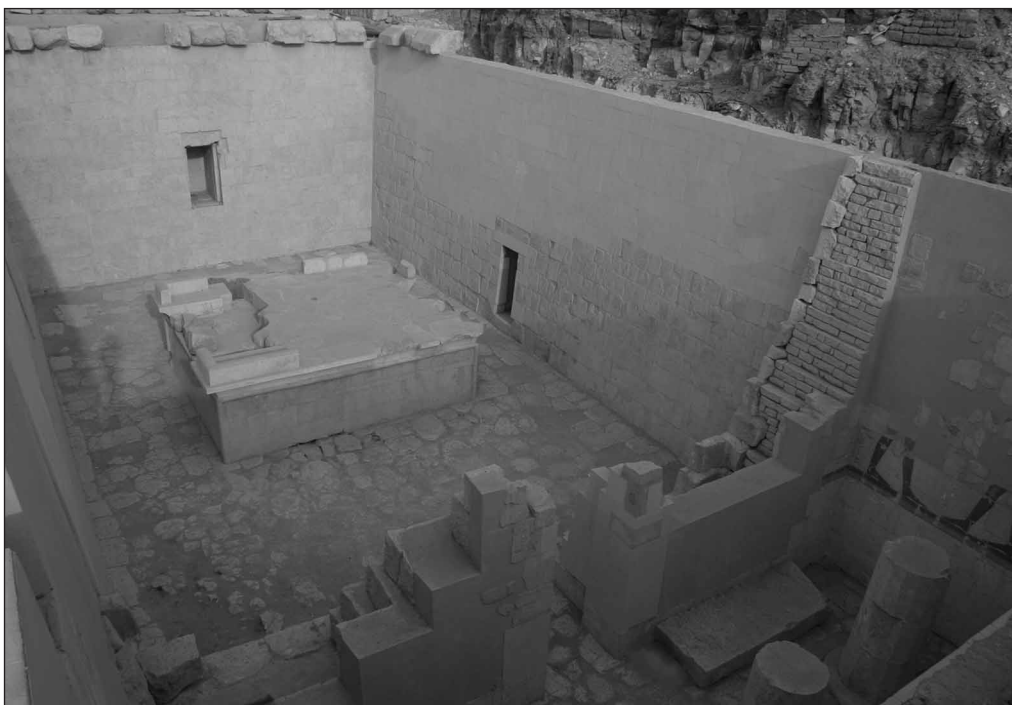
length of the walls, the gaps were completed with low walls plastered in the color of the limestone. Apart from the aesthetic value of this composition, it had the functional purpose of screening the structure of the ceiling over the Northern Chamber of Amun-Re [Fig. 7].

Fig. 7. Solar Cult Complex. General view toward the west and north. State during conservation work in 2005 (Photo M. Jawornicki)

already undergone conservation treatment (the blocks were preserved and protected by Andrzej Sośnierz). The first stage comprised four cornice blocks being set on the north wall, starting from the corner with the west wall. Further blocks were mounted on the west wall. For lack of blocks to fill the entire
