## Alexandria: Excavations and Preservation Work : Preliminary Report 2006

## EXCAVATIONS AND PRESERVATION WORK PRELIMINARY REPORT 2006/2007

Grzegorz Majcherek

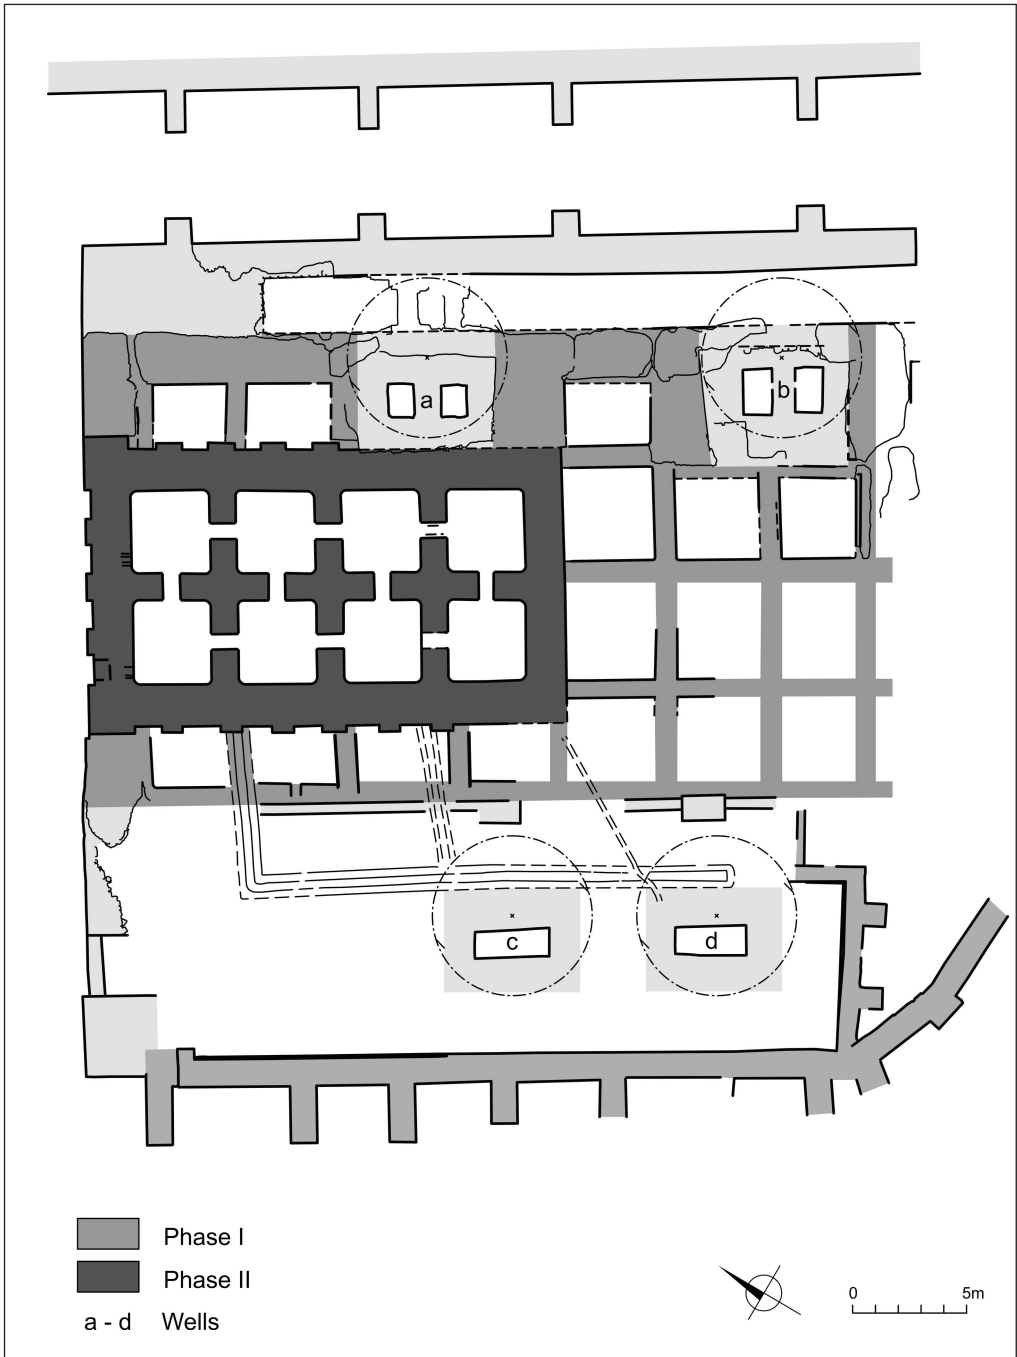
Fig. 1. Plan of the cistern installations from different phases  
(Drawing W. Kołataj, updated by A. Brzozowska)

Last year's clearing of an extant fragment of the medieval Moslem cemetery overlying the southwestern part of the cistern (the highest point on the site) opened the way to the exploration of vestiges of the cistern installations below [Fig. 1].

Two large wells were cleared directly below (marked *c* and *d* in the plan in Fig. 1).

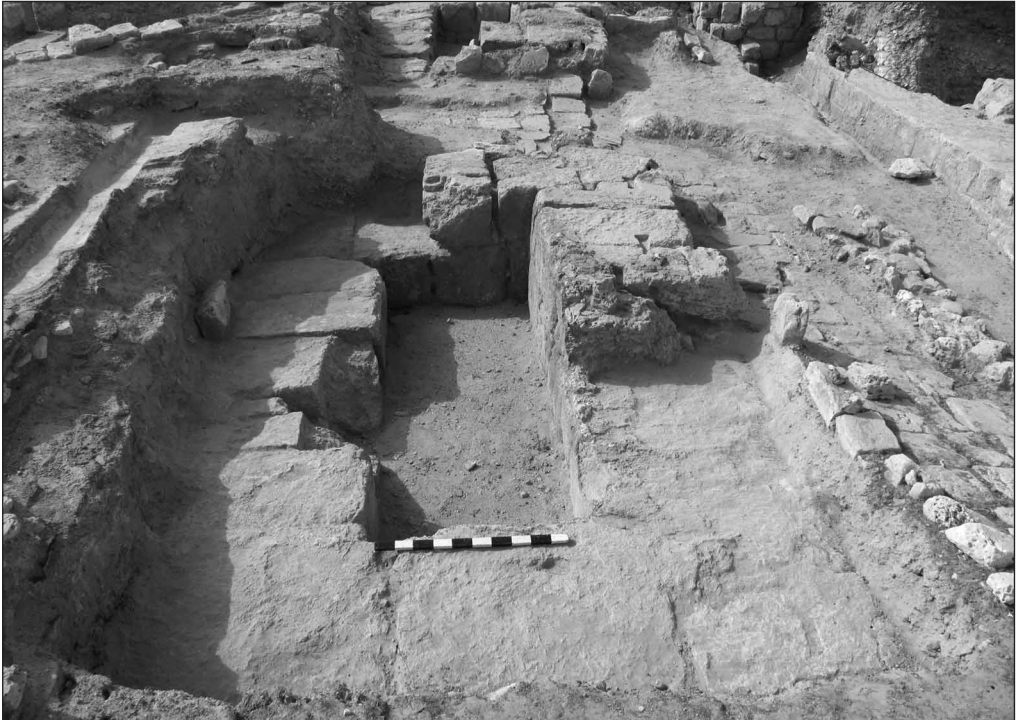
Fig. 2. Masonry wells in the southwestern part of the cisterns, view from the north (Photo G. Majcherek)

Both structures are rectangular in plan, measuring approximately 1.25 x 3.25 m. The shafts were built of surprisingly massive masonry, some of the blocks measuring even 1.10 x 0.60 x 0.55 m [Fig. 2]. The blocks were additionally joined with metal clamps, as evidenced by large openings of dove-tailed shape on their surfaces. The heads of the wells are not preserved; they were damaged most probably even before the medieval burials encroached upon the area. The walls inside turned out to be heavily incrustated with calcium–lime deposits,

indicating prolonged use. The wells must have been operated by a *saqiya* device despite no traces of the lifting gear remaining. This assumption is based not only on the large number of *saqiya* pots found in associated layers, but also on the unexpected discovery of a path trampled down in a circle around the northern well. The path, of which only a fourth of the original circumference has been preserved, was made of brick rubble, consolidated with clay and lime, and beaten hard by oxen driving the installation.

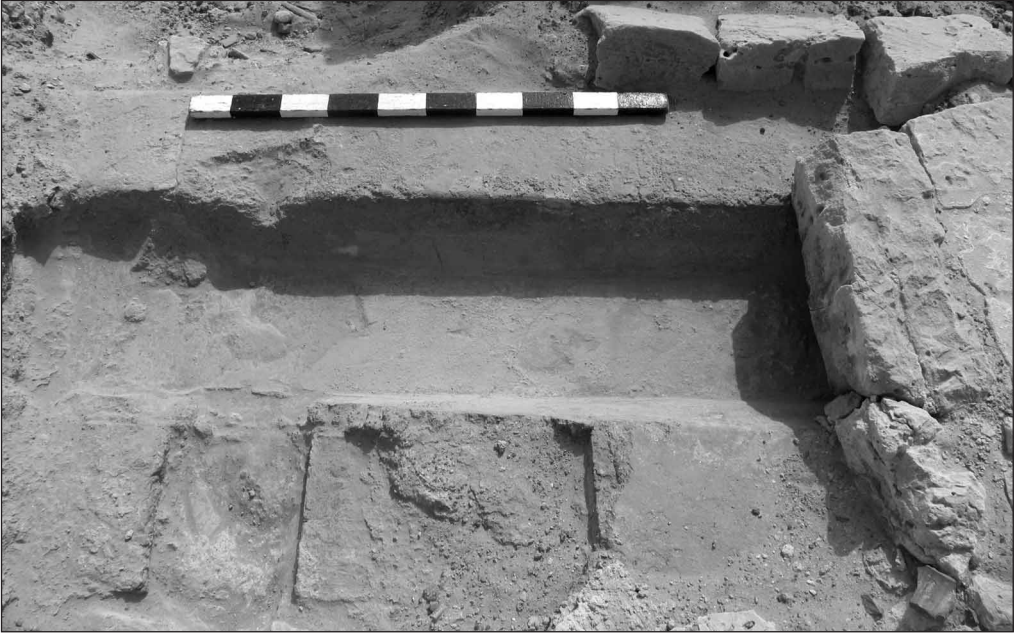
*Fig. 3. Channel from the drawing well to the tanks, view from the east  
(Photo G. Majcherek)*

Last season, a stretch of water-channel feeding the cistern was cleared next to the wells. It appears to have supplied water from the nearby drawing well to the cistern tanks located further along. The channel, which is trapezoidal in section, was built of red bricks (28 x 28 x 4.5 cm) lined with waterproof plaster and covered with horizontal limestone slabs [Fig. 3]. It was laid on massive foundations (1.40 m wide and 0.85 m deep), made of several layers of bricks interlaced with small limestone blocks. This year an additional bifurcation of the channel was cleared next to the southern well. It was built as a double-level channel, to control water distribution to particular tanks. Both wells were in operation during the second phase of the cisterns and went out of use sometime in the 6th century. By the time the last set of tanks was constructed, they were already abandoned and covered with limestone flagging (for previous excavations in the cisterns area, see Kubiak 1967: 47–81; Rodziewicz 1984).

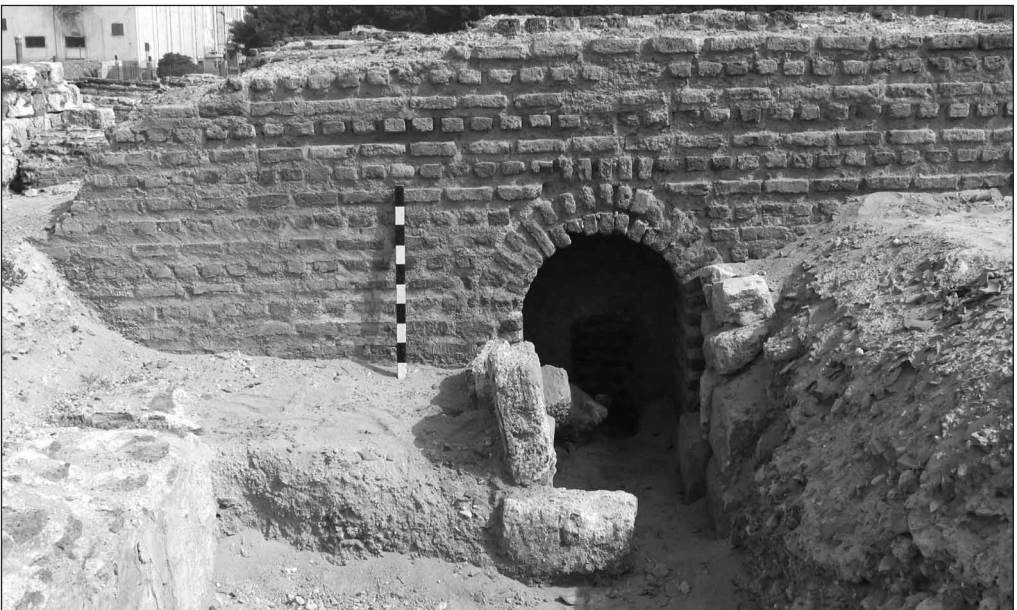
*Fig. 4. Water outflow from the last-phase cistern, view from the south  
(Photo G. Majcherek)*

Quite unexpectedly, explorations of the previously unexcavated southwestern tank of the last-phase cistern revealed an additional water outflow [Fig. 4]. The outflow pipe (not preserved) had been placed at the bottom of the tank, within a vaulted opening some 0.85 m wide and 1.55 m high. There can be no doubt as to its

contemporaneity with the original construction. A likely interpretation is that it was supposed to supply water to yet another public building (possibly baths as well) located further to the south, beyond the limits of the excavation area.

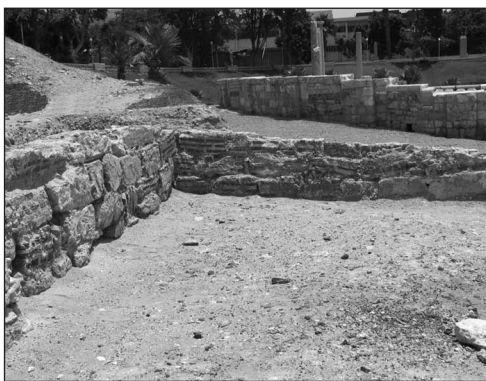
Fig. 5. *Dump-retaining wall in central part of the site, view from the north*  
(Photo G. Majcherek)

adding to its height in its southern run, close to where it joins a wall of similar masonry bordering the theatre on the north [Fig. 5]. The added courses consisted of large blocks cut from brick walls, quite likely from the abandoned water tanks in the cisterns or baths.

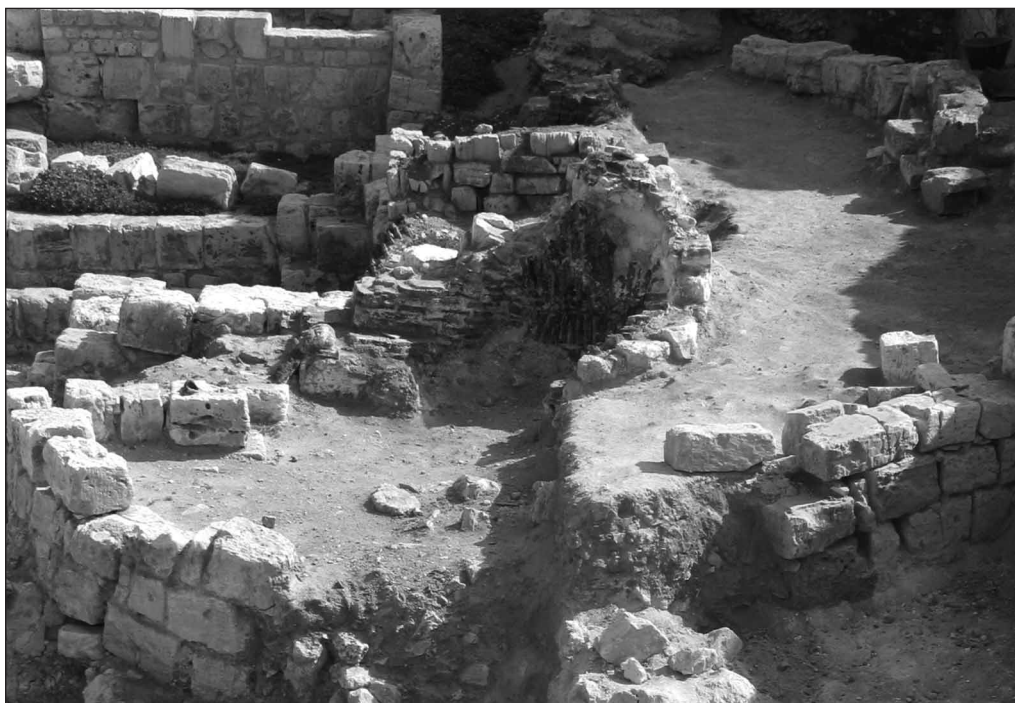
*Fig. 6. Kiln discovered below the layers of ash in Area F, view from the west (Photo G. Majcherek)*

Immediately below the deposits of ashes intermixed with rubble resulting from subsequent rebuildings of the bath, excavators cleared a partly preserved lime kiln. The structure, located in the southeastern corner of the trench, featured a circular (c. 1.00–1.10 m in diameter) updraft kiln built of red bricks set in clay mortar [Fig. 6]. The vaulted entrance to the furnace chamber had been discovered already in 1999, next to an almost identical

kiln located further east (Majcherek 1999a). The structure was surrounded with a large semicircular wall, built of several courses of assorted limestone blocks, most probably originating from earlier dismantled buildings.

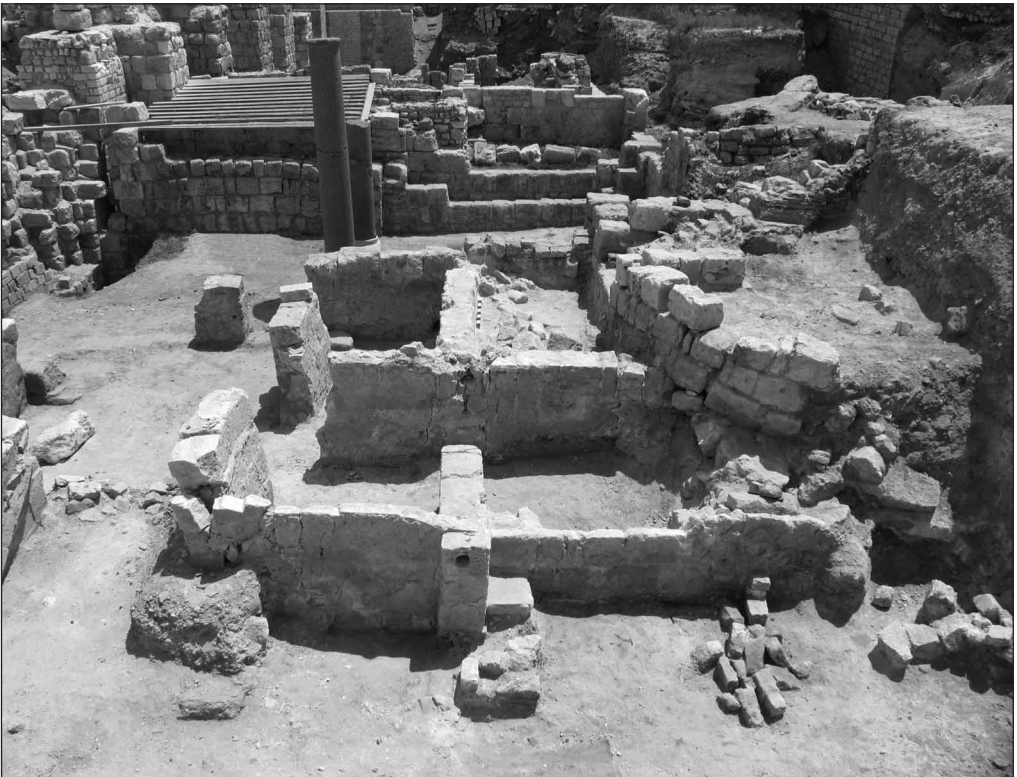
*Fig. 7. Early Roman House FB in Area F, view from the west  
(Photo G. Majcherek)*

Structures of earlier date appeared immediately below the lime deposits. They belonged to Early Roman house FB, partly uncovered already in 1998. The northern part of the house has been seriously damaged by later building activity, where the baths' huge outer wall was constructed across all existing structures. Current work in an area to the west of the previously explored section revealed a series of contiguous rooms, forming a purely domestic section of the building under exploration [Fig. 7]. The extent of house FB was not determined, but there is a strong possibility that the building extended another 10–12 m to the west.

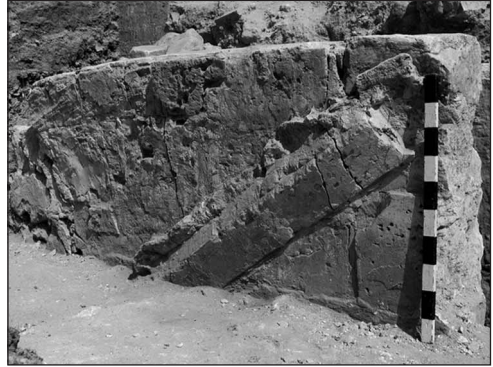
Fig. 8. Springing of stone vault under staircase in House FB, view from the south (Photo G. Majcherek)

Judging by the evidence of a row of rectangular socket holes that have been preserved in the north wall of room 6, the house would have had a second storey or at least a terraced roof. The stairs appear to have been supported additionally on a stone-made vault, of which only the springing has survived [Fig. 8]. The adjacent narrow room 7 (0.85 m wide) must have been intended for an upper flight of the staircase. The empty

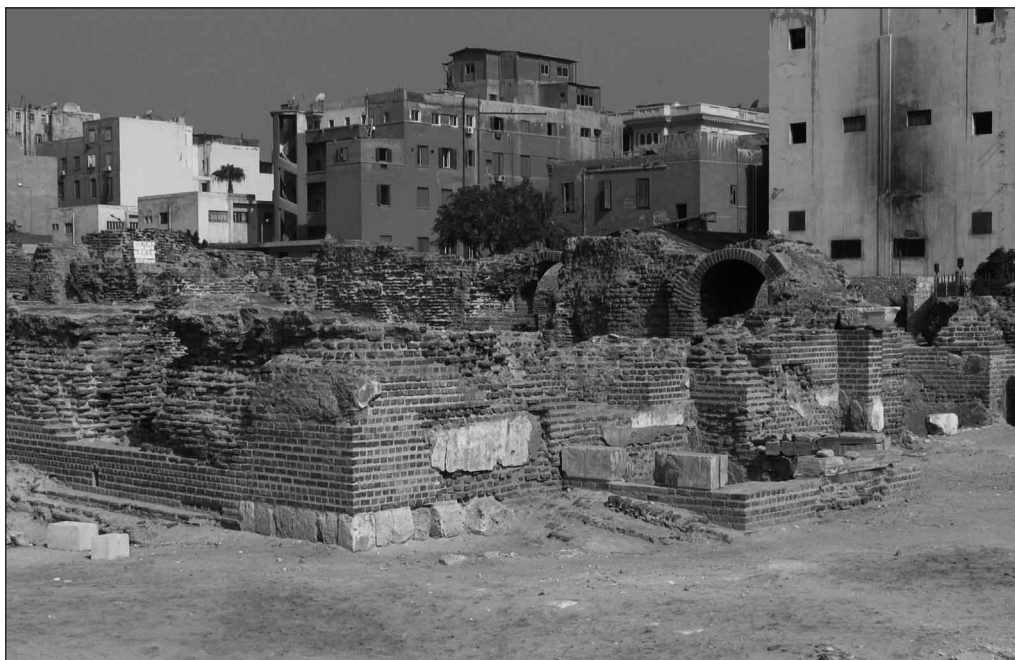
Fig. 12. East façade of the Late Roman Bath after conservation, view from the southeast (Photo G. Majcherek)

high in places, was restored with re-laid bricks. Deteriorated mortar joints were cleaned and re-pointed, and the brickwork stabilized as a whole. The principle of preserving original wall bonding, as well as minimal intervention, was strictly observed. In some extant areas belonging to the original phase of the building and structured in flat Roman bricks, new bricks cut to appropriate dimensions and matching original ones were used in order to preserve the historical substance [Fig. 12]. As a rule, only lime-sand mortar was used in the bonding.

A similar conservation operation was conducted on a 12-m long stretch of the southern elevation. The wall facing here, including much deteriorated and detached brickwork, was thoroughly restored [cf. Fig. 12]. The operation also included the restoration of an almost totally destroyed semicircular pool in the dextritorium. Additional repairs were made on the hypocaust system in both the tepidarium and the dextritorium. Some seriously deteriorated square *pilae* once supporting the hypocaust, initially secured

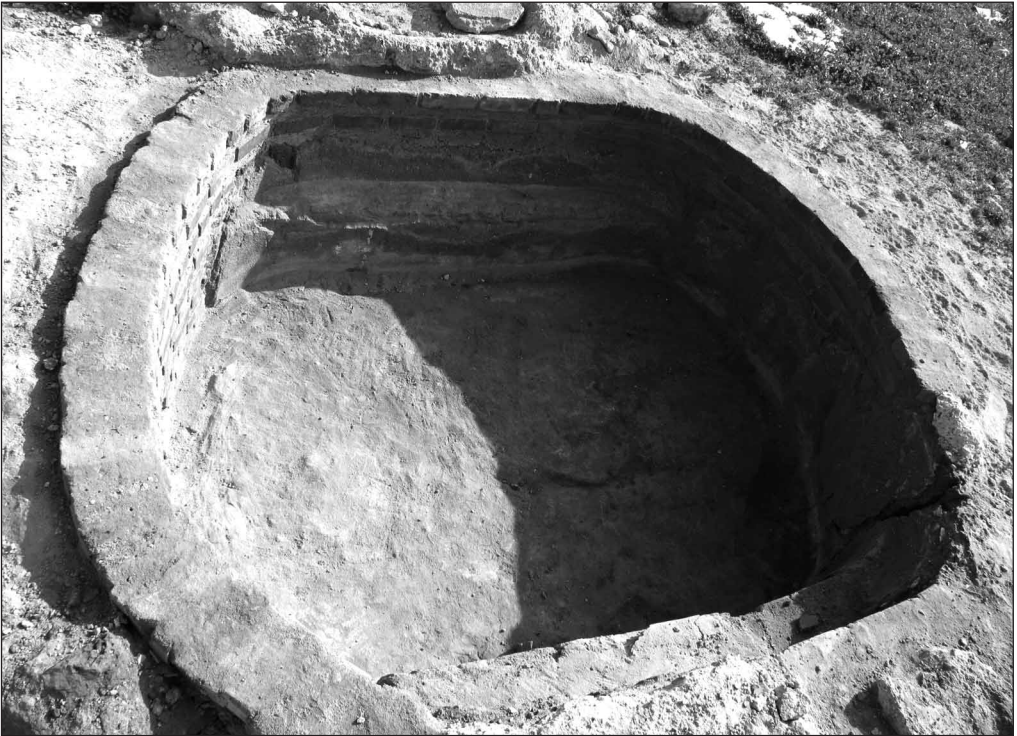
Fig. 13. Oval frigidarium pool, after conservation, view from the north  
(Photo G. Majcherek)

Yet another frigidarium pool, of oval shape, was also restored<sup>5</sup> with original bricks found nearby (Rodziewicz 1979) [Fig. 13]. The same procedure was applied to a nearby manhole which leads to the underground drainage system. Its walls were repaired with bricks and a new head, slightly elevated with regard to the surrounding ground, was built. The manhole was secured with a wooden grate.

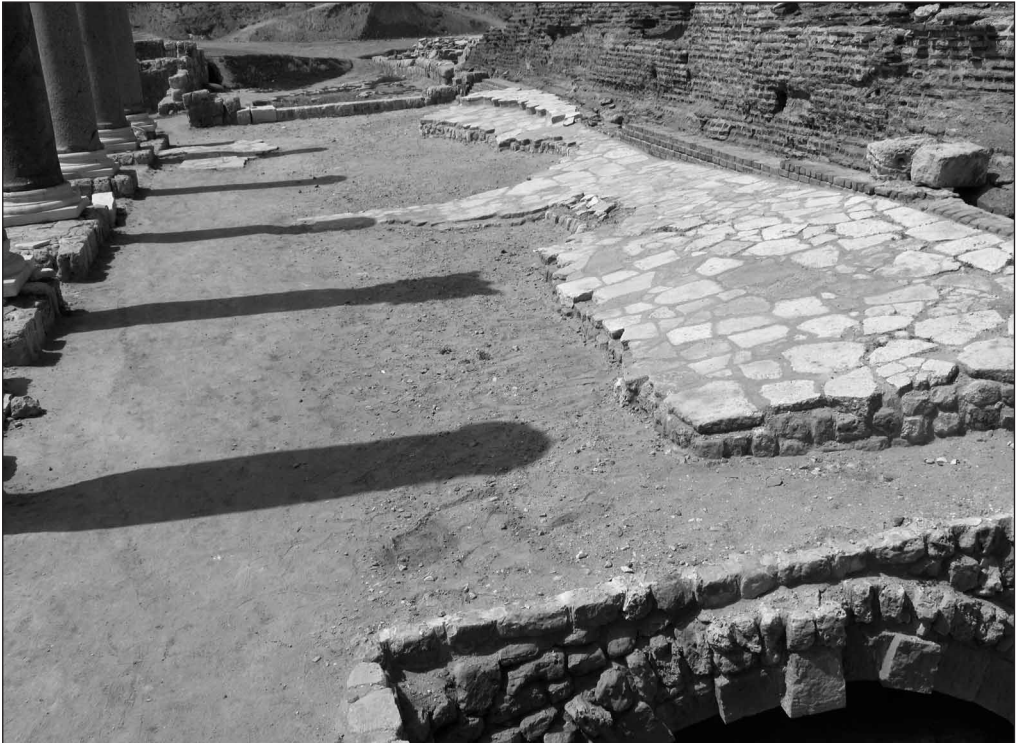
*Fig. 14. South façade of the bath and adjoining passage, after conservation, view from the east (Photo G. Majcherek)*

The conservation of an extant pavement in the southern passage of the bath proved to be a major operation. The pavement,

made of irregular nummulithic limestone slabs, had survived in several separate sections located mostly next to the channel running along the façade. The flagging has subsided considerably in places, most probably due to seismic activity. Whole sections of flagging were now set in a new mortar bedding and consolidated [Fig. 14]. The edges of the flagging were additionally reinforced with a supporting band of lime-sand mortar. The gaps in the flagging will be filled eventually with gravel.

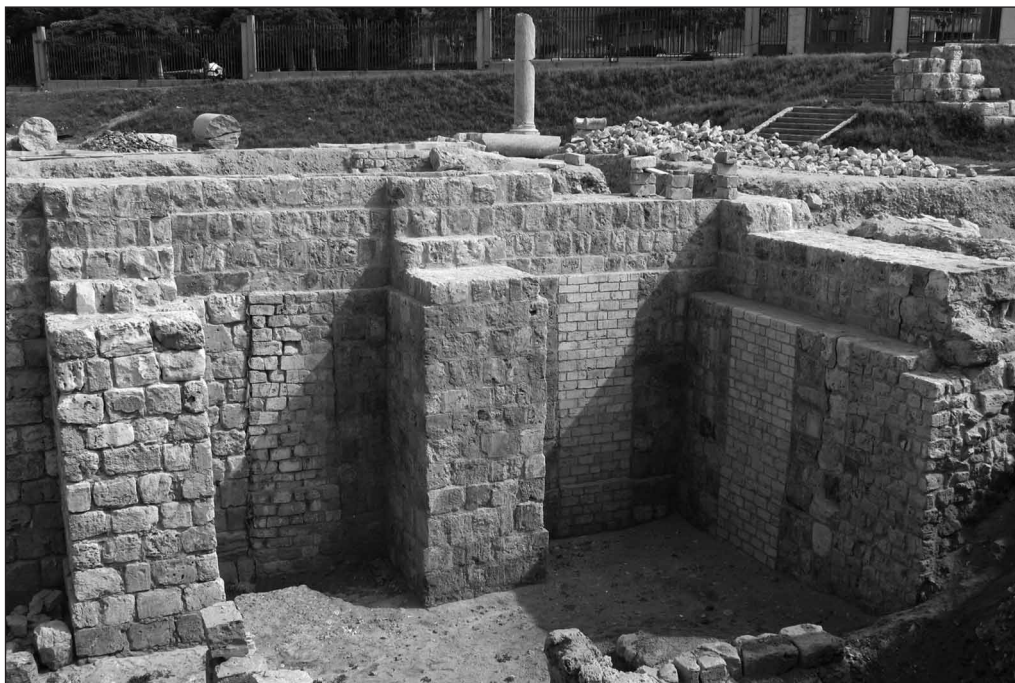
*Fig. 15. Outer wall of the bath, after conservation, view from the south  
(Photo G. Majcherek)*

of large masonry blocks at regular intervals, the intervening sections built in *opus caementicium* with limestone facing enclosing a rubble core. The pillars were almost totally gone, while extant screening walls were in very poor condition.

The latter were treated first. The core of the wall was consolidated and the masonry facing restored wherever necessary. In 2006, this huge wall (c. 1.55 m wide) was rebuilt to a height of some 1.60 m above ground level (Majcherek 2009: 38 and Fig. 9). This restoration was completed this season. The rebuilt section of the wall now reaches a height of some 4 m [Fig. 15].
