Excavating the Curtain Wall in Banganarti in 2007

Polish Archaeology in the Mediterranean 19, 342-358

EXCAVATING THE CURTAIN WALL IN BANGANARTI IN 2007

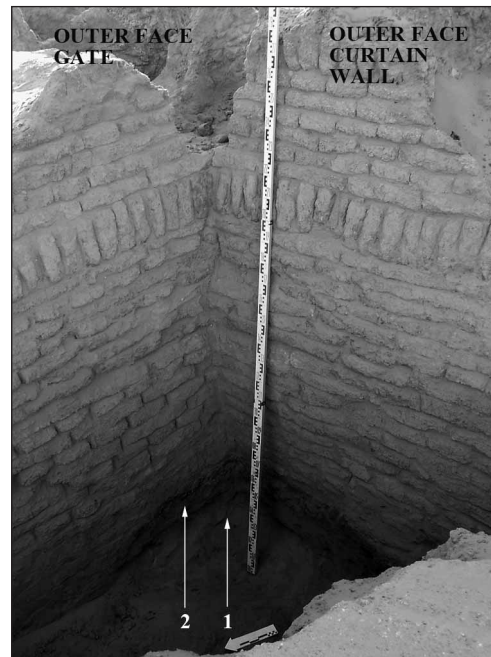
Fig. 3. Layers of burning and ash from Phase 1, recorded at the foot of the curtain wall in Sector IV; 1– dark brown sand, potsberds, small red brick fragments; 2– burning, charcoal, mud, argillaceous sand, potsberds, small rocks (Photo M. Drzewiecki)

Shortly after its construction the outer gateway was blocked with mud brick and red brick. This action seems to have been followed by violent events, which have left evidence in the form of layers of burning and ashes, recorded in all of the test trenches excavated in the area of the North Gate [Fig. 3].

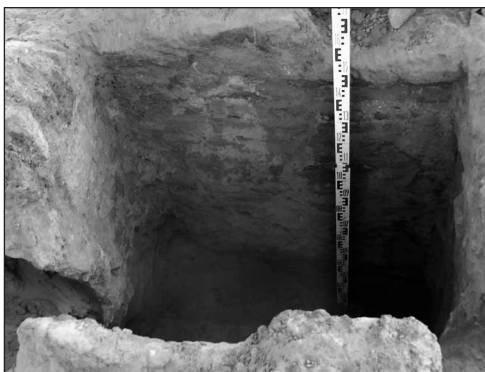
Fig. 4. Shaft for mounting a trebuchet (feature no. 2) in the North gate in Sector IV (Photo M. Drzewiecki)

Two unusual features appear to have been introduced at this stage. These are vertical shafts reaching down to the gate foundations, built into the wall of phase II but using the outer face of the wall from phase I as one of its sides [for feature no. 2, see Fig. 4]. According to the excavator, Bogdan Żurawski, these shafts were used to mount trebuchets (Żurawski 2007). The settlement layers connected with this stage are composed largely of ashes and burning. The

device, whatever it was, appears to have been destroyed and the shafts were filled with burning and ashes of two distinctive colors: ash gray and orange.

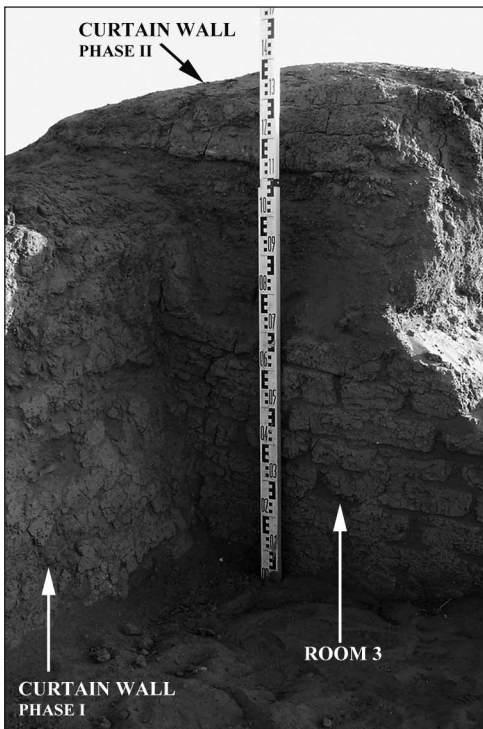
Fig. 10. Two phases of the curtain wall in Sector VII. February 2007 (Photo M. Drzewiecki)

The curtain wall is clearly a continuation of the wall uncovered in Sector VIII of the fortifications, but the present investigations have traced two phases of construction [Fig. 10]. In the first phase, the wall was approximately 2.20 m thick. About 1.30 m of the height was cleared without reaching the

foundations; the faces are damaged extensively making it impossible to ascertain brick size and the character of the bondwork. Remains of the second phase have been recorded on top of the first, in the form of four incomplete brick courses. The bricks are 33–37 x 17 x 7–8 cm in size, laid header–stretcher alternately, similarly as in Sector VIII (Wiewióra 2005: 265). Traces of this second phase can be seen only in section 1 of this sector.

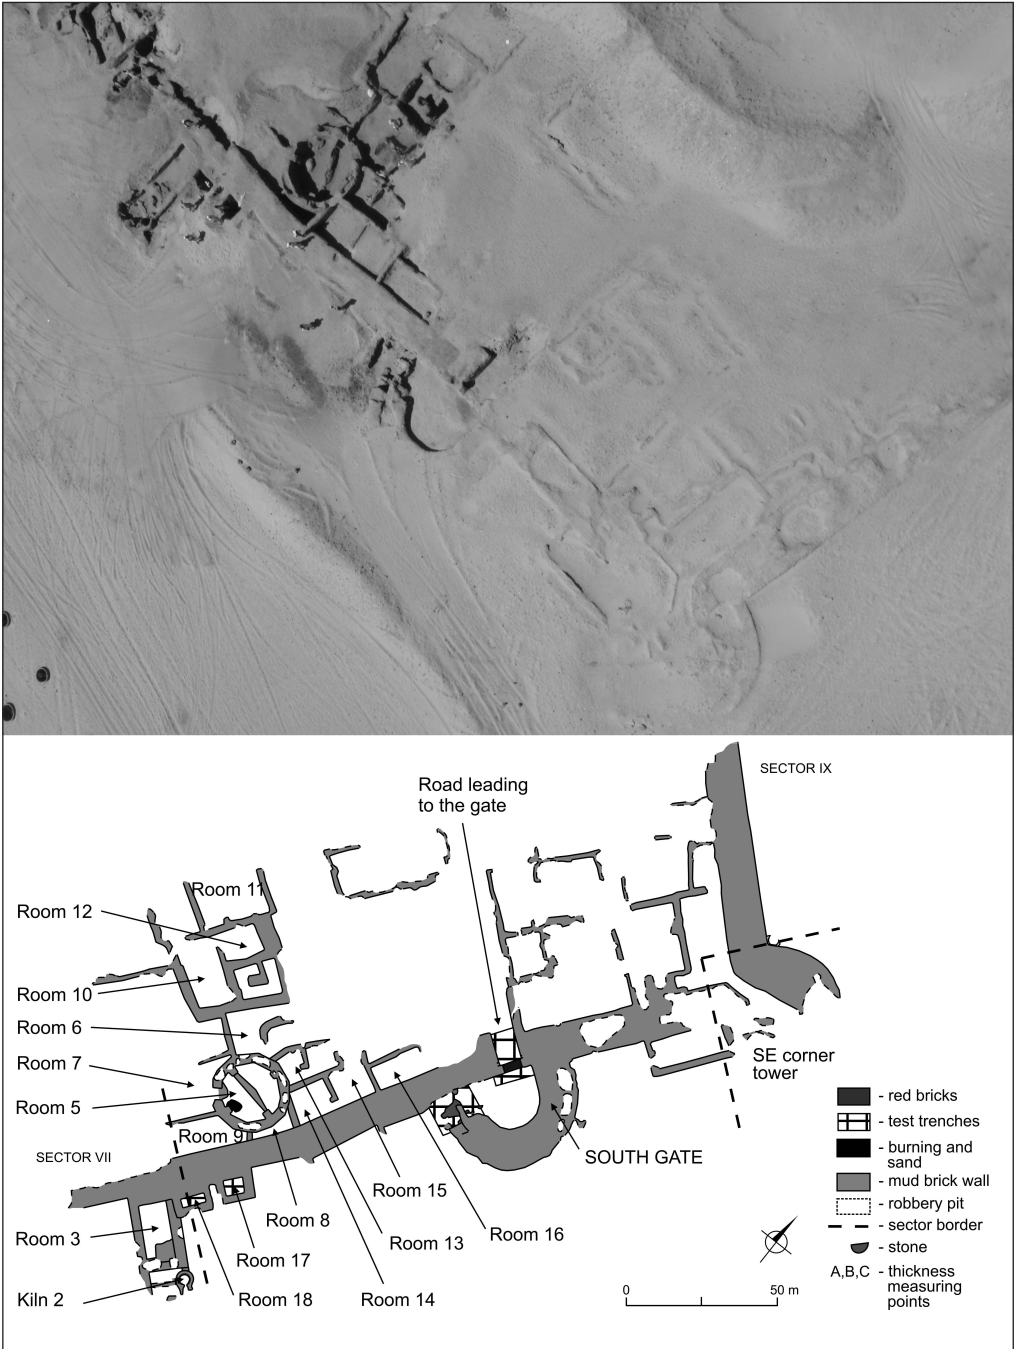
Fig. 11. Plan and aerial view of Sector VIII of the curtain wall. February 2007
(Aerial photo B. Żurawski; plan R. Łopaciuk, M. Drzewiecki)

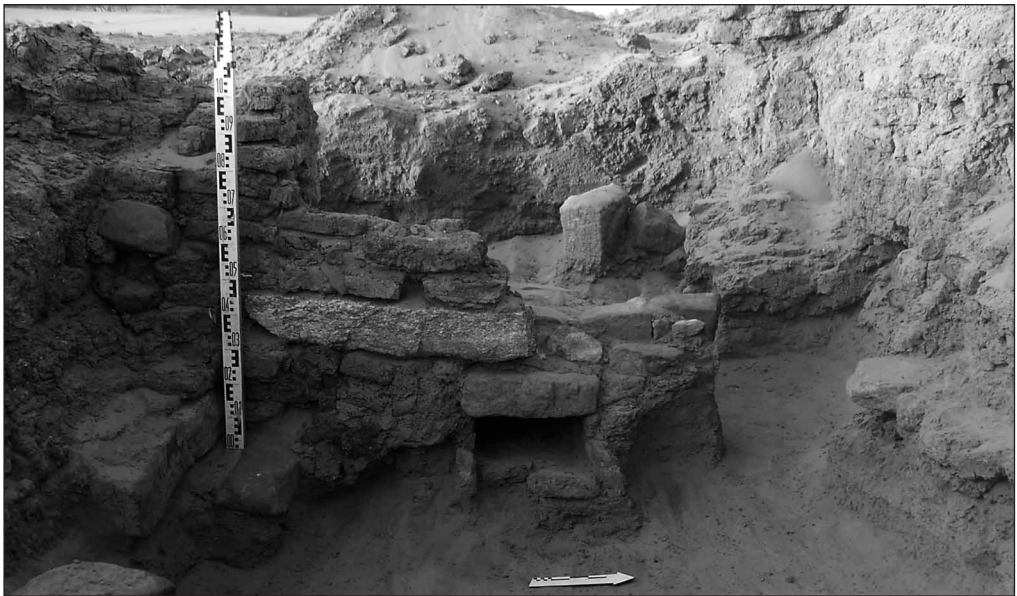
*Fig. 13. View of the South gate in Sector VIII from the east
(Photo M. Drzewiecki)*

One of the test trenches was excavated by the outside passage of the South gate. The passage proved to be in use in unaltered form until its final blocking. Only the northern part has been preserved [Fig. 13], leaving the excavators to conjecture that it was approximately 1.20 m wide. It was vaulted with red bricks. The northern end of the arch was found in the sand of the courtyard, while the southern end was still partly set in the semicircular wall of the gate. The face of the wall is marked by stones resting in a straight line in the lowest parts of the wall.
