Khone-Ye Div: Preliminary Report on the First Season of Irano-Polish Excavations

Polish Archaeology in the Mediterranean 19, 603-611

PRELIMINARY REPORT ON THE FIRST SEASON OF IRANO-POLISH EXCAVATIONS

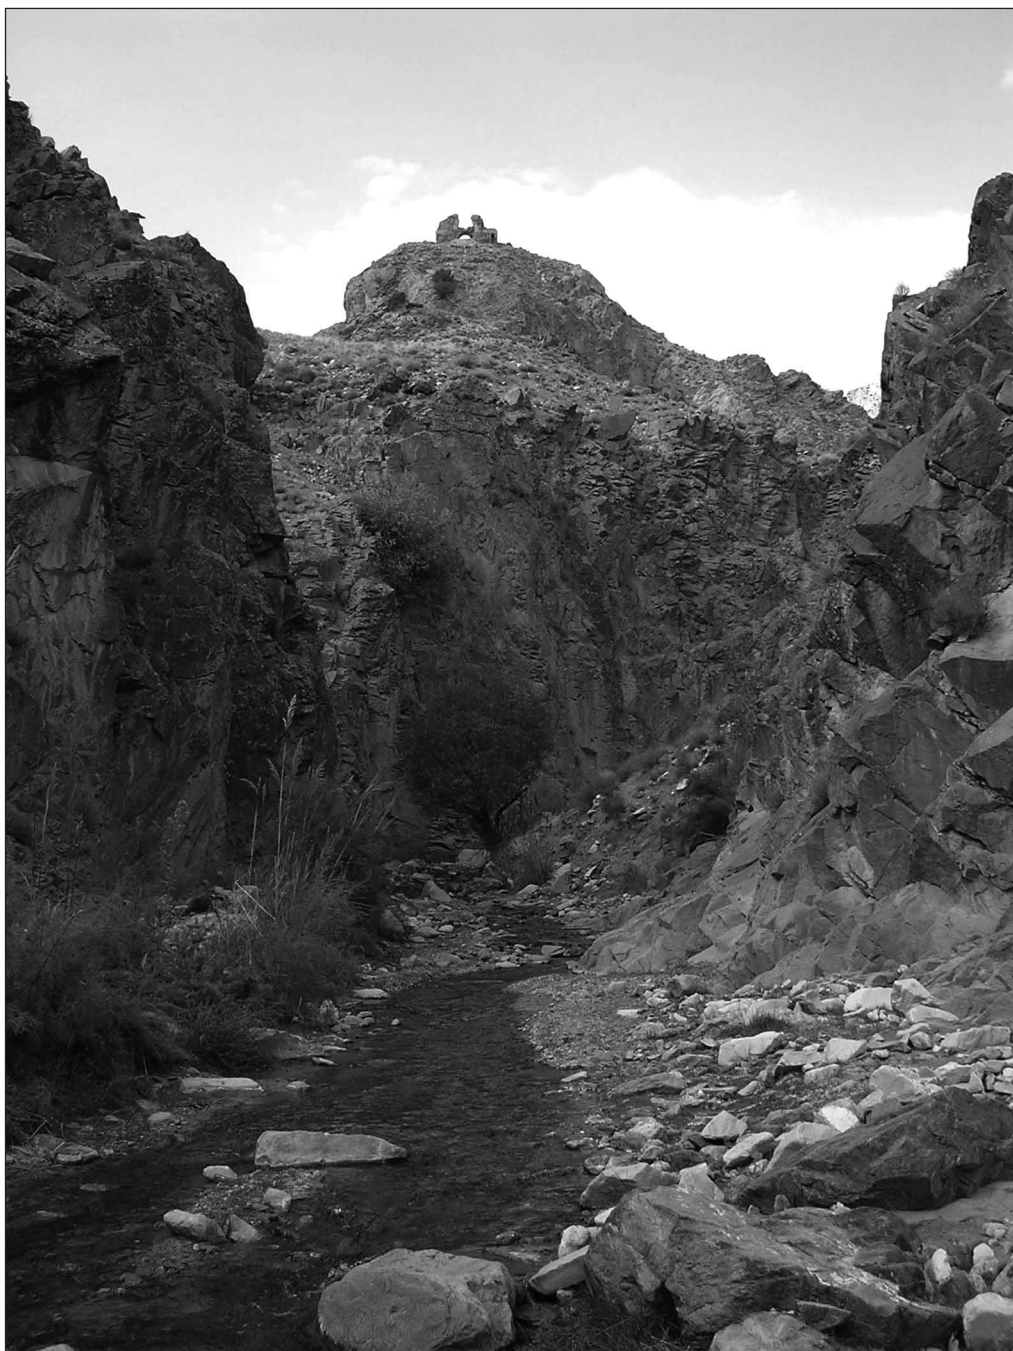
*Fig. 1. Ruins of Khone-ye Div, view from the southeast
(Photo B. Kaim)*

Khone-ye Div² lies in the mountain chain of Revand (also spelt Rivand), on a rock spur in the Revand River gorge [Fig. 1] (N 36°16'179; E 56°44'594), about 5 km north of the village of Foshtong (also different spellings, including Foshtang, for example) and 40 km northwest of the city of Sabzewar. The gorge, running northeast–southwest in this stretch, connects the ruins with the village of Revand, which lies 12 km away. There are no remains of any ancient settlements in the immediate vicinity of the site. The ruins are little known not only to the general public, but also to archaeologists, mainly due to the localization in the mountains, relatively far from any roads.

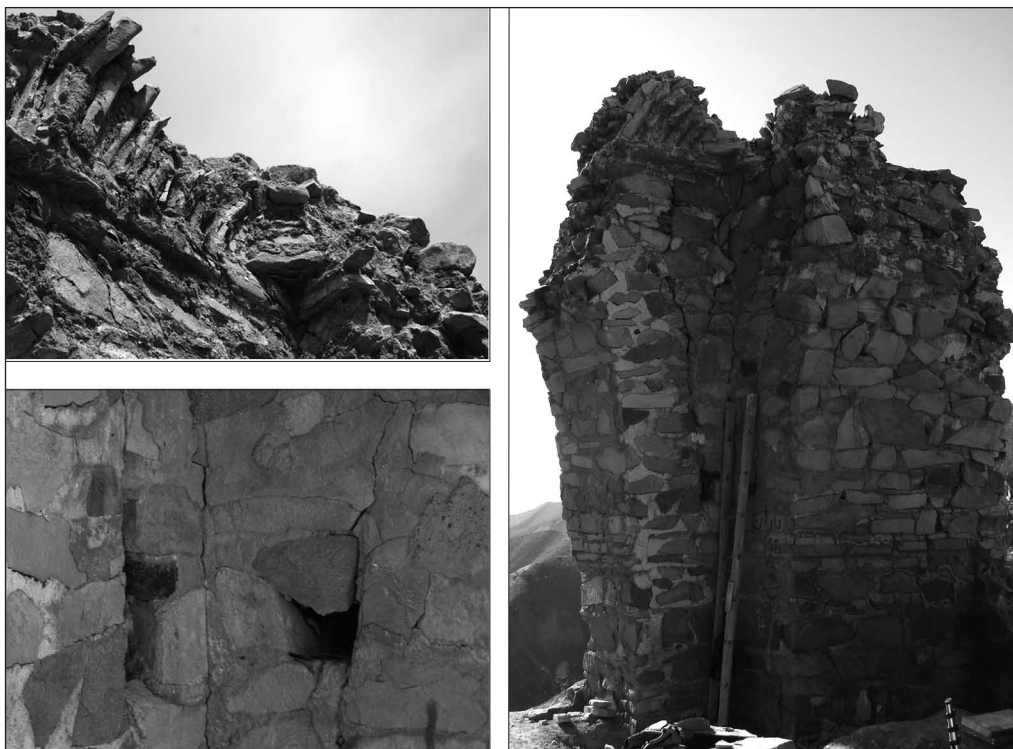
Fig. 3. *Masonry in the southern corner of the chahar taq, including close up of the squinch (top left) and of the putlog holes (bottom left) (Photo B. Kaim)*

The walls of the *chahar taq* were erected of mortared rubble and faced with large, roughly shaped stones set in more or less regular courses. The walls were shallowly bonded at the corners: the facing stones of one wall were slightly inserted into the adjacent wall [Fig. 3, right] and their courses in the bonded walls correspond with each other. For the construction of the lower parts of the walls big facing stones were used. Above them, flat slabs mark the transition from a square ground plan to a round dome [cf. Fig. 3, top left]. Two putlog holes in each corner provide evidence that the building was erected with the aid of scaffolding [cf. Fig. 3, bottom left]. Each wall is pierced by two such holes at 2.30 m above the floor.

In the northern corner, there are nine rows of vertical slabs, while in the southern one only five such slabs have been preserved. As far as it is possible to judge from these remains, the squinches were built of rough stone slabs laid on edge across the corners, successive courses moving in to close the space. The corner of each squinch was filled with flat slabs bonded by relatively thin layers of mortar, progressively projecting inwards to support successive courses of the slabs which were placed standing on edge [Fig. 3, top left].

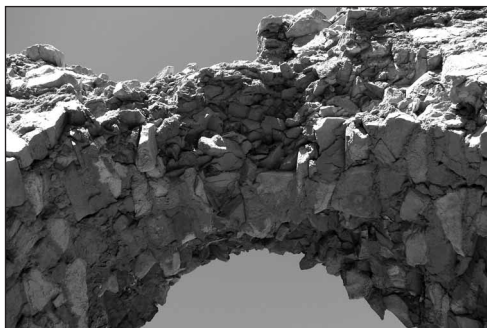
Fig. 4. *State of preservation of the northwestern arch (Photo B. Kaim)*

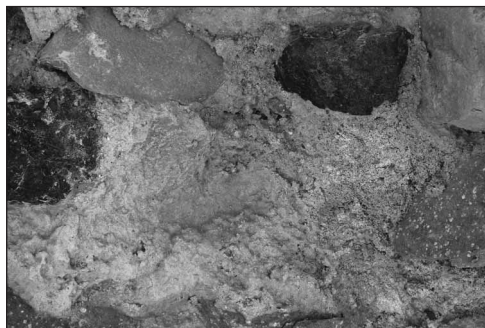
Fig. 5. *Outer face of the southeastern wall of the chahar taq (Photo B. Kaim)*

Inner wall surfaces appear to have been plastered as proven by fragments of gypsum plaster still visible *in situ*. Facing stones on the outer wall surface are often covered by an irregular layer of gypsum. It seems that after the facing stones had been set in place, the joints were pointed with gypsum mortar, the excess of which was carelessly spread over the wall, leaving some stones visible [Fig. 5].

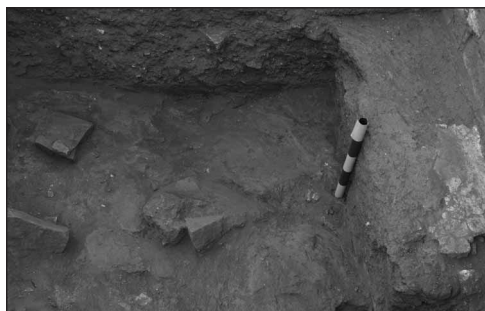
Fig. 7. Remains of a platform in Test Trench 1
(Photo B. Kaim)

The remains of one such structure were uncovered in the southern part of the trench [Fig. 7]. The uppermost part of this rectangular platform (1.36 by 0.96 m) was preserved at 1663.85 m a.s.l. The top had been destroyed by stones falling from a gradually disintegrating dome, making it

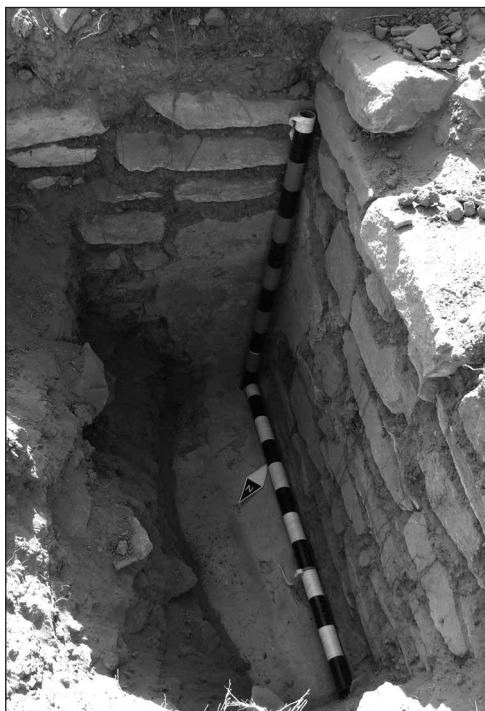
Fig. 9. Floor of the water reservoir in its southern corner in Trench 2 (Photo B. Kaim)
