Conservation Work at Marea in 2007

Polish Archaeology in the Mediterranean 19, 77-80

CONSERVATION WORK AT MAREA IN 2007

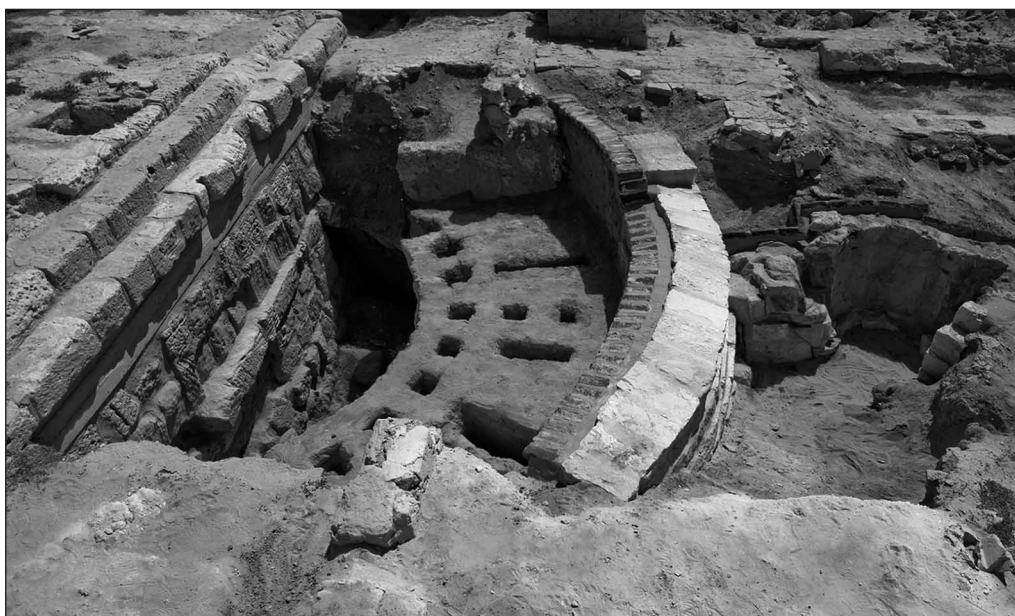
masonry structures located within the presbytery area of the basilica, namely, the baptismal font and the earlier structure of the pottery kiln [Fig. 1].

Fig. 1. Basilica presbytery area, general view, condition after the season in 2007. Note pottery kiln wall and baptistery font (Photo J.M. Kucy)

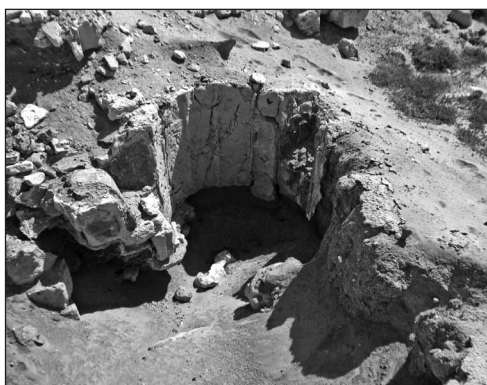
Less than half of the baptismal font has survived over the ages, including fragments of the steps and south half of the basin [Fig. 2, top] erected of limestone blocks and red baked brick. The undermined structure, missing floor and footing, was in danger of collapse. The east and west steps of the font were lined with waterproof plaster (*opus signinum*), and the basin was lined with a white limestone mortar bed featuring imprints of the finishing tiles (the latter not preserved). All the coatings were severely deteriorated, cracked and displaced and in

danger of detachment. The entire assembly was in immediate need of structural stabilization and conservation of the finishes.

Fig. 2. *Baptismal font, condition before (top) and after stabilization and conservation (Photo Jack M. Kucy)*

First of all, the steps and the basin of the font had to be supported [Fig. 2, bottom]. The new footing was constructed of limestone blocks set on a surface hardened with crushed brick, stone and light mortar soil, approximately 30 cm below the floor of the font. A small fragment of the basin, adjacent to the east steps, was supported and protected with a low retaining wall constructed of the limestone blocks set in lime mortar. All major voids between new support stones and the font were filled in with limestone mortar. The old structure was consistently separated from the new work with strips of bituminous membrane. After stabilization of the structure, conservation work on the preserved surfaces of the font was executed and included cleaning of the surfaces and cavities with water, filling the cracks and voids beneath the plaster with grout (a, for specification of materials used, see below), re-adhering edges of the plaster (b), and filling in the plaster cracks with grout (a) and mortar (c). Finally, all surfaces were dusted, desalinated and impregnated (d). The basin was backfilled with loose soil to the top of the new footing. Drainage was ensured in the ground and low provisional curbs were built around the font to limit water accumulation in this area.

The retaining wall built this season adjacent to the font to protect the pottery kiln wall (see below) abuts the new support of the east steps of the font.

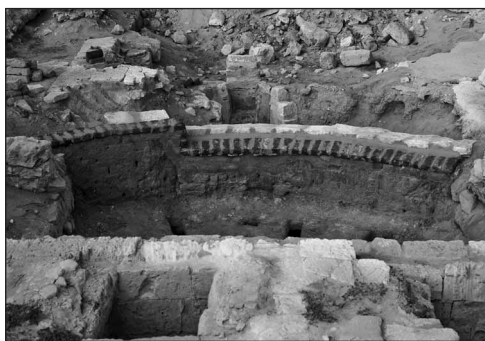
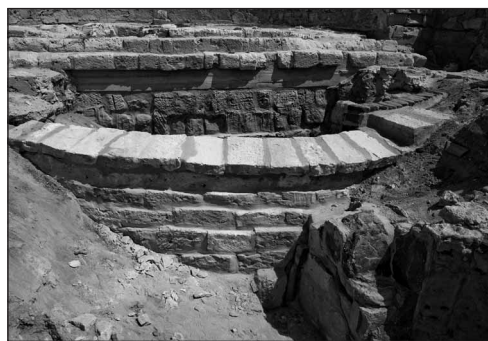
The outer wall of the pottery kiln, constructed of dried mud brick, was the object of conservation and protection during the previous season of 2006. Due to mechanical damage incurred over the past year to the temporary coping installed over the kiln's wall, and erosion of a soil infill found back of the wall, the method of protection needed to be revised. Provisional mud-brick copings installed during the last season and compatible with the original fabric, as well as a mud-mortar infill were noted to perform very well in protecting the original wall from mechanical damage. Mud mortar took impact well and had not been vandalized; the copings remained in excellent condition. All things considered,

Fig. 3. Outer wall of the kiln, inboard face (left) with new mud-brick infill and brick and stone coping, and outboard face (right) with new retaining wall and coping (Photo Jack M. Kucy)

The exterior face of the mud wall, now exposed, required a new backing at the very least. The new retaining wall [Fig. 3] was constructed of limestone blocks collected on site, set approx. 20 cm from the kiln's mud wall. The cavity was filled loosely with earth collected on the site. The mud-brick copings installed last season were reused to level the wall crown, set in a mud mortar [Fig. 3, right]. A new cantilevered limestone coping set on a new retaining wall, and a brick cap over the kiln wall (set on angle to discourage walking) were installed, separated from the original wall with bituminous membrane to prevent water penetration. As

a result, the original wall of the kiln is protected with a slightly higher outer stone wall and coping, capable to withstand accidental impact. The new wall has a distinctively different bond from any

original structures on site, but it blends in visually with the surroundings. If needed, it can be easily dismantled in the future, when conditions are created to protect this site permanently.
