## Alexandria: Kom El-Dikka Excavations and Preservation Work : Preliminary Report 2007

# ALEXANDRIA: KOM EL-DIKKA EXCAVATIONS AND PRESERVATION WORK PRELIMINARY REPORT 2007/2008

Grzegorz Majcherek

**Abstract:** Excavations by the PCMA's Polish–Egyptian team in Alexandria focused once again on the central part of the Kom el-Dikka site. One area of explorations covered a sizable section of the Ayyubid–Mamluk cemetery, which has been investigated extensively in the most recent seasons. In an adjacent sector of the site, digging continued on a huge mound of ashes and typical everyday refuse, located to the south of the Imperial bath complex from whence most of this rubbish had issued. The underlying layers contained more of the ruins of an extensive early Roman house, including a floor mosaic with geometric decoration.

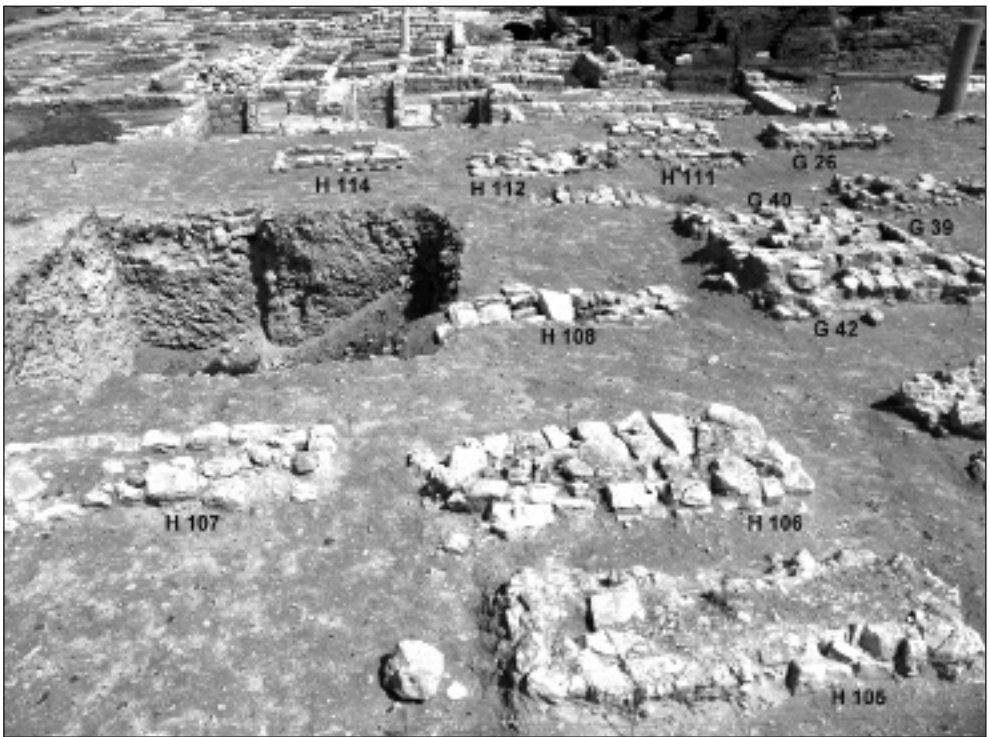
Fig. 1. General view of the excavated Islamic burial ground in Area H, looking north (Photo G. Majcherek)

extent of the excavation trench, although showing no regular pattern [Fig. 1; for the plan, see Fig. 1 on page 55].

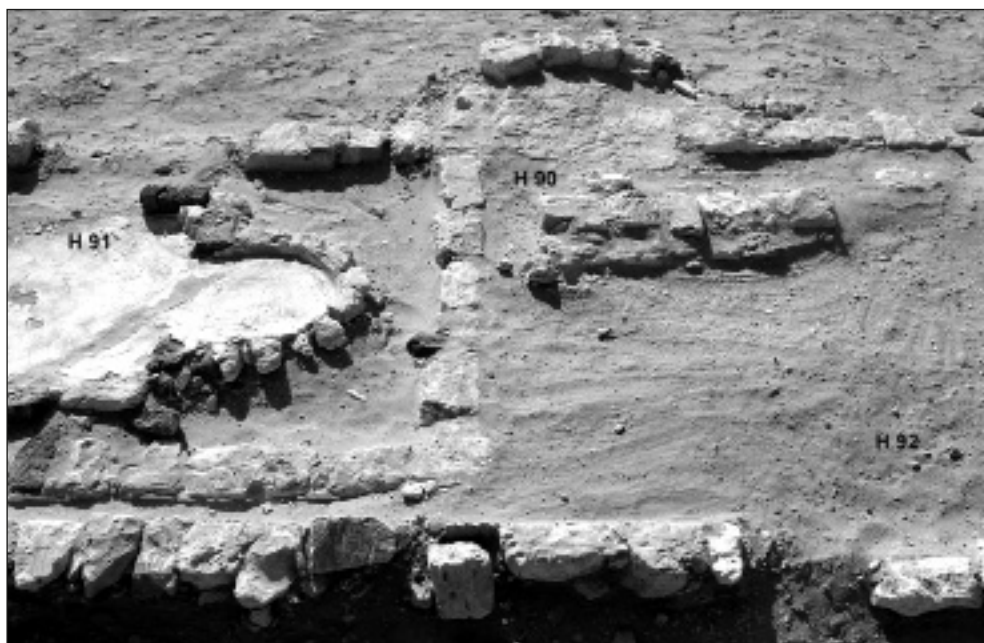
Fig. 2. Grave H 91 and associated burials in Area H  
(Photo E. Kulicka)

H 93 and H 91, the latter still retaining some of its original plasterwork [Fig. 2; see also Fig. 2, right, on page 56], were found to be enclosed together with H 90 within a rectangular stone wall enclosure, of which only the lower courses have been preserved. The enclosure, measuring some 5.50 x 4.80 m, was equipped with a small *mibrab* in the southeastern wall [see Fig. 3 on page 56]. Similar structures enclosing several neighboring graves, interpreted as family tombs, were previously recognized also in other areas of the cemetery (Majcherek, Kołataj 2003: 21).

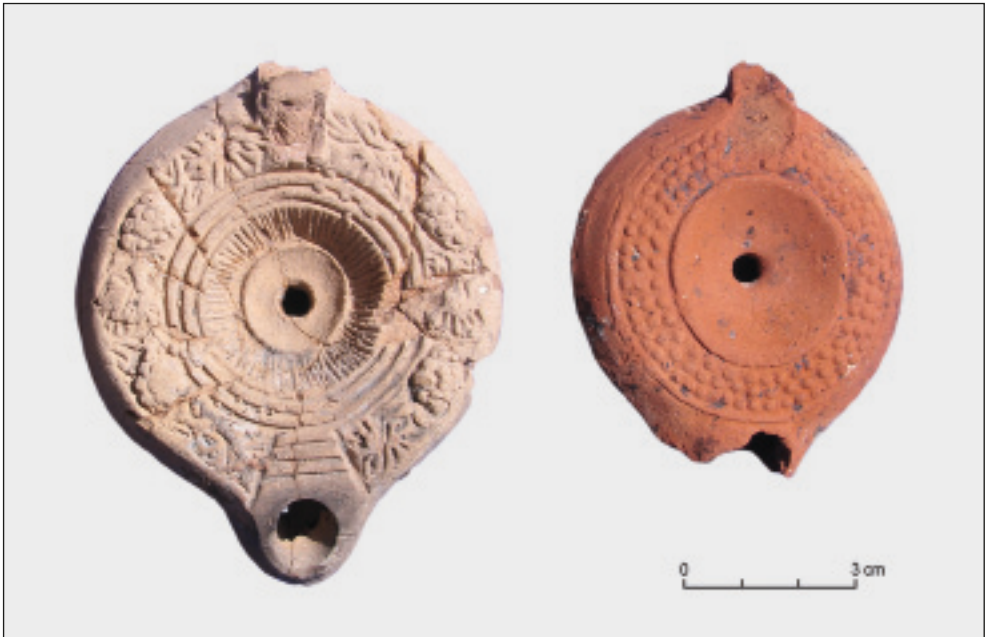
Fig. 3. Oil lamps from the 4th–5th century AD, reg. nos 5205 (left) and 5206 (Photo G. Majcherek)

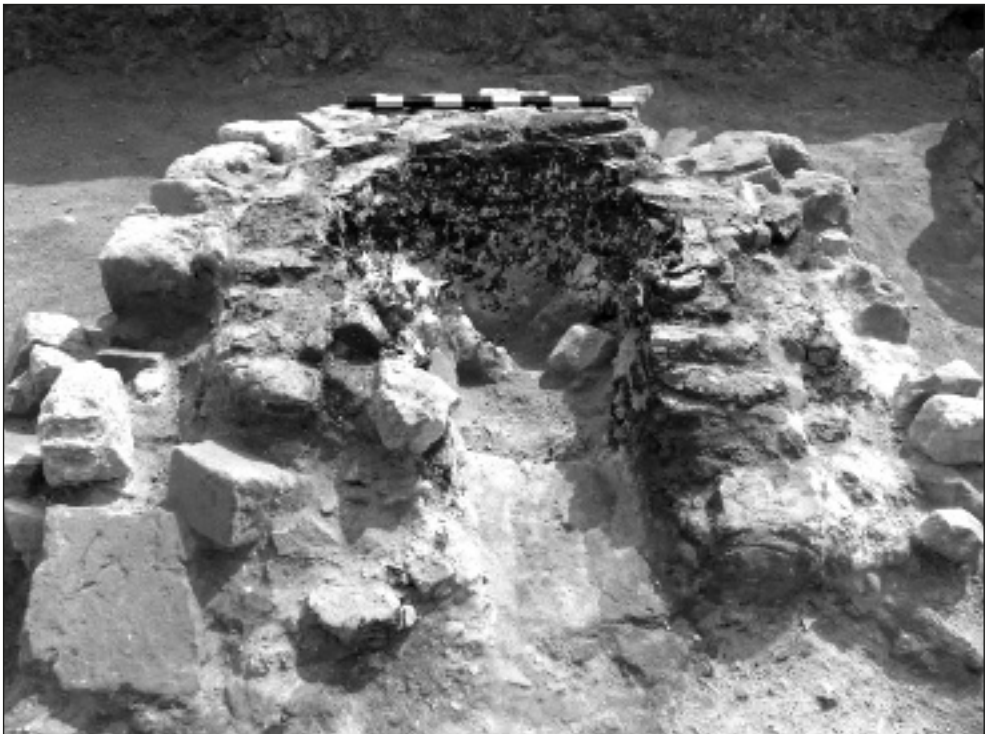
Fig. 5. Lime kiln in Area F, looking south  
(Photo G. Majcherek)

cleared immediately below the thick ash accumulation in the southwestern corner of the trench. Despite heavy damage to the structure, both features could be recognized as round updraft kilns, approximately 1.00–1.10 m in diameter, built of red bricks bonded in clay mortar [Fig. 5]. The brick-made firing chambers were reinforced with semicircular casing walls of stone. Remnants of brick-made vaults were preserved on the outer lateral walls. The inner surface of the kilns was found to be partly vitrified due to high temperature. Between the kilns there was a fragmentarily preserved tank for slaking lime. Narrow, corridor-like features were cleared in front of the kilns; they were constructed of loosely arranged assorted stones, also making use of still standing walls of an Early Roman house in the layer below. They were used in all likelihood in the loading and firing operation,

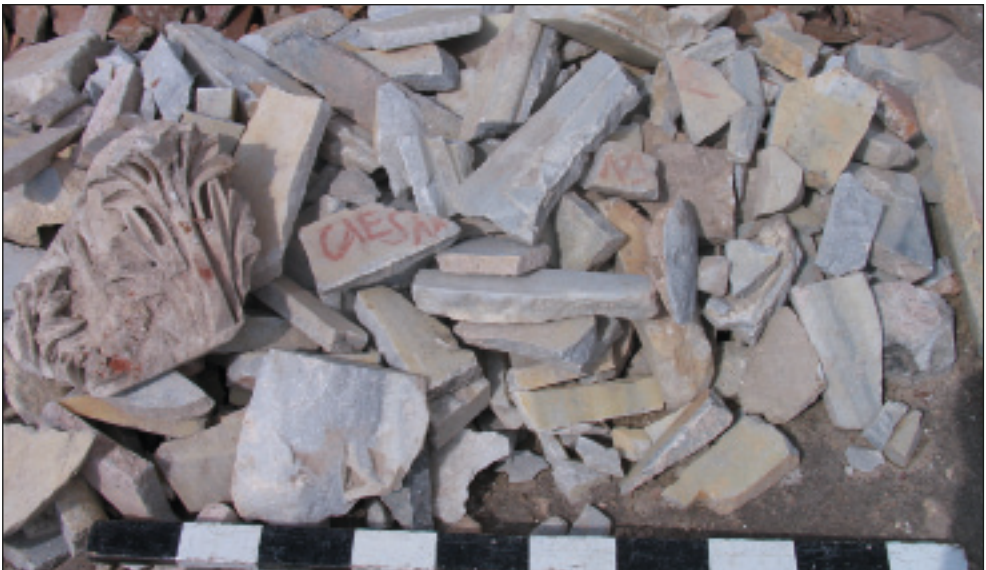
Fig. 6. Marble detritus including some pieces of slabs with red-painted inscription  
(Photo G. Majcherek)

Associated layers in the vicinity of the kilns, consisted almost entirely of lime refuse, ashes and slag, with heavy concentrations of marble detritus, partly burned or half-melted. Prominent among them were broken elements of architectural decoration: engraved slabs, fragments of capitals and bases etc., originating from the dismantling of older buildings. Among these were some marble slab pieces bearing fragmentary red-painted inscriptions in Latin [Fig. 6]. Two fragments stood apart, containing as they did the complete word “CAESAR” written in cursive script. Judging by their back surface, the slabs must have been used originally as wall revetment. Based on palaeographic criteria, the

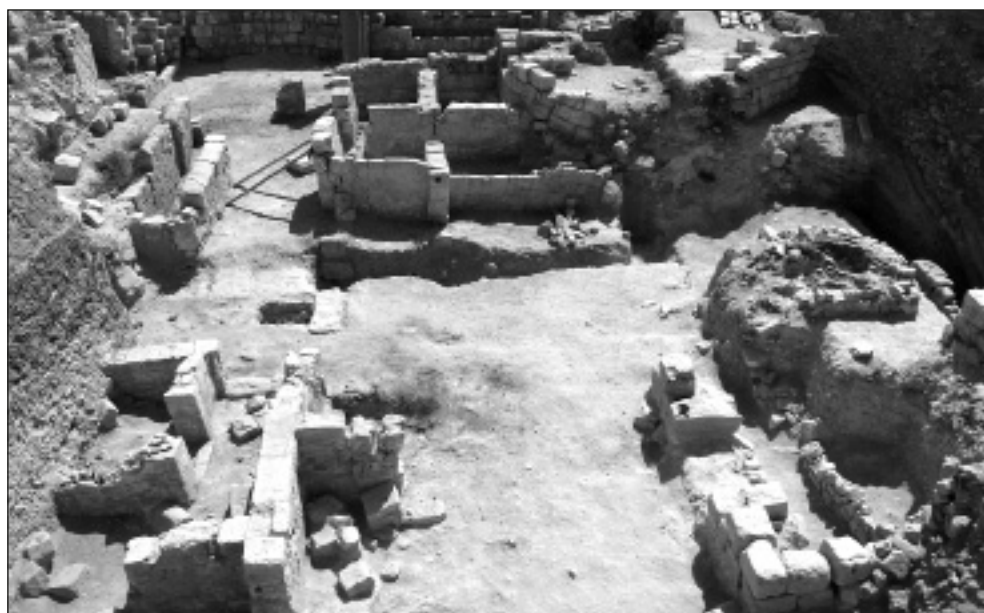
Fig. 8. General view of Early Roman house FB in Area F, looking east  
(Photo G. Majcherek)

Room 12, partly excavated in 2007, was separated from the rest of the building and acted most probably as a shop with access from the street. A cluster of rooms excavated this season in the northwestern part of the trench (at bottom left in *Fig. 8*) were difficult to interpret, having been largely obscured or damaged by the large outer wall of the bath which cut through the ruins of the Early Roman house. Given their rather small dimensions, they should be expected to serve a purely domestic function. Locus 15 was apparently a corridor (about 1 m wide) giving access to another, as yet unexplored, section of the house. In partly preserved room 17 a large charcoal deposit was cleared, representing most probably a secondary phase of occupation when the house was already prob-

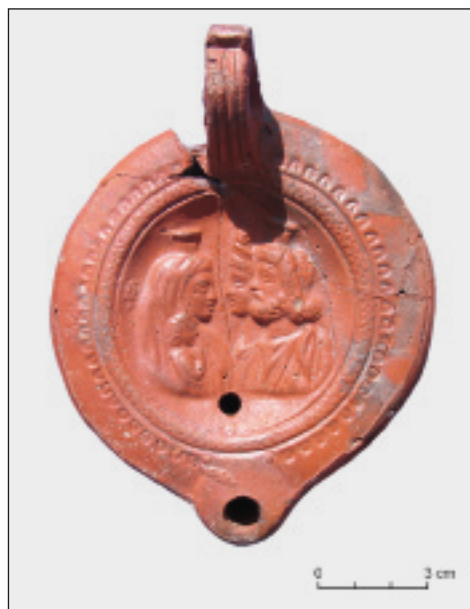
*Fig. 9. Terracotta oil lamp with representation of Isis, Harpocrates and Serapis (Photo G. Majcherek)*

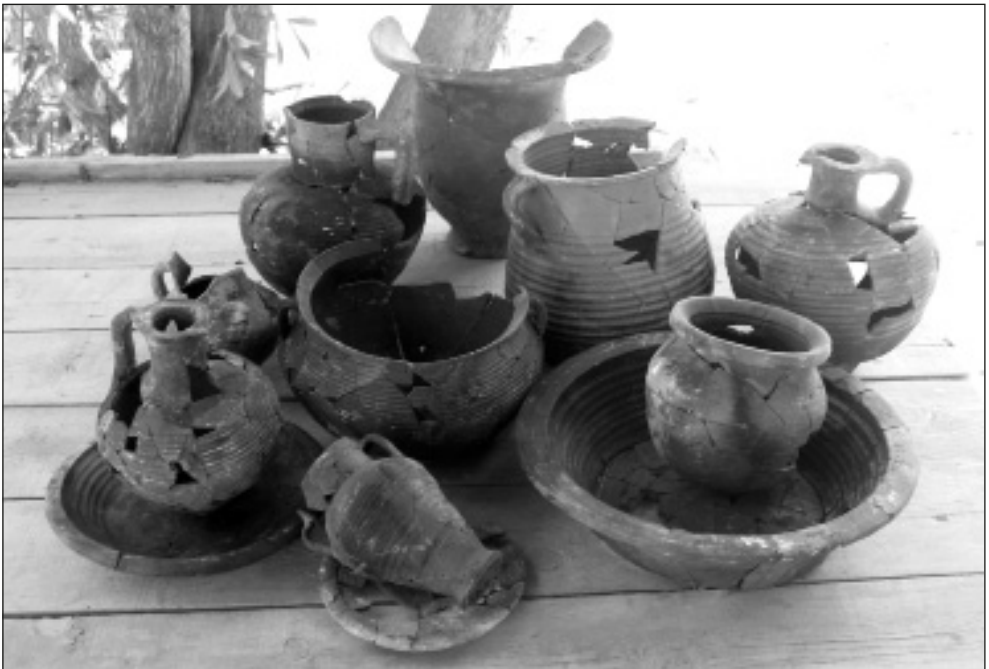
Fig. 10. Domestic ware vessels found in room 17 of Early Roman house FB  
(Photo G. Majcherek)

ably partly abandoned. Large quantities of kitchen ware, mostly cooking pots, jars and large dishes, all bearing traces of prolonged use, prompted its provisional identification as a kitchen. Altogether 16 vessel forms were recovered and duly restored. All were Egyptian-made (Nile silt fabric) and belonged to a 2nd–3rd century AD horizon [Fig. 10]. Several lamps were also recorded, including a fine example of an Egyptian moldmade lamp with a representation of Isis, Harpocrates and Serapis [Fig. 9]. A vast number of vessels (mostly Palestinian amphorae) was also found in rooms 13 and 14. The glass finds assemblage from the excavated area belonged to the same, 2nd–3rd century AD horizon and included also evidence

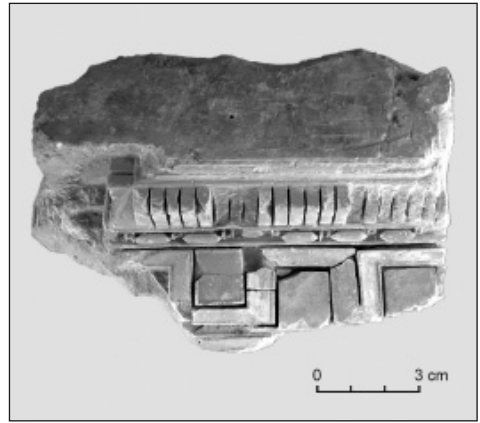
Fig. 11. Cornice of the Alexandria Corinthian order (Photo G. Majcherek)

order, e.g. a section of cornice with alternating flat grooved and square hollowed modillions [Fig. 11]. This, as well as a fragment of a Doric frieze and fluted half-column found there point to a rather sumptuous architectural decoration of this, as yet unexplored, house.

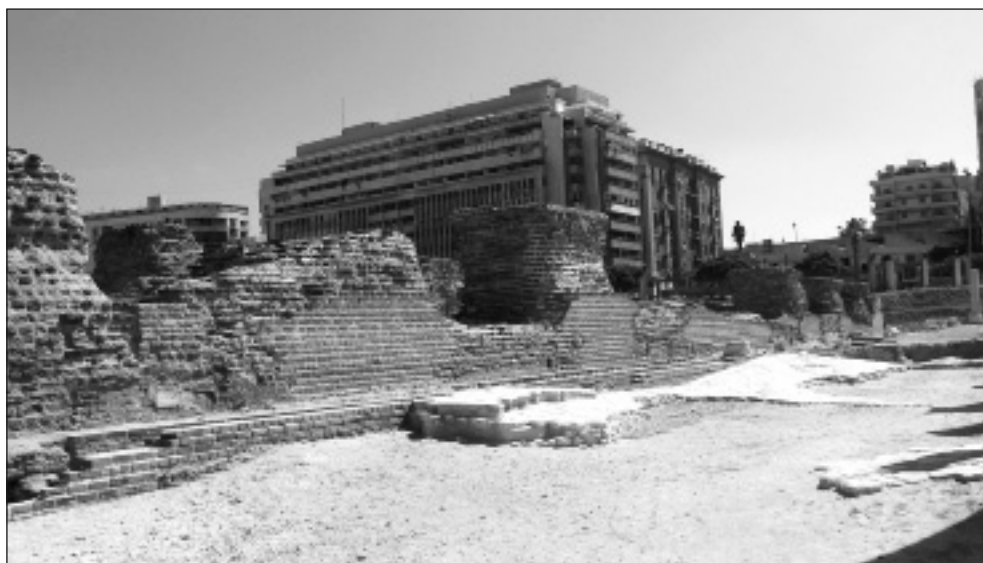
Fig. 12. Restored southern façade of the bath  
(Photo G. Majcherek)

The restoration of the southern bath façade, which is an integral part of the planned open-air display of the ancient ruins, has now been completed (some 30 m in length), following two earlier seasons of work on the eastern end of the façade (Majcherek 2005: 27–29) [Fig. 12].

The wall structure had suffered serious erosion and deliberate damage in late antiquity and the medieval period. Some of the bricks were found to be completely deteriorated, while the mortar had lost all its cohesive strength. Given the complexity of the original bonding (at least two basic

brick sizes had been used), it was deemed necessary to prepare first the required number of modern bricks to be used in the conservation operation. This was achieved by cutting modern factory bricks to the required size. The mortar used during the process was based on an ancient Roman formula made of sand, lime and crushed bricks mixed in a ratio of 4:2:1. This helped not only in achieving proper quality, but also the desired coloring. The elevation was restored to a height of some 1.60 m, that is, the level of the original window sills. In several cases, extant lower courses of the masonry had to be reinforced with new

mortar, and some of the more seriously damaged bricks replaced with new ones, to make the wall facing structurally sound.

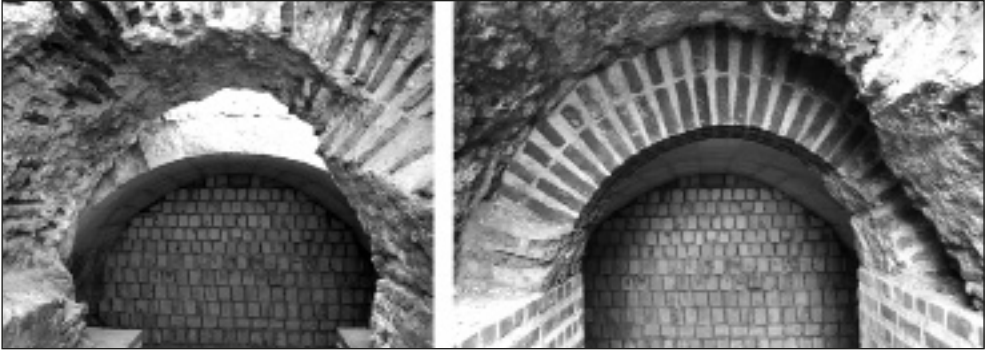
*Fig. 13. One of the restored vaults giving access to the furnaces in the baths, before (left) and after restoration (Photo A. Pisarzewski)*

Preservation of the southern elevation required also the restoration of two brick-made vaults, giving access to the furnaces located in the basement of the baths. Extant sections of the vaults were first consolidated. Existing void joints were filled in and some loose bricks were fixed with new mortar. For the full restoration original bricks found during excavations were used. Two such vaults, supporting the elevation, were entirely restored [Fig. 13]. Two additional, partially preserved furnace vaults were also consolidated.

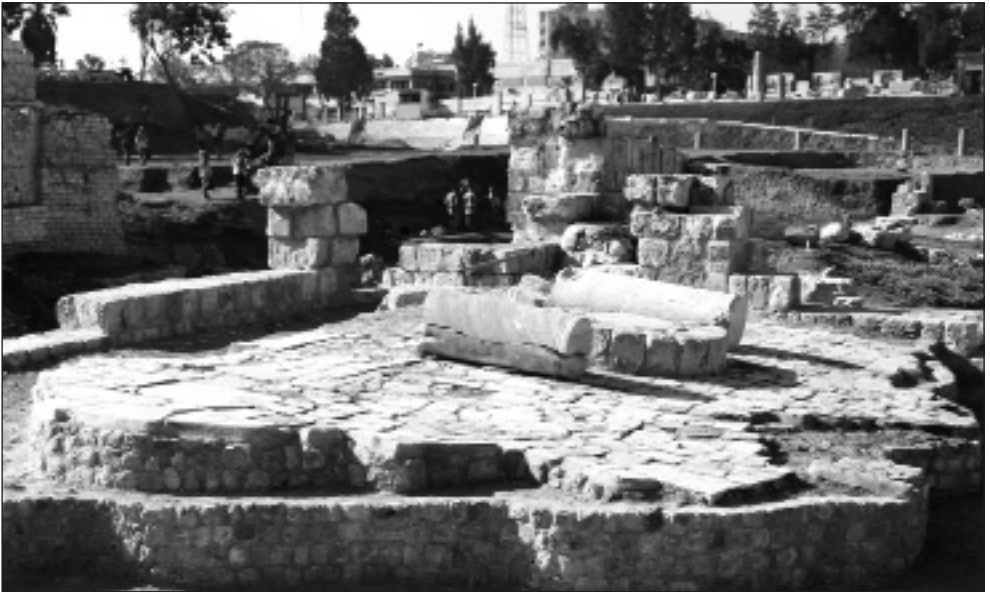
*Fig. 14. Bath apodyterium following restoration in 2008, looking southwest (Photo G. Majcherek)*

The nearby apodyterium also underwent thorough conservation. The extant floor pavement was consolidated. Some slabs were fixed with mortar and others re-laid on new bedding. Since the floor now rests

some 0.60–0.80 m above surrounding ground, the edges of the pavement had to be supported and protected with a low retaining wall to prevent subsiding and disintegration [Fig. 14]. The wall was built of small assorted stones, in a manner similar to the original bedding.

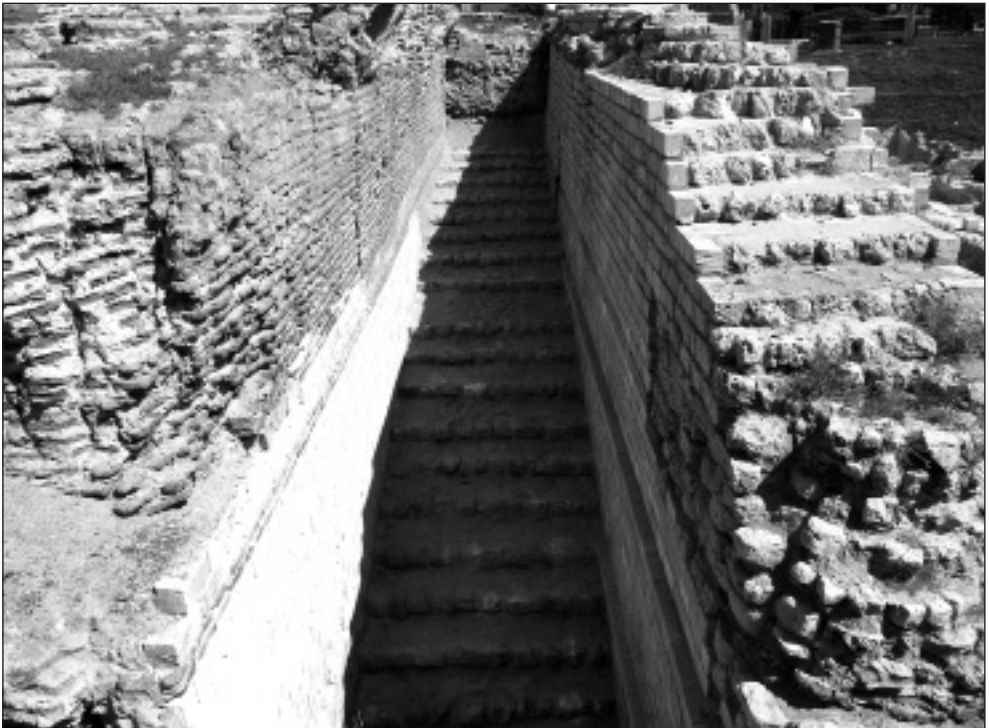
*Fig. 15. Restored staircase in the cistern building, looking north  
(Photo G. Majcherek)*

up to the level of the top of the water tanks, served most probably as a ramp for bringing up animals to run the water-lifting *saqiya* devices. The stairs were found to be either destroyed or dismantled along the edges, next to the walls of the corridor where most of the medieval robbing activity had occurred. The stairs were repaired and consolidated [Fig. 15].
