**Marina El-Alamein: Conservation
Work in the 2009 Season**

MARINA EL-ALAMEIN: CONSERVATION WORK IN THE 2009 SEASON

Abstract: In 2009 the Polish–Egyptian Restoration Mission to Marina el-Alamein proceeded with another season of conservation work in heavily constrained circumstances. Architectural studies preceding building conservation work were carried out in House H1, where the Mission has been active over the past few seasons. It was established that the house had an inner peristyle consisting of two tiers corresponding to building floors: pseudo-Corinthian of the Marina type on the ground floor and pseudo-Corinthian or pseudo-Ionic of the Marina type on the upper floor. A similar tiered architectural decoration was noted in the incomplete peristyle (unit 4) of the Southern Baths just off the presumed Main Town Square. Work continued on clearing the chambers of the baths and accomplishing preservation, conservation and subsequently building restoration works. A marble plaque with an inscription, found previously, was subjected to conservation treatment once standard condition monitoring demonstrated progressive deterioration of the state of this object.

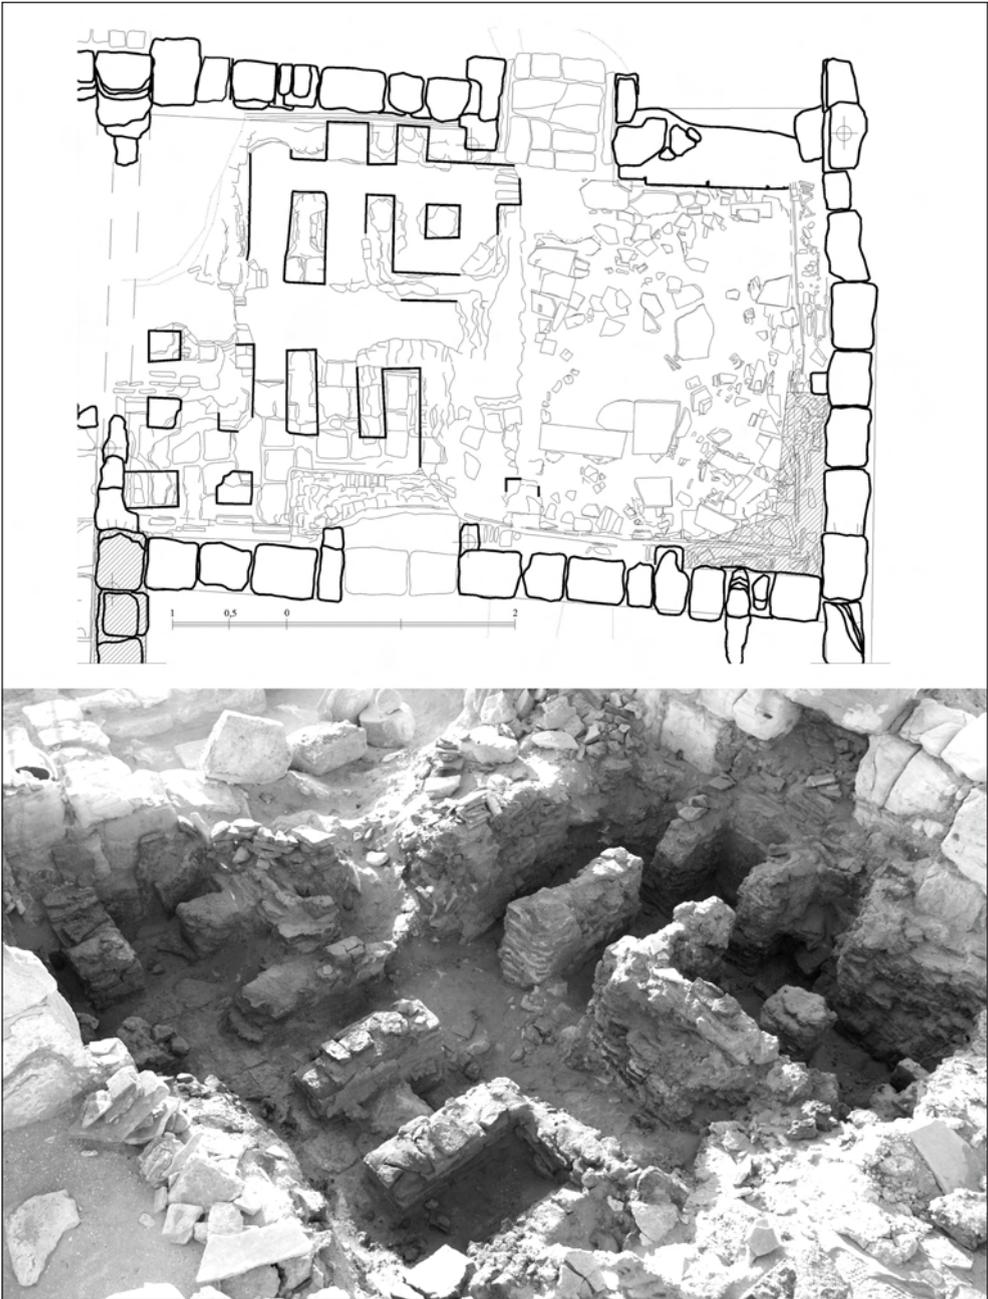
Fig. 12. Hypocaust cellar in unit 6 of the Southern baths: inventory plan (top) and general view (Drawing A. Brzozowska; photo S. Medeksza)

A study of the heating system in unit 6 showed that the hypocaust cellar was built entirely of ceramic tiles averaging 28 cm square in size. The structure comprised a set of square *pilae* supporting the *suspensura*, reinforced with walls built of ceramic tiles between some of them [Fig. 12]. Some of these spaces were vaulted. It is not clear why this system of reinforcements was put in. Perhaps there was a need to reinforce the foundations for the *tepidarium* pool. Another and perhaps more likely reason is better circulation of heat from the *praeefurnium* to other parts of the heated cellar. The heating furnaces themselves have yet to be located.
