**The Mosque Building in Old Dongola
: Conservation and Revitalization
Project**

Polish Archaeology in the Mediterranean 22, 248-272

THE MOSQUE BUILDING IN DONGOLA

CONSERVATION AND REVITALIZATION PROJECT

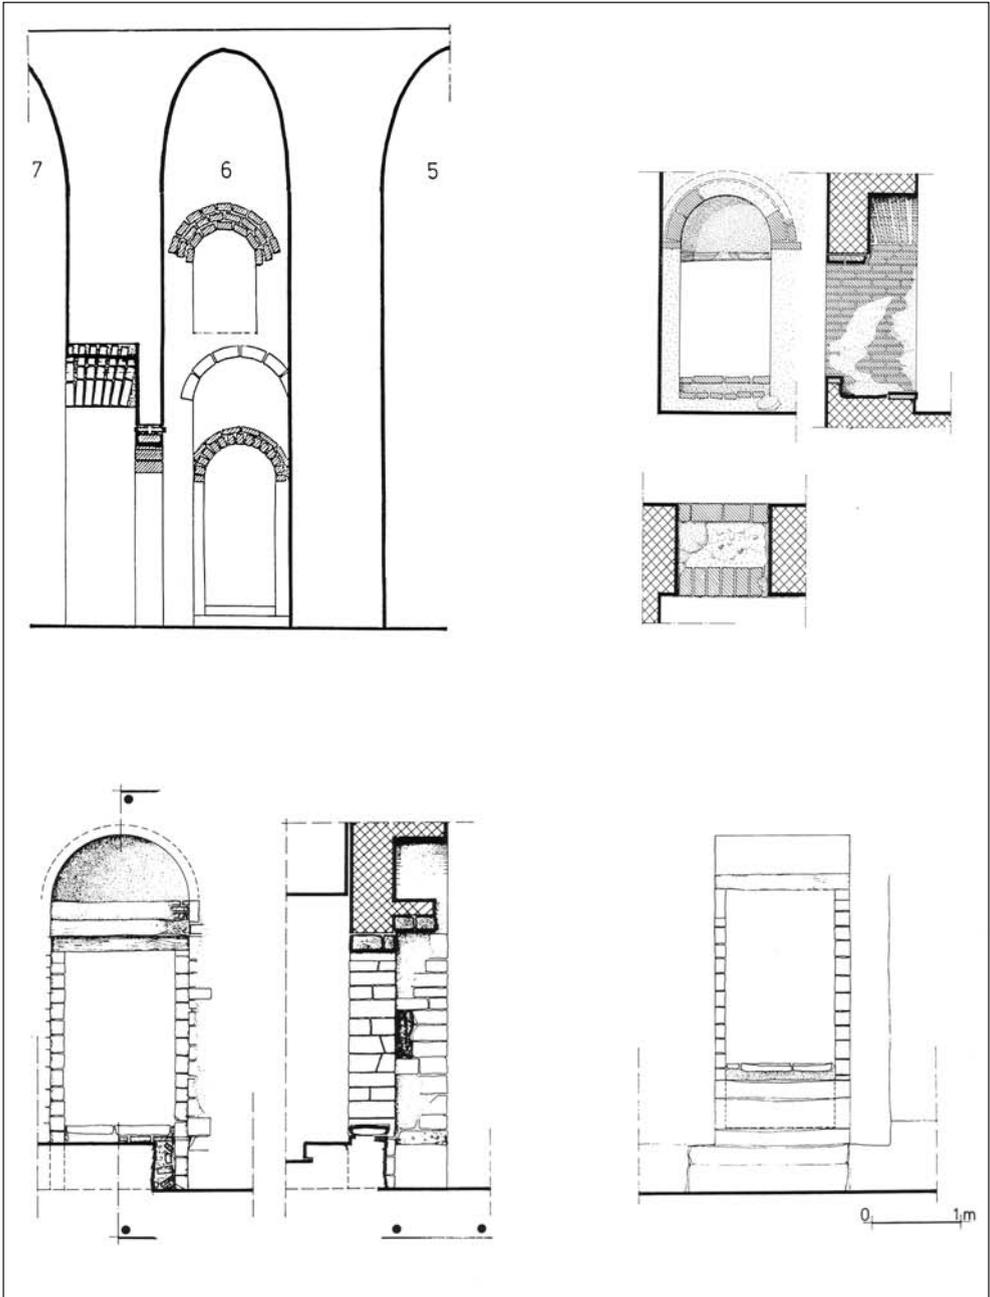
Fig. 7. The Mosque: top left, section through room 6 on the ground floor; top right, window in the western facade; bottom, western entrance (Archival documentation S. Medeksza)

This upper floor was reached by a monumental staircase entered from the west, which was the approach from the city and river. Official delegations and processions proceeding to the hall on the upper floor and the roof terrace could have followed no other way. The reveals in the entrance were built of sandstone blocks. The jambs and the construction of the transom and relieving arch have survived. The original entrance was 2.75 m high and 1.25 m wide [Fig. 7, bottom].

The western facade of the staircase had two large rectangular windows opening onto the city and lighting the interior [Fig. 7, top right]. The walls of the staircase were decorated with murals on two successive coatings of plaster [Fig. 10]. Probes

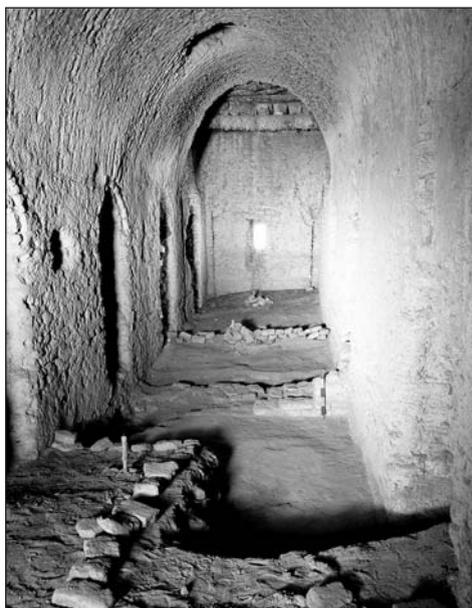
Fig. 12. Mosque, room 3 after rebuilding of the ground floor in 1974
(Photo W. Jerke)

The ground floor premises in the eastern quarter were partly filled to approximately 1.50 m above the original pavement; internal window openings were converted into entrances [Fig. 12]. Thus internal communication was provided, but it is not entirely clear for what purpose. Similarly, it is not evident how the ground floor rooms were entered in the period following the closure of the northern entrance arcade to room 3. Perhaps for a period of time in the 17th–19th centuries the ground floor
