# Marina El-Alamein: Conservation Work in the 2003 Season

Polish Archaeology in the Mediterranean 15, 91-100

# MARINA EL-ALAMEIN CONSERVATION WORK IN THE 2003 SEASON

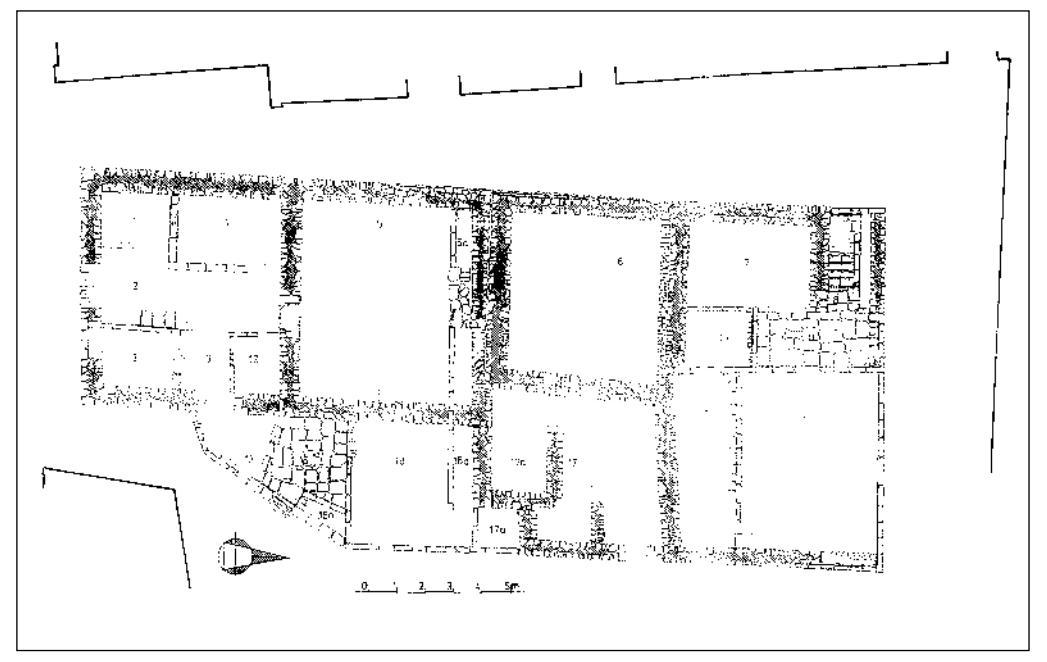
Fig. 2. House H 10"E". Complete plan following the 2003 season (Drawing S. Medeksza)

a height of c. 1.00-1.20 m, occasionally 1.40 m, in an effort to clarify the layout of particular houses and trace the surrounding streets. The houses are studied architecturally in the process. For example, this season the investigations of House H 10"E" were completed; the structure now appears to have had eighteen main rooms and five subsidiary ones (*Fig. 2*). It also seems clear now that rather than the four houses previously hypothesized in this insula, there were only two.
