**Marina El-Alamein: Preservation and
Conservation in 2005**

Polish Archaeology in the Mediterranean 17, 99-115

MARINA EL-ALAMEIN

PRESERVATION AND CONSERVATION IN 2005

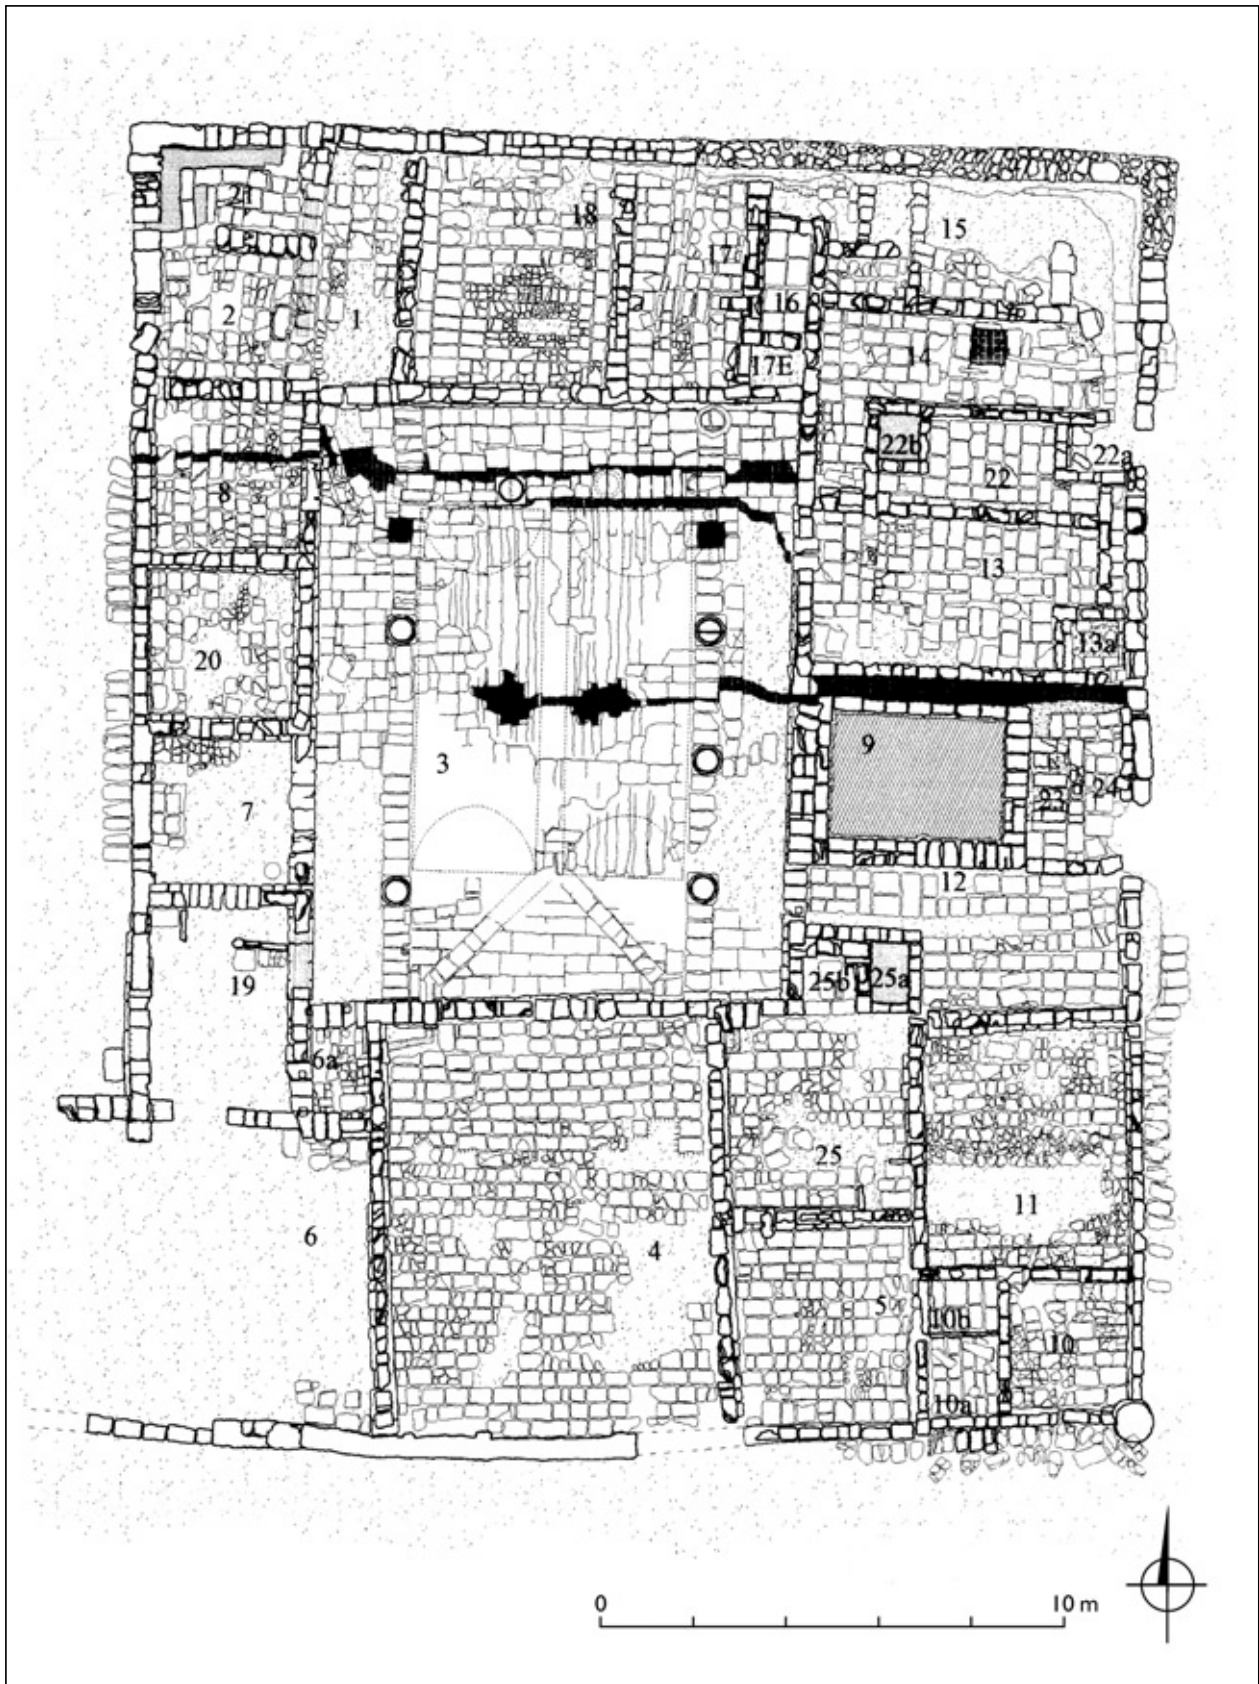
Fig. 2. Plan of house H1
(Inventory drawing R. Czerner and M. Krawczyk)

The building has suffered evidently from earthquakes and ground movement caused by other geological factors, resulting in a considerable distortion of the architectural appearance. Much subsidence of the original stone pavements is in evidence, especially in the courtyard (north portico of the peristyle) and in the area of rooms 4, 5, and 10 [*Fig. 3*]. Only the vaulting of the cistern under the floor in room 3 seems to be at the original level, but it has a deep E-W fissure that is pushing apart room 13 and basin 9. The perimeter wall also proved to be very poorly preserved, even missing entirely in places (especially in the eastern part of the house, in the vicinity of rooms 15, 14, 22, 13, 24). Room 6 appears to have been a projection, extending west, beyond the rectangular body of the house.

The ruins of House H1 have been prepared for conservation and partial reconstruction

for the past two seasons. Rubble and secondary deposits, including vegetation, have been removed, and the vaulting of the cisterns under the courtyard protected. Architectural documentation work, in preparation for the building works to start next year, was completed this season, including fundamental revisions of the earlier documentation [*Fig. 2*]³ (indeed, more research needs to be done in order to understand the internal chronological stratification of the building).
