**Marina El-Alamein: Conservation
Work in the 2007 Season**

Polish Archaeology in the Mediterranean 19, 81-97

CONSERVATION WORK IN THE 2007 SEASON

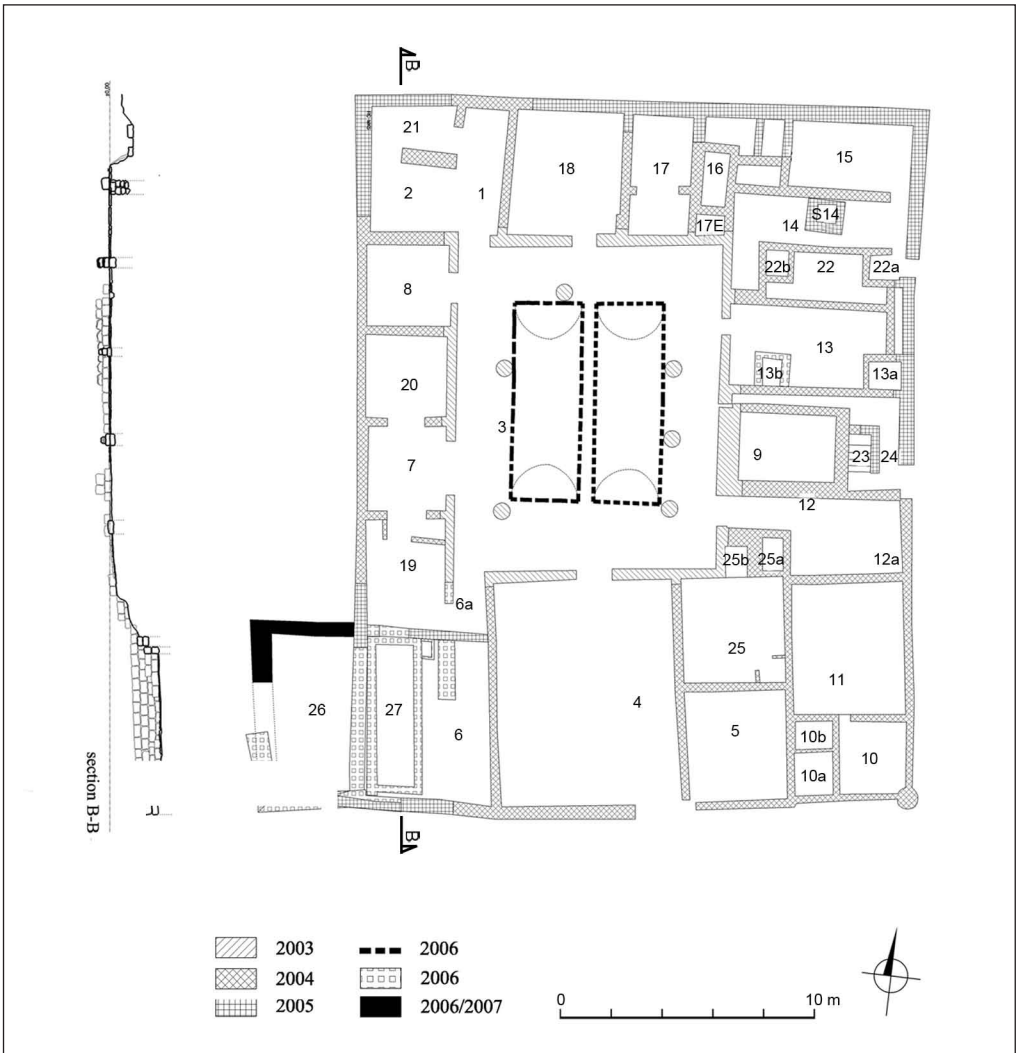
Quake-related damages to the wall structure have largely obliterated the original wall bonding, hugely encumbering research on the building stratigraphy. Nonetheless, the latest phase of the building now appears as a rectangle with the long axis aligned N-S. The units identified in 2006, Rooms 6 and 26, appear not to belong to the 4th century phase, the amphorae and other pottery discovered there pointing to their use in the building of the 2nd and 3rd century. Also the foundation trench for the western perimeter wall of the 4th century house cut across this cooking and storage area, confirming its earlier date (the storage wares found in these apparent cellars are dated to the 1st, 2nd and 3rd centuries). In the 4th century, unit 6 was subdivided and

Fig. 2. House H1. Updated inventory plan after the 2007 season; on left, N-S section through the western wing looking east (Plan M. Krawczyk-Szczerbińska)

southwestern corner and west wall in the center (by Rooms 20, 7 and 19) were completed, advancing the task of closing the rectangular outline of the house. A marble block which had served presumably as a pedestal under a lifesize bronze statue, was set up in its original position in Room 7. The west wall after restoration will serve as

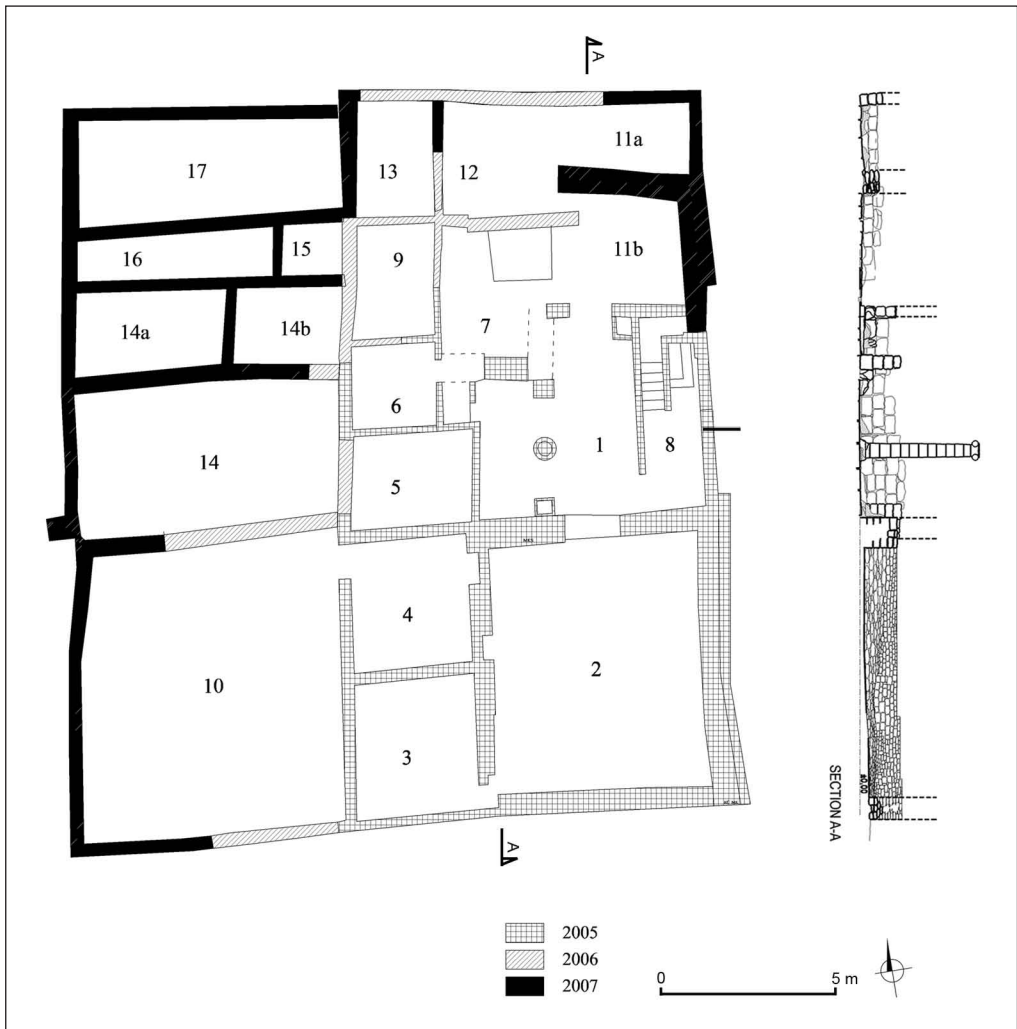
Fig. 4. House H2. Updated inventory plan after the 2007 season; on right, N-S section through the eastern wing looking east (R. Czerner, updated M. Krawczyk-Szczerbińska)

Only three fragments of walls were restored, mainly the west wall closing room 10 and 14 in the uncovered part (the viewing platform should be dismantled before the work can be completed). The broken-stone wall between Rooms 1 and 7 was raised along a stretch 2.50 m long, and the south wall and part of the wall around Room 3 were also reconstructed.

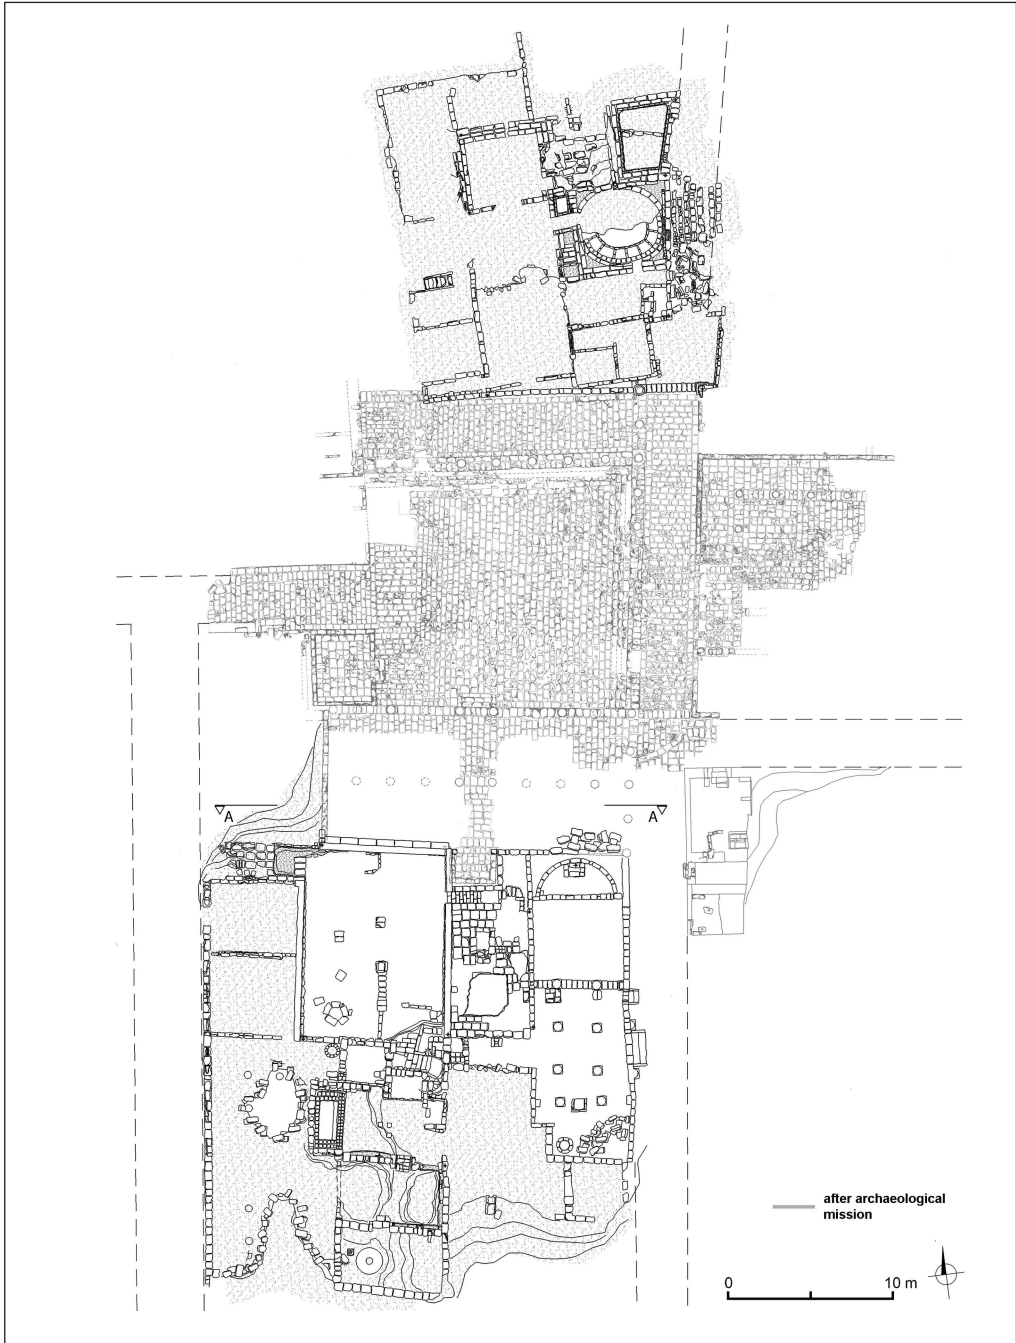
Fig. 6. Plan of the Main Square and Baths, updated inventory plan for 2007 (Plan J. Dobrowolski, A. Błaszczuk, updating by M. Krawczyk-Szczerbińska)

The deep portico on the south side of the main square had a double row of columns of the pseudo-Ionian type commonly used in Marina. An anastylosis to full height of two westernmost columns in the second, back row of the portico was completed in 2007 [Figs 6–7]. Five drums accounting for more than half the height of a third column in this row were also reintegrated, preparing them for full anastylosis in the coming season. The engaged column closing the front row of columns on the west was raised to the height of two drums.
