Photographs from 1887. New sources for the study of the architecture of the Romanesque Church of the Blessed Virgin Mary in Inowrocław

Historia Slavorum Occidentis 2(9), 137-149

PHOTOGRAPHS FROM 1887. NEW SOURCES
FOR THE STUDY OF THE ARCHITECTURE OF THE
ROMANESQUE CHURCH OF THE BLESSED VIRGIN
MARY IN INOWROCŁAW*

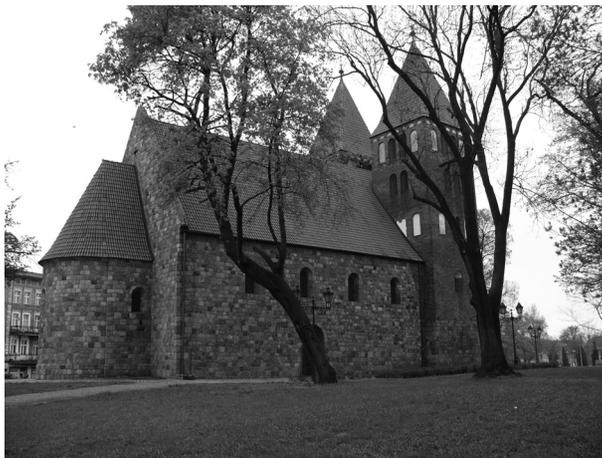
Photo 1. Church of the Blessed Virgin Mary in Inowrocław, present view. Photo by M. Danielewski.

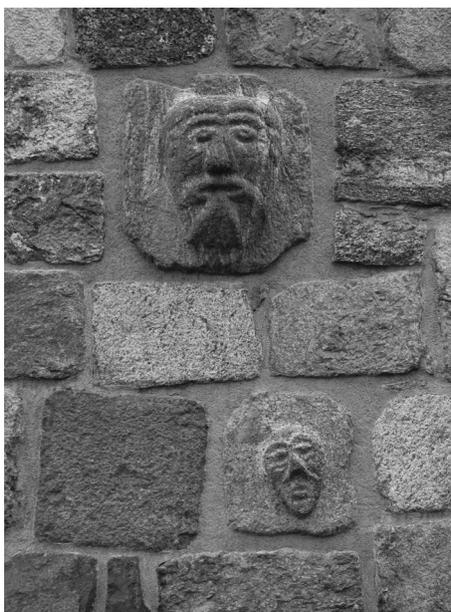
Photo 2. Stone blocks with flat reliefs embedded in the north wall of the church. Photo by M. Danielewski.

The most recent major alternations to the structure were made in 2011. Back then, I demonstrated that the decision to embed two stone blocks with flat reliefs into the north wall of the church was ill informed³⁵. Meydenlender's photograph no. 521 was apparently unknown to the authors of the project. Zygmunt Świechowski was right when he noticed twenty years

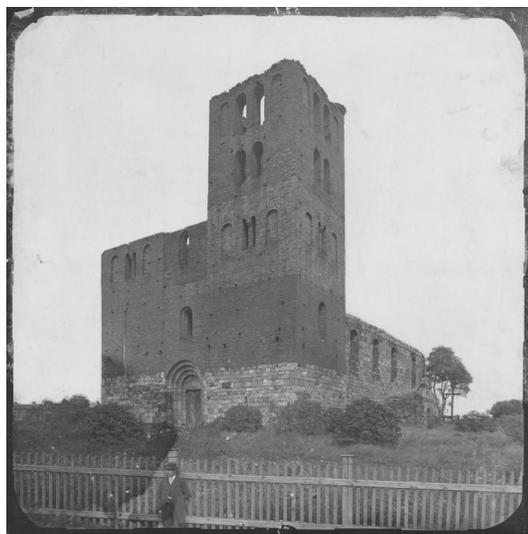
Photograph no. 519. Church of the Blessed Virgin Mary in Inowrocław, south-west view. Photo by Meydenlender, 1887 (Iconographic Laboratory of the Special Collections Department of the University Library in Poznań).

Significant alternations were also made to the tower system. Photographs 519, 520, 521, 522, 523 show rectangular and square holes that were used for receiving the ends of poles to form scaffolding during construction. More than a hundred of such putlogs are noticeable in the photographs. Unfortunately, all but two were filled in sometime in the course of the 1900–1902 restoration novation of the church, a controversial decision considering that they dated back to the time of the construction of the towers, i.e.,

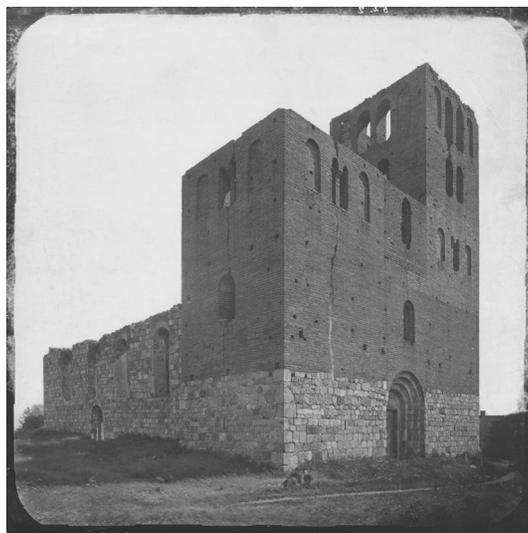
Photograph no. 520. Church of the Blessed Virgin Mary in Inowrocław, north-west view. Photo by Meydenlender, 1887 (Iconographic Laboratory of the Special Collections Department of the University Library in Poznań).

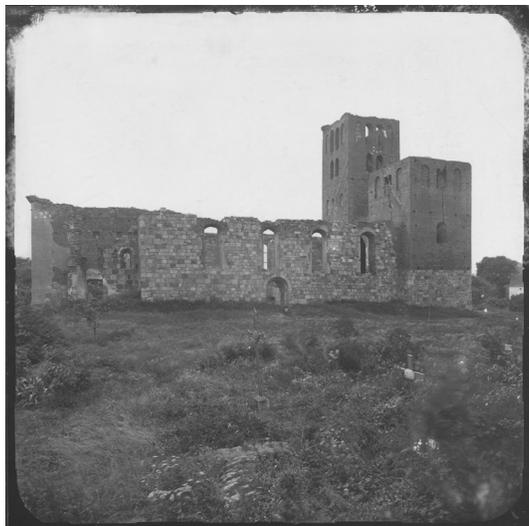
Photograph no. 521. Church of the Blessed Virgin Mary in Inowrocław, north view.
Photo by Meydenlender, 1887 (Iconographic Laboratory of the Special Collections
Department of the University Library in Poznań).

The original Romanesque apse was remodelled sometime in the course of history into a square chancel, largely of bricks, which is well illustrated in photograph no. 521. The existence of an apse prior to the square chancel was rightly surmised as early as in the nineteenth century²⁵. The Romanesque foundation of the apse was uncovered in 1891 by J. Kohte²⁶. It was a common view that the church should terminate in an apse from the east, if and when a general restoration were carried out²⁷. A new apse was indeed erected, having been modelled on that of St. Margaret's Church in Kościelec Kujawski²⁸. While the very idea to restore the apse to its original shape was in my opinion valuable, its implementation turned out to be a failure. First, the 1950–1952 investigations demonstrated that the originally the apse was smaller than now²⁹. Second, during the reconstruction of the chancel, the stone blocks in the north wall of the apse were somewhat rearranged. Photograph 521 shows that the rearrangement was done in a zone, where the stonework of the chancel changed into brickwork³⁰. It must have been related to the dismantling of brickwork and construction of the apse during the renovation of the church in the years 1900–1902. Following the demolition of the brick part of the chancel, the stone blocks were probably re-embedded, albeit not in original positions.

earlier that the north wall of the Church of the Blessed Virgin Mary in Inowrocław was the least altered or remodelled section of the structure³⁶. These remarks were probably neglected during the 2011 conservation, yet photograph 521 unmistakably corroborates Świechowski's opinion. A meticulous analysis has demonstrated that both stone blocks with concave and flat reliefs and some other remained in their original positions until 2011, except maybe for those located near window openings or in the upper section of the wall. Four years ago, six original stone blocks were removed (one of them was subsequently re-inserted, yet in a different location) and two other stones blocks were laid in lieu thereof. They were brought back to Inowrocław from the Kórnik Library – Kórnik Castle, where they had been housed since the second half of the nineteenth century as part of Tytus Działyński's collection³⁷. A stone block with flat relief showing a bald head with bulging eyes, a distinctive beard (also interpreted as a tongue) and his mouth in a grimace is known to have been set in the upper section of the north wall³⁸. On the other hand, the original location of the second stone with flat relief, showing a beardless and hairless head with mouth open wide, is unknown³⁹. It is possible that the block does not come from the Church of the Blessed Virgin Mary at all. Such stone blocks with reliefs are known to have been present at Płowce, as reported, for example, by Julian Ursyn Niemcewicz⁴⁰, in the context of the images from Inowrocław. This issue, however, should be further elaborated upon.

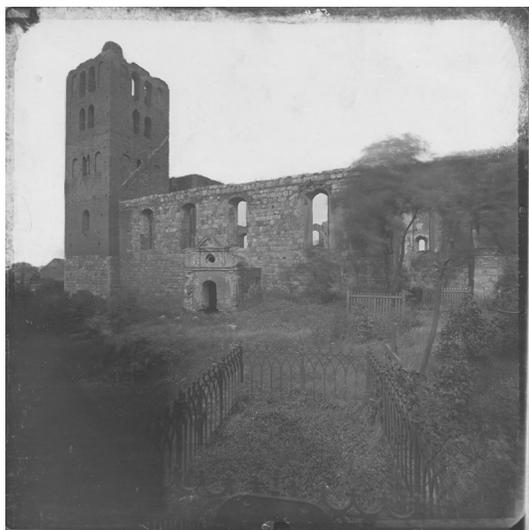
Photograph no. 522. Church of the Blessed Virgin Mary in Inowrocław, south view.
Photo by Meydenlender, 1887 (Iconographic Laboratory of the Special Collections
Department of the University Library in Poznań).

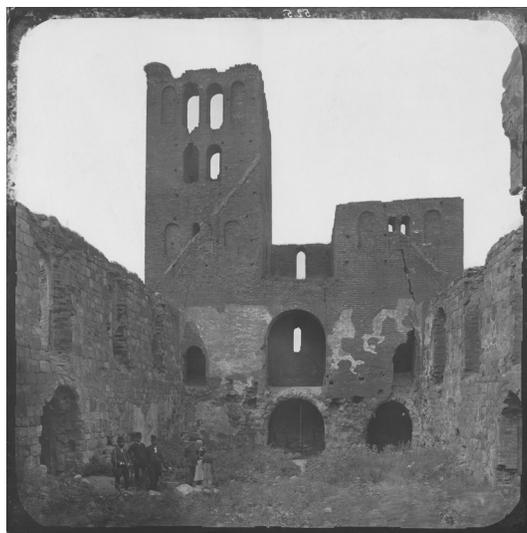
Photograph no. 523. Church of the Blessed Virgin Mary in Inowrocław, inside view of the gallery and tower. Photo by Meydenlender, 1887 (Iconographic Laboratory of the Special Collections Department of the University Library in Poznań).

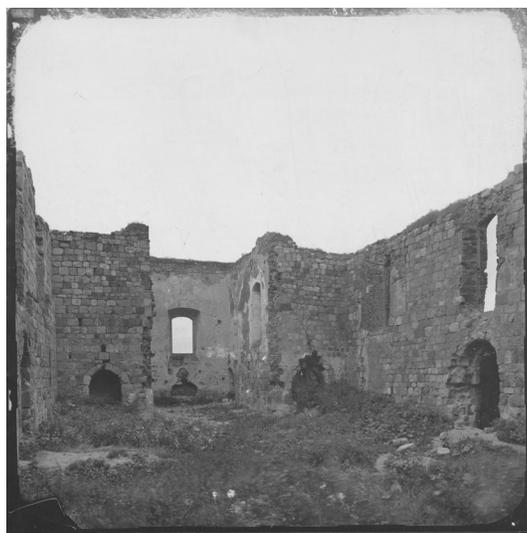
Photograph no. 524. Church of the Blessed Virgin Mary in Inowrocław, inside view of the presbytery. Photo by Meydenlender, 1887 (Iconographic Laboratory of the Special Collections Department of the University Library in Poznań).
