Polish Archaeology in the Mediterranean 5, 101-110

NEA PAPHOS 1993

Wiktor A. Daszewski

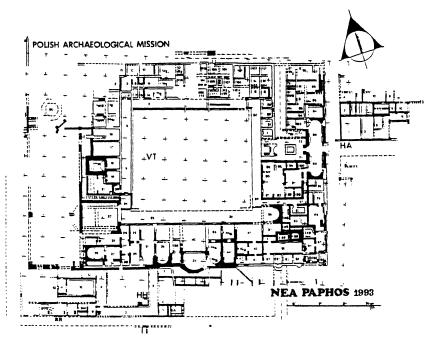
Fig. 1. Structures discovered in the Polish sector at Nea Paphos. VT - Villa of Theseus, HA - House of Aion, HH - Hellenistic House, RH - Roman House. All drawings S. Medeksza.

The Hellenistic House is located directly to the south of the Villa of Theseus (Fig. 1). Originally, it occupied a space limited on the north and south by two parallel latitudinal streets.³ As for the eastern and western boundaries, they remained indefinite, although it had been assumed that the building occupied a whole insula, meaning that on the east and west it touched upon streets belonging to the regular town network. The building was destroyed in an earthquake in the seventies of the 1st century AD. Several years later its northern part along with the adjacent street disappeared under the walls of a new villa (=Villa of
