Old Dongola: Kom H, Southwestern Unit

OLD DONGOLA

KOM H, SOUTHWESTERN UNIT

Bogdan Żurawski

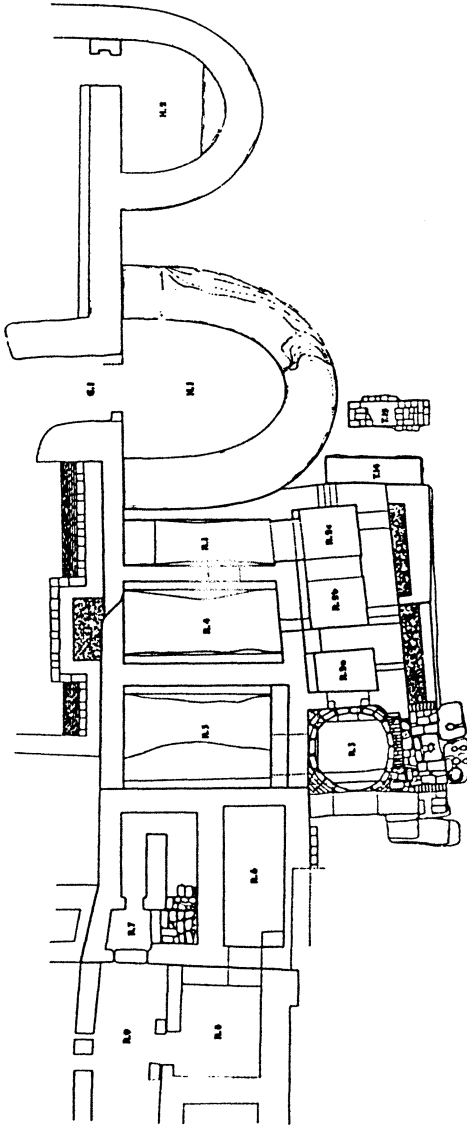
*Fig. 1. Southwestern Unit on Kom H in Old Dongola. General plan of the excavated area.
Drawing B. Żurawski.*

Unit SW started being excavated in 1989, even before exploration of the monastery itself had begun. Thirteen graves unearthed during the 1989 season on the southwestern slope of the Kom were coded TWH (=Tombs west of (Kom) H). After the 1991 season, when more graves were found, the TWH cemetery was subdivided into TNWH (=Tombs northwest of (Kom) H) and TSWH (=Tombs southwest of (Kom) H, Fig. 1).

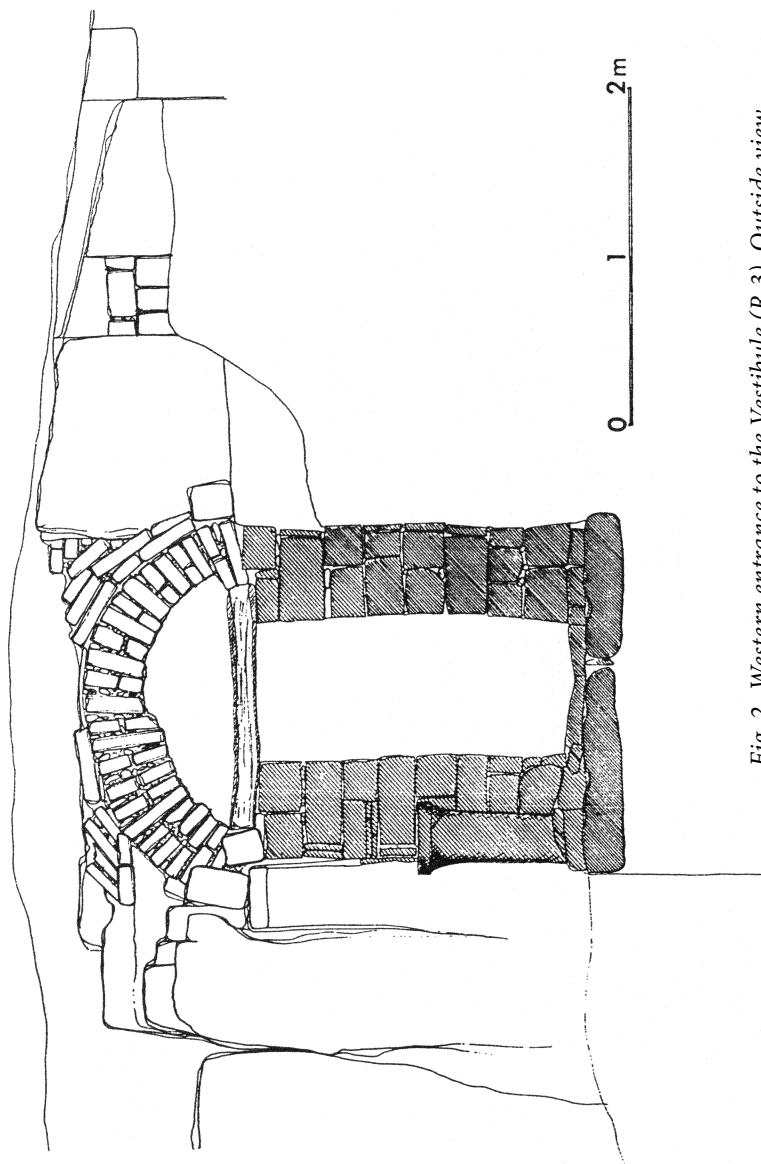
*Fig. 2. Western entrance to the Vestibule (R.3). Outside view.
Drawing B. Żurawski.*

Large-scale excavations in Building SW were triggered by the finding (in 1995) of two Late Christian murals representing the Enthroned Virgin Nursing the Child. The clearing of Rooms 1 and part of 2c in 1995 produced a third image of the Enthroned Virgin and Child, and two fragmentarily preserved murals representing a bishop (?) and a Prophet (?). An entrance vestibule was also traced north of Room 2a. It was entered through an arched opening flanked by stone jambs (Fig. 2). Fragments of a horizontal wooden beam were also found on top of the jambs.

In January 1996 excavations were resumed in the entrance vestibule (Room 3). The stone door jambs were exposed to the original walking level. The threshold was found at a depth of 3.20 m below the surface of the Kom. It was made of a reused stone toilet slab which was pierced in the middle. Two similar toilet slabs were found in front of the gate, at a slightly lower level than the threshold because of the sloping ground here. On top of the northern slab (provided with two perforations) a truncated column shaft was found in a semi-vertical position. A bowl-like depression in the top of a shaft seems to suggest its use as a font. Its location to the left of the entrance appears not to be accidental.

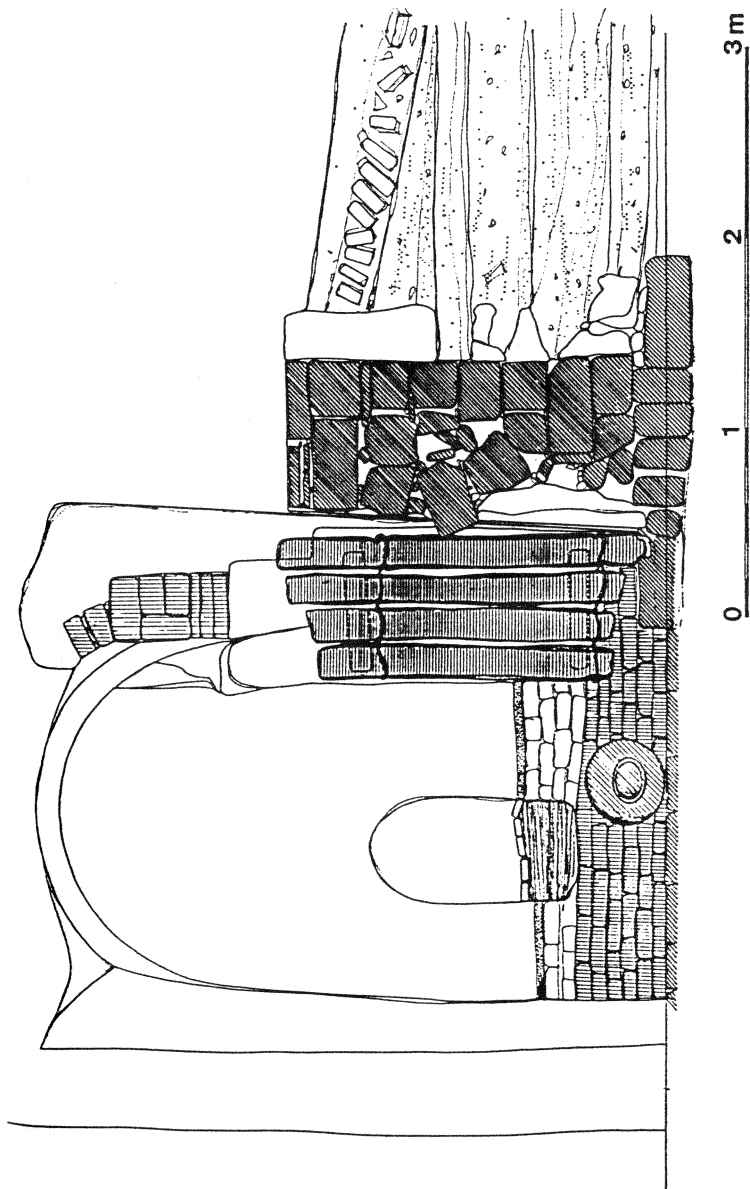
Fig. 3. Section E-W through the Vestibule (R.2). Looking south.
Drawing B. Żurawski.

The Vestibule (R.3) was paved with roughly dressed stone blocks. The western entrance was closed with a door made of four palm logs tied together with ropes and connected by stretchers (Fig. 3). A finely dressed stone was used as a door socket placed in the southwestern corner of the vestibule.

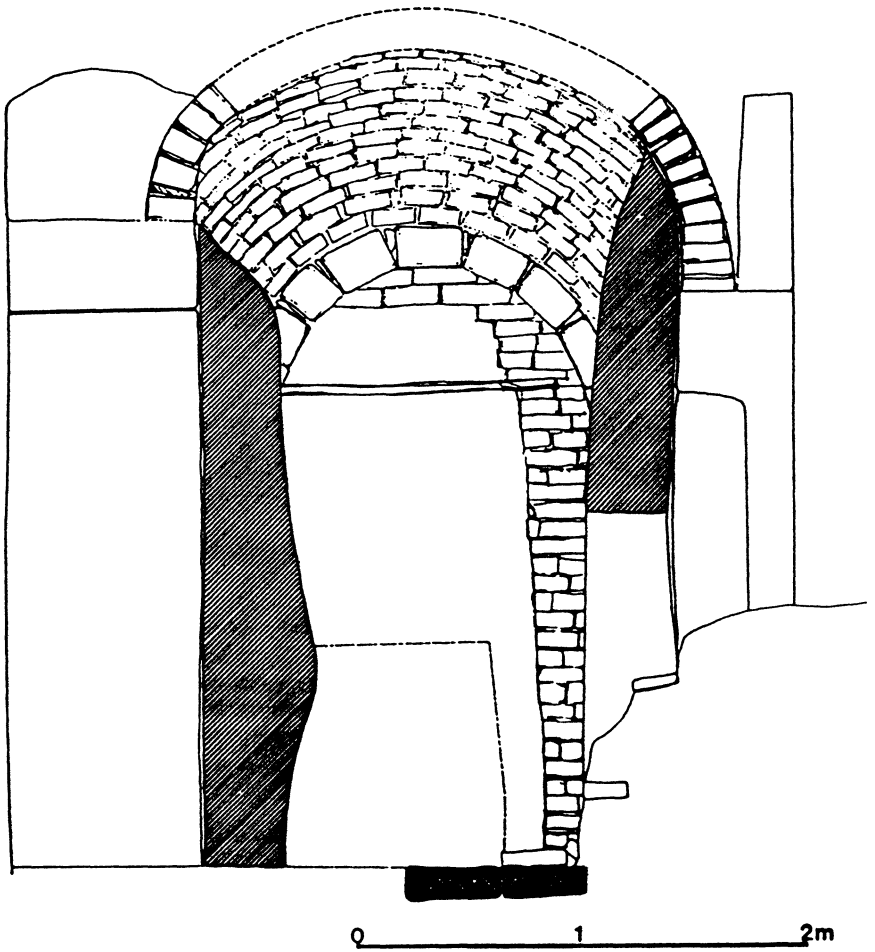
Fig. 4. Section N-S through the Vestibule (R.3). Looking east.
Drawing B. Żurawski.

The Vestibule (R.3) was constructed on a tetrapylon principle. Of its four arched openings, the northern one was blocked. The remaining three gave access to Rooms 2c and 5. The eastern opening was cut in the western wall of R.5 (since the Vestibule was added to R.5, it has no eastern wall of its own). Since the secondary openings cut through R.5's western wall had reduced its carrying strength considerably, the wall was doubled from the inside and buttressed by a coffer-like mud-brick structure filled with rubble. The western entrance was reinforced by two mighty stone jambs. The northwestern corner was enclosed within a mud-brick abutment and the incurved northern wall was additionally buttressed from inside (Fig. 4). The construction of a buttress against the southern wall reduced the span of the passage giving access to Room 2a.

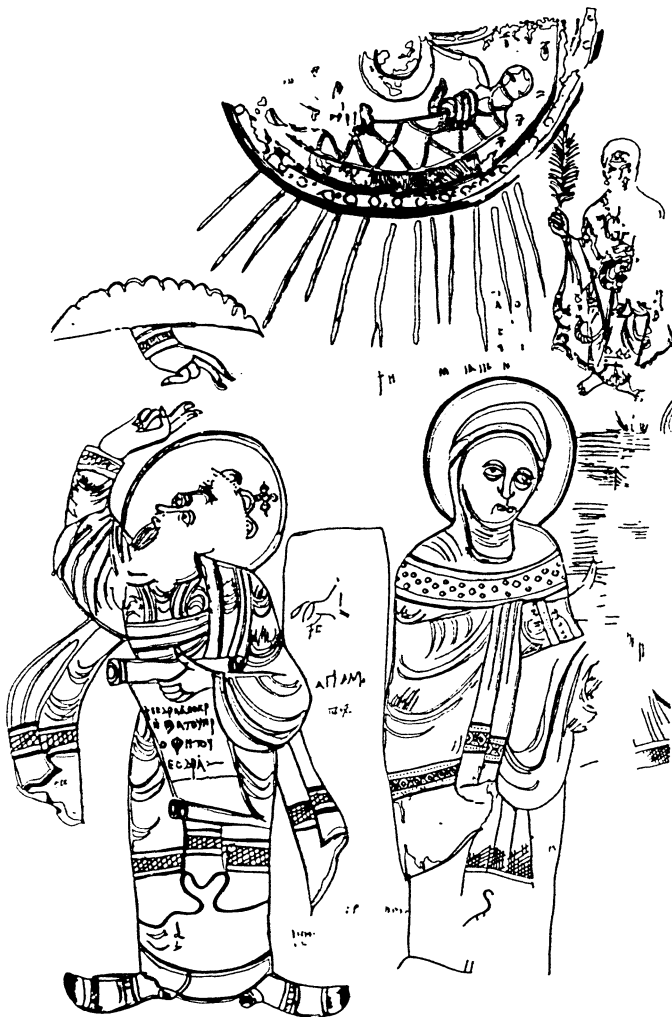
Fig. 5. Prophet Ezra. Painting on the western wall of Room 2.
Drawing W. Chmiel and B. Żurawski.

The magnificent murals adorning the walls of R.1 and R.2 were painted on the latest walls inside the building (Fig. 5). In R.2, the murals were painted on the first layer of plaster. Simultaneously, the intrados of the arched passage from R.1 into R.2 was plastered and a set of murals that was uniform in style and execution with those in R.2 was executed.

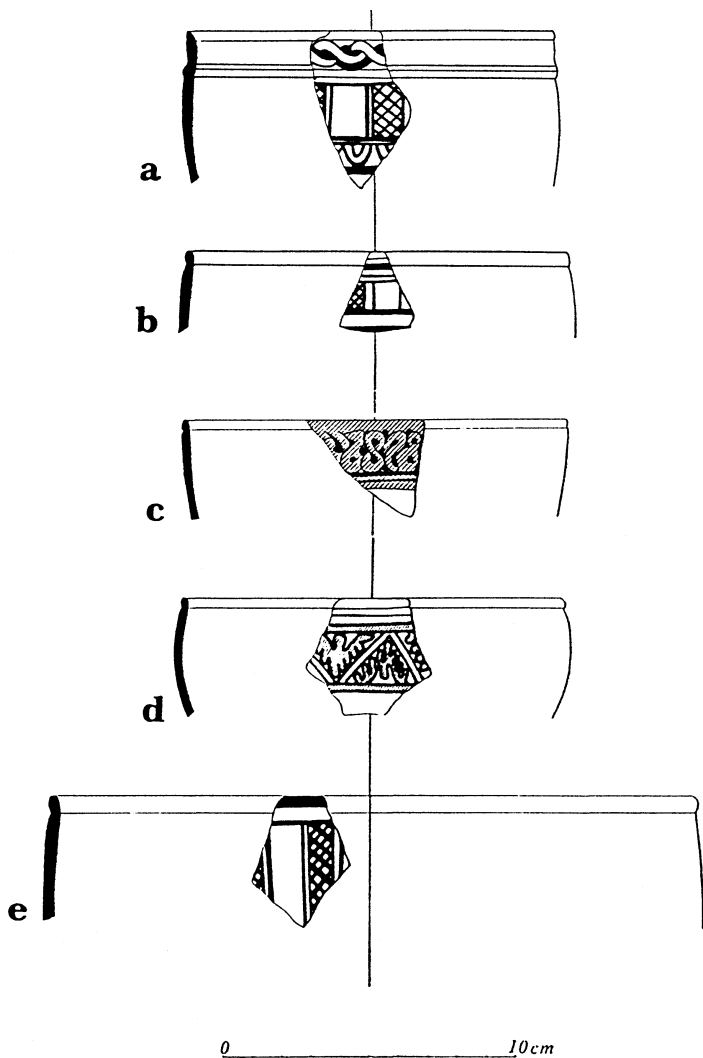
Fig. 6. Pottery from the layer of domestic waste (earliest habitation phase).
Drawing B. Żurawski.
