Late Pueblo III sites in Lower Sand Canyon locality, Montezuma County, Colorado - preliminary report of the archaeological survey of 2009

Contributions in New World Archaeology 2, 113-144

2010

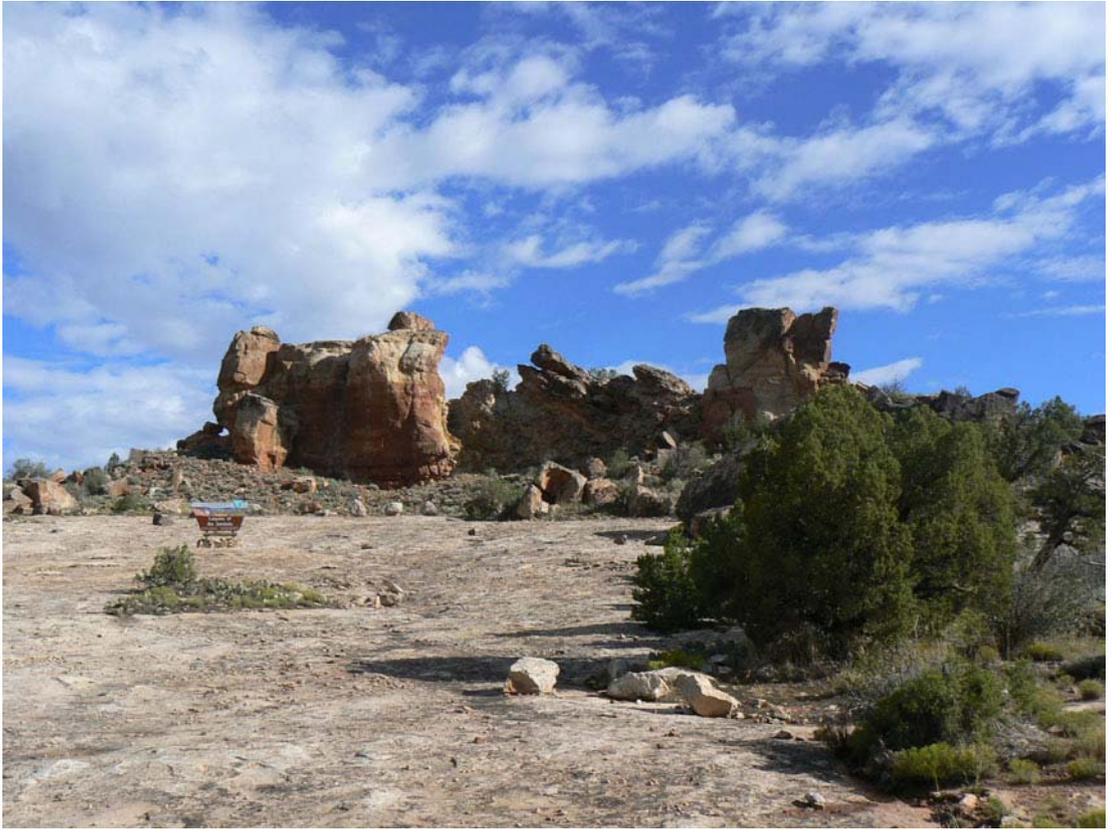
Fig. 6. Castle Rock Pueblo; looking northeast. Photo by R. Palonka.

Castle Rock Pueblo is situated on and around the base of a 20 m (65 ft) tall butte (Fig. 6), the lower section of which is Entrada Formation; the sandstone slickrock below the talus slope Navajo Formation (Varien 1999, ed. by). Most structures were built on the talus slope north and south of the butte and some are abutted to the butte face. Some buildings were also constructed on the butte itself and on a large boulder south of the butte. The sites face various directions; however, most of the structures within these sites probably faced south.

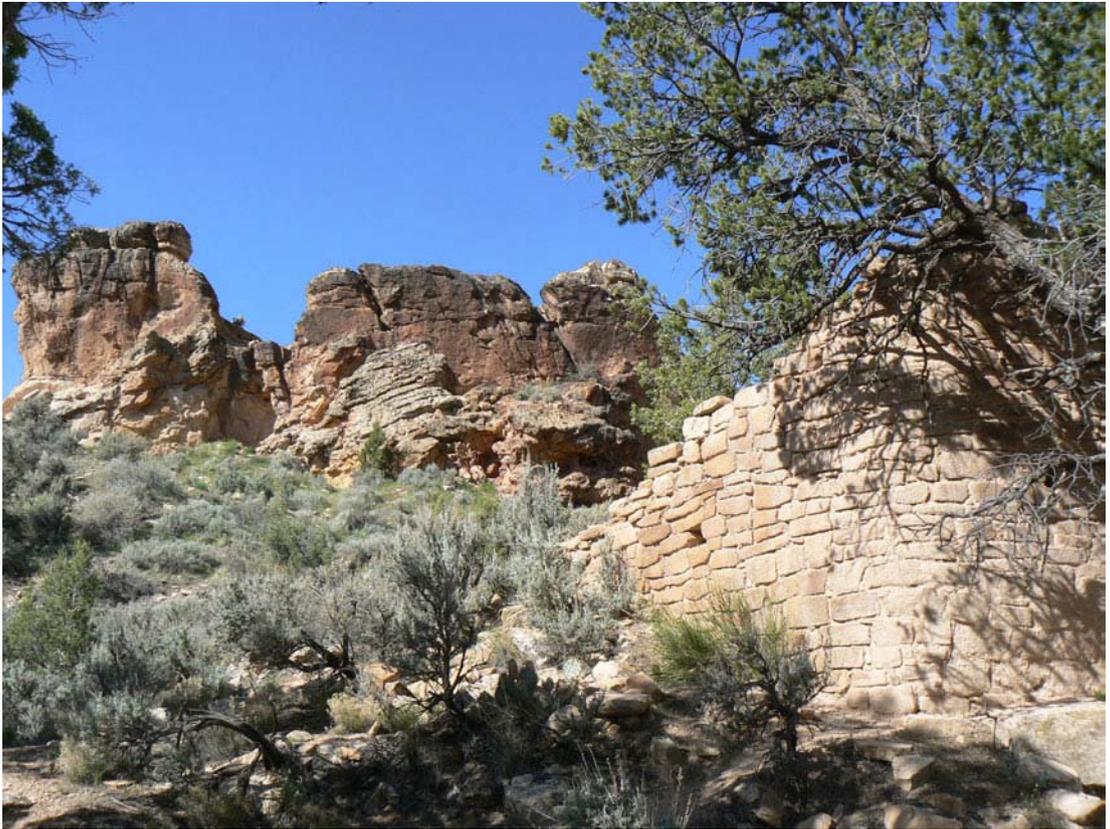
Fig. 7. Castle Rock Pueblo: Structure 404/409 (tower) with loophole in east wall. In the foreground the north face of the butte. Photo by R. Palonka.

An estimated nine towers were constructed at Castle Rock Pueblo; this estimate resulted from excavations conducted at the site from 1990 to 1994 by the Crow Canyon Archaeological Center (Kuckelman 2000, ed. by; Kuckelman et al. 2002:488). Six of these (structures 207/208, 301, 305, 307/310, 401, and 404/409/410 – Fig. 7) were tested during excavations, and three additional structures

Towers were constructed in different areas of the settlement. At least three were built on the top of the butte—Structure 301 plus two structures known only from historic photographs. The others were built on the northern and western sides of the village. Structure 301 might have protected the northern approach to the butte (Kuckelman 2000, ed. by). Structures 305 and 307/310, along with Structure 301, might have also protected access to the butte from the north. Kuckelman (2000, ed. by) concluded that the structures considered to be towers at Castle Rock Pueblo were built to increase the defensibility of the village; at least three were situated on the butte top in difficult-to-access locations. Structure 408

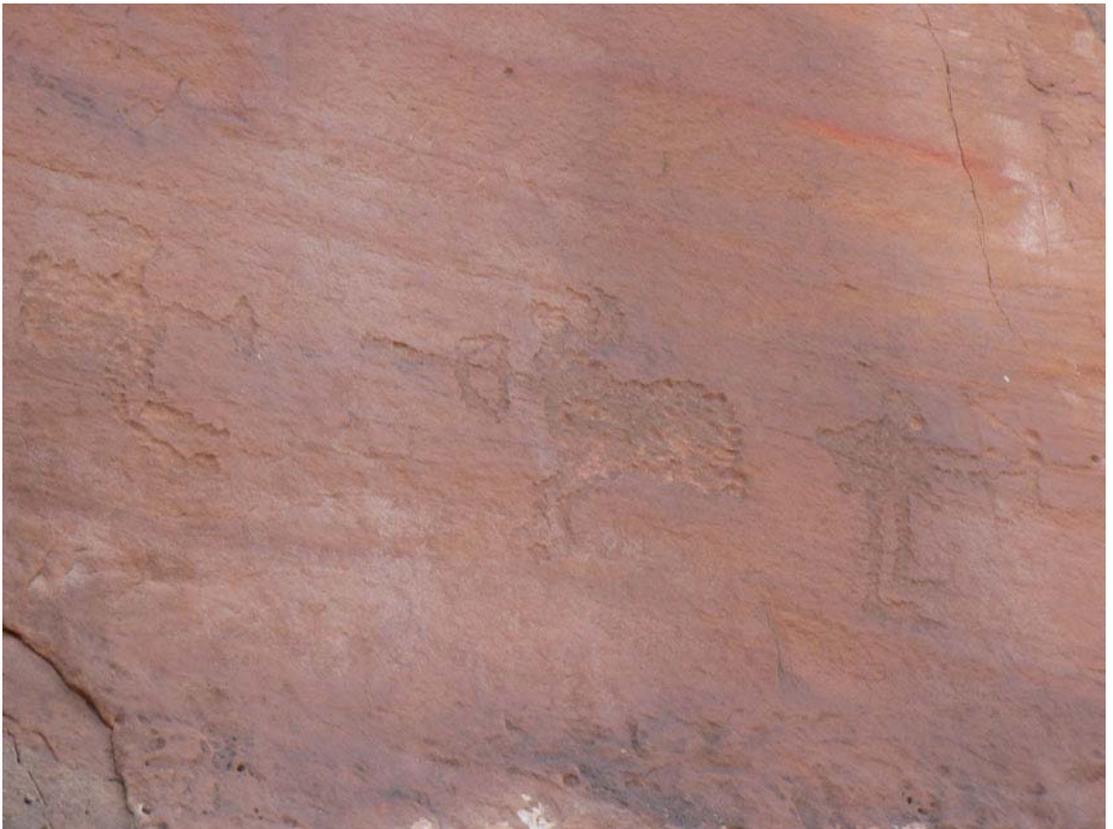
Fig. 8. Rock art in Castle Rock Pueblo showing the fighting peoples. Photo by R. Palonka.

A rock art panel on the north face of the butte depicts three people fighting (Figs. 8-9). “The three figures have rectangular or globular bodies that may represent warriors’ shields. The figure in the center and the figure on the right hold bows and arrows, stand back-to-back, and appear to be defending each other. The figure in the center seems to be shooting an arrow toward the figure on the left. The figure on the left, with his legs in front of him, appears to be falling away from the central figure and holding up a shield in defense against the arrow” (Kuckelman 2000, ed. by). Kuckelman infers that this panel was created during the occupation of the settlement, or it was made by the survivors or attackers after the battle at Castle Rock Pueblo that forced the surviving residents to migrate.

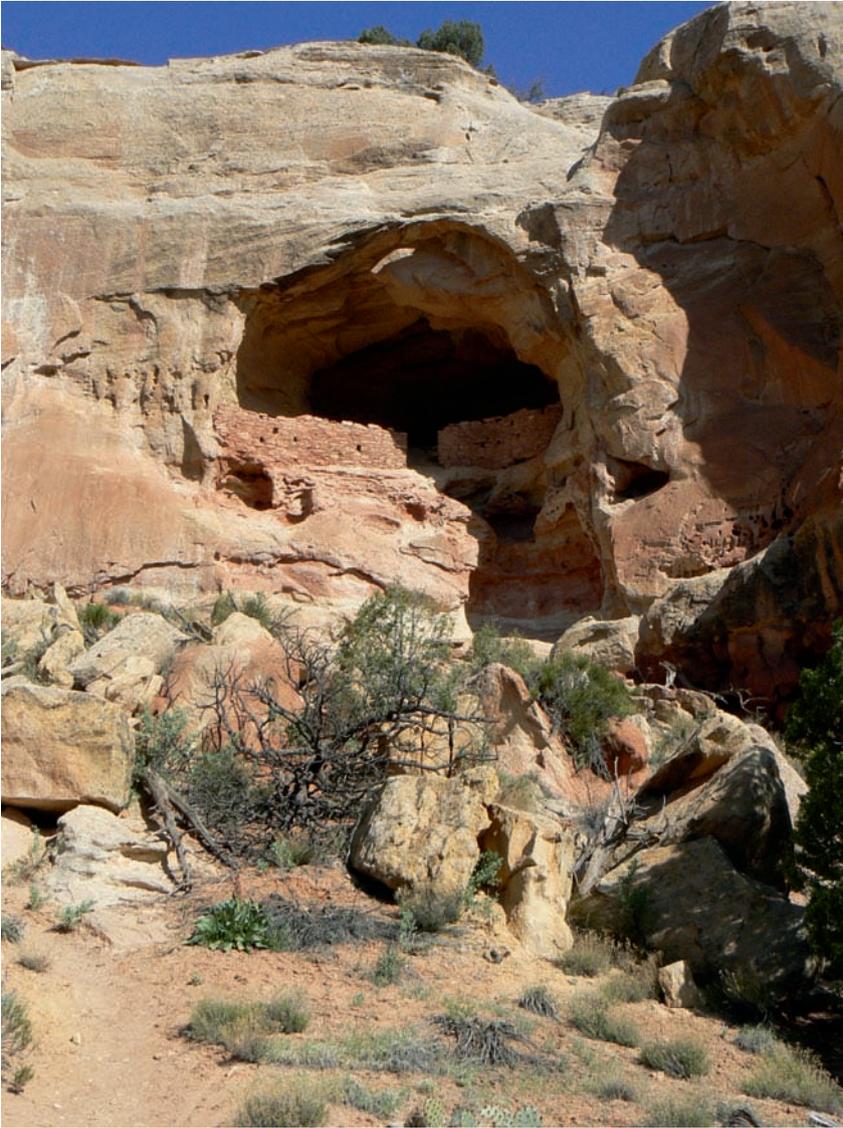
Fig. 11. Photo of Site 5MT1826; general view from the south. Photo by R. Palonka.

At small sites in the lower portion of the Sand Canyon locality, in the proposed Castle Rock Community, evidence of retaining walls can be observed below some alcoves. Walls that were built along the entire length of the alcove are visible at sites such as 5MT265, 5MT1826 (Figs. 10–12),

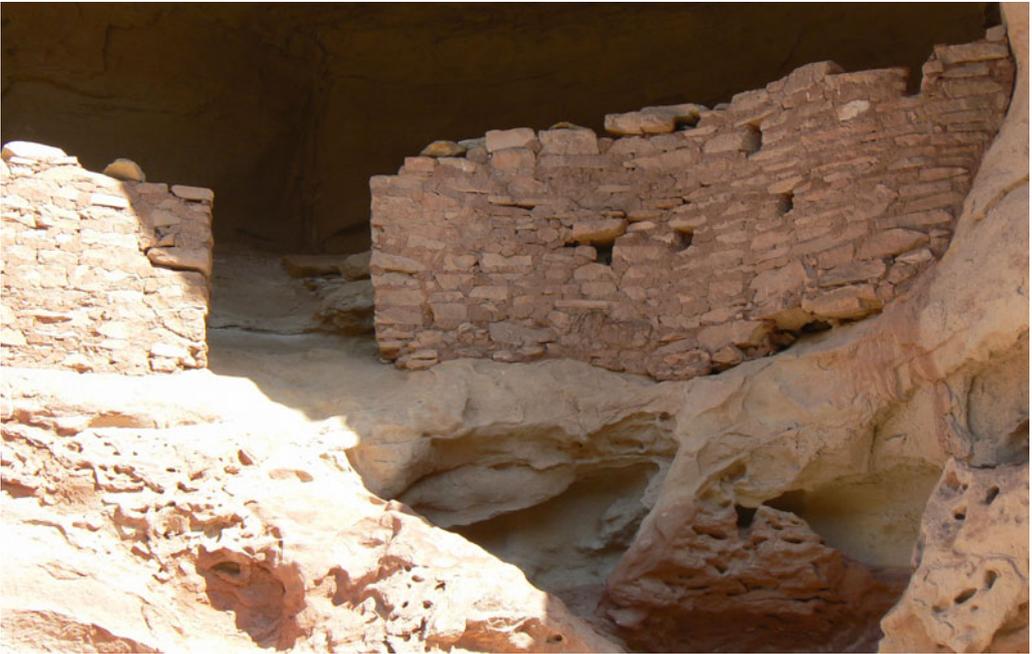
Fig. 12. Photo of Site 5MT1826 with visible loopholes or windows and the doorway. Photo by R. Palonka.

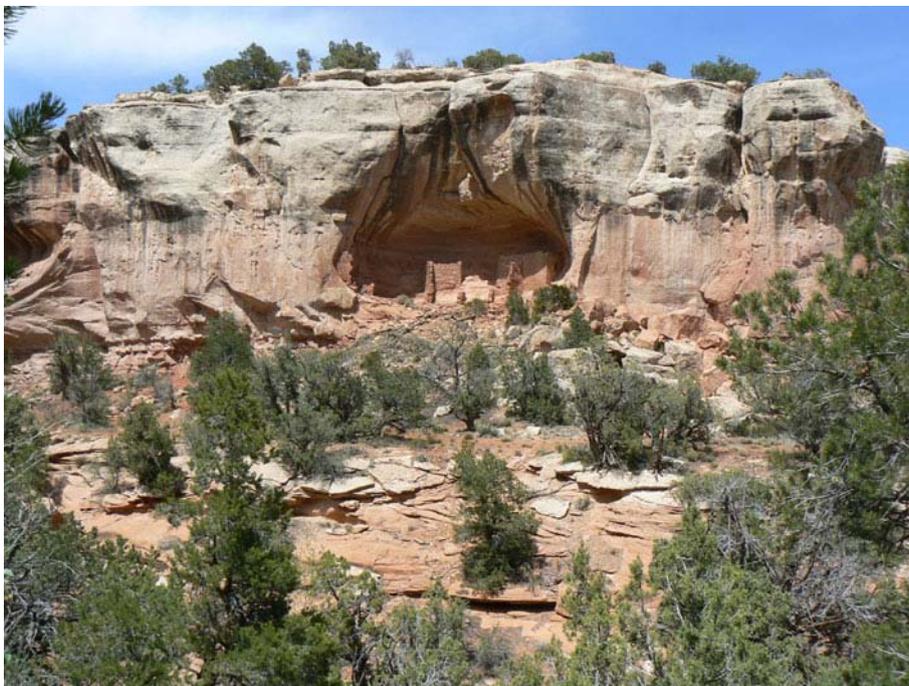
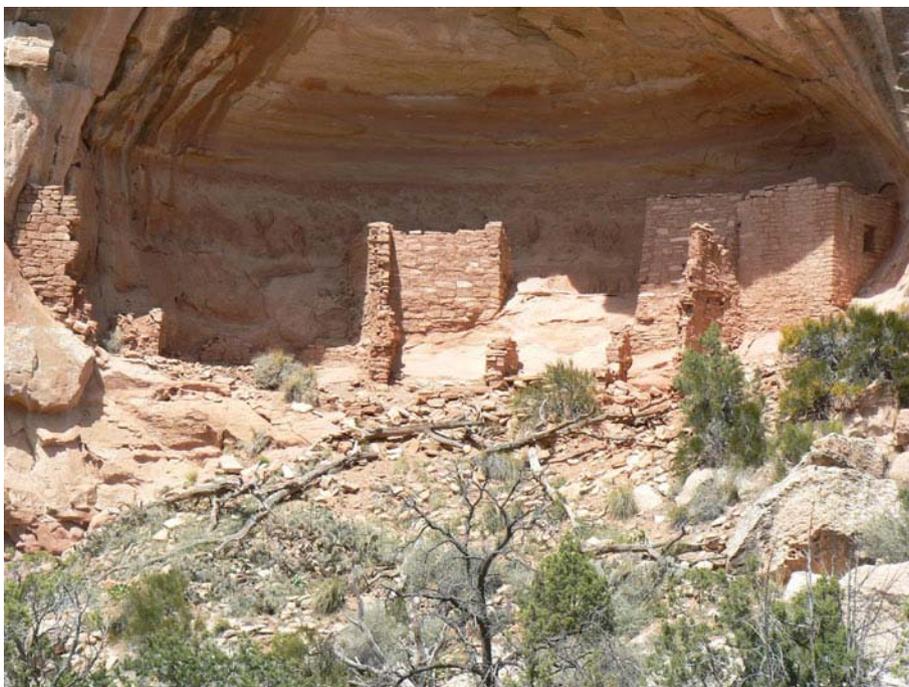
Figs. 14 a, b. Photo of Site 5MT135. View from the tower considered as a part of the site. Photo by R. Palonka.

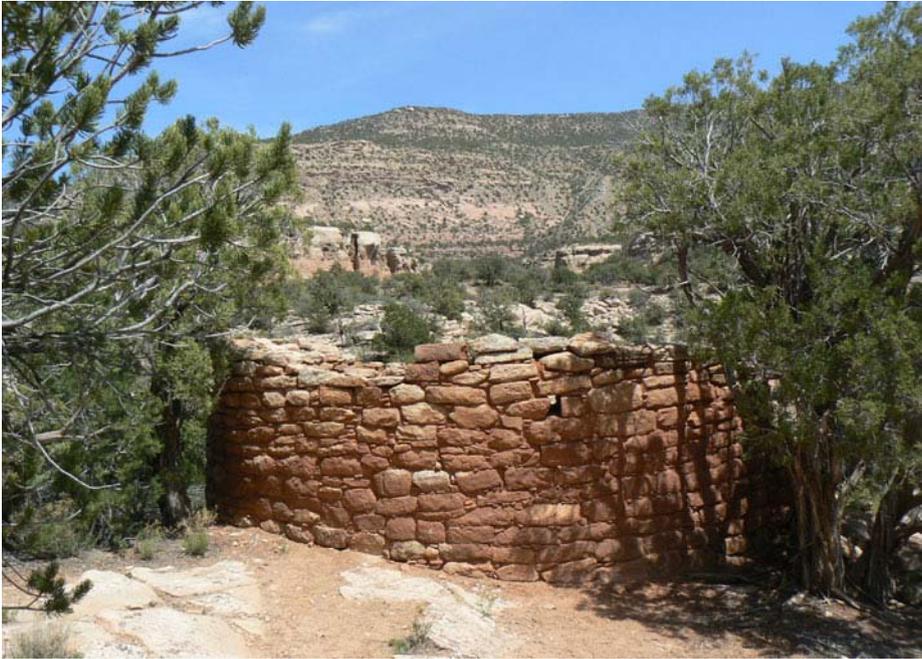
Fig. 15. Photo of tower included in Site 5MT135. Photo by R. Palonka.

Also the loopholes are present at small sites in the proposed Castle Rock Community. This includes small rectangular loopholes in the tower associated with Site 5MT135; at least one of these loopholes provides a view of the only route to the tower and to Site 5MT135 in a cliff alcove. Loopholes were

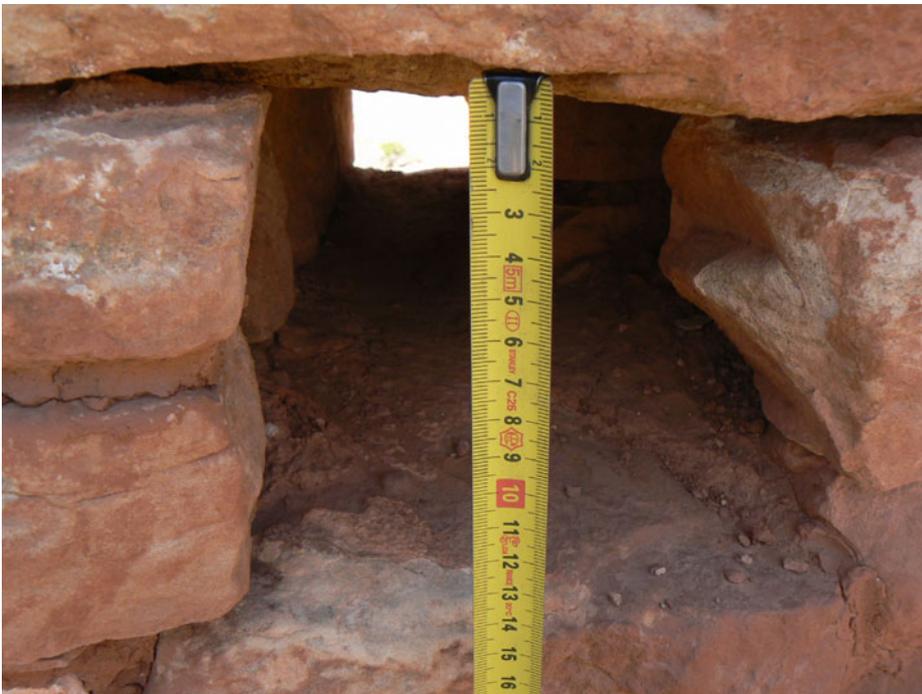
Fig. 16. A loophole in the tower in Site 5MT135 (the example of typical loopholes that may be seen in towers and walls of sites in Lower Sand Canyon). Photo by R. Palonka.

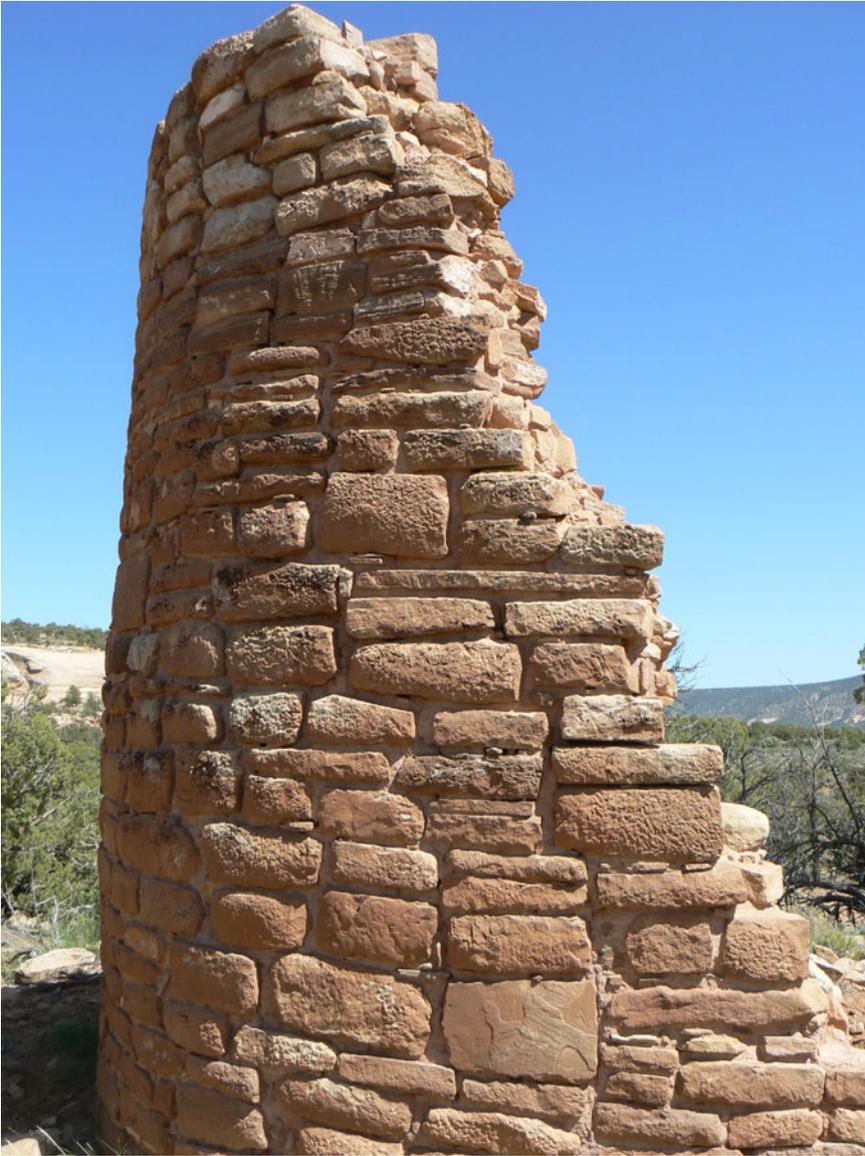
Fig. 18. Photo of Mad Dog Tower. Photo by R. Palonka.

Intervisibility has been confirmed in the fourth proposed group: Mad Dog Tower (Site 5MT181) and the tower located above Saddlehorn Hamlet (Site 5MT262) 1 km west across Sand Canyon. This intervisibility indicates that inhabitants of the two habitations could have communicated via the towers if the two habitations were contemporaneous. Other sites with towers that might have been contemporaneous with 5MT181 are Site 5MT2797, which lies 300 m to the southeast, and Site 5MT261, located 720 m to the southwest. All of these sites include a structure that may be called a tower or a "lookout" structure. From these structures, at least two, and possibly all, of the other sites were visible (Kleidon 1999; observation made by the author). Sites 5MT261 and 5MT257 might have been intervisible; the latter is located in relatively strategic high point of a talus slope on a bench overlooking McElmo Canyon.

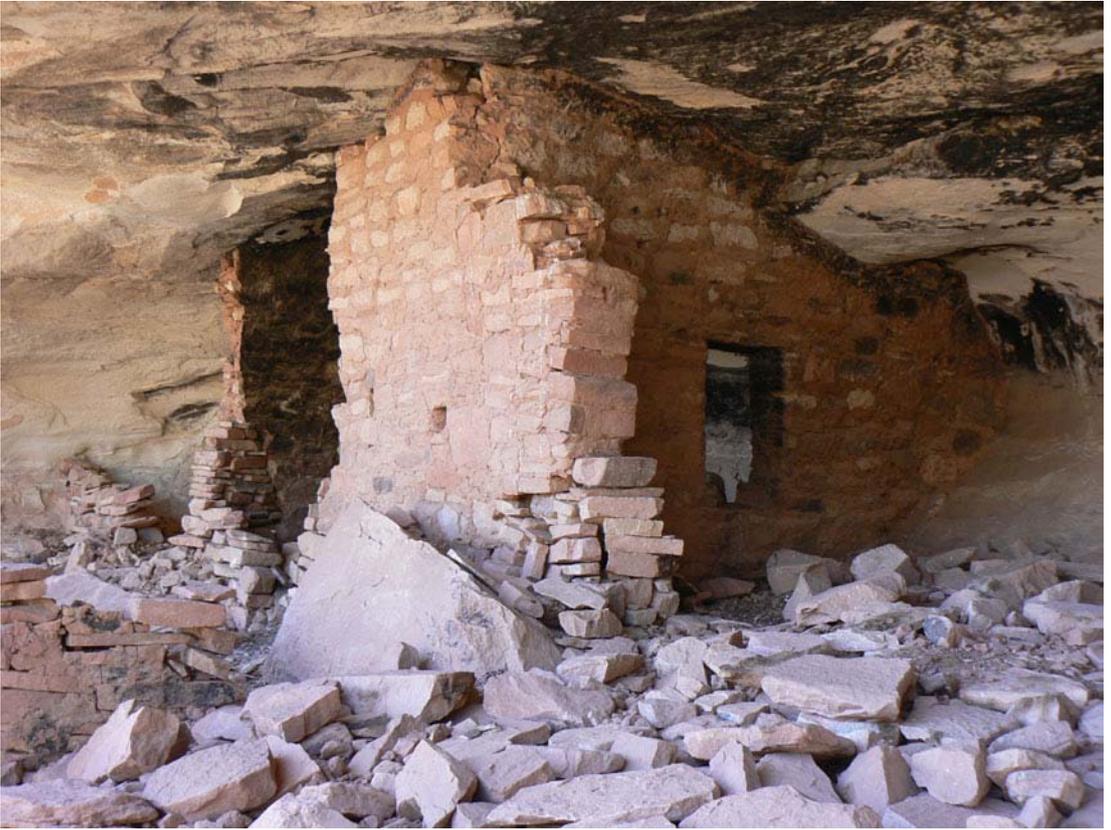
Fig. 20. Part of the Site 5MT261. Photo by R. Palonka.

constructed in the southern or outer walls of rooms at Site 5MT186 and in the outer walls of at least one room at Site 5MT261 (Fig. 20). One possible loophole in a tower at Site 5MT261 affords a view northeast to the main part of the site. A loophole in the tower that is Site 5MT1842, associated with Site 5MT264, provides a view of the main part of the site in a cliff alcove 100 m from the tower. Some loopholes were constructed in walls built along the edges of alcoves. These features vary in height above the floor of the cave but none are higher than 1 m above the floor. Site 5MT1826 contains several such loopholes; at least four are located west of the entryway, and at least six are east of the entryway. The outer wall of Site 5MT1831 (Fig. 21) contains at least 12 loopholes, and although most are angled downward, one is level, and one opening is located in the southern wall of the passageway. A possible loophole was noted in a room at Site 5MT1807. Loopholes might also have existed at other sites, especially in walls near the edges of alcoves; however, most of these walls are too poorly preserved to make an accurate assessment. Other and larger openings such as windows might have also been used as lookouts.

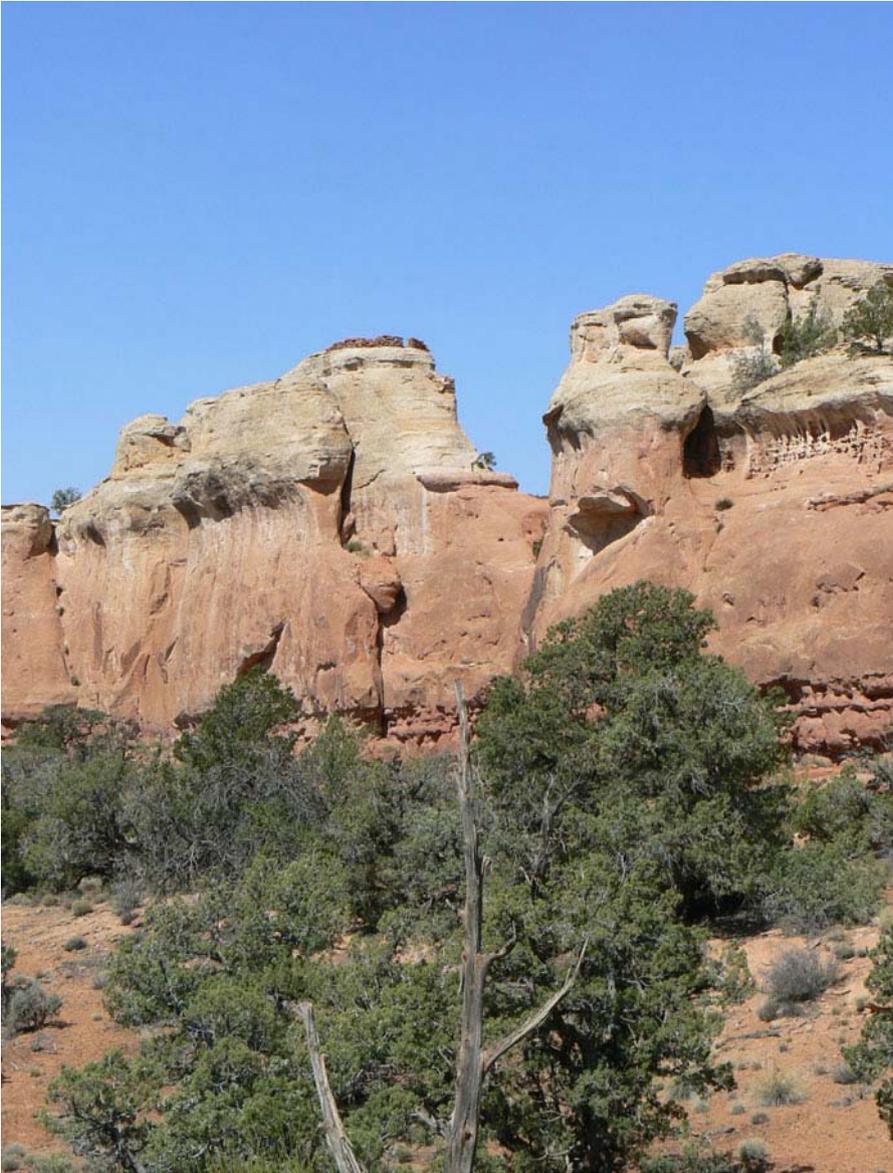
Fig. 22. Photo of Site 5MT2800. Photo by R. Palonka.

possible group consists of five sites: 5MT1826, 5MT1827, 5MT1828, 5MT2799, and 5MT2800 (Fig. 22). The second group consists of eight sites: 5MT264 and 5MT1842, often considered one site; 5MT265; 5MT1831; 5MT2636; 5MT1829; 5MT13251; and 5MT14659. A third group might have been formed by sites 5MT135, 5MT133, 5MT134, 5MT132, 5MT125, 5MT126, 5MT127, 5MT129, 5MT182, and possibly 5MT186. The fourth group consists of sites 5MT181, 5MT257, 5MT261, 5MT262, 5MT263, 5MT1804, 5MT2797, 5MT2801, and 5MT10366. The fifth group is made up of five sites: 5MT1805, 5MT1806, 5MT1807, 5MT1808, 5MT1824, 5MT2644. And the sixth group consists of four sites located on Battle Rock: sites 5MT1999, 5MT2000, 5MT2001, 5MT2002; however, these might be considered one site.
